**YGG CWMLLYNFELL  
BRYN ROAD  
CWMLLYNFELL**

**BAT (& protected spp.) SURVEY**

**September 2019-May 2020**

This report is a **May 2020 amended** version of a September 2019 submitted report of survey at the school, and incorporates an additional “in season” activity survey visit.

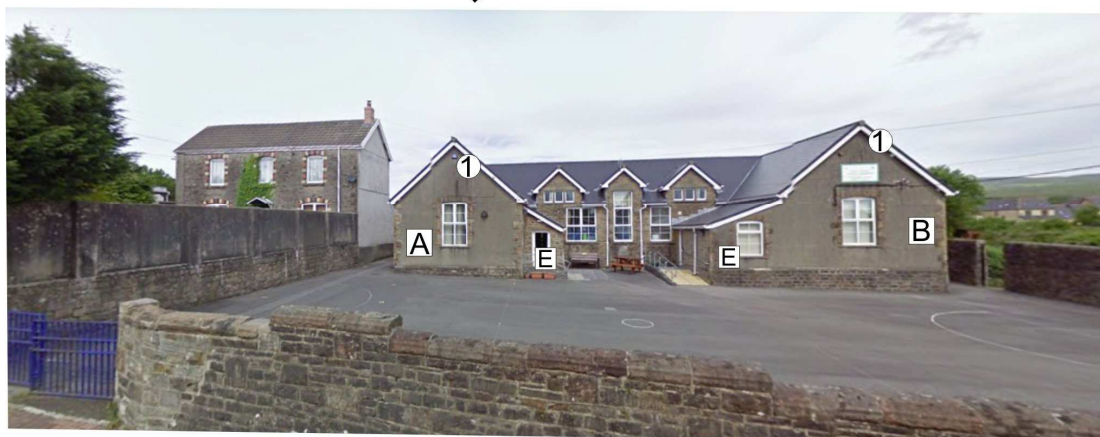
- 9.2 Buildings: general description; potential bat access points; evidence of bat presence:  
*annotation refers to sketch plan/photo, below*

The principal (original?) building consists of two north west-south east “wings” (A & B), connected by a north east-south west central section (D) and with a third nw-se, central section (C) between the two wings. A more recent single-storey, flat roofed, section (D) is built to most of the rear of the building. There are single storey lean-to/monopitch roofed extensions (E) at each inner wing at the school frontage.

The west longwall of A is masonry; all other walls (block at D; stone at others?) are externally rendered; all walls are in good repair, with no potential bat-access intra-masonry; all (uPVC) doors/windows are intact/sealed.

Walltops at A-E are generally sealed to soffits but with potentially bat accessible gaps (eg. 1, sketch plan/photo) at slight irregularities in the render faces at the main wings' front gables, single dormer gables at each external longwall and at three front dormer gables: no bat (guano) evidence was found at walls or pavement below these possible access opportunities.

Walltops at F are tight sealed to roof edges.

The flat roof at F is tight sealed at edge fold-overs to-wall, with no potential bat-access opportunity. All other roofs are slate clad, in good repair and with no (visible from ground) bat-access opportunity; all ridge tiles are tight-bedded.
