## PHOTOGRAPHIC LOG

**Site Location: Swansea University Bay Campus, Swansea**

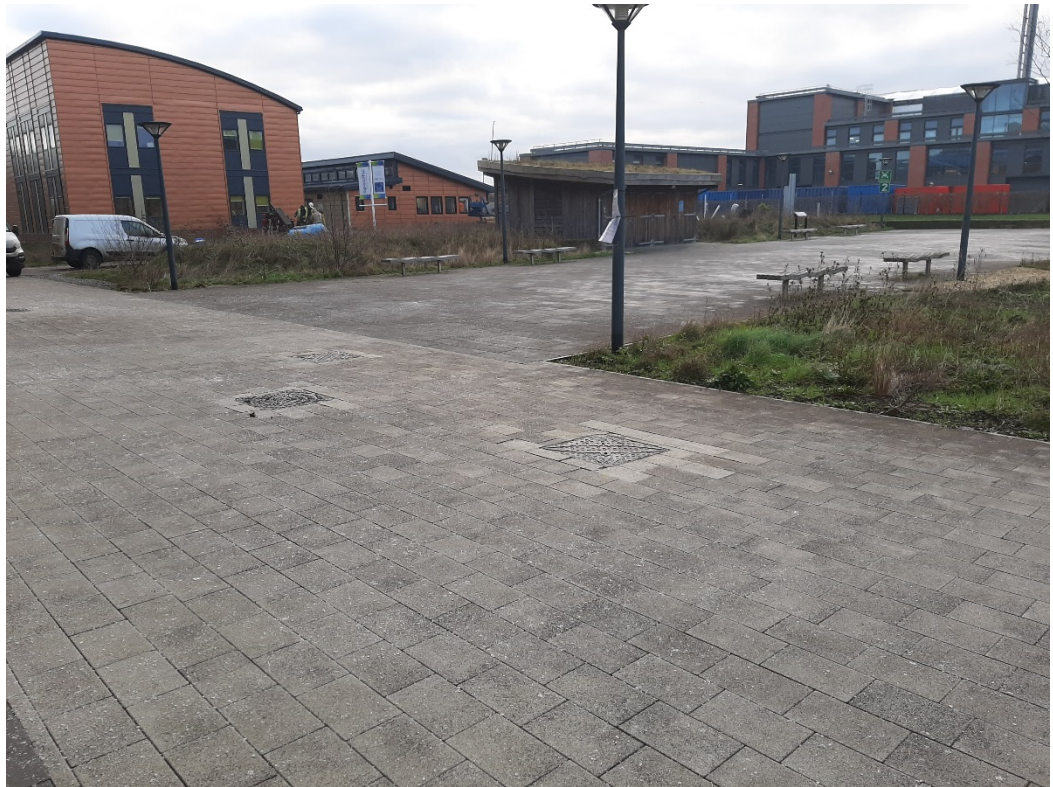
**Photo No.**  
**3**

General view  
of site facing  
southwest  
from  
northeast  
portion

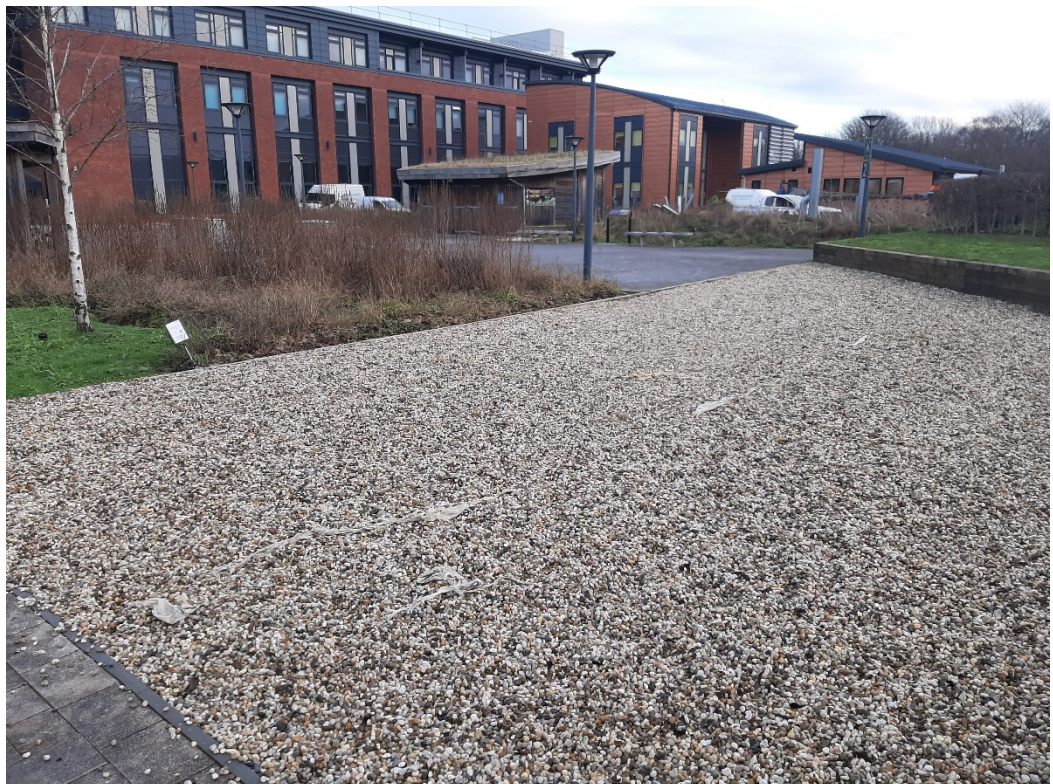
**Photo No.**  
**4**

General view  
of site facing  
northwest  
from  
southeast  
portion

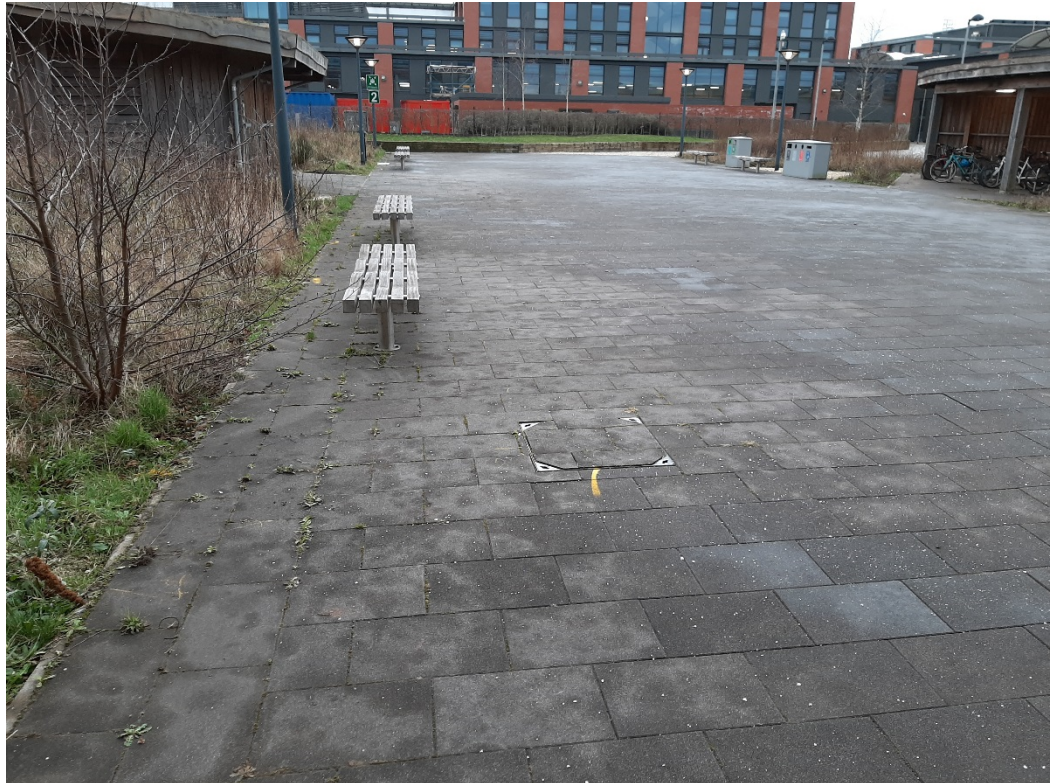
**Photo No.**  
**5**

General view of area in central portion showing paved pathway. Bike shed and pathway were in constant use. Services indicated underlying slabs.

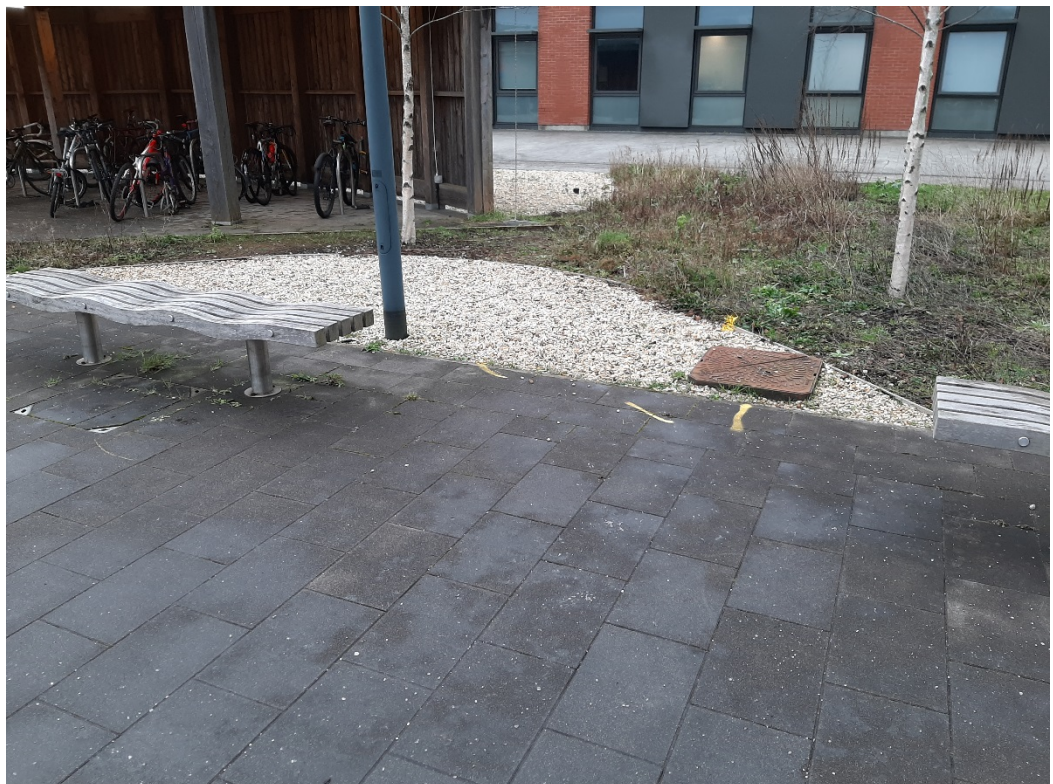
**Photo No.**  
**6**

General view of western portion of site. Further live services identified showing to cross pathway

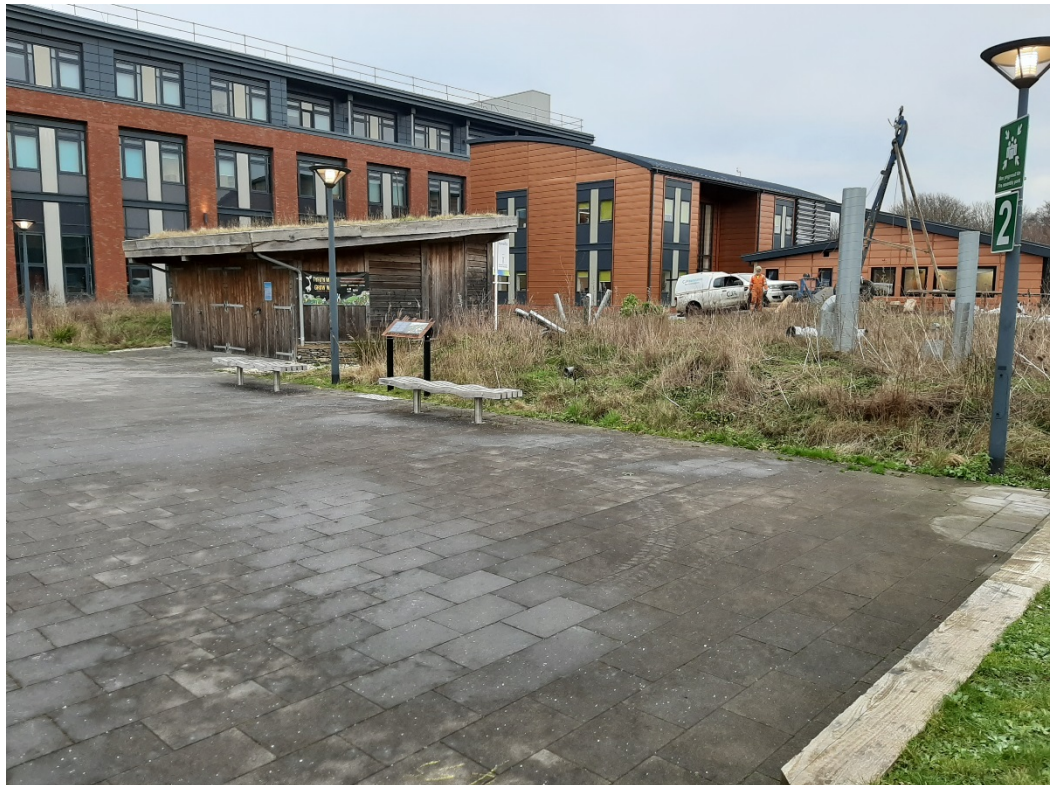
**Photo No.**  
7

Further view of walkway in western portion with potential service identified in the bottom centre of picture.

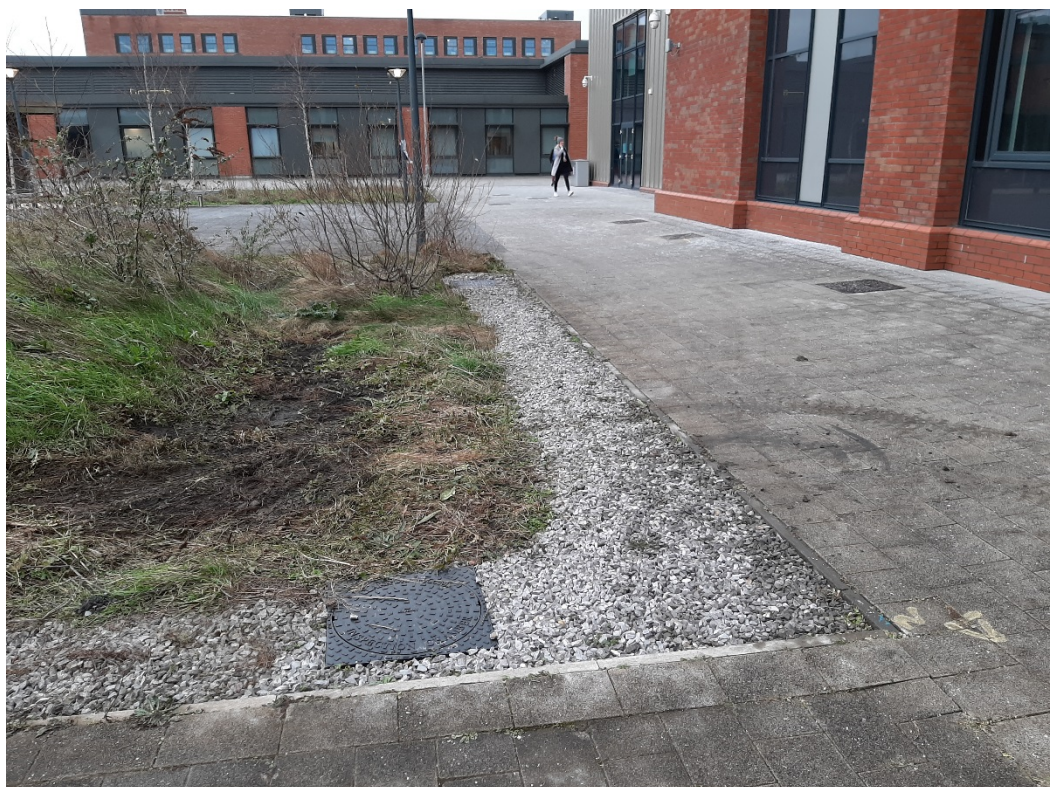
**Photo No.**  
8

General view of area in northern portion. Numerous visible services and further service running close to base of slope (BT)

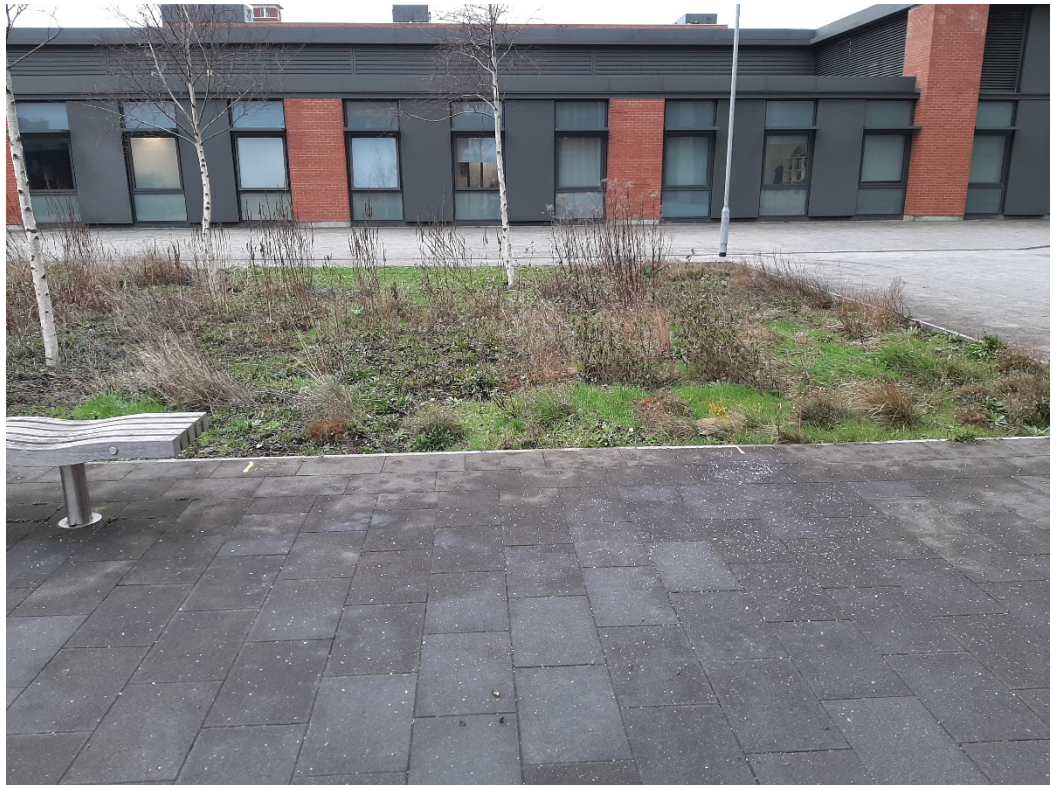
**Photo No.**  
**9**

Further view of western portion with potential service identified trending across the soft landscaping.

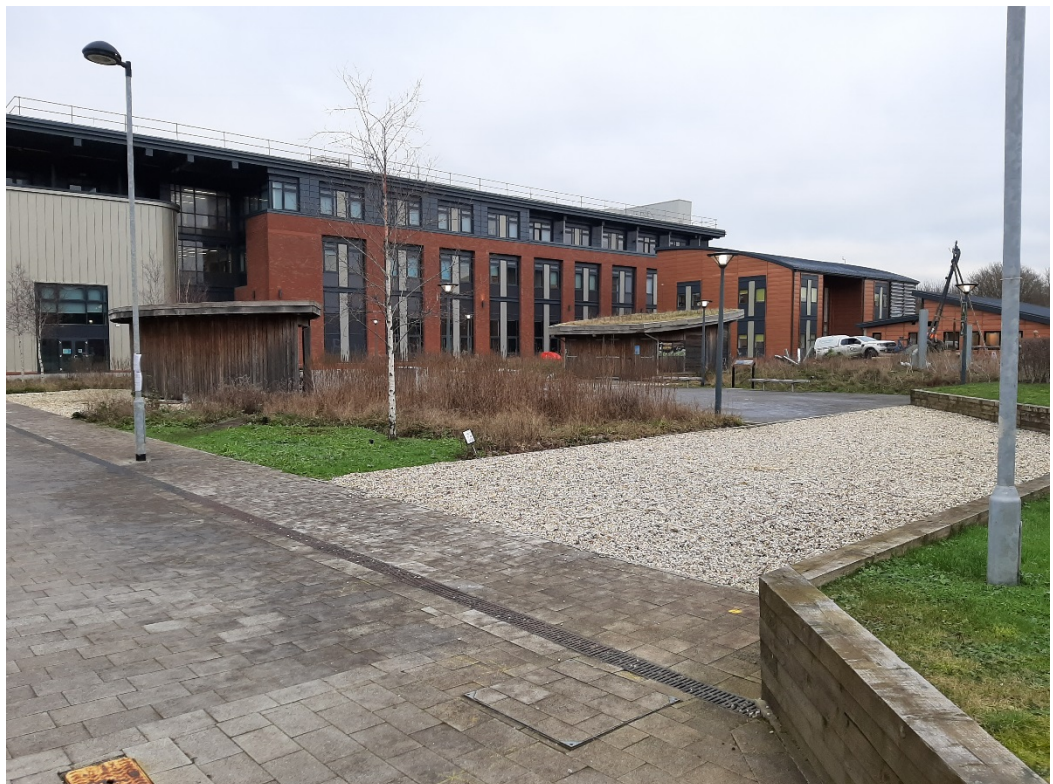
**Photo No.**  
**10**

General view of area in southern portion with services identified underlying the gravel surface
