# BAT SURVEY REPORT

SKEWEN SNOOKER CLUB

CASTLE GROUP

| <b>Project: SKEWEN SNOOKER CLUB</b> | | |
|---|---|---|
| <b>Document Number</b> | L015- Bat Report-V1.2 | |

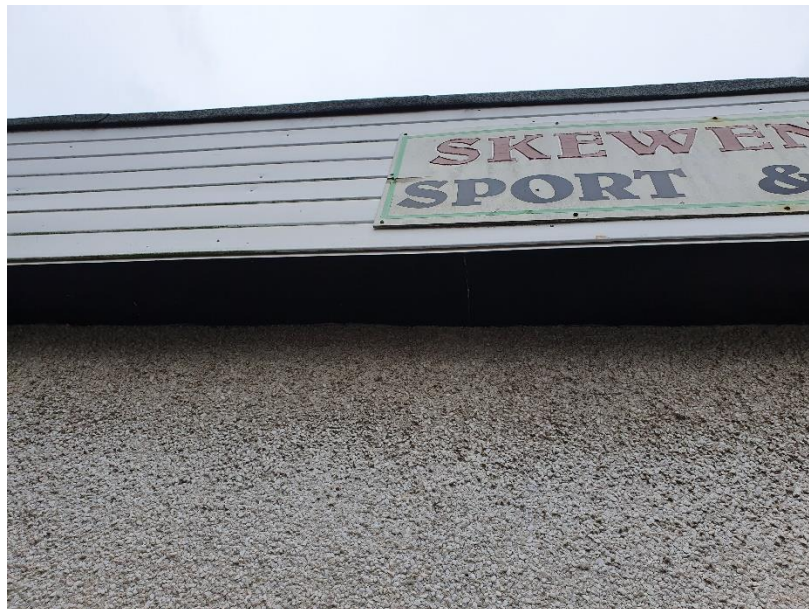
- 4.2 *Plate 1:* Front of the building. Along the front of the building (eastern aspect), the plastic facias are in good order and are flush with walls offering no suitable roosting features for bats.

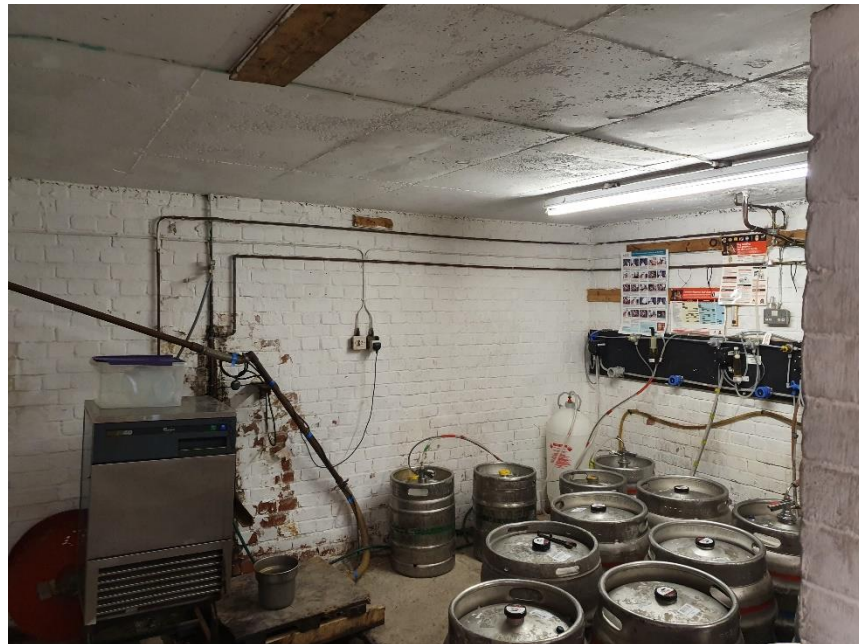
4.3

*Plate 2:* Inside the cellar. The cellar has a solid ceiling and brick walls, negligible bat potential.

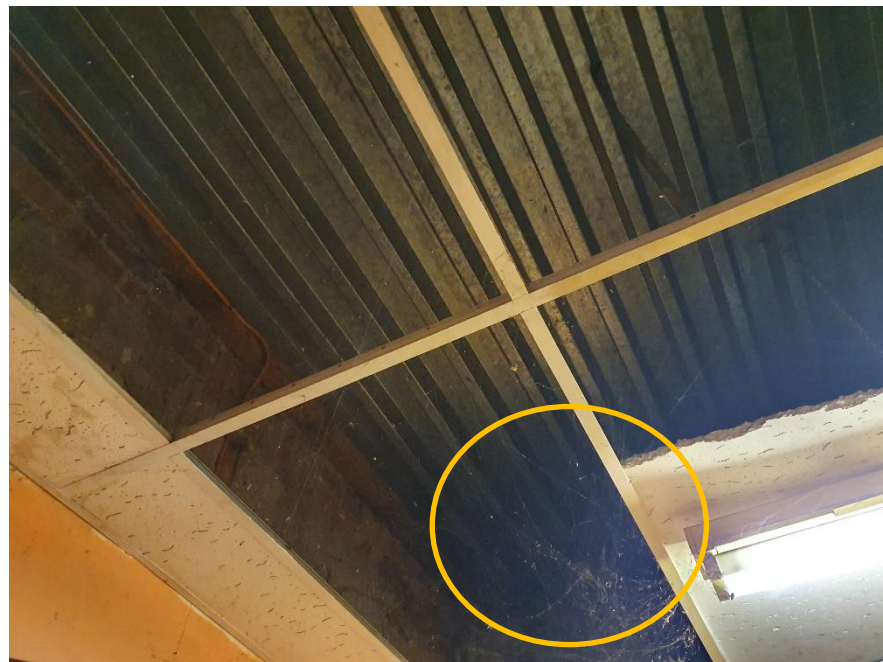
4.4

*Plate 3:* The roof of the snooker club is corrugated steel, with a suspended ceiling. The yellow circle highlights the cobwebs and the lack of any activity within the suspended ceiling.

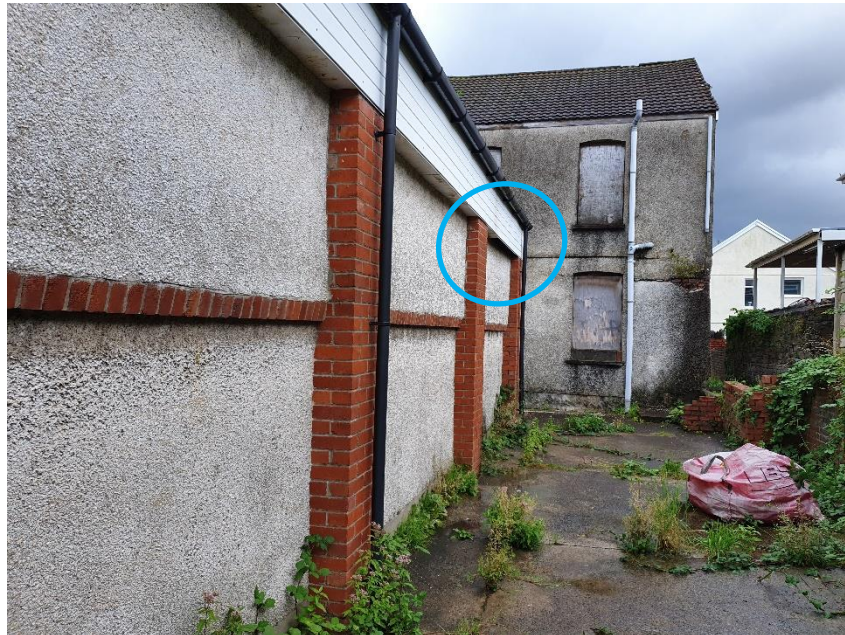
4.5

*Plate 4:* The plastic fascia's along the southern side of the building are in slightly poorer condition with a small bit of damage to the soffit boards.

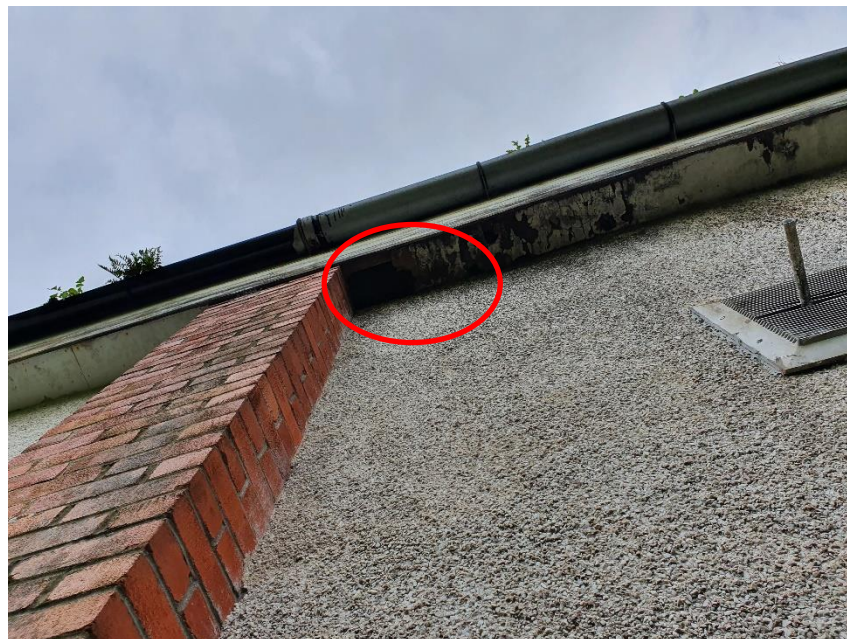
4.6

*Plate 5:* Further damage to the soffit along the southern aspect of the building.

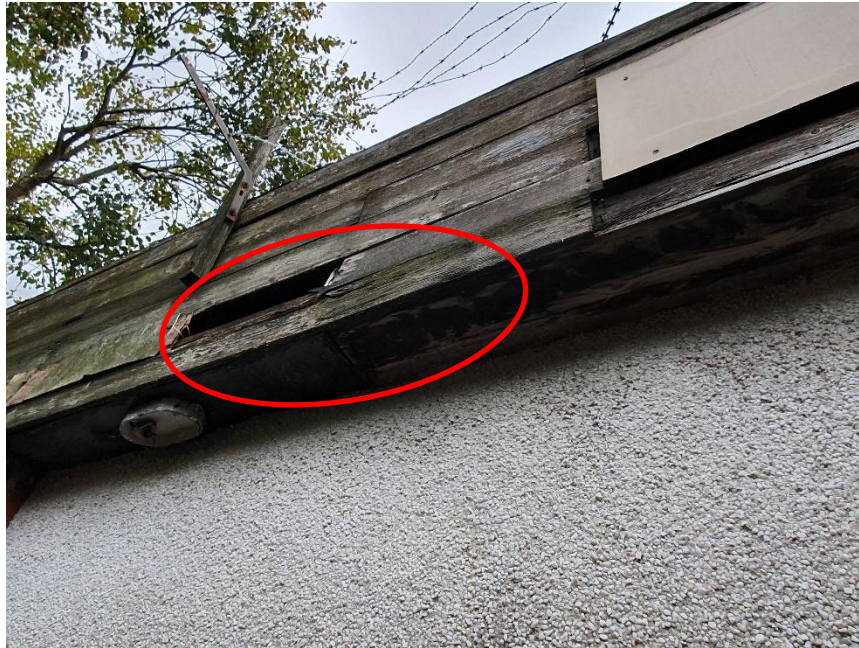
4.7

*Plate 6:* The rear fascia's (western aspect) are in wood, and in poor condition and likely an original features of the building. The holes in the wood offer low roosting potential for bats.

Considering the number of potential access points, the lack of any bat evidence, and the lack of internal activity, the building has been designated as having low suitability for bats.
