Bat Roost and Emergence Survey

**Pentyla Farm, Kenfig Hill, Bridgend CF33 6RD**

# **Report on survey for Bat Roost sites**

at  
**Pentyla Farm,  
Kenfig Hill,  
Bridgend  
CF33 6RD**

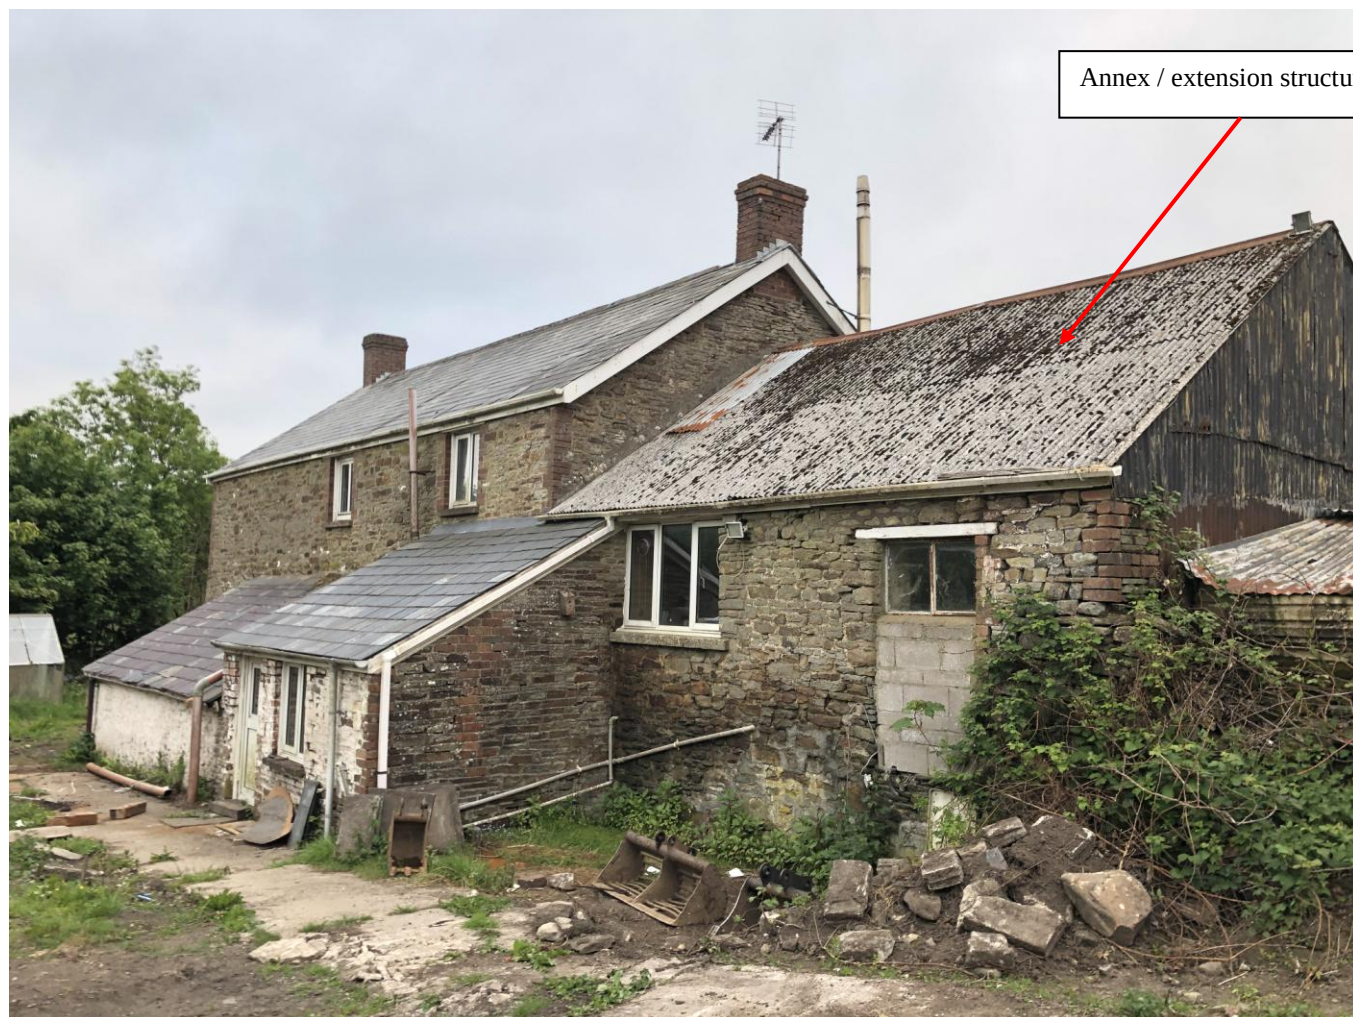
#### North Elevation:

**7.2** The annex building structure appeared to be in relatively dilapidated condition, with significant gaps in the masonry on the north side and gaps around the asbestos cement and corrugated metal roof covering and side panel. The fascia boards had a number of gaps along the lower edge which could potentially provide roosting opportunities. The open-fronted garage to the west elevation presented limited opportunities but also formed part of the survey.

Annex / extension structure

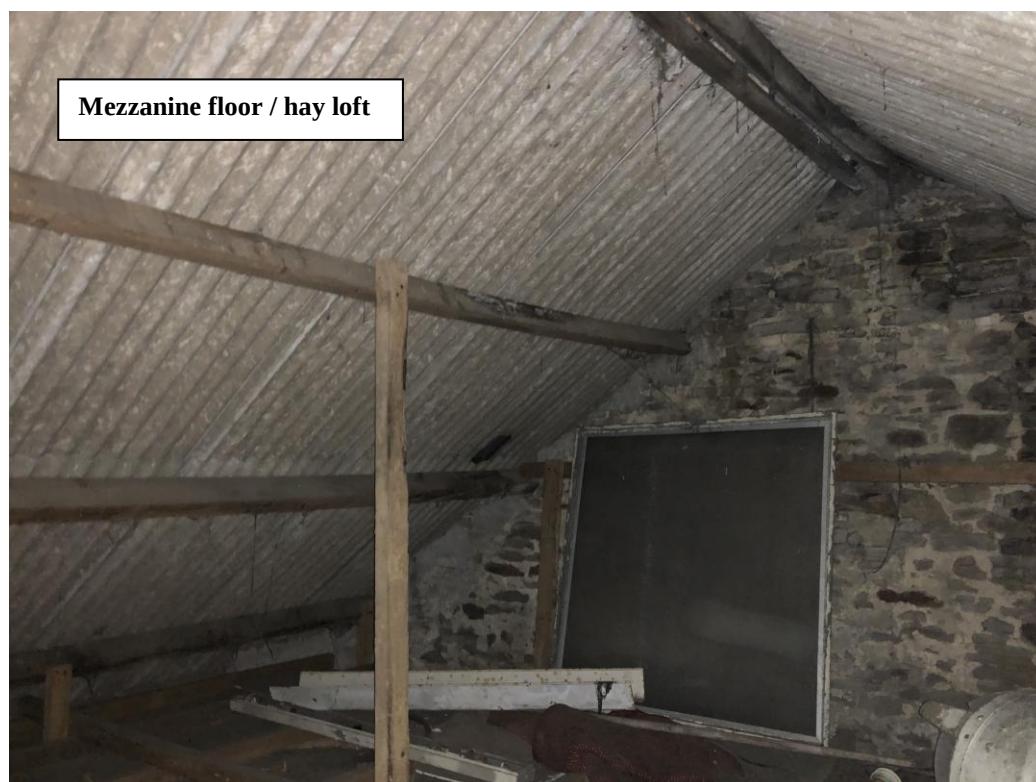
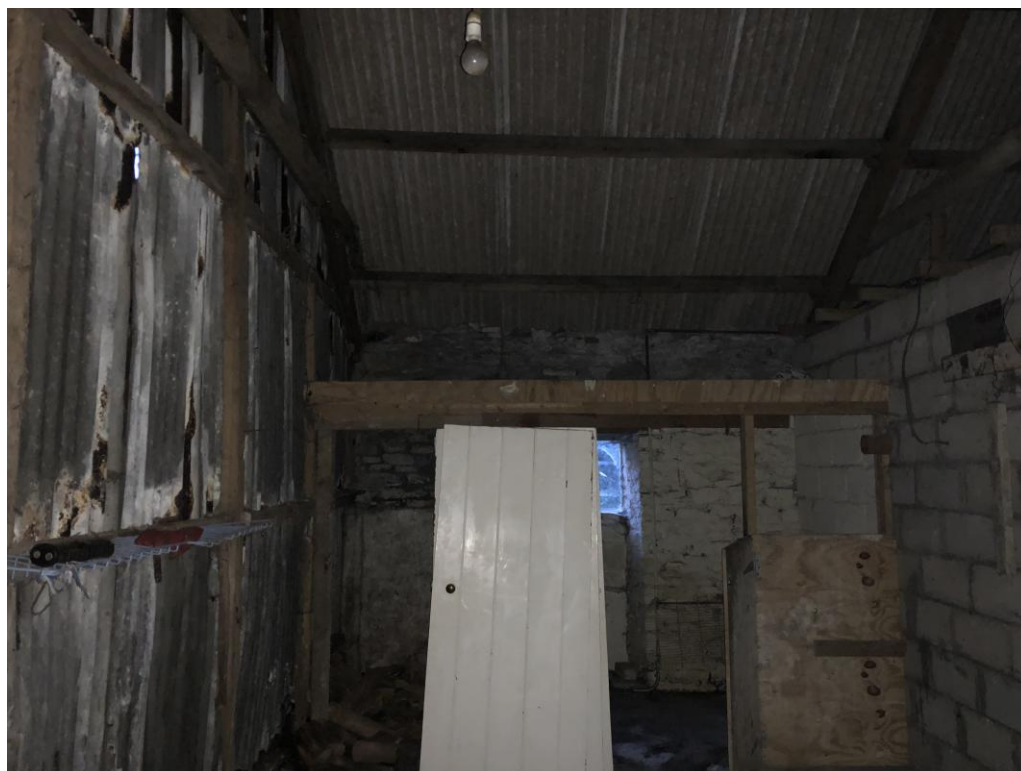
Interior of annex:

**7.3** During the internal inspection of the annex building, no droppings or other evidence of bat presence was found despite a thorough search. The internal inspection was carried out with the aid of a spot lamp, close-focusing monocular and endoscope.
