# **PRELIMINARY ROOST ASSESSMENT AND OBSERVATION SURVEY, GERAINT HOUSE, MARGAM.**

**TAI TARIAN LTD**

**June 2020**

Ref: HE/48/2019  
Issue 2, 07/06/2020

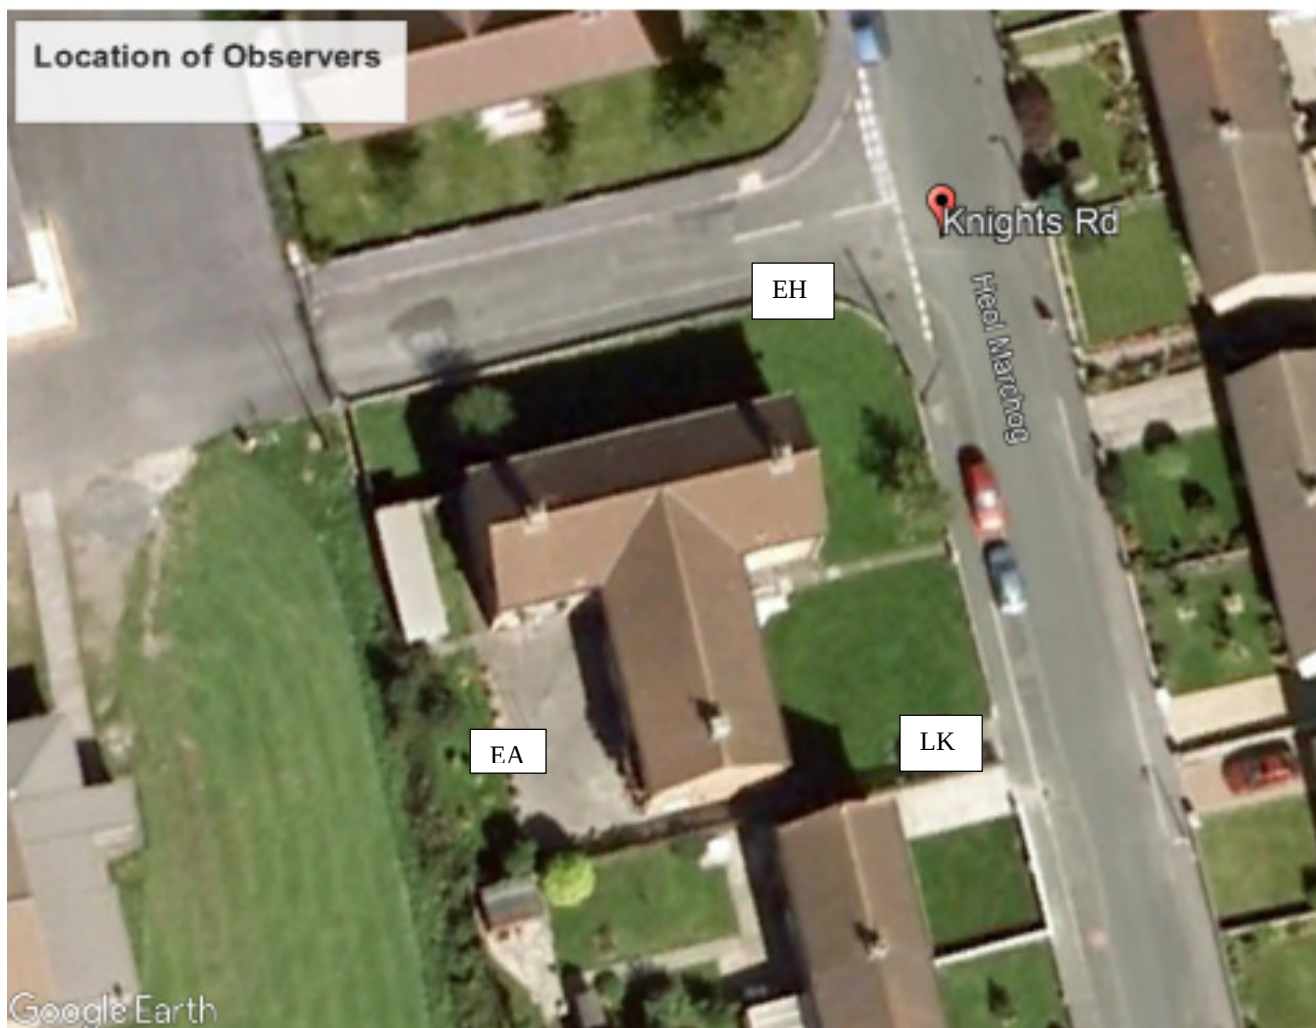
**FIGURE 1:  
LOCATIONS OF THE OBSERVERS**

- 2.5 Observations involved three observers and covered all relevant aspects of the buildings. Machines used were Echo Meter 3 Real Time Expansion units. Locations of the observers are shown in Figure 1.
- 2.6 Recordings were made continuously on the EM3 machines. The recordings were analysed using AnalookW and Batsound software, by use of which it is possible to separate most species present from the sonograms produced.

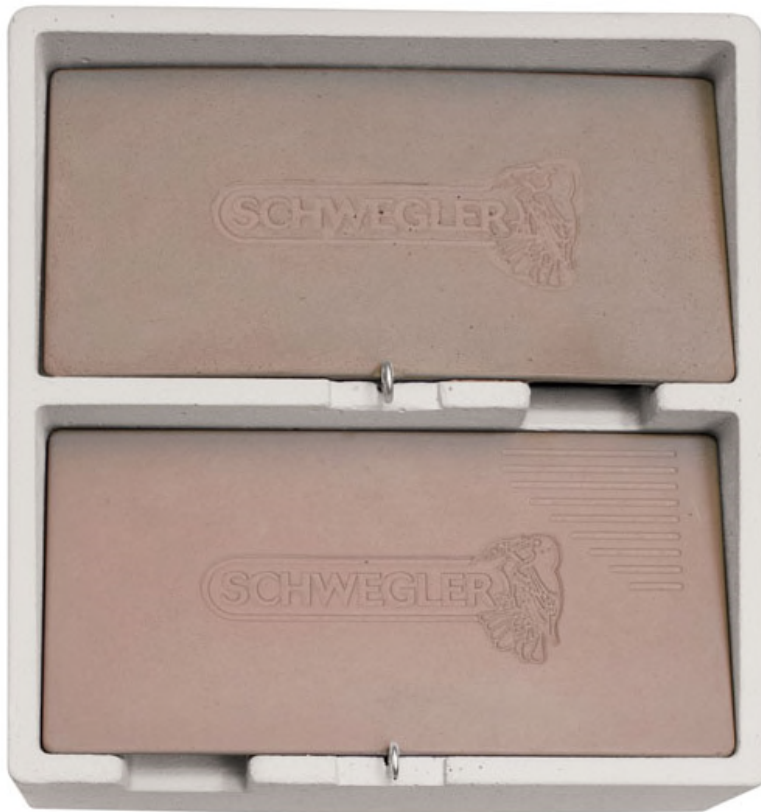
**FIGURE 4**  
**SCHWEGLER 1MF SWIFT/BAT BOX**

The Schwegler 1MF allows two pairs of Swifts to brood separately from each other. Two brood chambers with separate entrances are provided for this purpose. The rear wall is set back, providing sufficient space between the building wall and the box for Bats to use it as a roost or nursery roost. The design, shape and texture of the rear Bat area is created to meet the needs of crevice dwelling bats such as the Pipistrelle species.

- 7.9 No breeding bird species were noted. The proposed works will be of **no significance** in relation to nesting birds in either a local or wider context. Recommendations are made in Section 9 to enhance the property for use by swifts which were apparent during the survey.

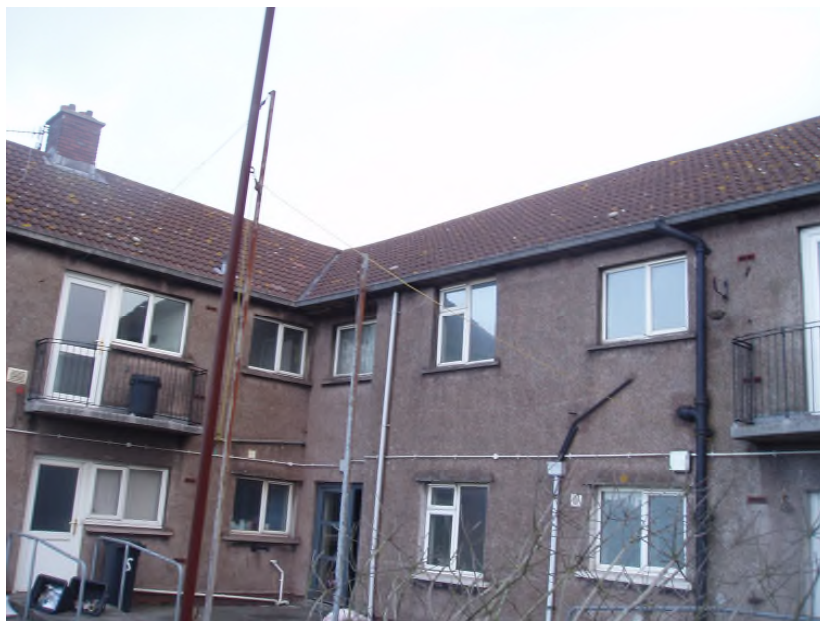
- 5.2 Externally, the building is brick faced and largely rendered with only the eastern gable end fully exposed brick and the northern elevation with exposed brick on the ground floor. The render is worn but in fair condition with no obvious or deep cracks present; the brickwork is in good condition.

The rear of Geraint House looking north west

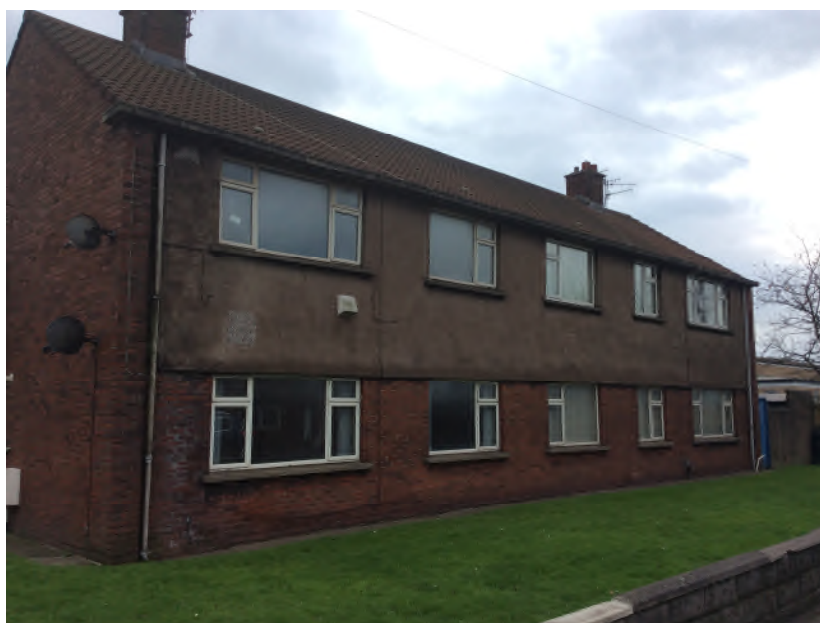
The northern facing elevation of the main east west axis building

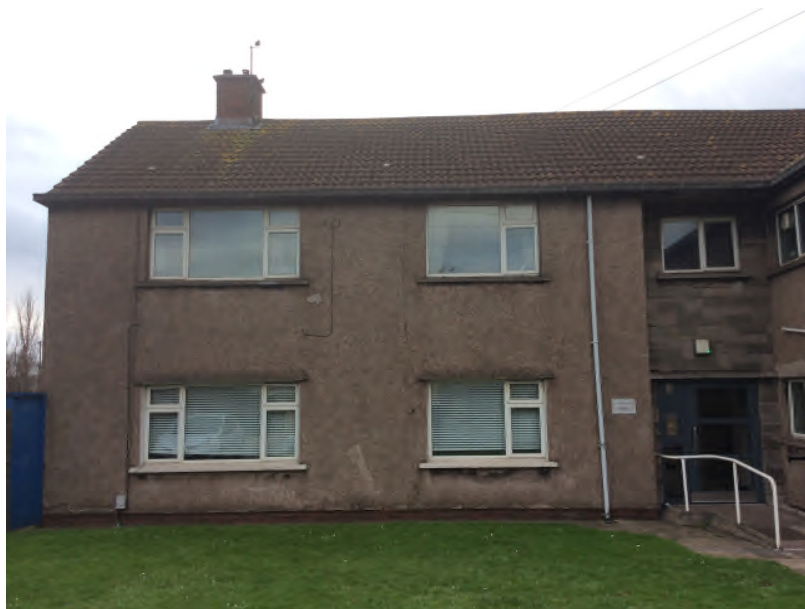
The southern annex

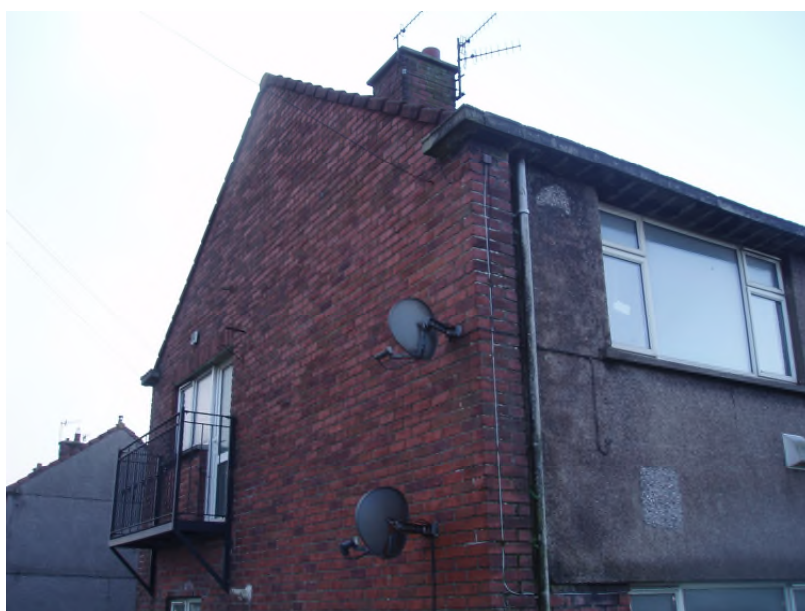
- 7.4 The verge at the gable ends were sealed at the wall tops with no access to the rear of them where the walls were rendered. The third eastern facing gable, fronting onto Knights Road, was unrendered and did have access to the rear of the verge tiles although the wall tops could be seen to remain sealed to bat access. This was considered in survey and all elevations were properly observed.

The render free eastern facing gable

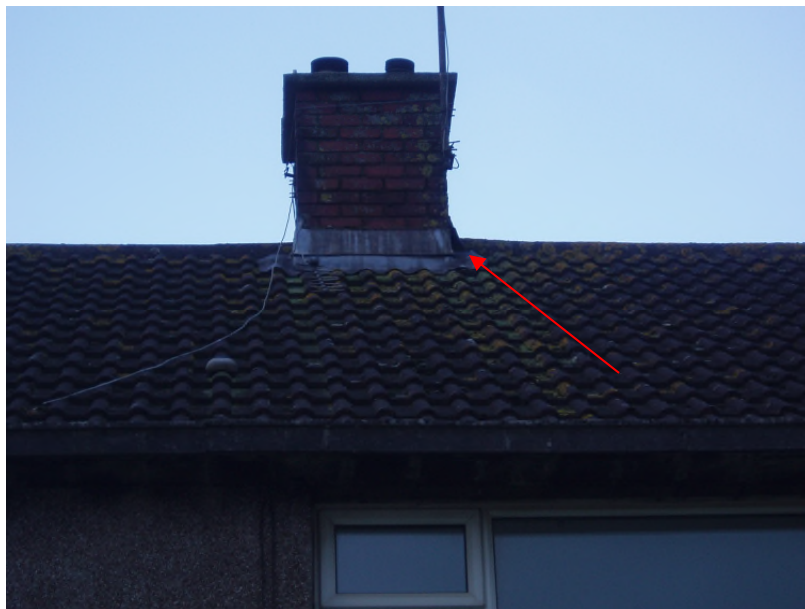
- 5.5 There are three chimneys on the building, all are in good condition however the flashing at those on the east west axis did show some gaps.
- 5.6 Internally the building is divided into six flats with three on the first floor. There was damage to the ceiling above flat 4 in the eastern end of the main building. Access was possible to all parts of the roof space and Figure 2 shows the loft layout above the flats.

- 5.10 The PRA found no direct evidence of bats using the building. There was no visible access to the roof space however there were gaps in the chimney lead flashing. Due to this factor and the presence of a leak a valley the building was considered to be of **Low potential** to support roosting bats. As the proposed works involve the removal of the Finlock gutter system and chimneys and replacement of the roof cover, it was considered that a single observation should be undertaken in line with the accepted guidelines.

- 7.1 The daytime inspection of the buildings found no direct evidence of bats using the buildings but did find limited potential for them to gain access to the roof via some loose flashing around the chimney. A full and detailed search of the loft space was possible and found no evidence of bats being present in the loft space although a large amount of rat droppings was noted in the southern annex near the gable end.

The loose flashing found on two of the chimneys (indicated by arrow)

**It is concluded that Geraint House does not currently support roosting bats and shows no signs of having done so. However, as gaps are present around the chimney flashing recommendations for safe working practices are made within the report.**

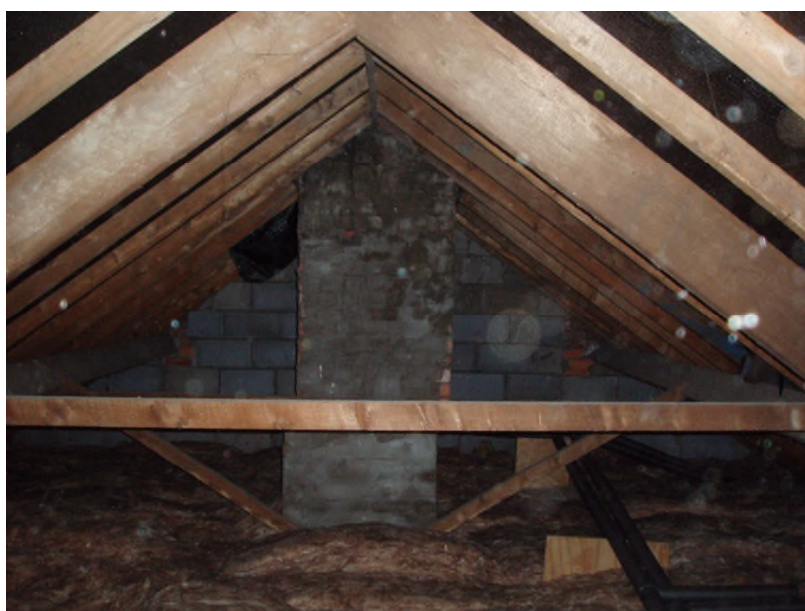
- 5.7 There were essentially three loft areas, all interconnected and all showed slight differences in structure. The roof above flats 4 and 6 shared a similar structure with an essentially open cut roof with occasional 'tie-beams', the loft above flat 5 showed many more tie beams but was again essentially an open cut style roof.

The loft over flat 6

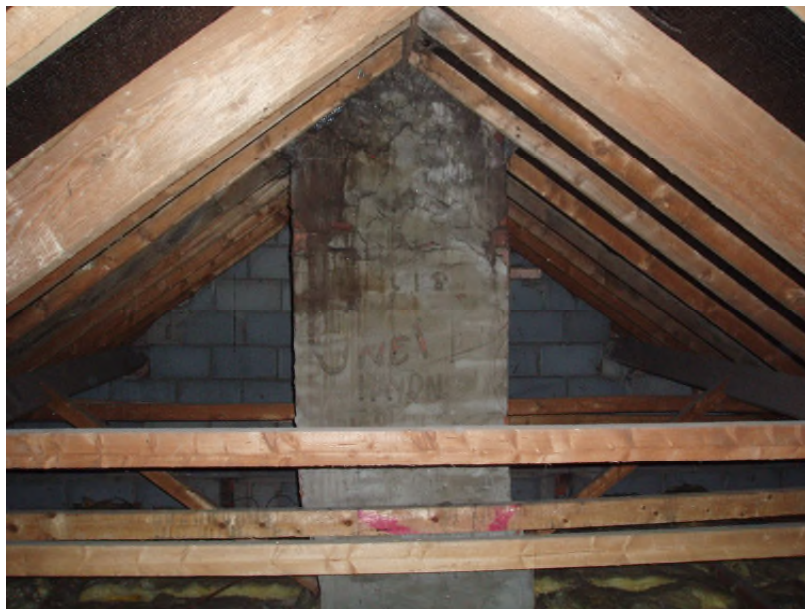
Inside the loft over flat 5

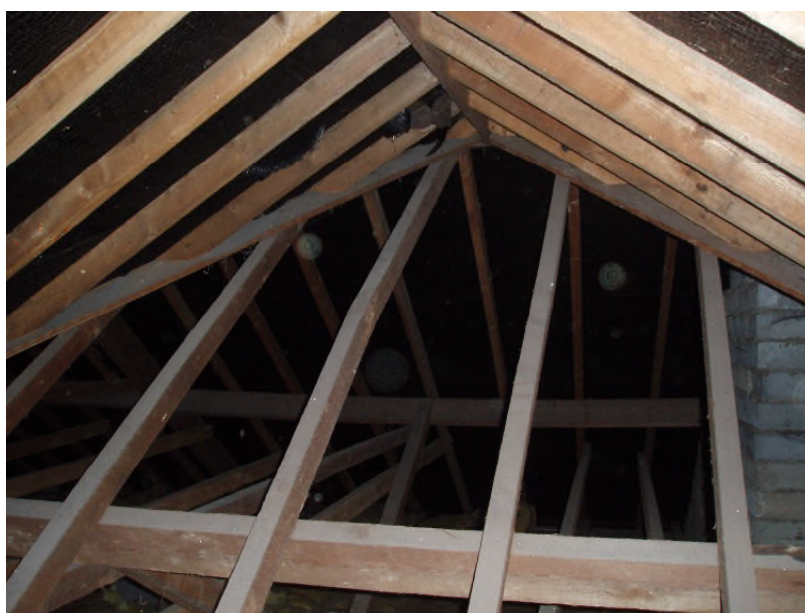
- 5.8 The underfelt is bitumen, but appears to be plastic backed, and is in generally good condition. There is evidence of water damage from the leak in the valley above Flat 4 but no evidence of a hole or suitable bat access point. The lofts are insulated with a mix of rockwool and glass fibre insulation. No holes or access points were apparent, but there were remains of an old nest on the southern gable. This appears to have been prior to repairs and there is no current access to this area for animals.

Looking from the loft over flat 6 to the main east west axis over flats 4 and 5
