Bat Roost and Emergence Survey

**Salem Chapel, Brynhyfryd Terrace, Seven Sisters, Neath Port  
Talbot, Wales, SA10 9BB**

June 2020

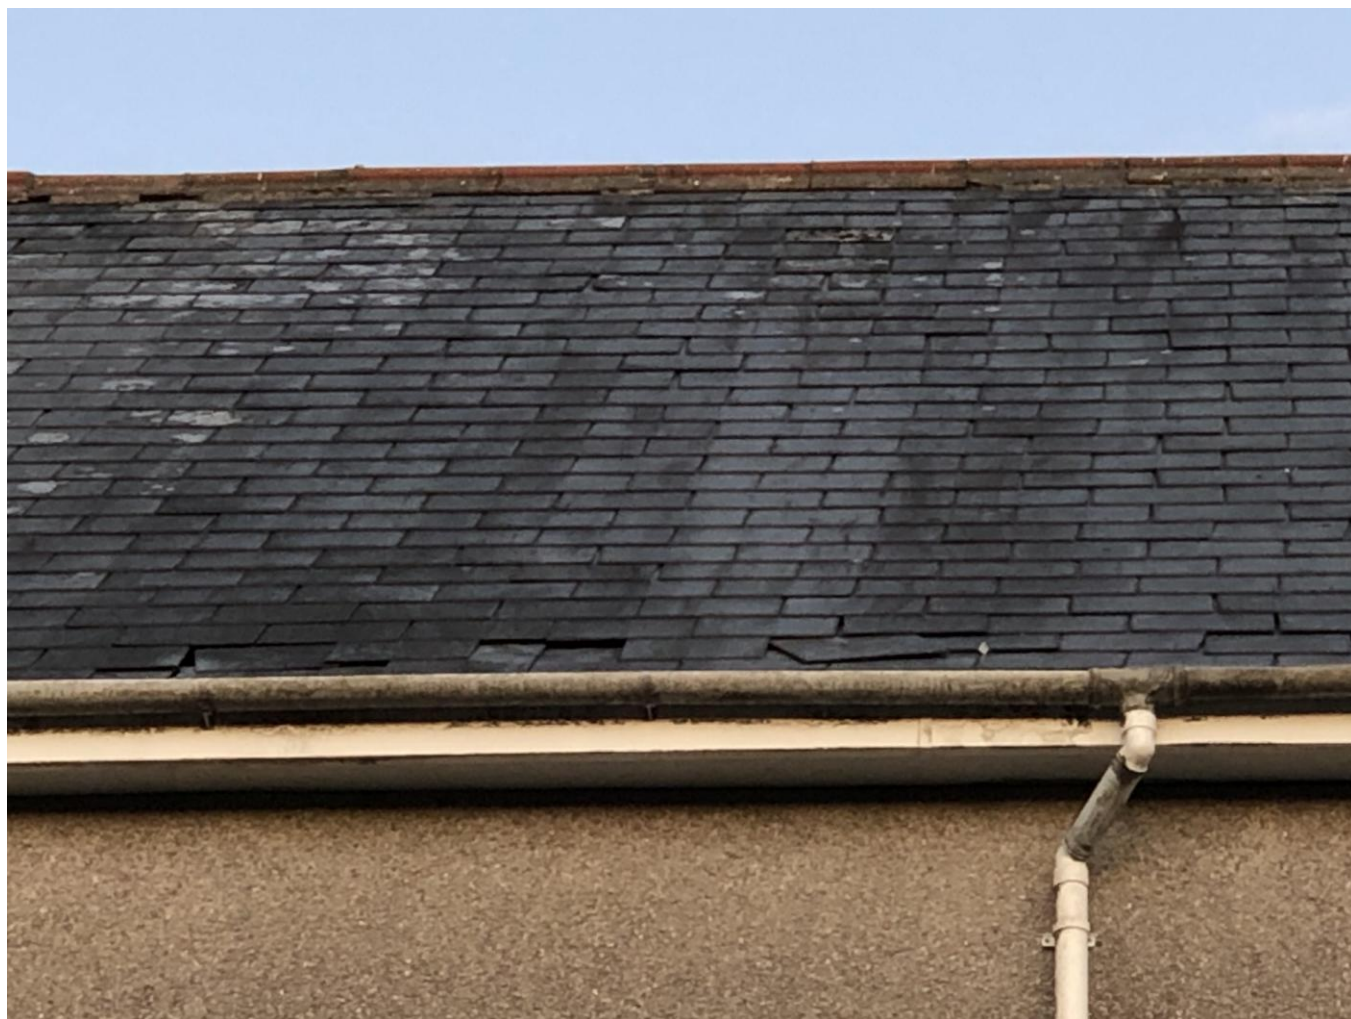
**7.2** The building structure appeared to be in good condition. The soffit boxes and fascia boards were in generally good condition but with certain gaps along the lower edge which could be used by bats. There were a number of slipped and damaged roof tiles on the western roof slant which could potentially provide access to the roof void. The ridge tiles had a small number of gaps which could potentially be used by bats to access the building. One of the upper windows to the front of the property was damaged, allowing potential access to the interior of the building.

**Slipped and damaged tiles:**

**12.5** Contractors should be instructed to implement a 'soft-stripping' approach, which will involve checking for the possible presence of bats on the undersides of roofing materials and fascia boards and any other features that bats may use to roost or to access a roost. Such features should be removed by hand, checking for the presence of bats as they are lifted off, before smashing or dumping them. This is especially important at the outset of the works, since once works have started the disturbance is likely to drive any bats, which are present away voluntarily.

**12.7** Further enhancement measures could include that specific gaps are created around the eaves and soffit sections of the new development to allow access for crevice roosting species such as pipistrelle bats. This would comprise a gap of 15mm – 20mm between wall of building and soffit board, allowing access to any eaves cavity. New barge boards, gutter plates and fascias could be left with a gap of 15mm- 20mm along the lower edge (between wall and

board), allowing access to bats behind the board.
