**Maes y Gwilog Farm  
Skewen**

**Bat and Nesting Bird Survey Report**

**October 2020**

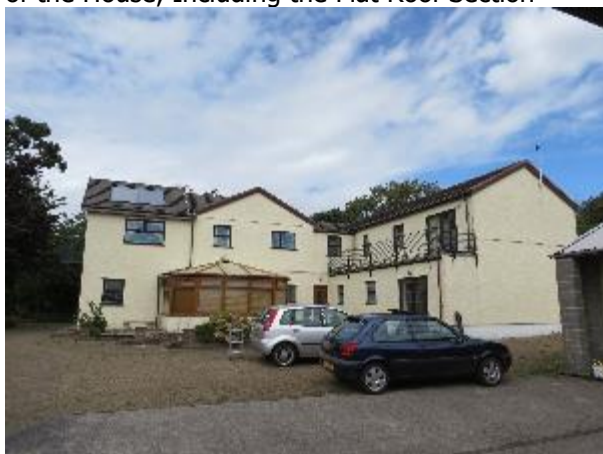
Photo 1: Southern and South-Western Elevations of the House, Including the Flat Roof Section

| Roof | The house roof is pitched and constructed from cement tiles with clay ridge tiles. Two solar panels are positioned on the roof of the southern elevation of the house (Photo 1). Roof tiles are generally well aligned with minimal gaps. There are, however, gaps under some of the end roof tiles where the cement mortar has been weathered away, such as near the solar panels (Photos 7 and 8). The porch's roof has various lifted and broken slate tiles (Photo 9). |

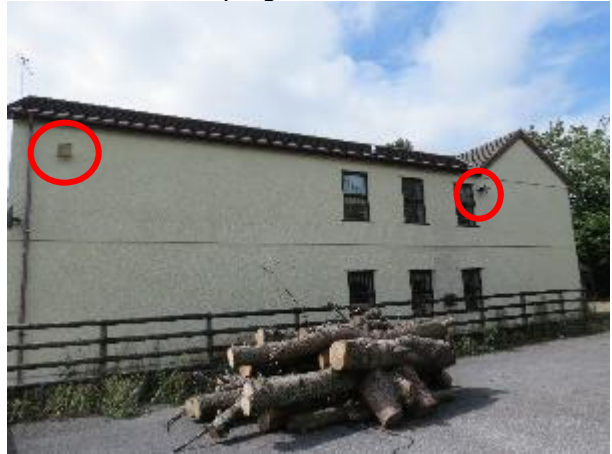
Photo 4: North-North-Eastern Elevation of the House and Security Lights

| Security Lighting | Security lights are present and active on the house on the western, southern, south-western and eastern elevations (Photos 4, 6 and 14). |

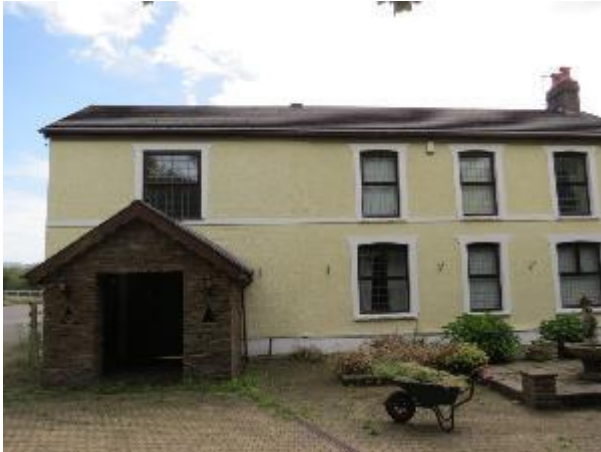
Photo 5: North-North-Western Elevation of the House with Porch

| Building Type | The house is an L-shaped, two-storey detached building made with pebble dash rendering and is in good condition (Photos 1-6). The south-western elevation comprises of a single storey extension with a flat roof and balcony (Photo 1). The north-north-western elevation has a single-storey porch with an A-frame roof with a symmetrical gable end and walls made from stone bricks (Photo 5). |

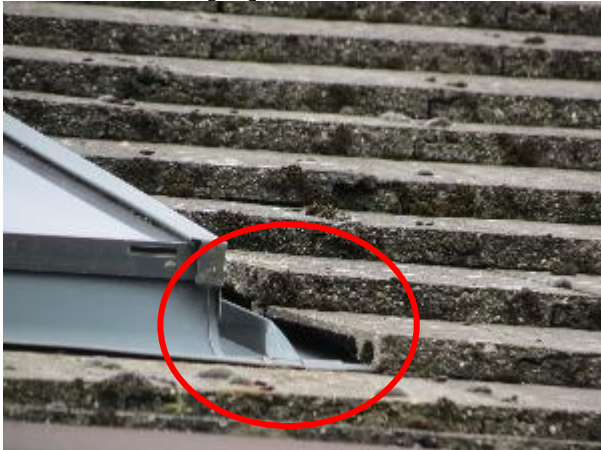
Photo 7: Eroded Cement Mortar Under Roof Tiles Near Solar Panel [R1]

There are some access points for bats including within a hole and crack in a soffit box (Photos 12 and 13), gaps under roof tiles near the solar panels (Photo 7) gaps under the ridge tiles near the chimney breast (Photo 8) and under lead flashing (Photos 10 and 11).

- R1 – Gaps under roof tiles created by eroded mortar near solar panels (see Photo 7);
- R2 – Gaps under the ridge tiles near the chimney breast (see Photo 8);
- R3 – Gaps under broken and lifted tiles of the porch (see Photo 9);
- R4 – Between roof tiles and bitumen roof lining; and
- R5 – Within the roof voids of the house (Photos 15-20).

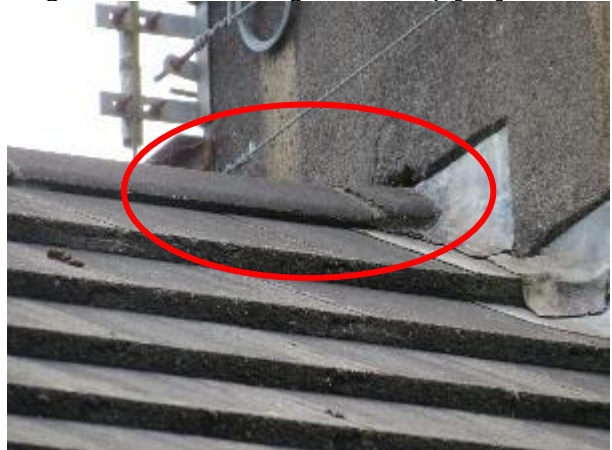
Photo 8: Gap Under Ridge Tiles and Gap Between Ridge Tile and Rendering of Chimney [R2]

| Chimneys | There is missing mortar around the chimney stack base (Photo 8). |

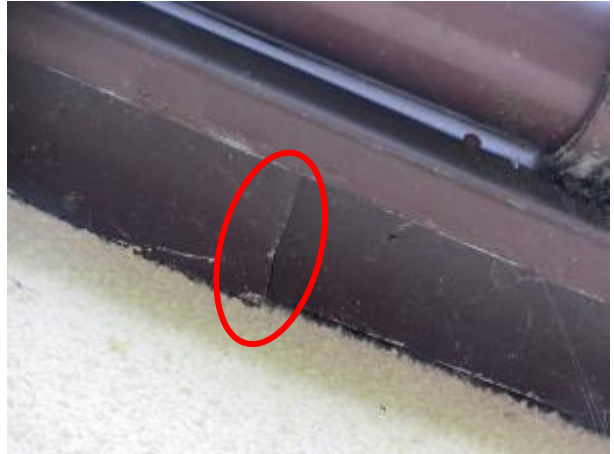
Photo 12: Cracked Soffit Box

| Soffits, Fascias and Bargeboards | The PVC soffits are well sealed in places, however, there is a hole and a crack in a soffit box which could enable access for roosting bats (Photos 12 and 13). |

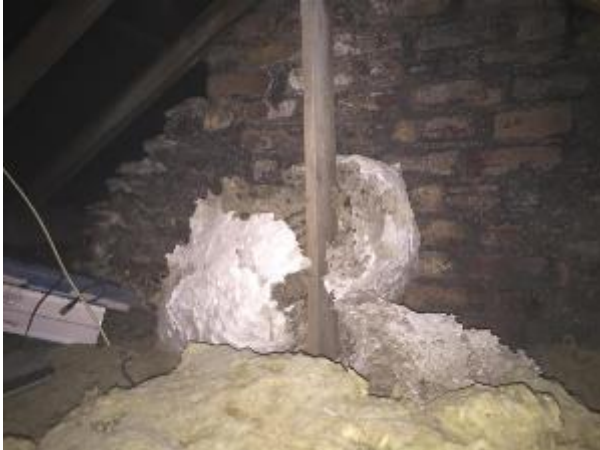
Photo 15: Piled Insulation in Loft 1

| Roof Void, Lining and Construction | <p>Loft Space 1 located at the south-eastern elevation of the house was very dark and filled with a lot of rockwool insulation, including a pile of it at the most southerly wall of the void (Photo 15). The void is approximately 2m high and is constructed with modern A-frame timbers (Photo 16). The roof is lined with bitumen felt that is in good condition. Overall, the void was airy and open, with a gentle breeze felt by the surveyor.</p> <p>Loft Space 2 also contained a lot of rockwool insulation laid on the floor and was constructed of modern A-frame timbers that were covered in a lot of cobwebs (Photo 17).</p> <p>Loft Space 3 is cavernous and lined with bitumen felt, containing two water tanks behind the loft hatch (Photo 18) voids and some light ingress at the eaves (Photo 19). The construction is a fink truss made of older beams than those found in Loft Spaces 1 and 2 (Photo 20). A breeze was also felt within this loft space. An active wasp nest was also found (see Plan 3).</p> |

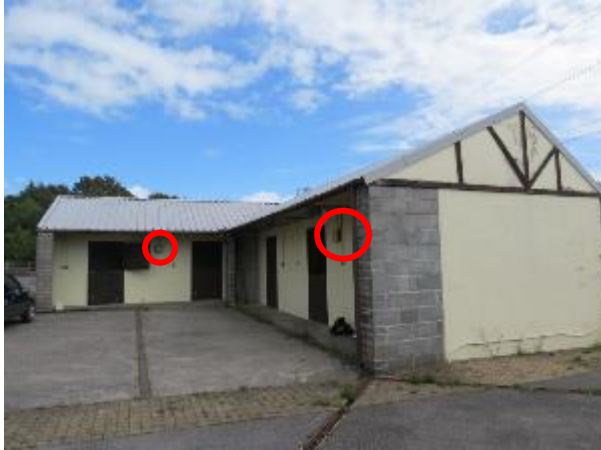
Photo 21: Northern and Western Elevations of the Stables, and Security Lighting

| Soffits, Fascias and Bargeboards | The metal bargeboards are flushed tightly against the gable end walls (Photos 21 and 22). |
| Doors and Walls | The timber doors have timber frames (Photos 21-24). There is open access into the stables via the open storage area and stable doors on the northern elevation, and the cupboard at the south-eastern elevation (Photo 24). The wooden dividing walls between each stable are in poor condition (Photo 26). |
| Security Lighting | There are four security lights on the northern, eastern, western, and southern elevations. These are active, which could act as deterrents to bat roosting (Photos 21, 23 and 24). |

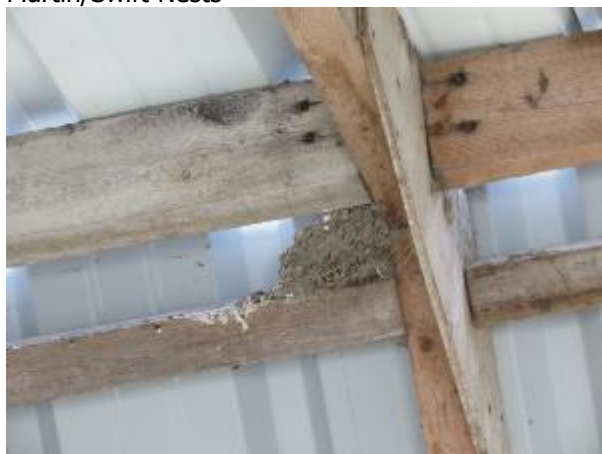
Photo 28: One of Three Active Swallow/House Martin/Swift Nests

| Nests | There is an active wasp nest within one of the two stables at the southern elevation of the building (see Plan 3). Three intact and active nests of swallows ( <i>Hirundo rustica</i> ), house martins ( <i>Delichon urbicum</i> ) or swifts ( <i>Apus apus</i> ) are located in the stables cupboard and the first stables to the left of the storage space on the northern elevation of the building (Photo 28 and Plan 3). |

Three active swallow nests were found in the stables' cupboard and the first stables to the left of the storage space on the northern elevation of the building (Photo 28). One swallow was observed entering and later emerging from the stables during the dusk emergence survey.

Three active swallow nests were observed in the stables on the roof trusses. According to the RSPB, swallows have a UK green conservation status (Eaton et al., 2015). Birds on this list are the least critical group. A swallow was observed entering and then emerging from the stables during the dusk emergence survey.

There are three active swallow nests situated within the roof of the stables on the western elevation. The demolition of this building will be undertaken from September to February outside the bird breeding season (March to August inclusive). Alternatively, any works undertaken from March to August will be subject to a check for nesting birds by a suitably qualified ecologist immediately prior to the works. If any active nests are found these will be protected, along with an appropriate buffer zone of approximately 10m, until the nesting is complete, and the young have fledged<sup>31</sup>.

Opportunities for nesting swallows, will be provided within the developed house using the recommendations listed below. All artificial nests will be installed on the house, including on the proposed extension to compensate for the possible loss of swallow, nesting opportunities within the stables. This will be in the form of a Ridge Overhang Swallow Nest box or suitable equivalent. Further details are found in Appendix 8.

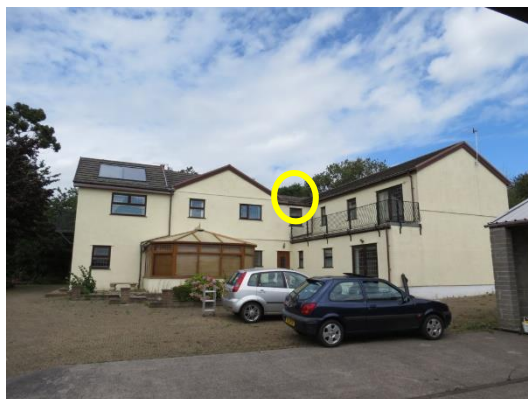
**Photo 1:** Showing the area of the house where the access point was observed. The common pipistrelle access point is highlighted by the yellow circle.

The preliminary roost assessment found no evidence of bats roosting within the house or stables. During the dusk emergence survey of the house, a common pipistrelle was recorded emerging from beneath a tile in the centre of the south-east facing roof between in the valley of the two pitched, south-east facing roofs.

The house has been confirmed as supporting a common pipistrelle day roost. It is anticipated, however, that the proposals would not result in either the permanent/temporary loss of the roosting site, or that the works would result in a significantly high level of disturbance to bats. Precautions will be needed, however, to reduce disturbance to bats during construction and to ensure that the bat access is unaffected by the final works. Recommendations for precautionary measures to guard against impacts on bats roosting opportunistically within the house are presented in Section 6.

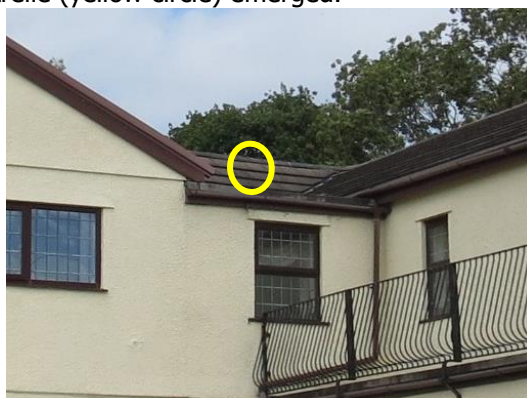
**Photo 2:** Showing the access point underneath a roof tile on the south-east facing slop of the pitched roof where the common pipistrelle (yellow circle) emerged.
