# **PORT TALBOT HARBOURSIDE**

## **Additional Gasholder Intrusive Investigation**

**PROJECT NO. 70057278**

**DATE: NOVEMBER 2020**

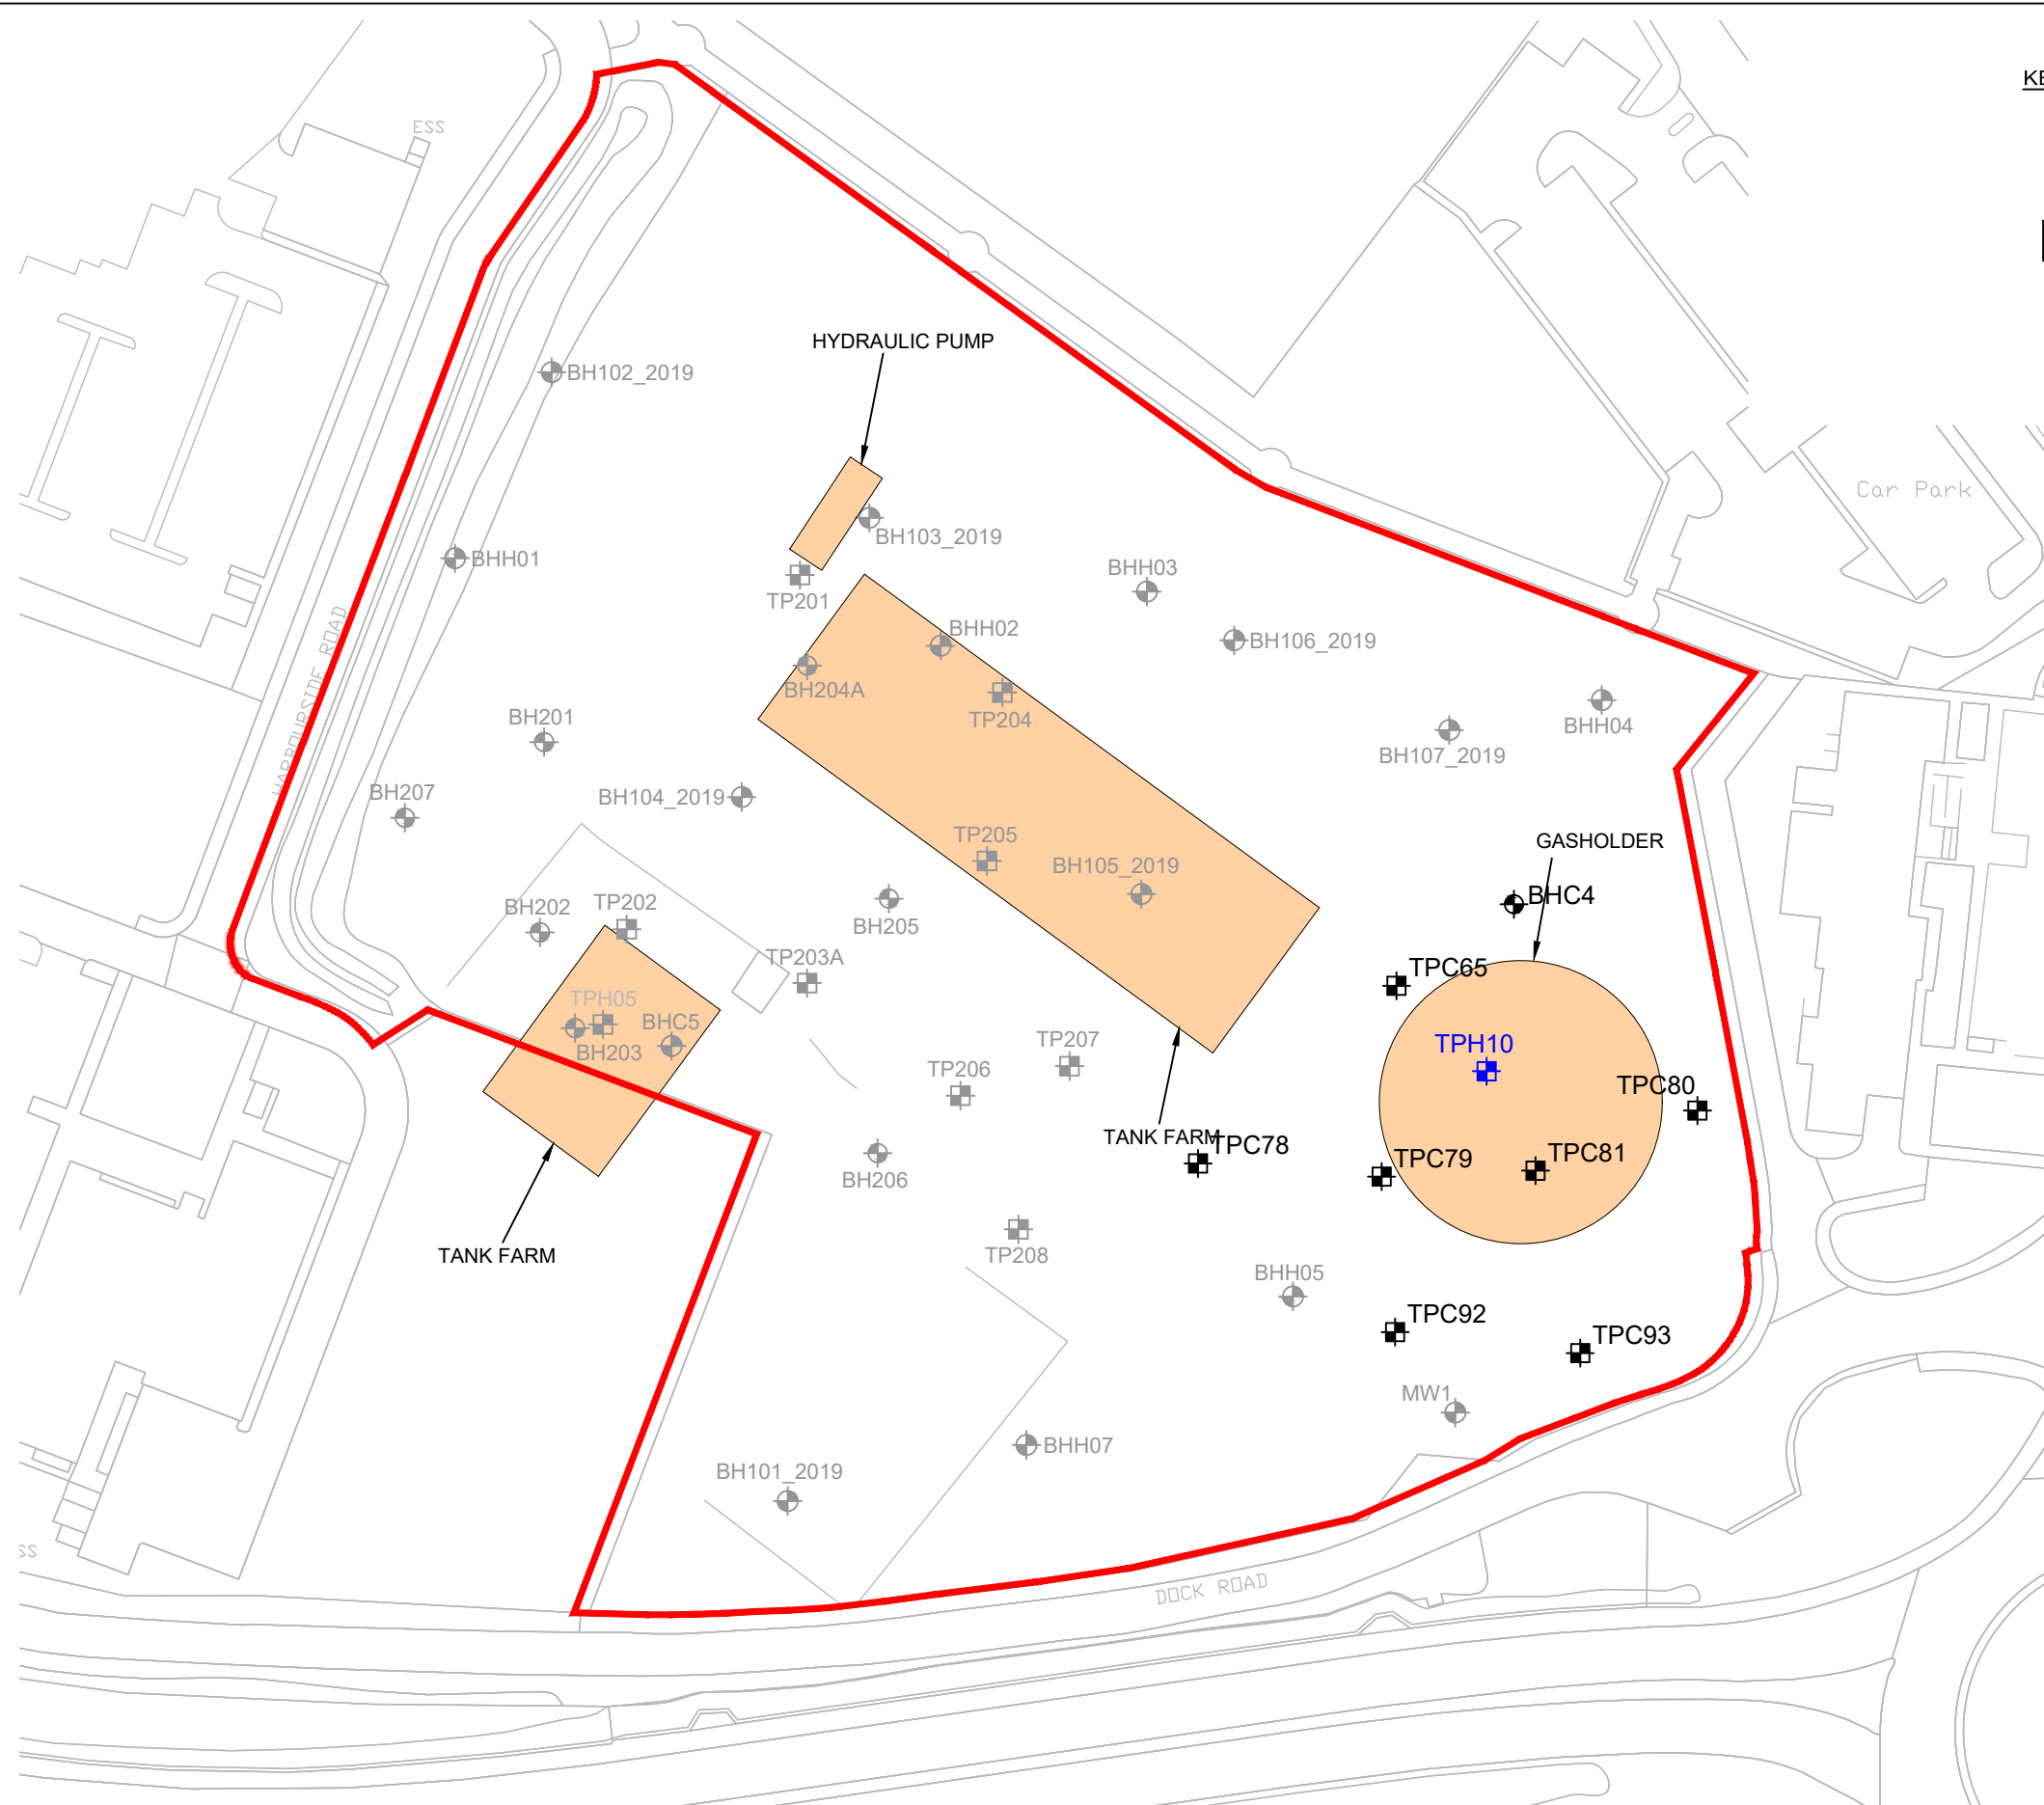
| 70057278 | | FIGURE 2 | | |

A ground investigation completed by Structural Soils in 2007, completed the below exploratory locations within and in close proximity to the gasholder, locations of these can be found in **Figure 2, Appendix A**).

A supplementary ground investigation by Opus (now WSP) in 2017, included an exploratory location beneath the former gasholder, the location of which can be found in **Figure 2, Appendix A**).

- KEY**
- SITE BOUNDARY
  - WSP MONITORING LOCATION
  - POTENTIAL HISTORICAL SOURCE AREAS
  - 2007 EXPLORATORY LOCATIONS
  - 2017 EXPLORATORY LOCATIONS

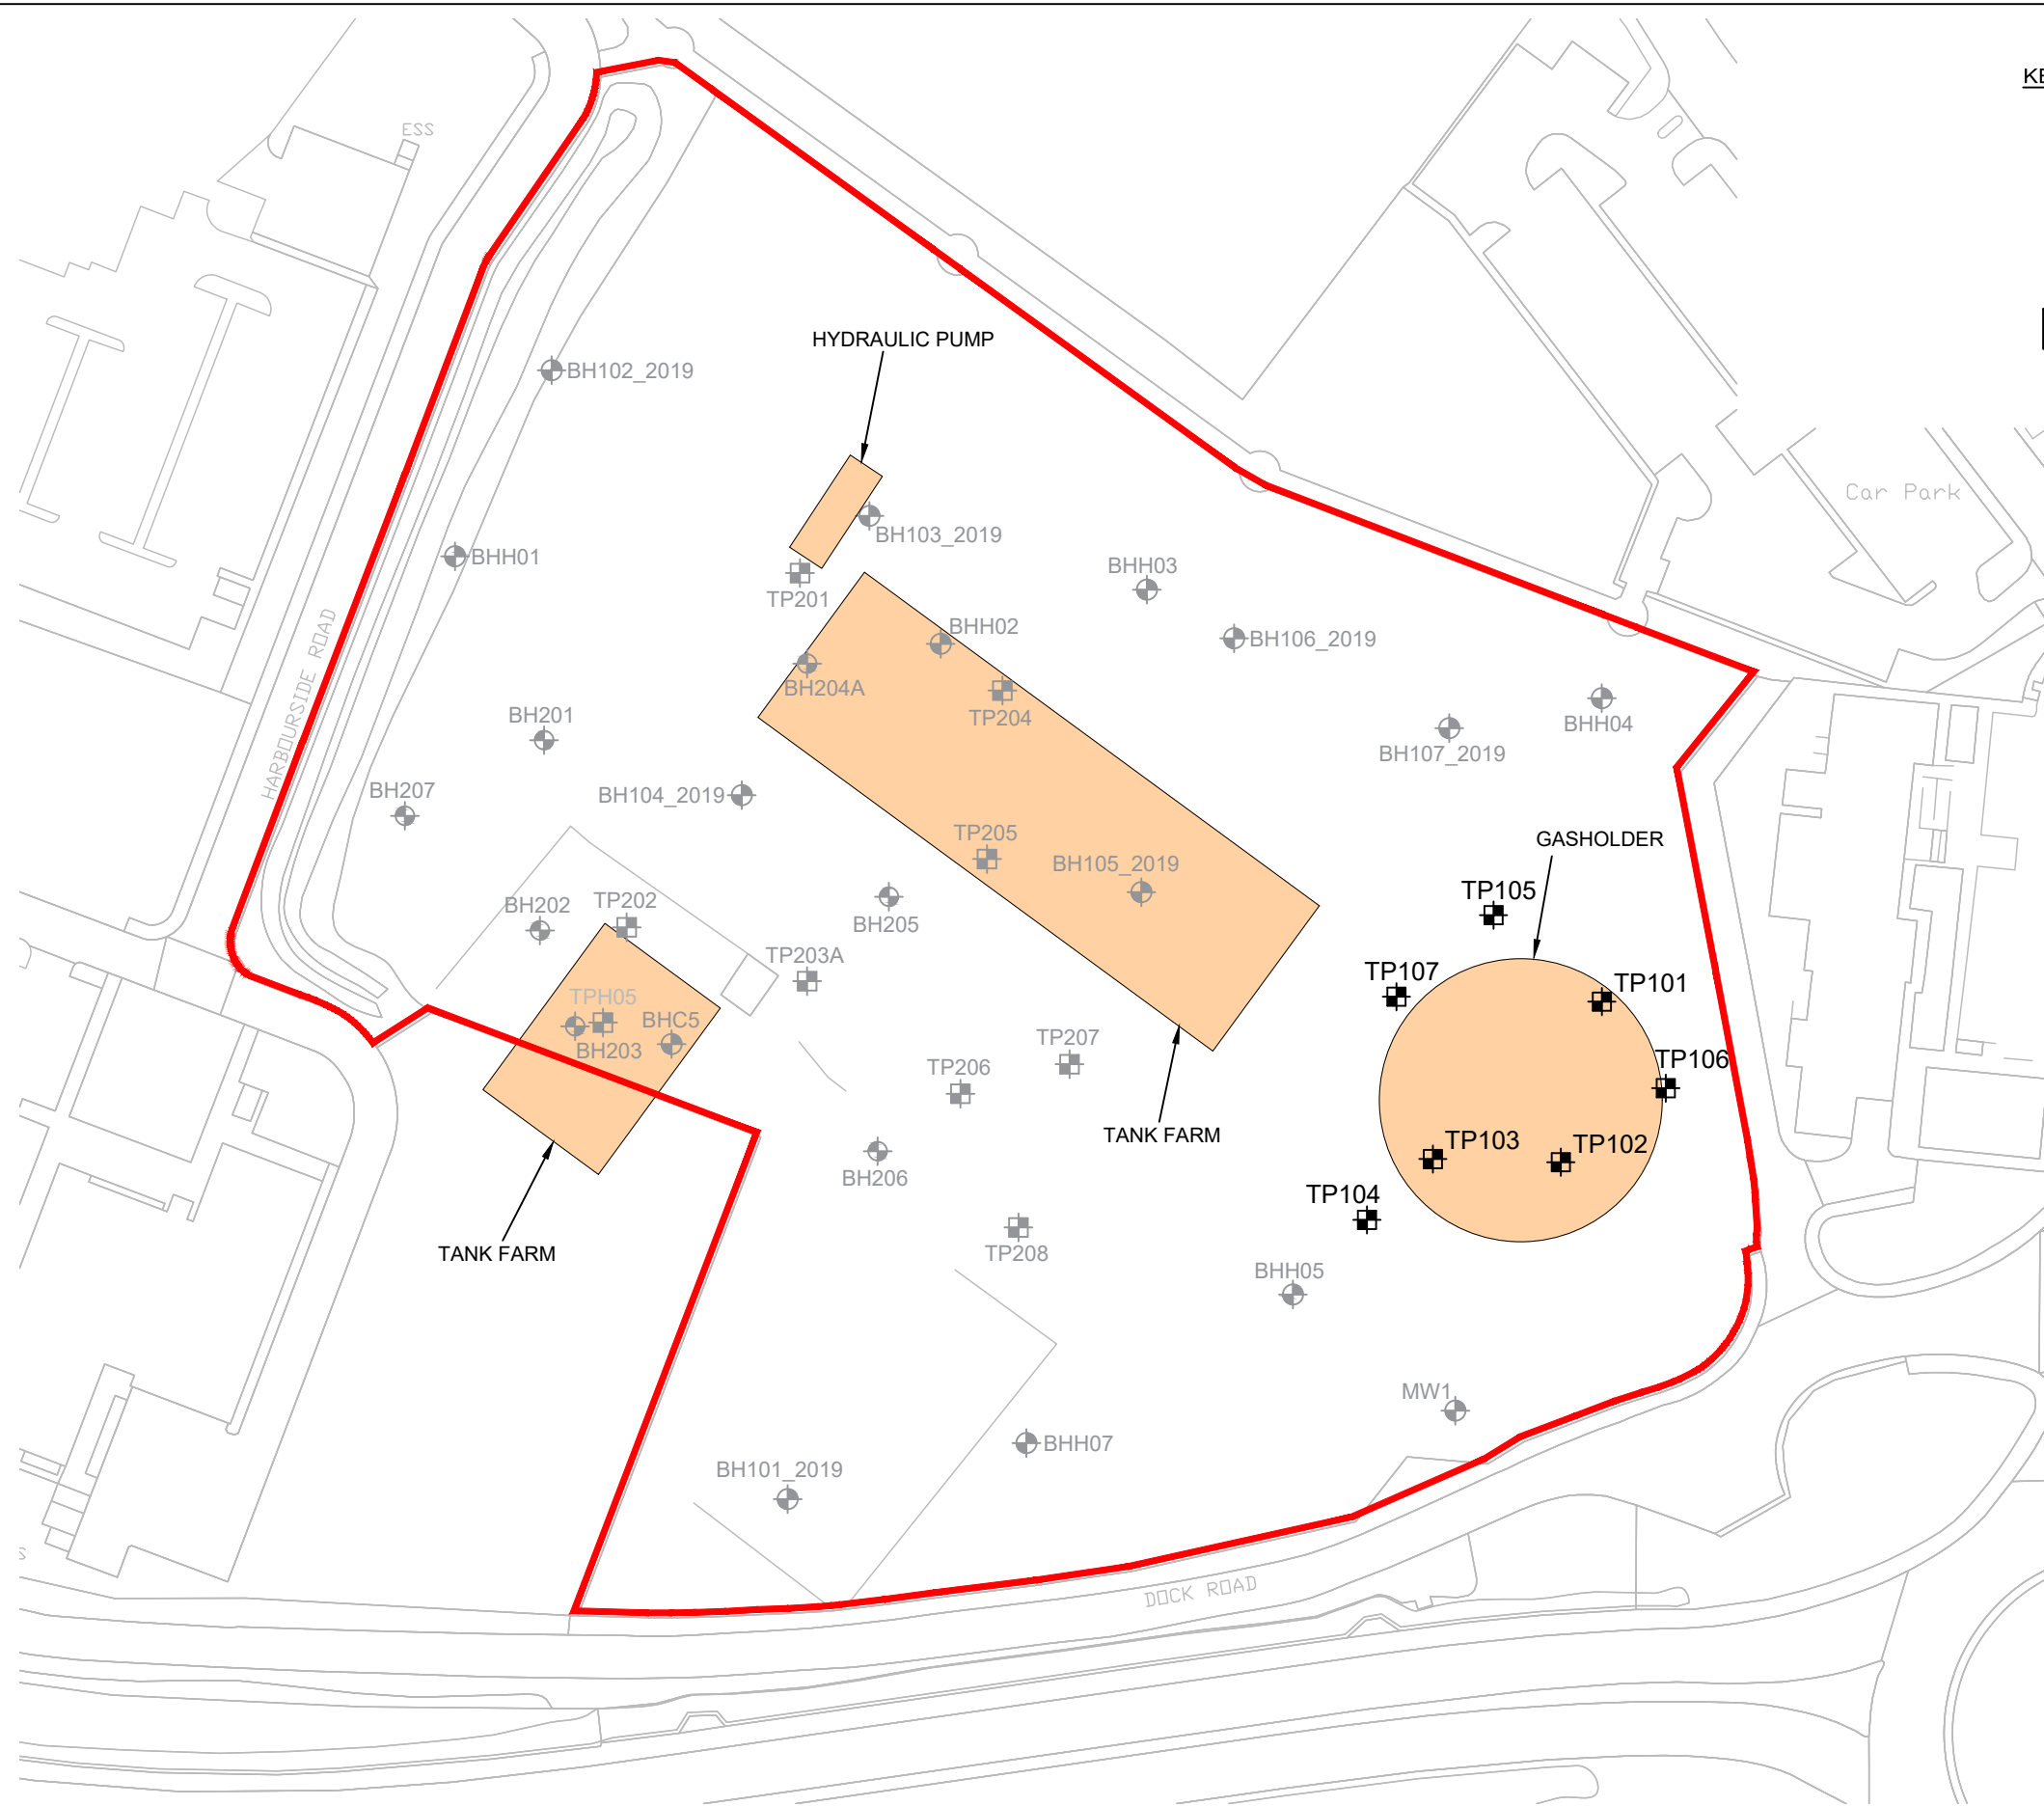
| 70057278 | | FIGURE 3 | |

- SITE BOUNDARY
- PHASE 1 - HISTORIC OPUS EXPLORATORY HOLE
- PHASE 2 - WSP EXPLORATORY HOLE (AUGUST 2019)
- PHASE 3 - WSP EXPLORATORY HOLE (DECEMBER 2019)
- POTENTIAL HISTORICAL SOURCE AREAS
- 2020 GASHOLDER TRIAL PITS

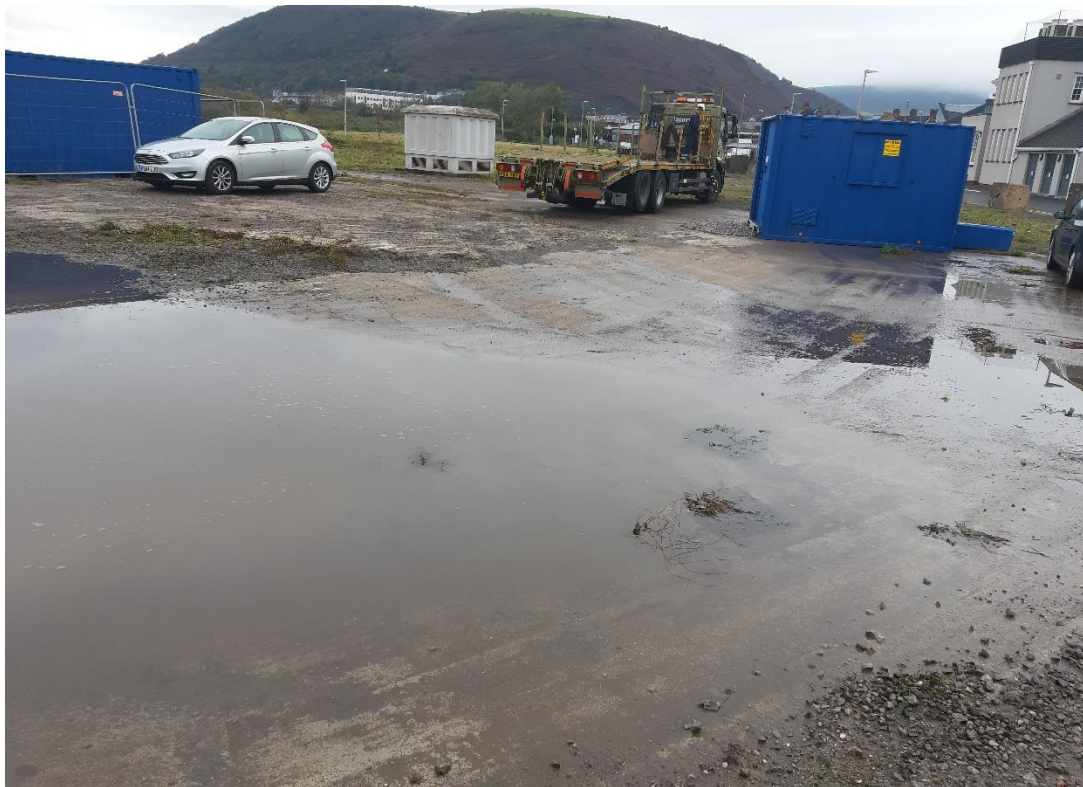
**Photo 1:** The gas holder base, view to the east. (WSP, October 2020)

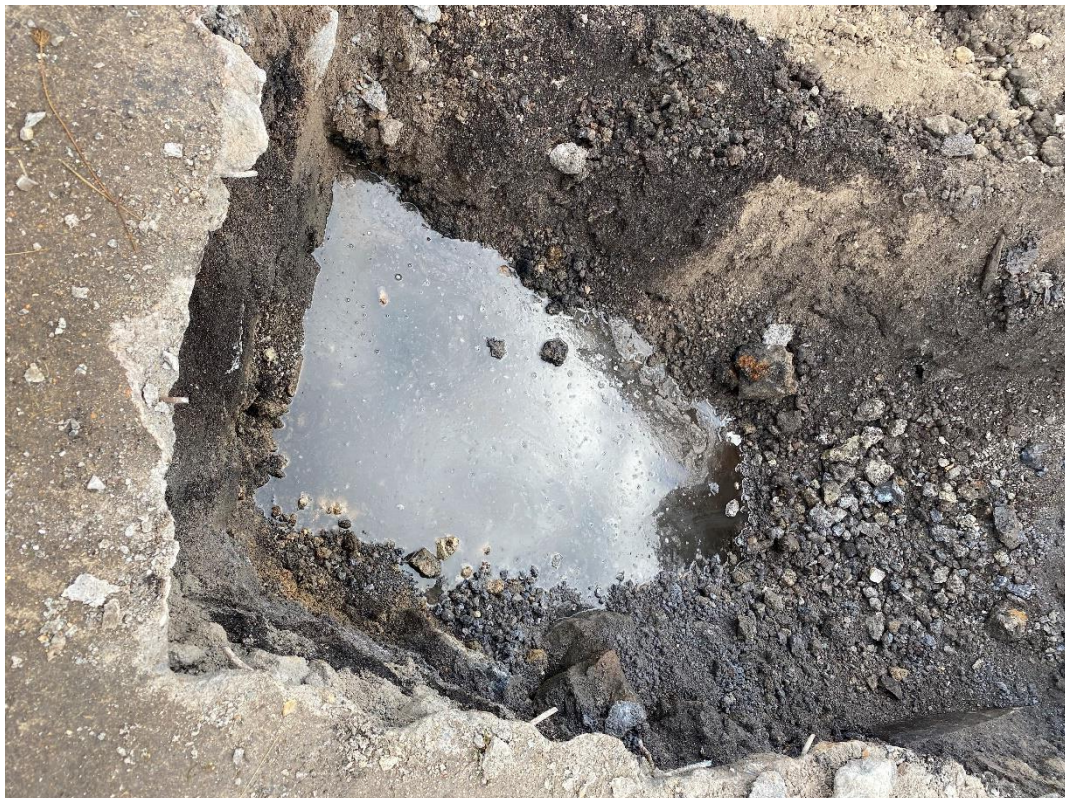
**Photo 2:** TP101 with groundwater resting at 1.5m bgl. (WSP, October 2020)

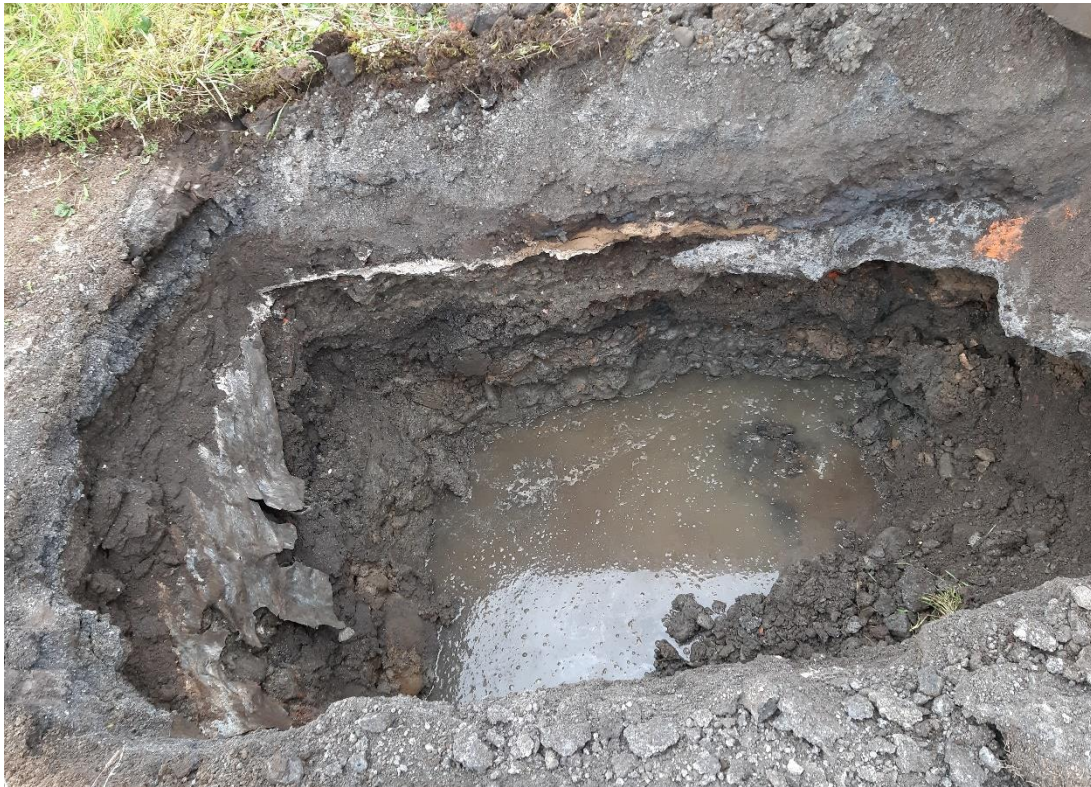
Photo 5: TP104. (WSP, October 2020)

| Determinand | Laboratory result (mg/kg) | Comments |
|---|---|---|
| Asbestos Identification | 2x positive ID | Asbestos was identified in two samples:<br>i TP104, 0.2m bgl – fibre bundles of chrysotile, quantified at <0.001%<br>i TP105, 0.8m bgl – trace detections of loose fibres of chrysotile. |
