## Survey for Bats

## September 2020

**Survey Site:**  
11 Hen Felin  
Gellinudd  
Pontardawe  
SA8 3HN (Grid Reference SN 738 044)

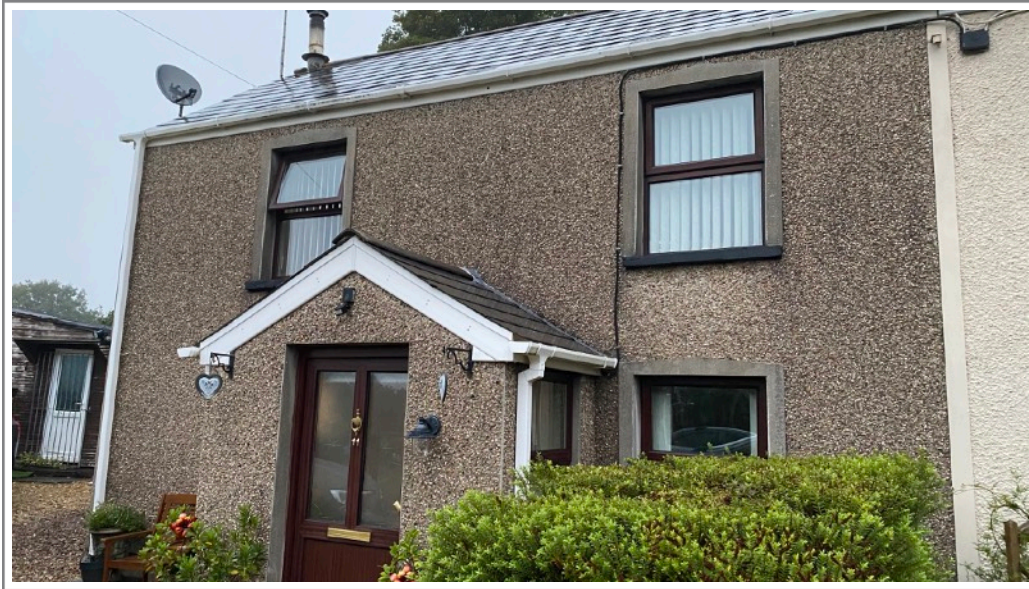
- No opportunities were available for bats to enter the internal habitable parts of the building either on the ground floor or the first floor (see photo's 1 & 2)
- No evidence of bat use was found in the roof void (see photo 5)

**Photo 1:** South-west facing elevation of the main dwelling

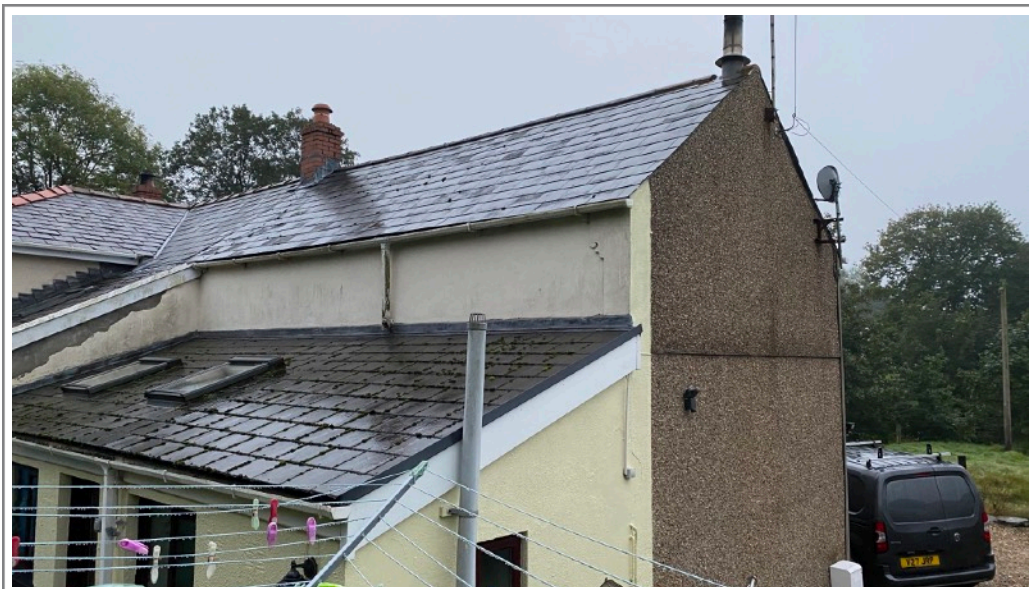
**Photo 2:** North-east and north-west facing elevations of the main dwelling with lean to

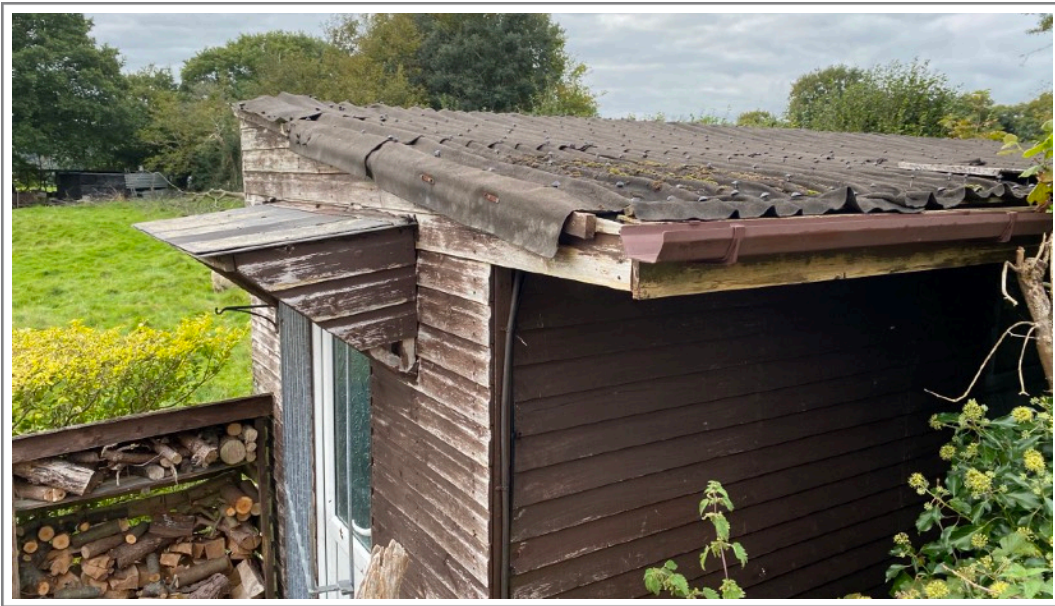
- The small garage adjacent to the north-west elevation of the house was inspected internally and externally with no evidence of bat use found. A small accumulation of guano was noted and collected off various surfaces inside (see photo's 3 & 4) the garage

**Photo 3:** Detached garage

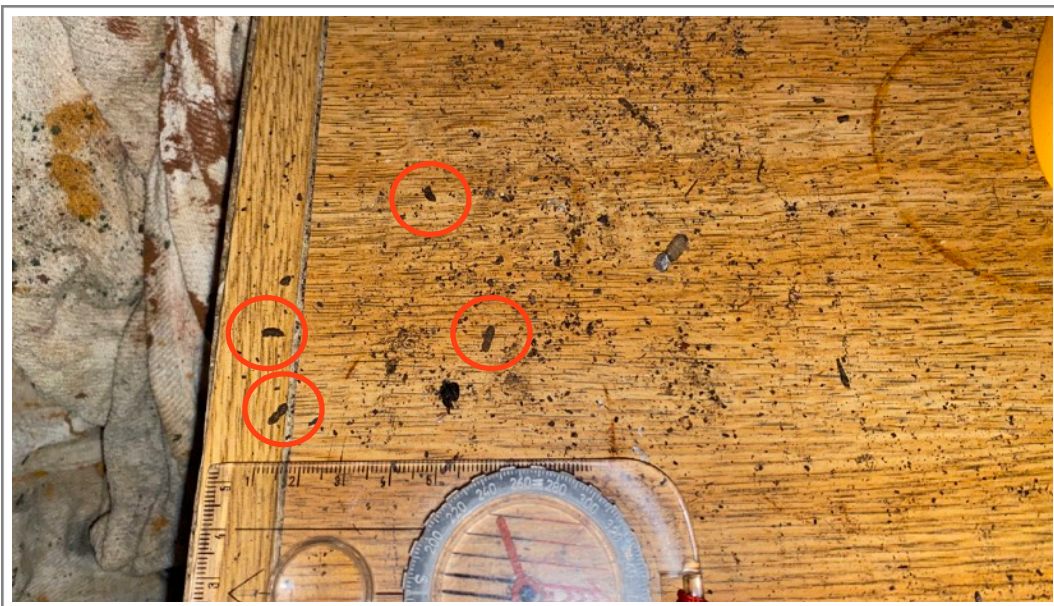
**Photo 4:** Guano inside garage (circled)

- Neither the main dwelling or the garage present roosting opportunities for bats in its current state
- Guano was found in the garage with only a handful of stools present and were collected and sent to laboratory for DNA analysis and were confirmed not to be deposited by bats, although a number of the stools were bat like in their morphology, however rodent droppings can be very similar
- No bats were seen leaving either building during the evening surveys

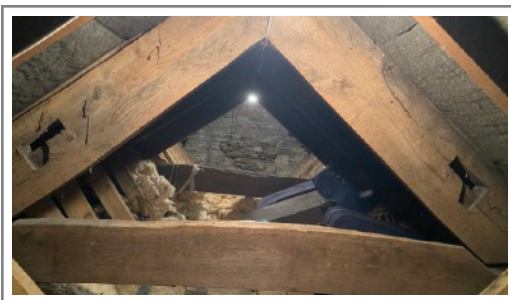
**Photo 5:** Shallow roof void of main dwelling

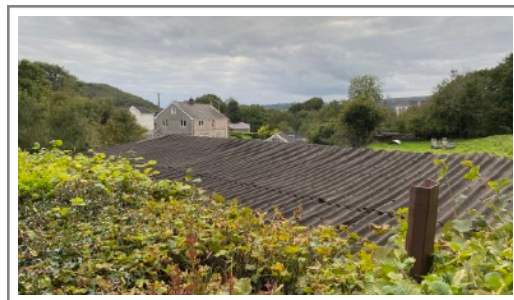
**Photo 6:** Garage roof

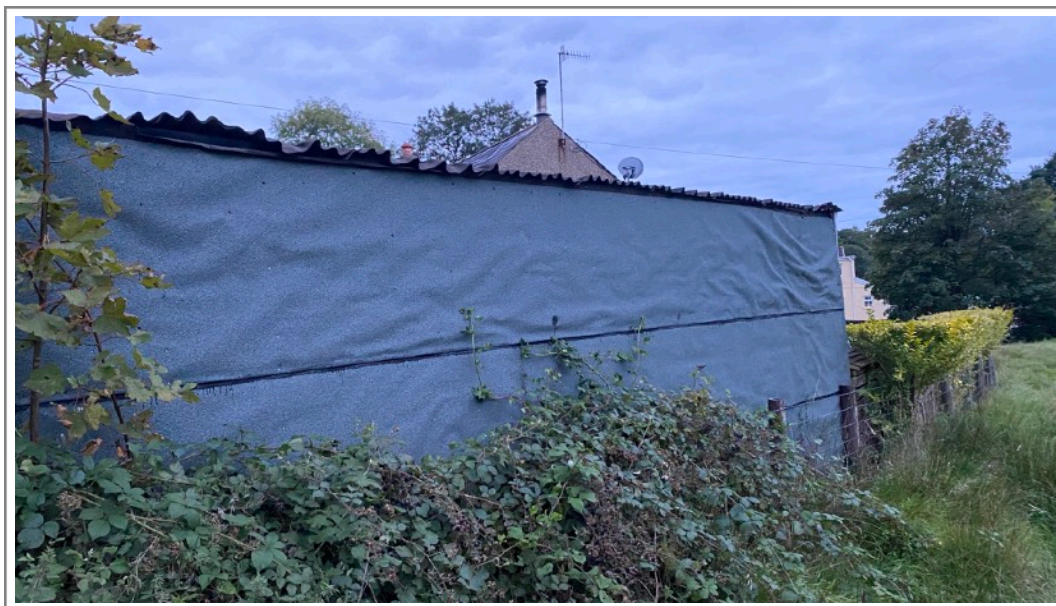
- All the internal/external observations of the 8<sup>th</sup> September visit still applied on this second visit
- No fresh guano was noted in the garage
- The east and north elevations of the garage are obscured by hedgerow and overgrowth respectively

**Photo 7:** West facing elevation of garage
