**The Old Swan Hotel, 54–58 Gurnos Road,  
Ystalyfera, Neath Port Talbot, SA9 2HY**

**Bat Survey Report for Mr G. Shell**

| <b>Report type</b> | Bat Survey Report |

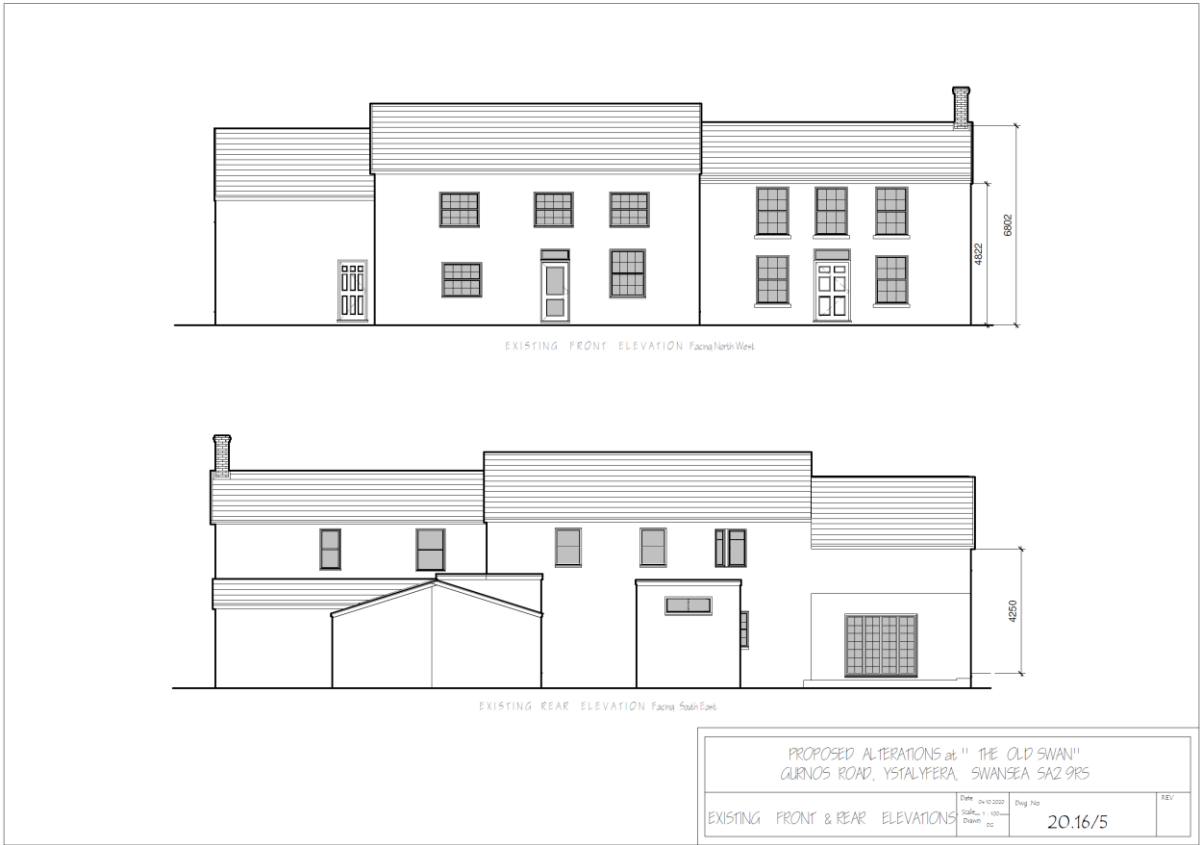
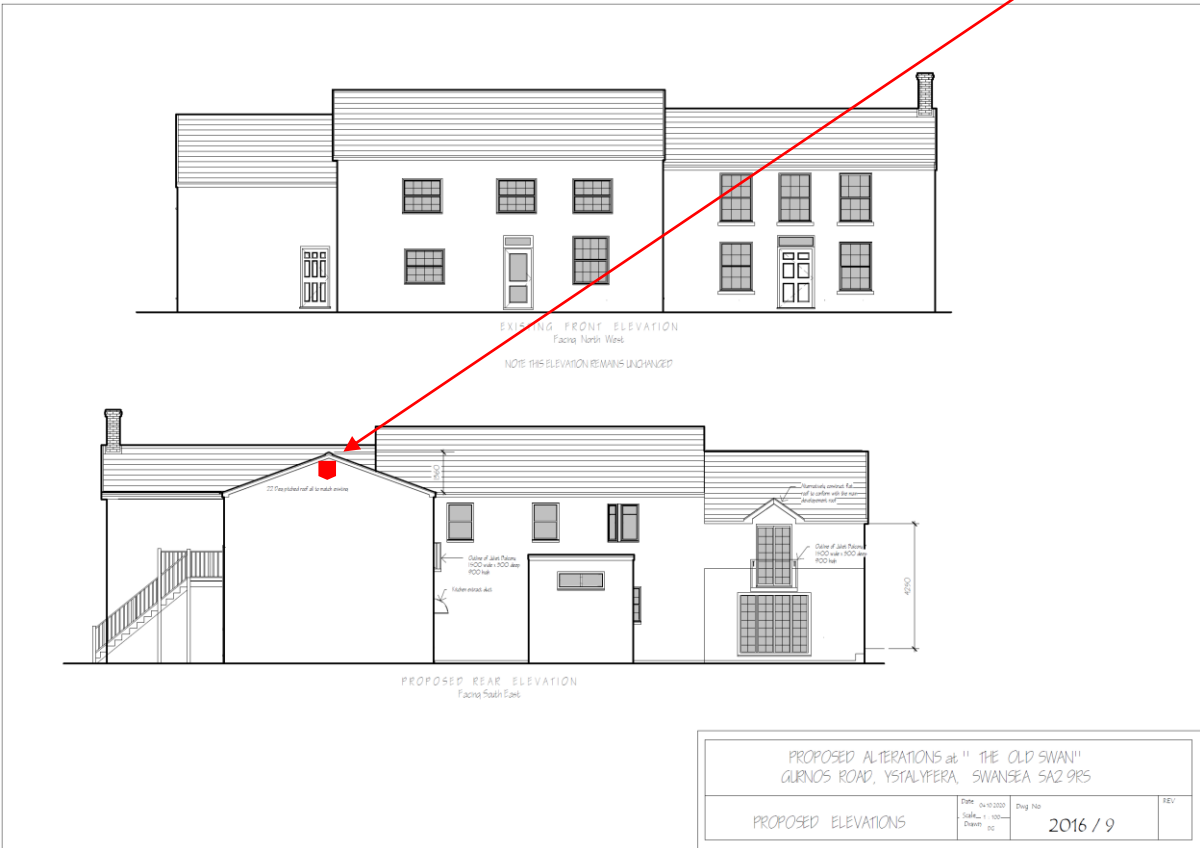
Existing (above) and proposed (below) front and rear elevations for the property. The proposed location for the bat box on the rear of the new extension is shown by a red arrow.

**Recommendation 1:** 1 x Schwegler 1WQ (or similar) bat box to be affixed to the rear (south-east) of the new extension. To be affixed in an elevated position away from artificial light and potential predation and not above any windows or doors.

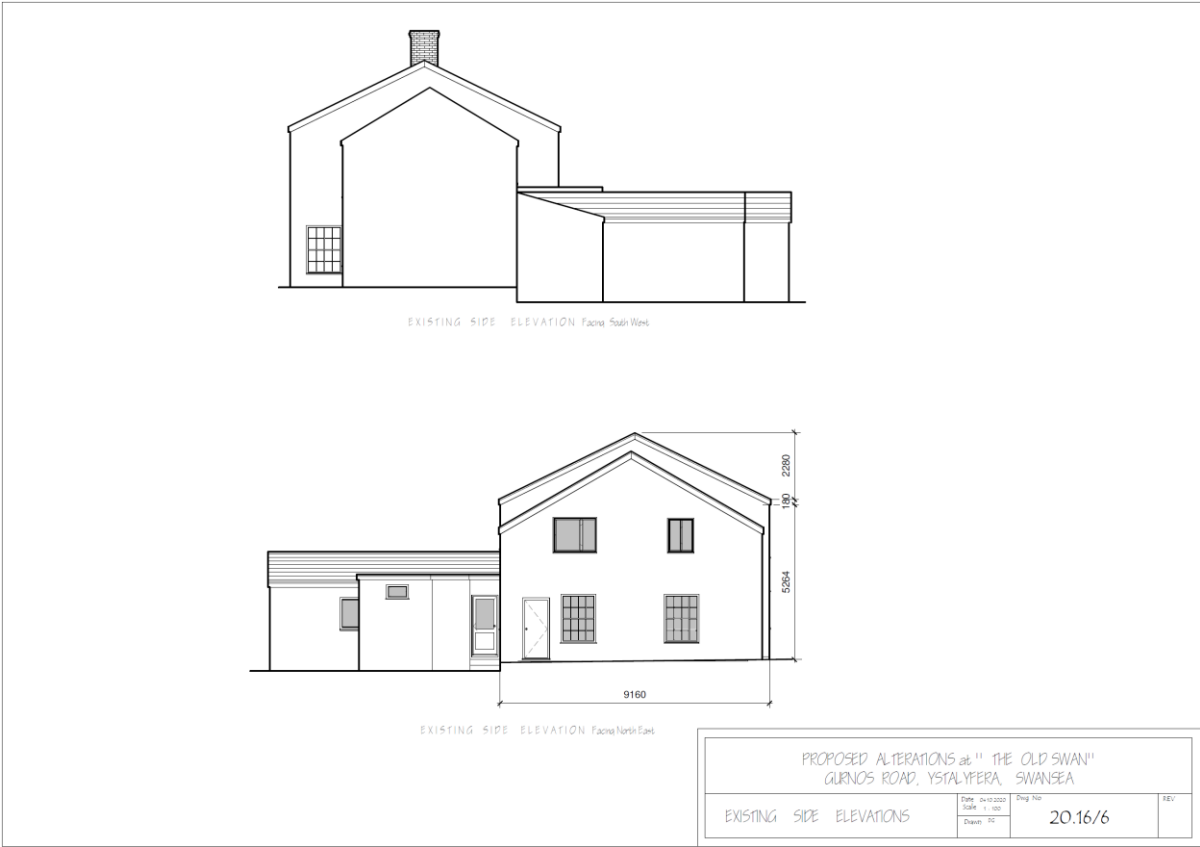
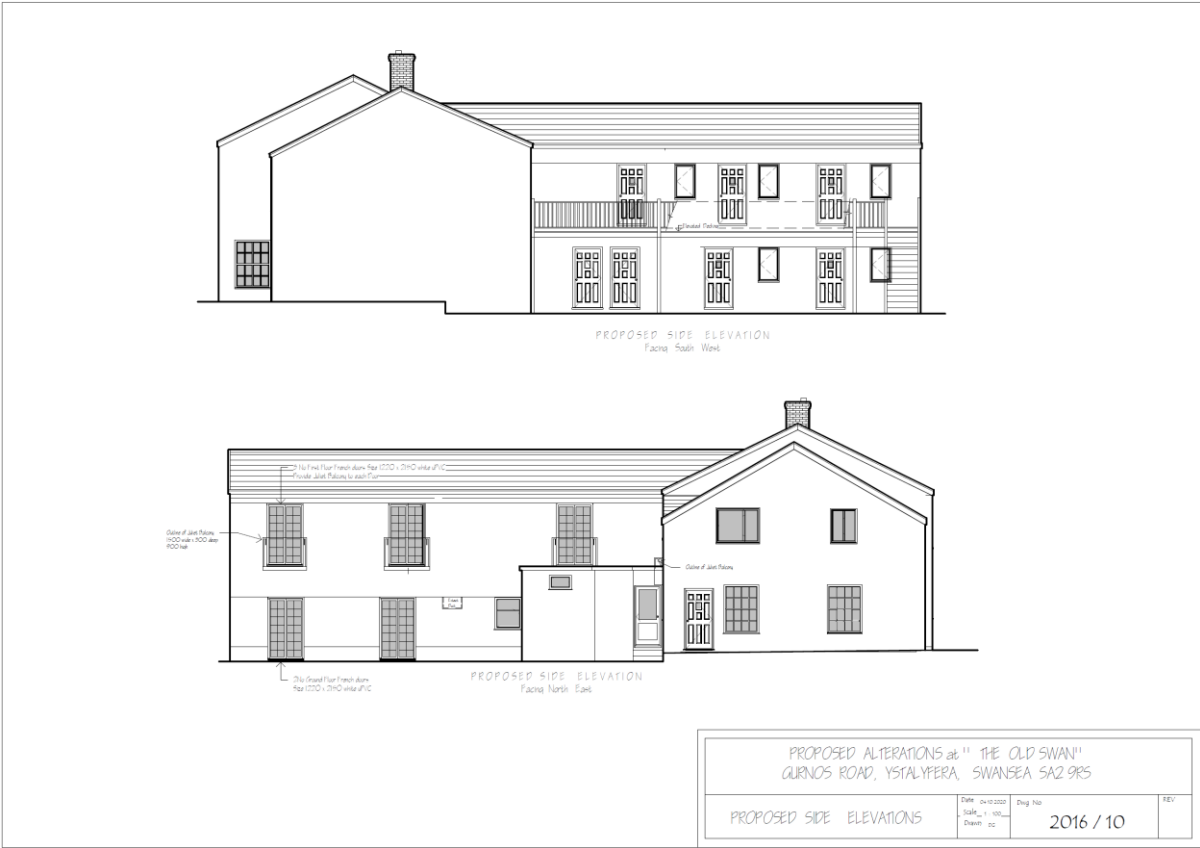
Existing (above) and proposed (below) side elevations for the property.

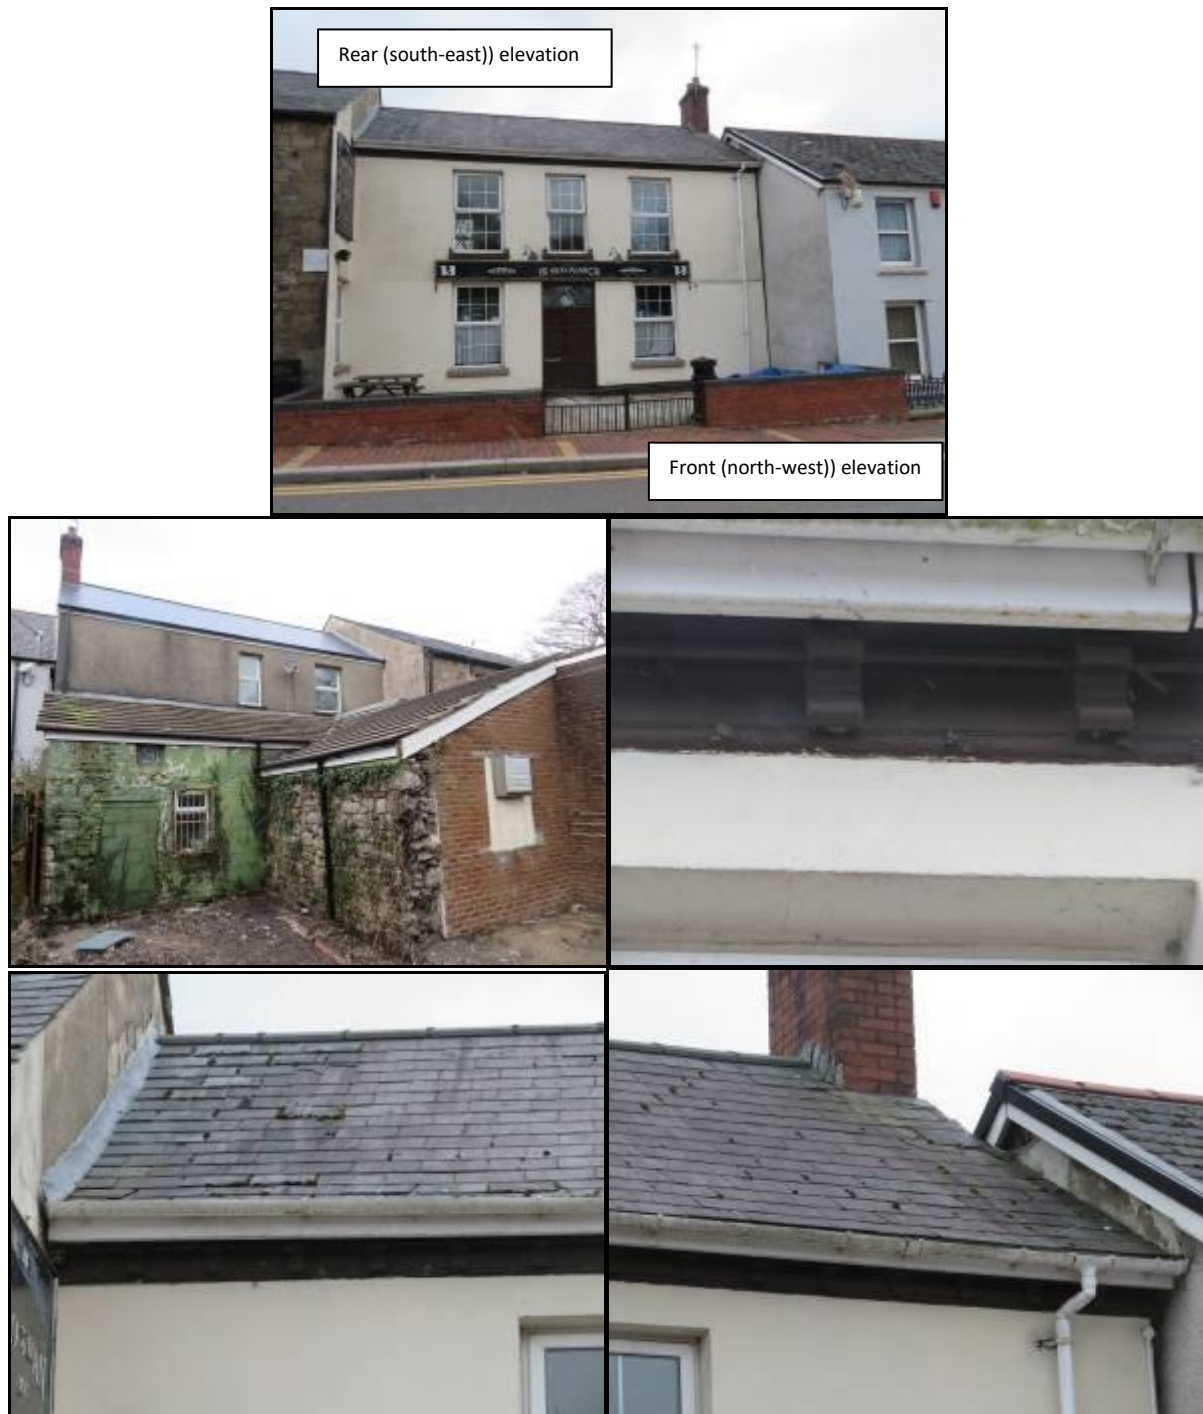
The property is north-west facing public house which covers three buildings, with the north-east elevation being an end of terrace. The rear of number 54 (it also covers part of number 56) is subject to proposed plans for a two storey extension which involves the demolition of two existing single storey extensions. The main building is constructed of brick which has been rendered and painted to the front and rendered to the rear with a part non-bitumen coated/part unlined pitched part natural slate/part slate effect roof. The rear extensions are part brick, part block and part stone with monopitch bitumastic felt lined tile roofs. It is in excellent condition, well maintained, and tightly sealed.

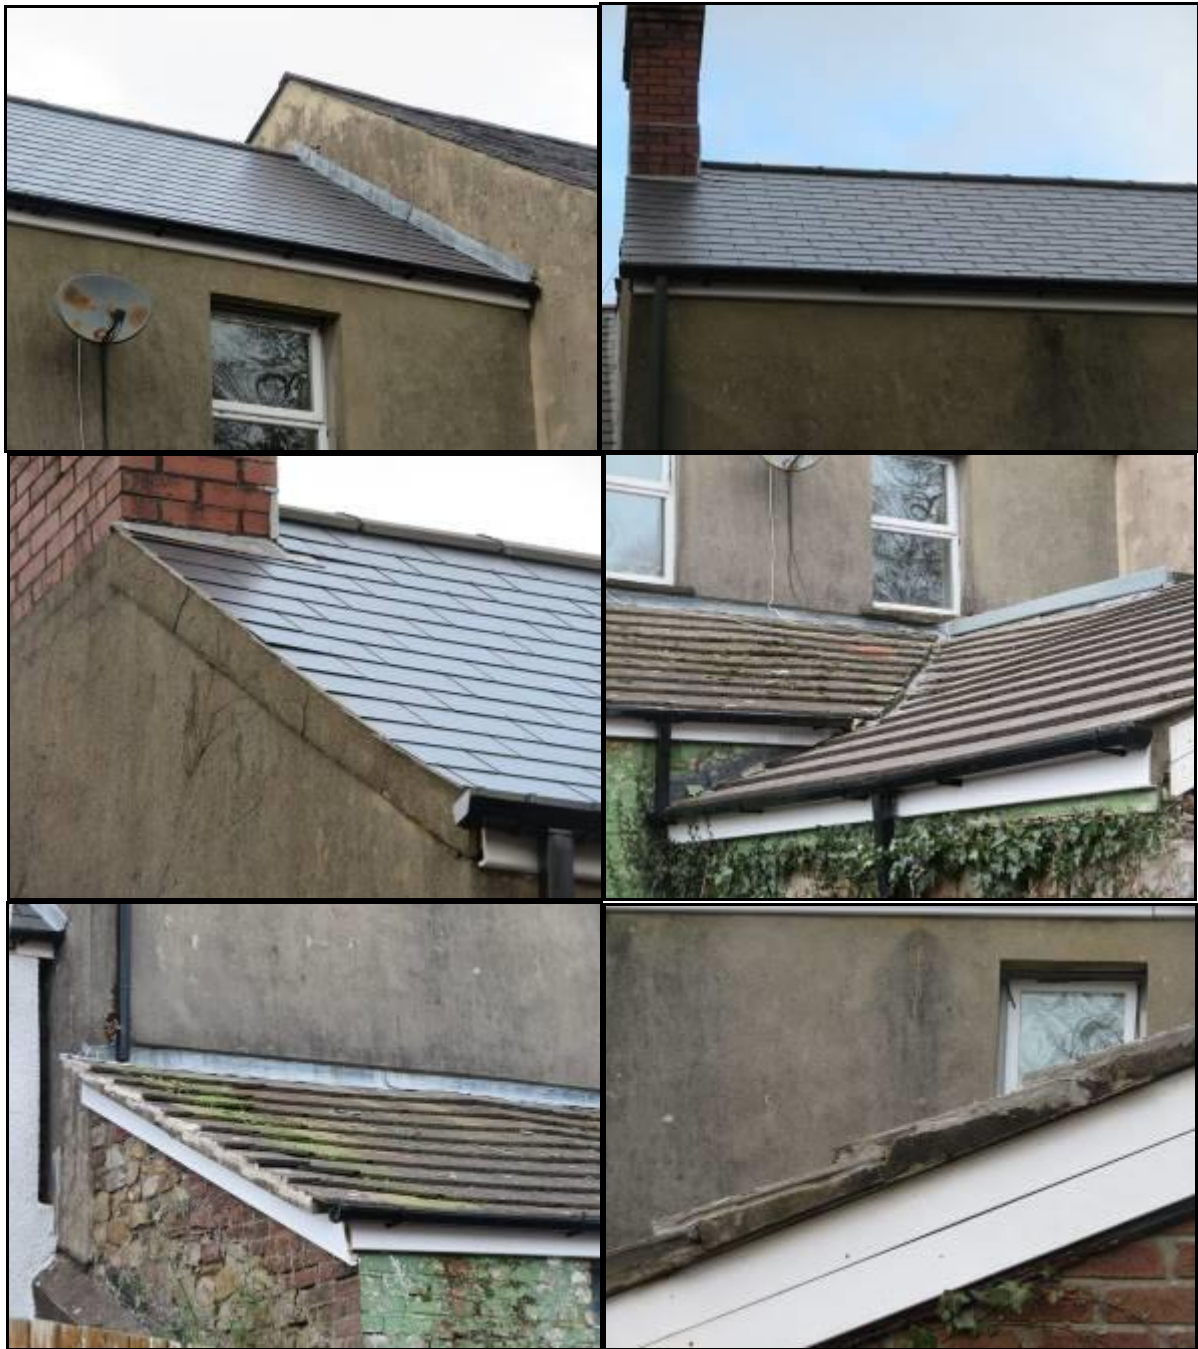
The walls are in very good condition with no potentially exploitable cracks or crevices and no missing dash while the roofs are in excellent condition with no slipped/damaged/missing slates or tiles, no raised ridge tiles, and no gaps under any of the flashing. The building had a new roof, soffits and gutters around six months ago along with internal refurbishment which reused the natural slates to the front and installed new slate effect tiles to the rear. Where present, the uPVC soffits/fascias and barge boards are in excellent condition with no gaps anywhere while the uPVC framed windows and timber door are all intact and remain closed when not in use.

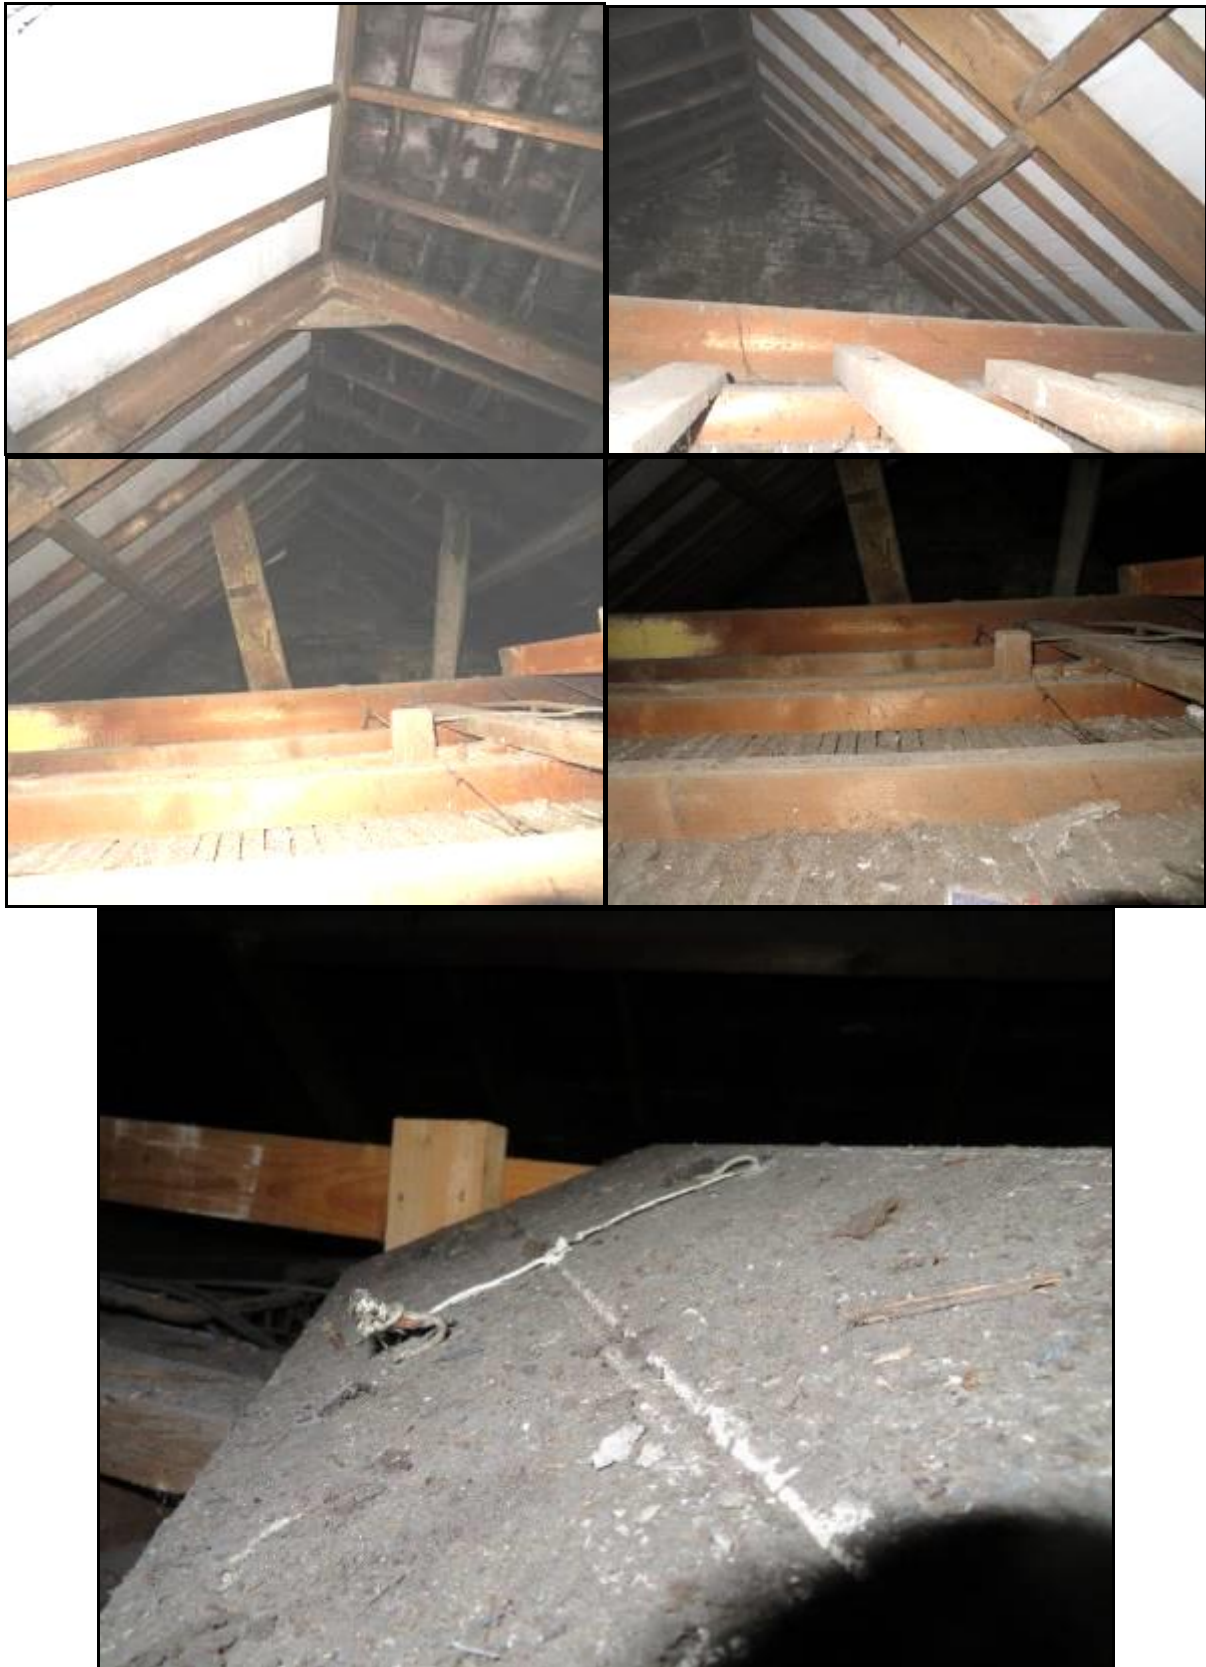
The main pitched roof loft is part unlined and part non-bitumen coated roofing membrane lined. In the unlined section, there are no potentially exploitable gaps in the slates and no natural light enters the space. The lined section was only installed around six months ago and is therefore as new. The timbers and surfaces within have only dust on them, and the walls have no potentially exploitable cracks or crevices.

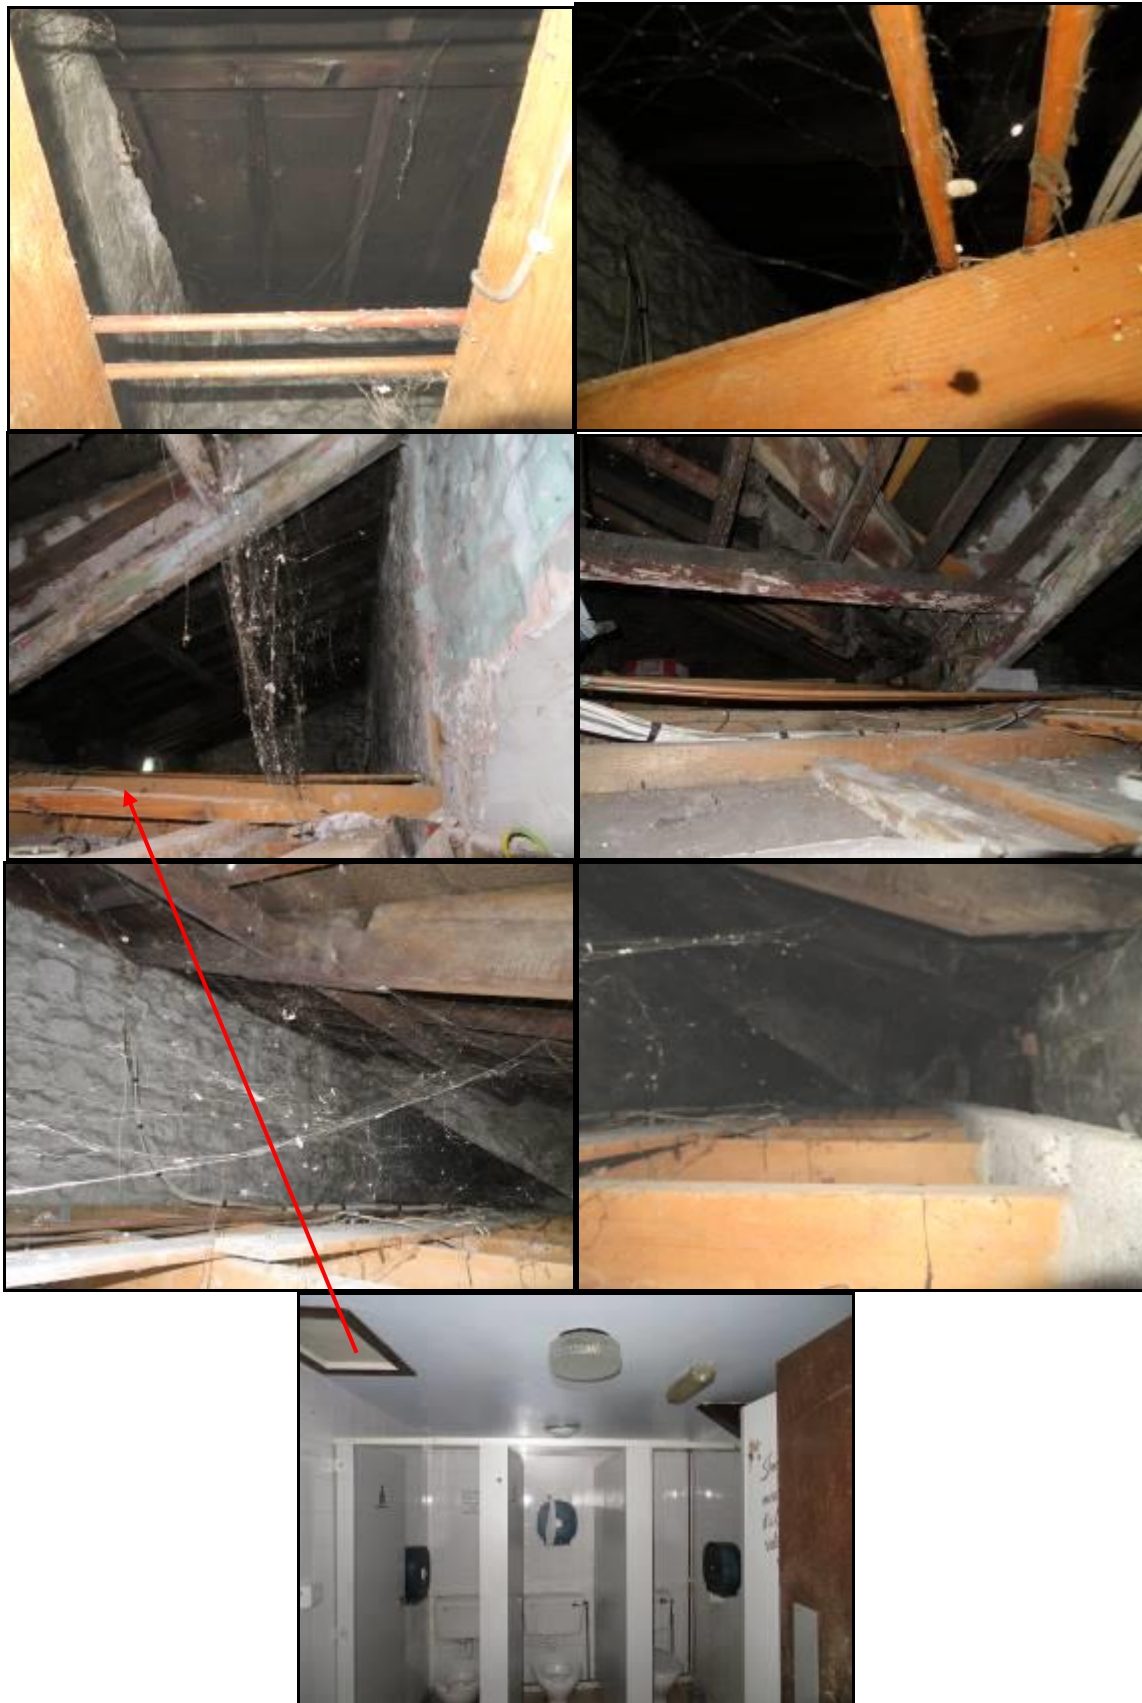
The loft spaces above the existing extensions have bitumastic felt lined tile roofs, and the linings are in very good condition with no damage and only a large number of cobwebs present on both the linings and the timber. In the extension immediately at the rear, light enters part of the loft from a small stained glass window on the south-east elevation.

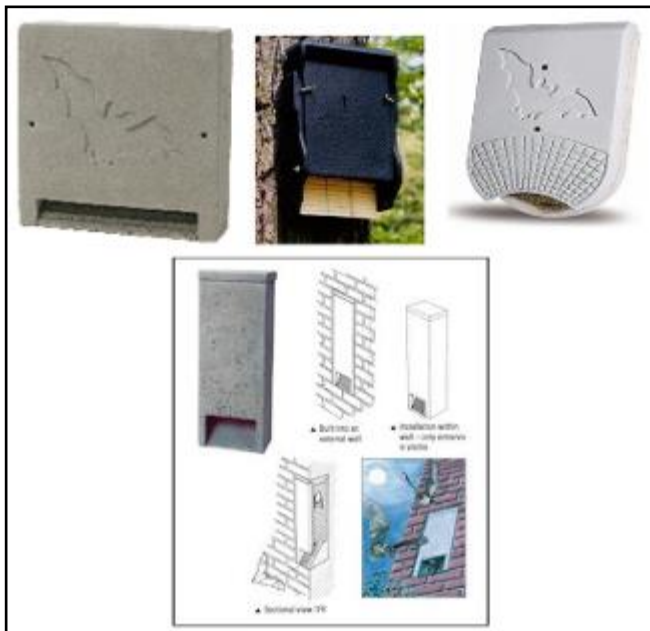
**Top:** From left to right, the in-wall Schwegler 1FR, the tree mounted 1FF and the multi season 1WQ. The bottom image shows the 1FR in situ.

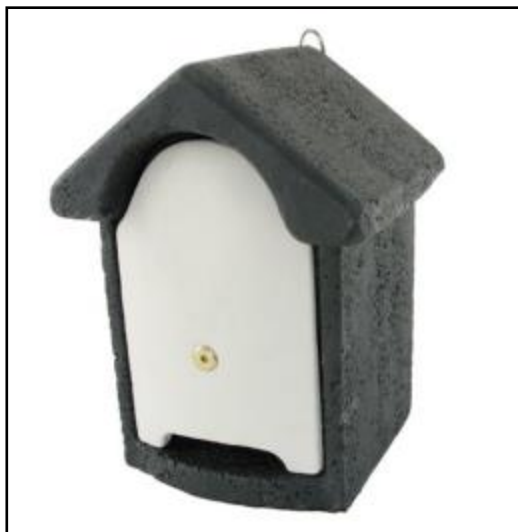
**Middle:** The Harlech Woodstone bat box offers excellent insulation with a minimum of condensation for roosting bats. Ideally you should site at least 2 to 3 boxes which should be erected facing in different directions to account for temperature changes of the day. WoodStone® is a mixture of sawdust from FSC wood sources and concrete, and it is designed to last for years. It is breathable so there will be no problems with condensation and Woodstone maintains a consistent temperature inside, providing excellent insulation for roosting bats. **Specifications:** Height 24cm x width 19cm x depth 18cm; Weight 4.4kg; Colour: Black with White front panel; Hook for hanging; Removable front panel for inspection / cleaning; 10 Year Manufacturers Guarantee.
