## Geo-Environmental Investigation

Proposed Aldi Store

Abbey Road

Neath

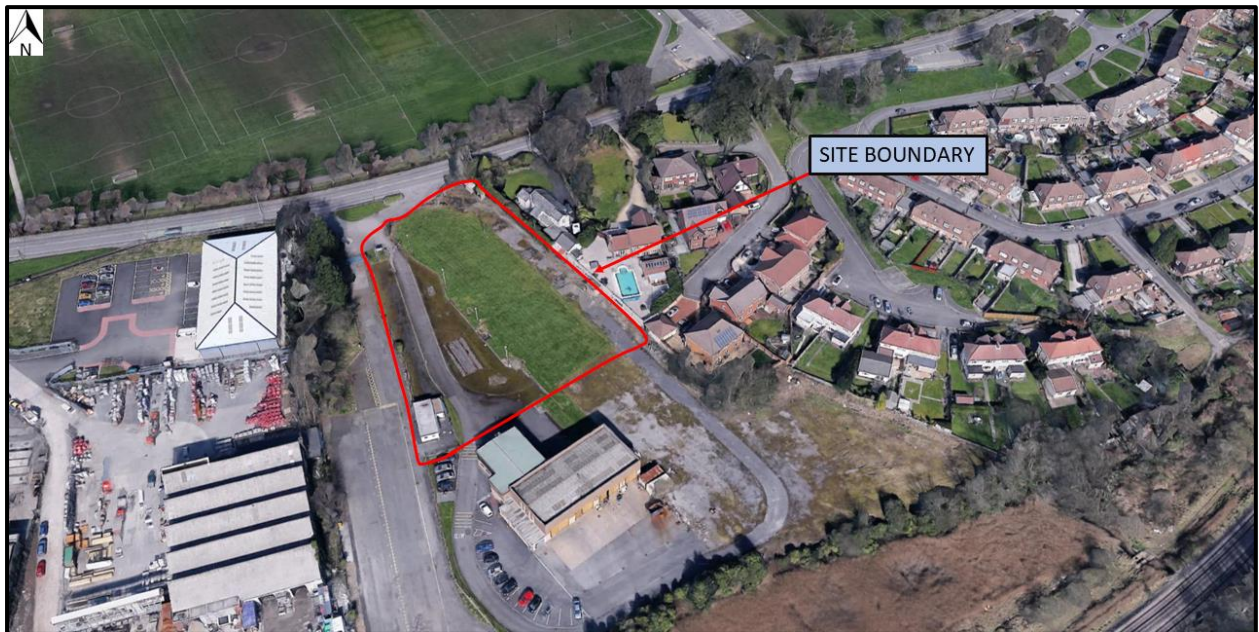
**Figure 2 – Aerial Photograph of Site**

At the time of the investigation the site was disused/unoccupied. Situated at the southern edge of the site is a one-storey office block with associated office space and workshop/machinery. The site is bounded to the east by residential properties and to the north by Neath Sports Centre and Dwr Y Felin Comprehensive School, to the south is derelict woodland, railway tracks and the A465, to the west the site is bounded by a series of commercial stores including a builder's merchant, embroidery and printing and cars sale showroom.
