## Bat Scoping Survey: 48 Park Avenue, Glynneath, Neath, SA11 5DR.

Instructed by: Jan Hutchings

Reported by: Ecological Services Ltd  
10 Mount Pleasant, Llanelly Hill, Abergavenny, Monmouth NP7 0NT

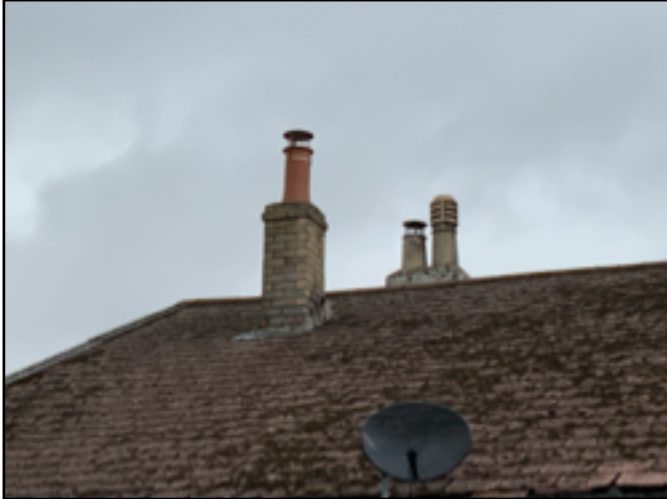
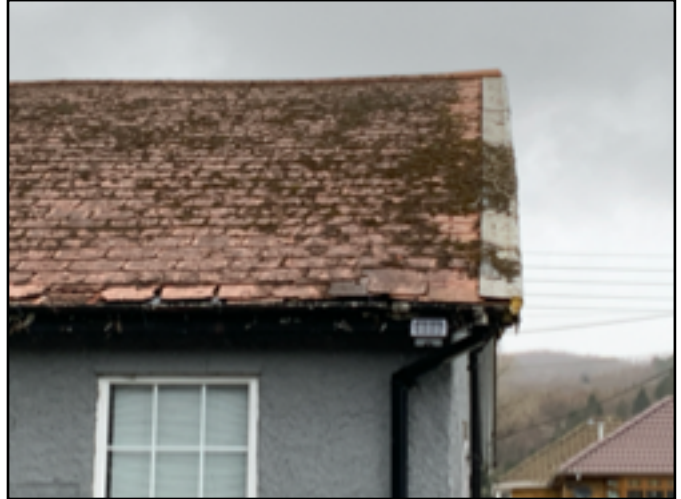
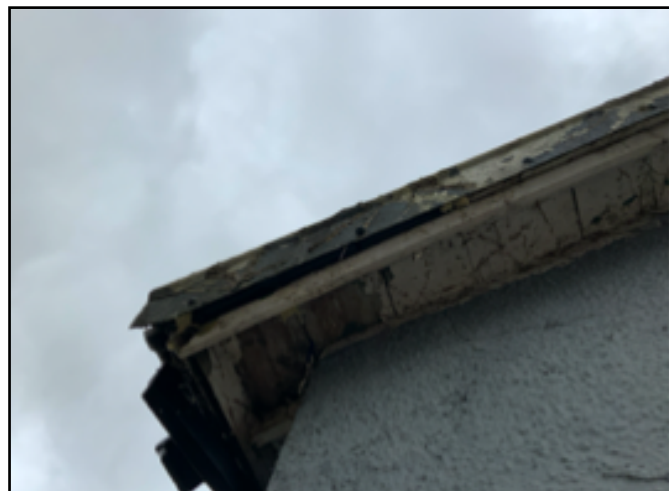
**6.4 There was areas of lead flashing on the roof suitable for bat access. There was slipped and missing roofing tiles . There was also damaged soffit and a**

**6.5 The building was deemed too offer moderate potential for bats use.**

**6.6 No droppings or evidence of bats were discovered on any external features although this would not be definitive of bats not using the building at other times of the year.**

**9.4 If the schedule of works proposed involves demolition, roofing works, including the roofline or significant works to any internal attic space then it is recommended that further exit/return surveys are undertaken during the core maternity season for bats of May to August inclusive. These results must be submitted with any planning application for the building.**

**9.5 If the schedule of works do not involve roofing works, works to the external roof line, any areas detailed in section 6 of this report or significant works to any internal attic space then it may be possible for works to proceed under a detailed ecological method statement which must be drafted by a suitably qualified ecologist and submitted for approval by the LPA Ecologist. In this instance a retained ecologist will be appointed for the project to oversee the works and offer direct supervision where required. The retained ecologist will ensure that no potential bat roosting areas will be impacted upon and will act accordingly if bats or evidence of bats are discovered ongoing.**
