# **PRELIMINARY ECOLOGICAL ASSESSMENT AND BAT SURVEY AT 15 CAE RHYS DDU, CIMLA, NEATH, SA11 1JB.**

**ON BEHALF OF  
MR MIKE ROBERTS**

**April 2018**

Ref: HE/78/2017

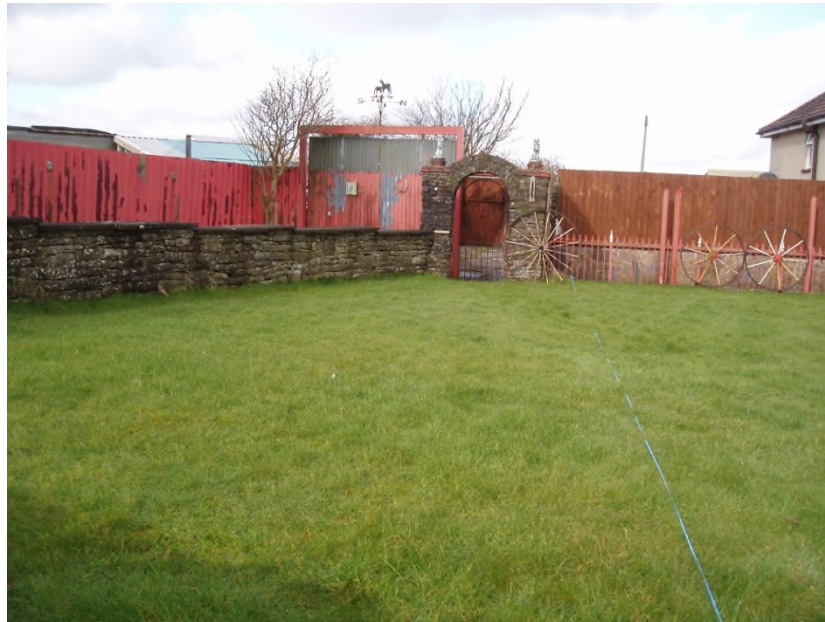
Mown lawn and stone wall (TN3)

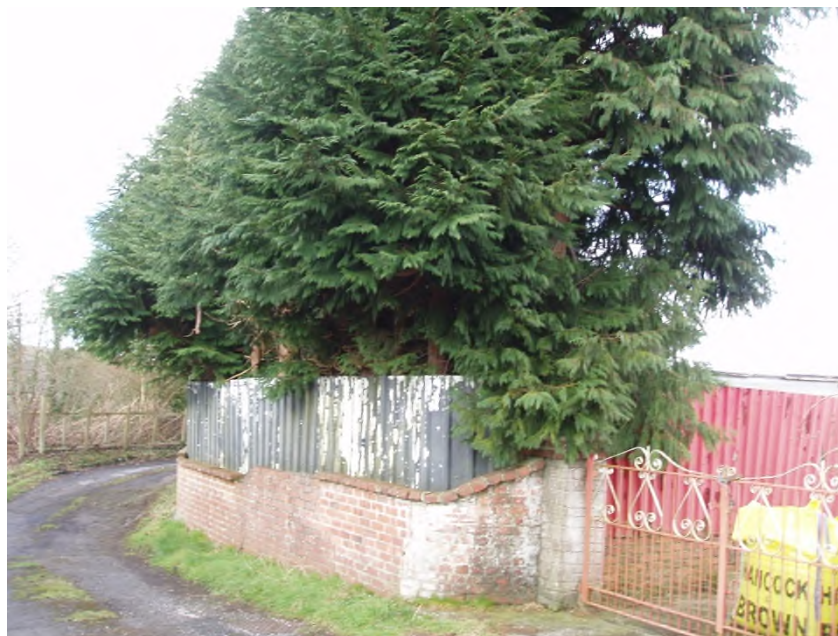
Site walls and cypress hedge

- 8.1 Removal of trees and shrubs should be undertaken outside the accepted bird breeding season of March to August. If this is not possible, the affected areas will be searched by a suitably experienced ecologist prior to commencement of works. There is no licence for the destruction of active bird nests and translocations invariably fail. Any nest will be protected by a buffer zone until such time as it is no longer in use.

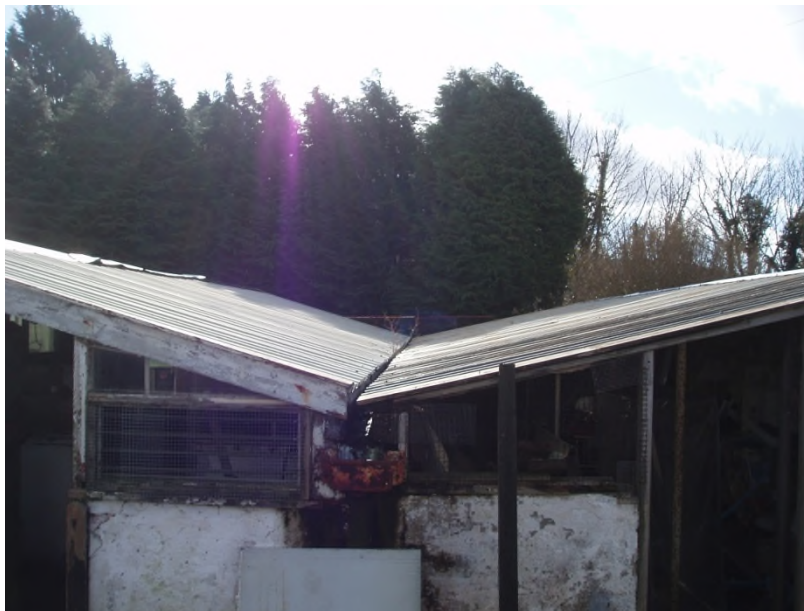
- 5.8 None of the buildings were considered to hold serious potential for supporting roosting bats although there were limited features present such as the lifted ridge sheets which may offer some opportunistic roost potential. Bats could clearly access the majority of the former glasshouse and shed complex through open doors but there was no evidence to suggest this happens in any regular manner; although the assessment was undertaken in the non activity season, there was enough material stored in the sheds to retain any accumulation of droppings.
- 5.9 The sheds, buildings 2 and 3, showed no evidence or potential for bats to use them as a roost.

Roof valley between building 1a and 1b

- 8.3 Removal of the garden complex building roofs (building 1) should be undertaken with care and by hand. Should bats be found during this operation, works will stop immediately and a suitably licensed ecologist or Natural Resources Wales contacted without delay to offer advice on how best to proceed. A Derogation Licence may need to be obtained in this instance.

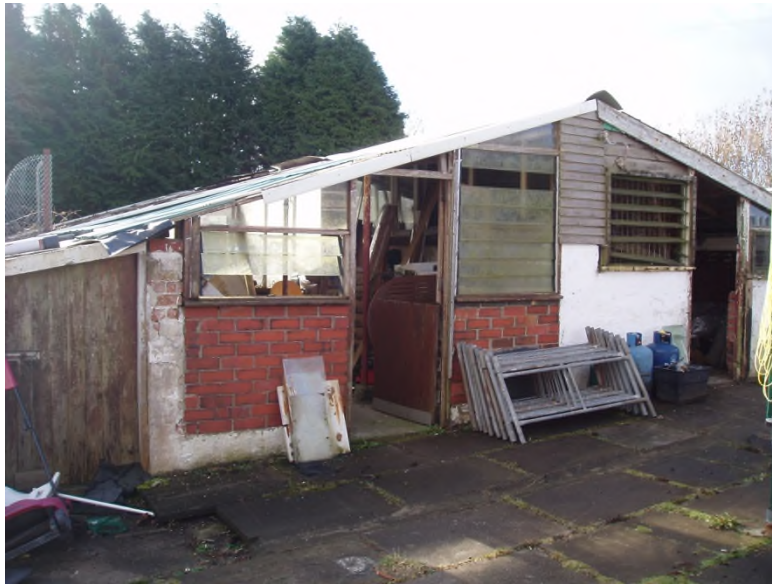
| No | Wall Structure | Roof structure and loft space | Comments | Assessment of Bat Roost Potential |
|---|---|---|---|---|
| 1b | Low single skin brick walls, eastern wall partially glazed. | Double pitch roof forms valley with roof of building 1a, open to roof, western section is wood roofed with no underfelt, southern is glass and has partially collapsed. Some areas have been recovered with metal profile sheets. Ridge partially covered with metal sheet. | Brickwork is generally in sound condition with some rooted wood. The glass roof is partially collapsed and the building in a dangerous condition.<br><b>Direct evidence of bats:</b> None<br><b>Potential for roosting bats:</b> As above, some of the metal has lifted on the ridge, possible opportunistic roost opportunities but no easy flight access to them. | None - Low |

Showing buildings 1b

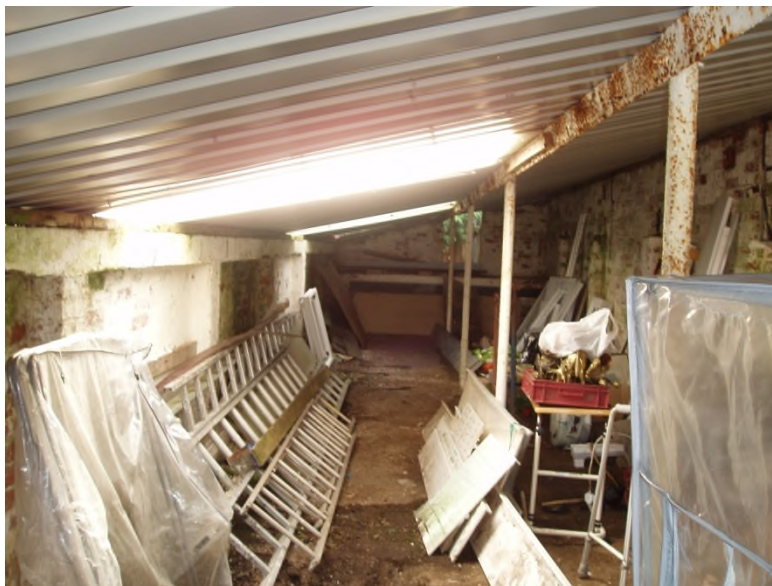
| No | Wall Structure | Roof structure and loft space | Comments | Assessment of Bat Roost Potential |
|---|---|---|---|---|
| 1a | Single Skin brick wall, western wall is boundary of Site. Wooden fascia on outside wall, tight to wall. | Mono-pitch, east facing, open to roof internally. Roofing materials a mix of wood, metal profile sheets and clear polycarb sheets. | Brick construction, solid walls, roof well sealed with no access for bats, no underfelt.<br><b>Direct evidence of bats:</b> none<br><b>Potential for roosting bats:</b> Very limited access to the building through open doors and window, no potential roost sites noted internally. | None - Low |

Building 1a interior

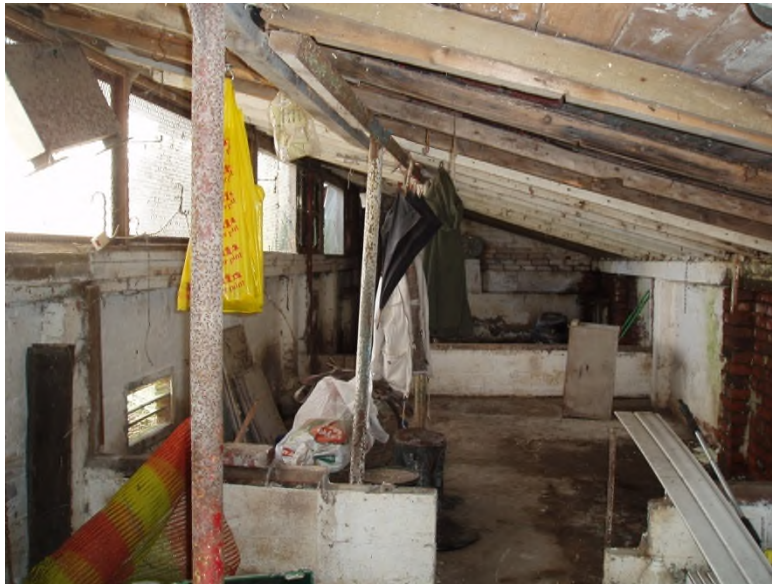
Building 1b interior

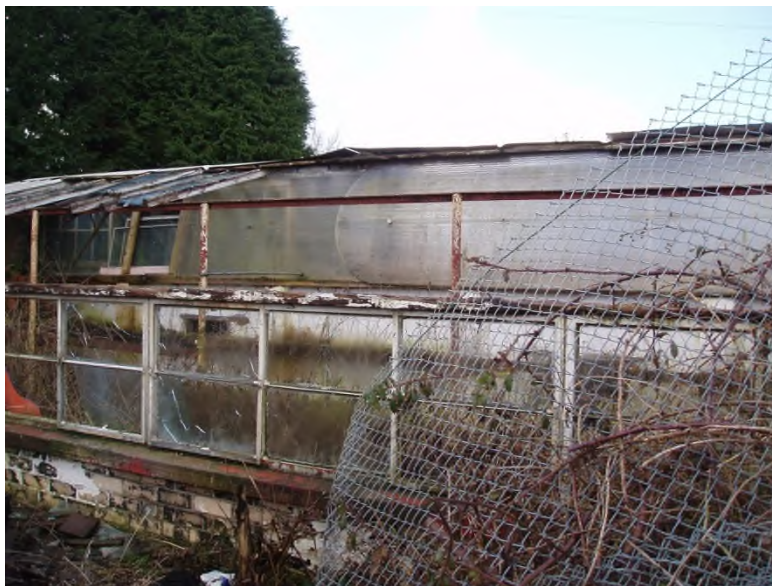
- 1.3 The buildings on Site date from around the 1950's and are all in poor condition with one of the glasshouses partially collapsed. They are currently used for storage although some clearance of old stored material has taken place. The Gardens are still managed and looked after by Mr. Roberts.

Partially collapsed glasshouse roof (building 1b)

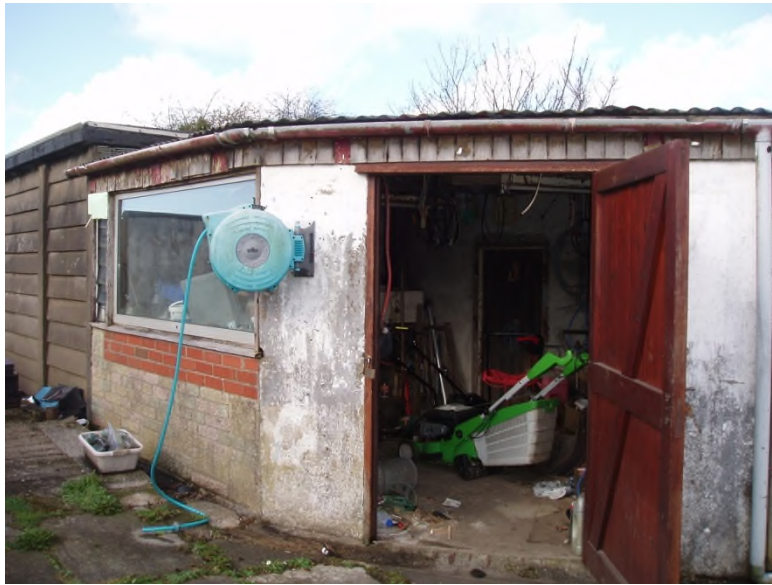
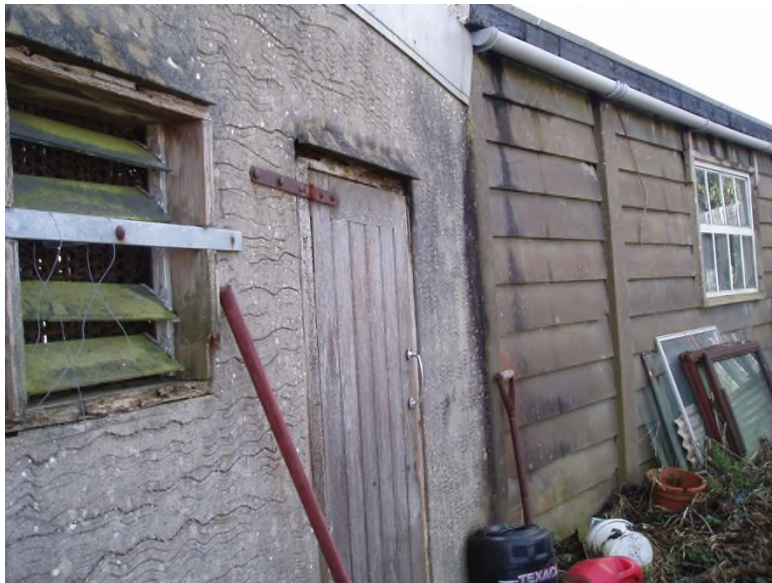
| No | Wall Structure | Roof structure and loft space | Comments | Assessment of Bat Roost Potential |
|---|---|---|---|---|
| 2 | Single skin brick shed, large window. | Flat roof, covered with corrugated zinc sheet. | Well used tool shed attached to building 3.<br><b>Direct evidence of bats:</b> None<br><b>Potential for roosting bats:</b> None | None |
| 3 | Concrete panelled shed, large window. | Flat concrete slab roof with felt cover. | Attached to shed (building 2) and used for tool storage. Some water ingress and seals in the concrete roof failing.<br><b>Direct evidence of bats:</b> None<br><b>Potential for roosting bats:</b> None | None |

The tool shed and concrete buildings (nos 2 and 3)
