# TECHNICAL NOTE

| SUBJECT: | Port Talbot Harbourside - Gasholder Excavation Watching Brief & Sampling | | |
| PROJECT: | 70057278 | AUTHOR: | R. Evans |

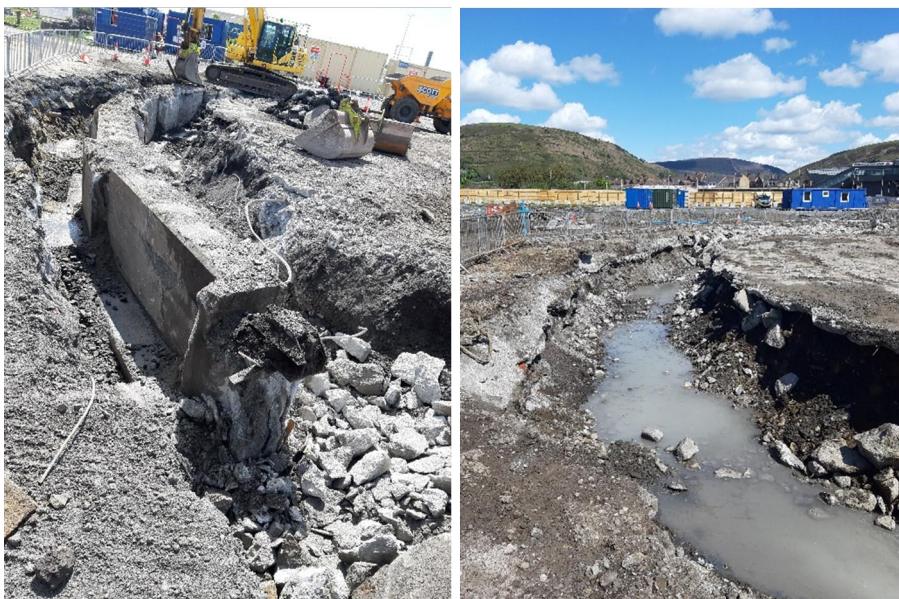
*Left - Reinforced concrete ring-beam encircling gasholder.  
Right – Excavation following removal of ring beam.*

At the time of the visit, approximately 75% of the ring-beam had been exposed with approximately 50% of the ring-beam broken out. WSP observed no signs of visual or olfactory evidence in the exposed soils, and none had been noted by the on-site Andrew Scott supervisor during the works.
