## **BAT ACTIVITY SURVEY**

2 The Greenway, Llandarcy, Neath, SA10 6JB

**Report Reference – WW/Bats/150521**

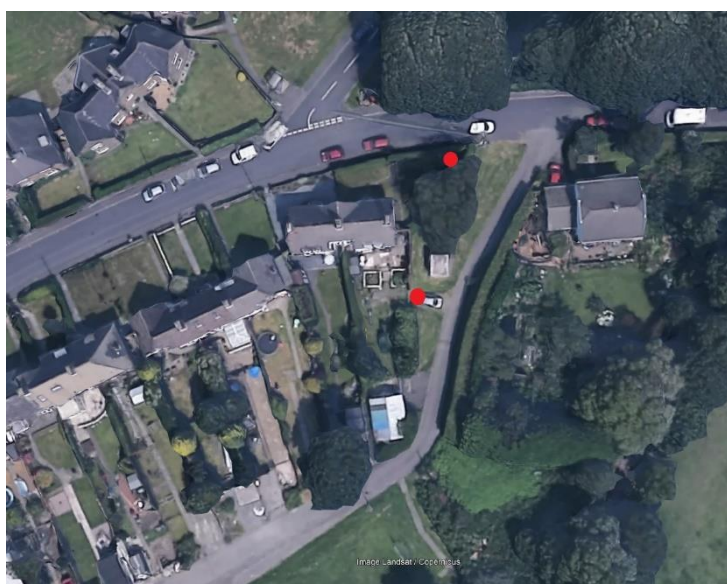
Figure 2. Surveyor locations

One dusk emergence survey was undertaken on 15<sup>th</sup> May 2021. The survey followed good practice guidelines, starting approximately half an hour before sunset. Two surveyors took part during the survey positioned at opposite sides of the site (Figure 2). A range of detectors were used including Anabat Express (frequency division) detectors, Anabat Scout (full spectrum) and Pettersson D240x (time expansion). All bat calls recorded were analysed using Anabat Insight or Analook software.

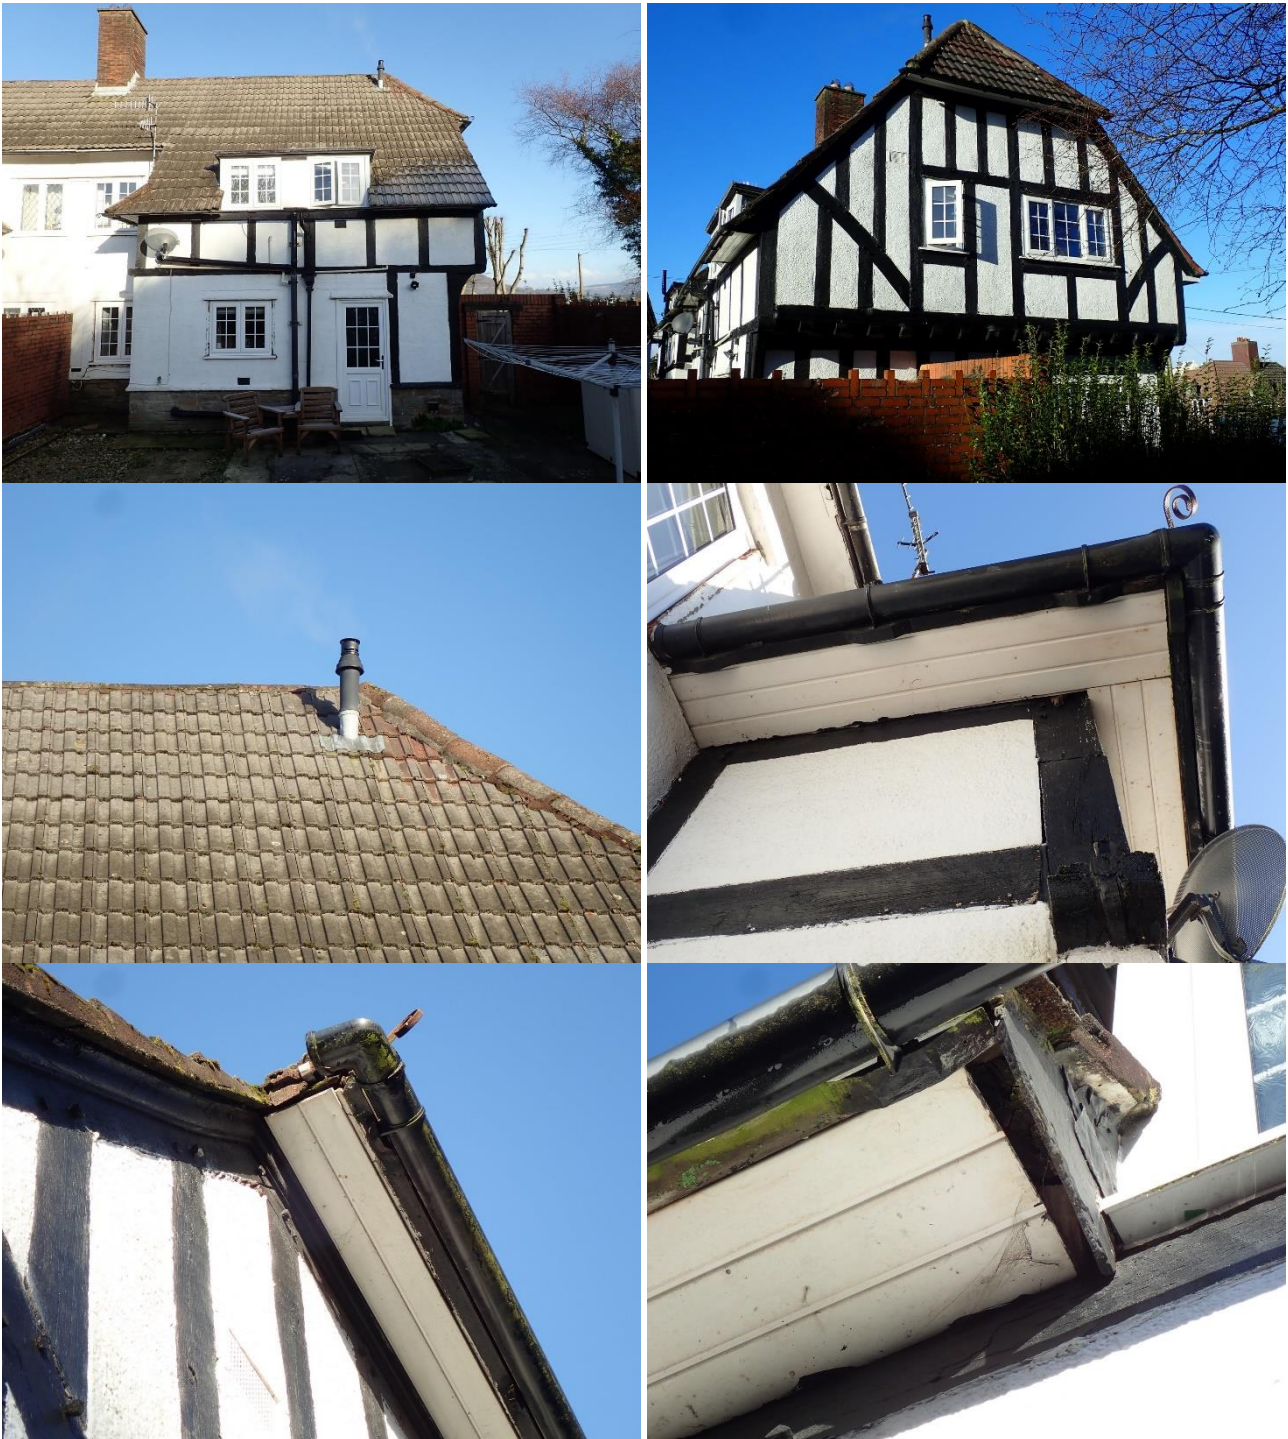
The semi-detached double storey dwelling is comprised of roughcast rendered blockwork to all walls. The eastern elevation and the upper section of the south elevation is of exposed timber and beam structure. The pitched concrete interlocking tile roof is of sound construction with no tiles missing or cracked. One tile is slightly lifted on the south-western corner; ridge tiles are intact and well-mortared. The exposed timber and beam structure eastern elevation has a hipped roof towards the top third of the gable end. All tiles are intact. Small gaps are present at the base of the hipped roof above the timber and beam structure.

The chimney between this property and the neighbouring property is well-mortared and the lead flashing is well-sealed. The flue on the eastern end of the southern roof pitch is well-sealed with lead flashing. Timber bargeboards are present on the gable end below either side of the hipped roof; these are rotten at the eaves. Soffit boxes are constructed of uPVC and are tight fitting in all but a couple of locations. One gap is present at the end of the soffit box adjacent to the left window of the dormer, the other is adjacent to the right window of the dormer. Doors and windows are uPVC and are well fitted. The lead flashing adjacent to the dormer windows on the southern elevation is slightly lifted. There are no crevices in the walls.

*External photographs (Clockwise from top left): South elevation with dormer windows; eastern elevation with timber and beam structure and hipped roof; minor squeeze gaps behind soffit box; potential access into soffit box adjacent to dormer window; base of hipped roof on eastern elevation; well-sealed flue adjacent to well-mortared hip tiles.*

The inspection found the building to have potential access points where bats could gain access: either side of the rear dormer windows into the soffit box and on the eastern gable end on top of the timber beam below the hipped roof. No cavities are apparent in internal or external walls.
