**YSGOL GYMRAEG BRO DUR  
YSTALYFERA****BAT & PROTECTED spp SURVEY****June 2021****1 survey at the request of-**

Phase 3, Stage 2 demolition:  
Demolition of i) canteen block & ii) music/drama block, Ystalyfera School.

YG Bro Dur (Ysgol Gyfrun Ystalyfera site) Glan yr Afon Rd, Ystalyfera SA9 2JJ  
SN770088

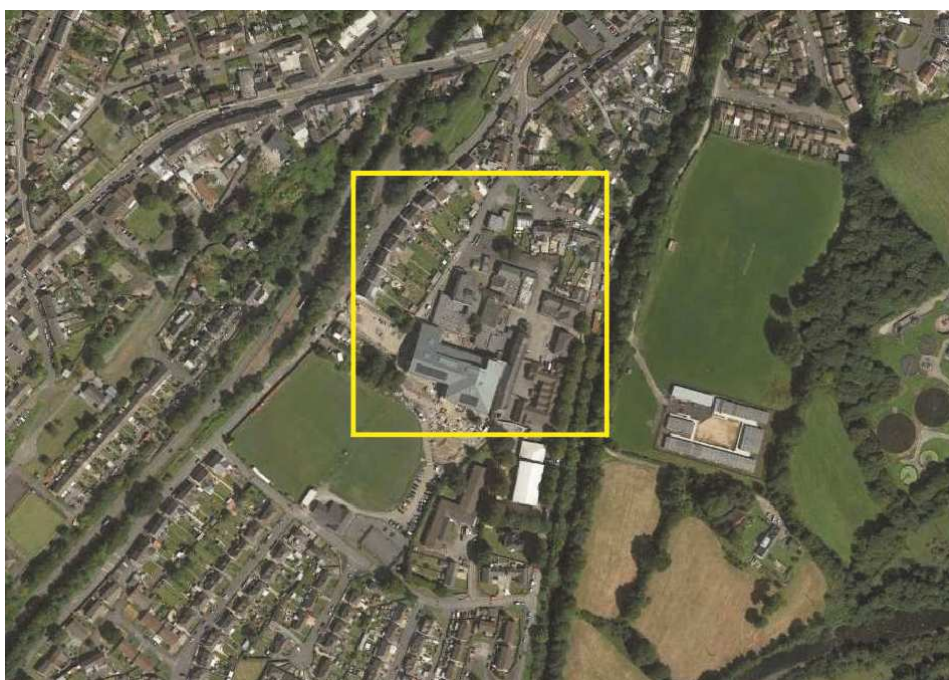
### 9.1 site location, adjacent habitat:

The site is at the south-eastern edge of Ystalyfera village. There is housing to the north and west and amenity-grass playing fields to the south (& over-river to-east), giving suitable habitat for generalist/opportunist (pipistrelle) bat species; the Twrch riparian tree-corridor, immediately over-road to the east, gives good foraging habitat for light-intolerant woodland specialists, with an increased potential for day roosting by such species at buildings facing the Glanyrafon Rd/s-e corner of the wider school campus.

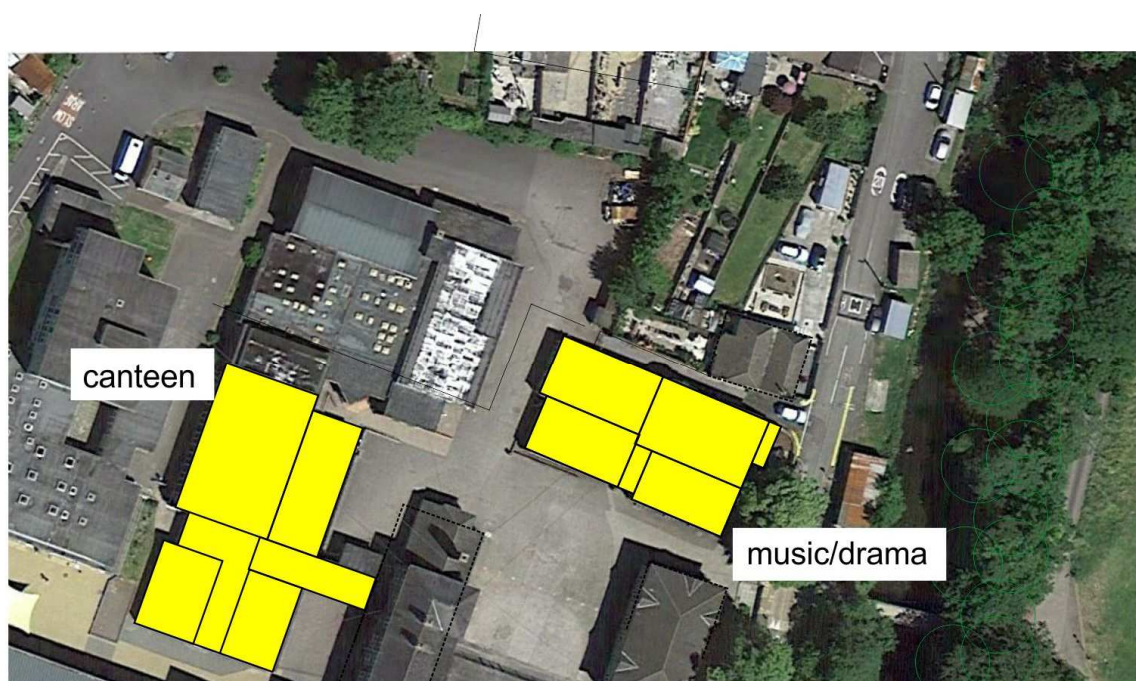
2021 survey effort was directed to two in-use buildings at the north-west of the school campus, both scheduled for demolition/removal: the canteen-block stands towards the centre of the campus, whilst the music/drama block is at the campus north west perimeter, over-lane from the Twrch riparian tree corridor.

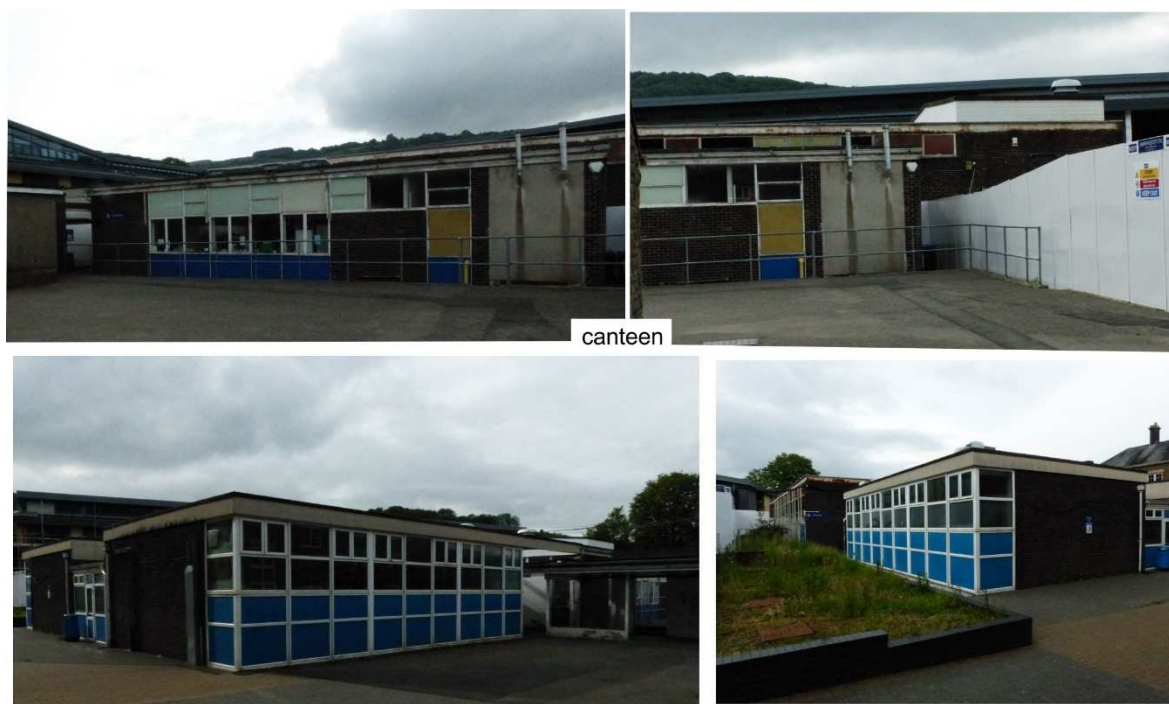
The flat roofed, single-storey, Canteen Block consists of four contiguous blocks, internally/externally interconnected by slightly lower roofed link corridors: the north

west section has a slightly higher roof than the other three sections; a shelter roof with open sides extends from the east-centre to-east.

End (north & south) walls are largely brick; all longwalls are largely glass & panelling, with some full height brickwork; windows/doors/panels are intact, and all walls are sealed against any possibility of intra-masonry bat-access: all walltops have tight sealed fascias/soffits.

Slab roofs all have well-sealed bit. felt coverings,

No evidence of bat use was found and no potential roost opportunity was seen.

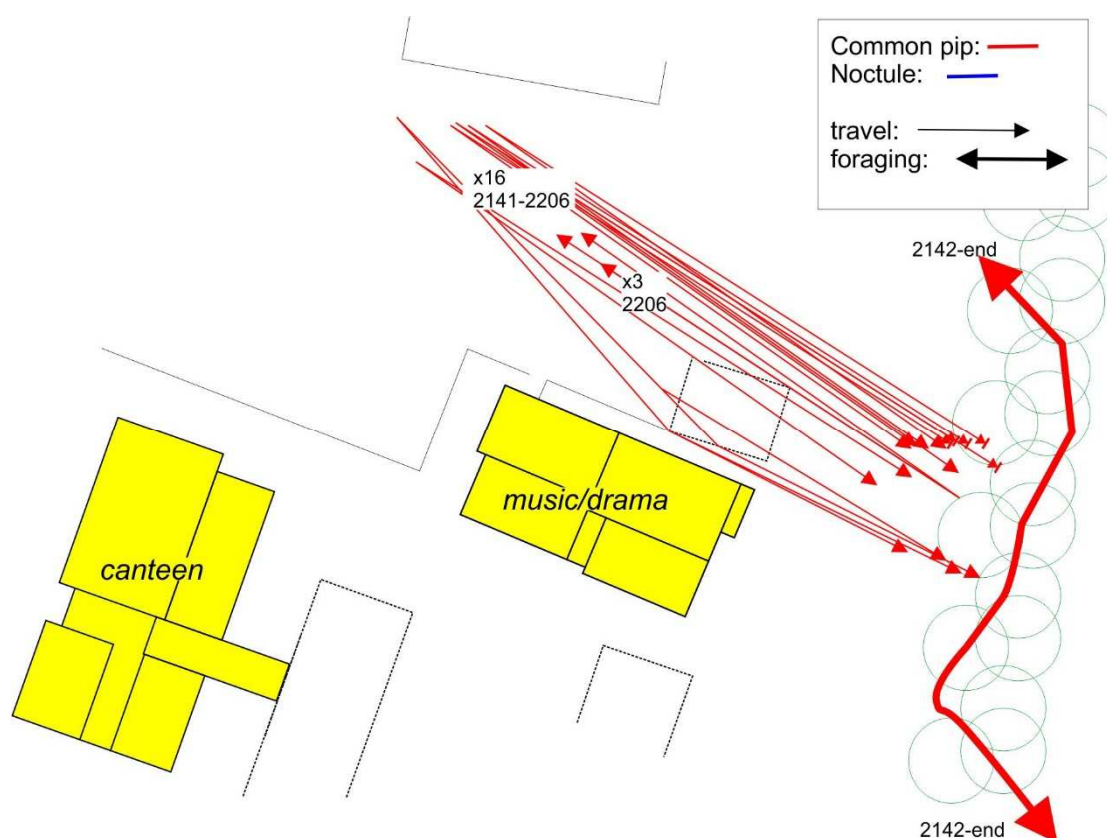
9.3.3 22<sup>nd</sup> June 2021  
2120-2245  
start temp. 14°C  
30% cloud  
no wind

Common pip: x16 animals crossed the north-of-campus, flying from the north/north-east direction of beyond site housing to the river corridor- four of these passed between A-B and the north-of-campus bungalow but most were high/above the bungalow roof, 2141-2206. Two-three foraging animals were present at the river corridor, 2142-end.

No bats emerged from, or entered, the survey buildings.
