**Bat Survey:** 10 Graig Road, Trebanos, Pontardawe, Swansea, SA8 4BA

Instructed by: Tudur Jones

Reported by: Ecological Services Ltd

## **6.0 External Scoping Survey**

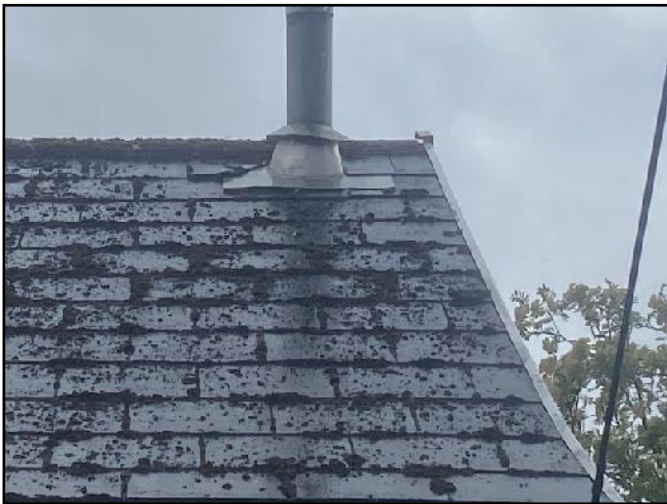
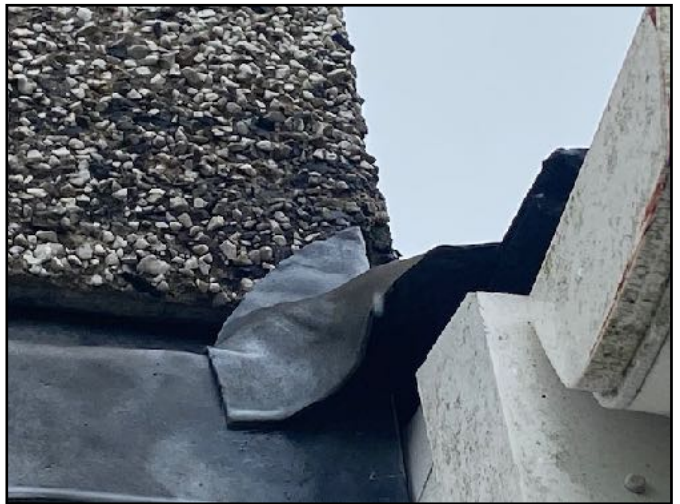
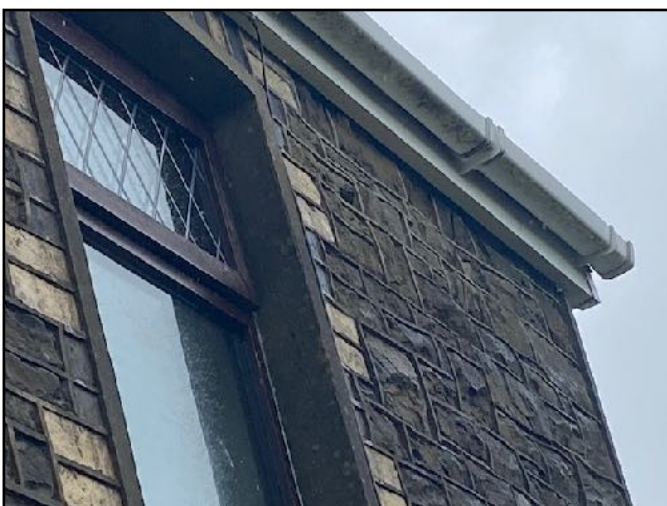
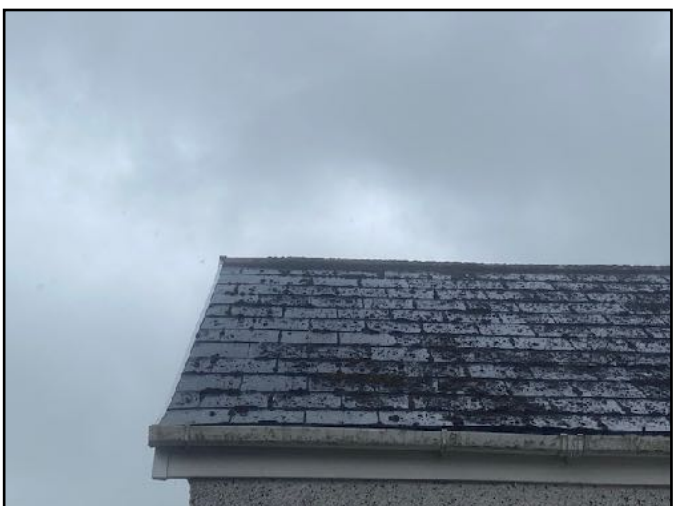
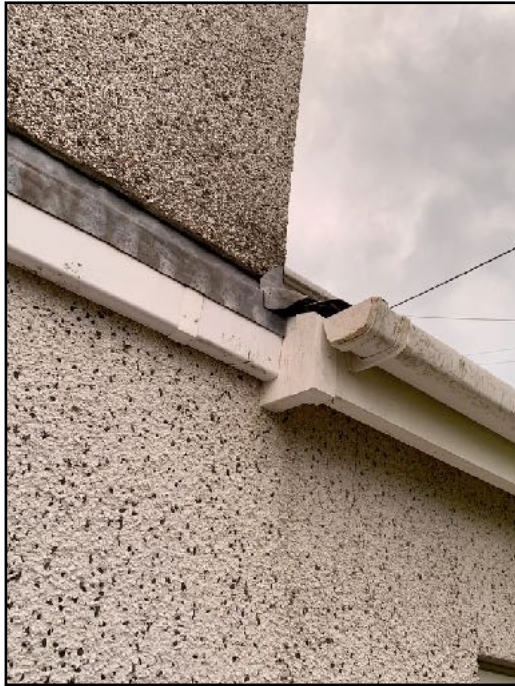
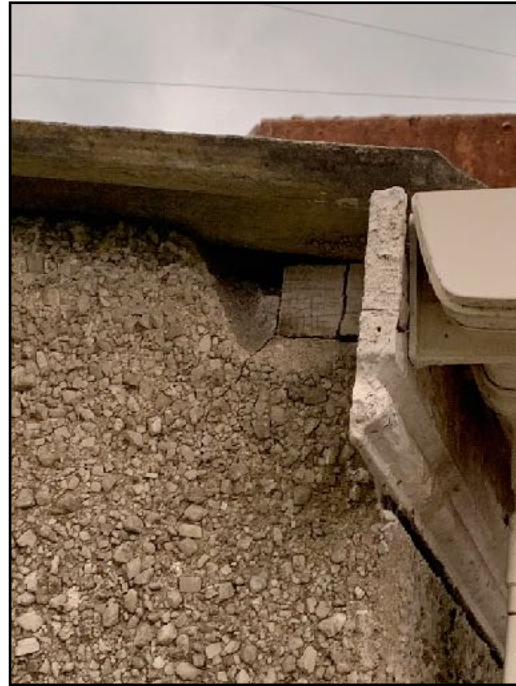
**6.5 Examples of apertures allowing access to cavities in the buildings:**

**6.3 Due to the condition of the building there were opportunities for bats to roost. Those that were available were deemed as moderate potential. There were apertures in the fascia of the lean-to; there was an area of raised lead flashing on the roof and around the chimney which were suitable for bat access and there were multiple raised slates on the rear of the roof. The building was classed as moderate potential for roosting bats.**

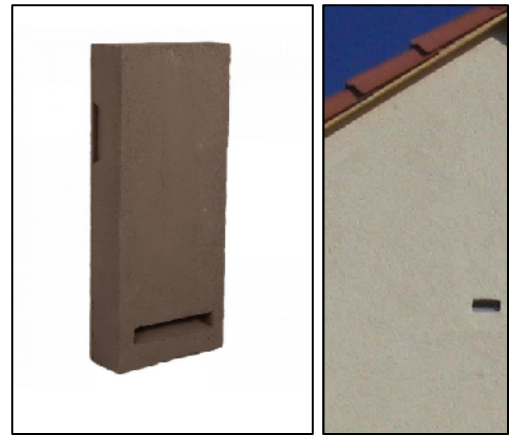
**10.8 Further new roosting for bats will be created by fitting 1 number Vivara Pro Build-in Woodstone Bat Tube. This will be built integral to the new block work and can be rendered over and painted to match the finish of the building. Care must be taken to leave the access/egress slot at the bottom exposed for access. This will be fitted as high as possible on a suitable gable end.**

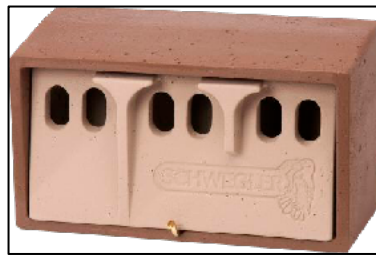
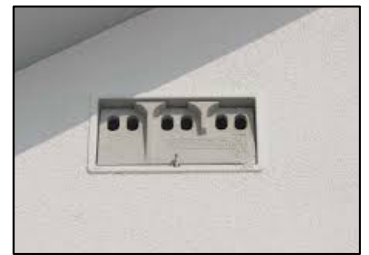
**10.10 The Schwegler 1SP sparrow terrace will be built into the render. These will not be situated on a south facing elevation. The sparrow boxes should be recessed or partially recessed into the render or cladding if possible. They also can be surface mounted if this is not possible.**

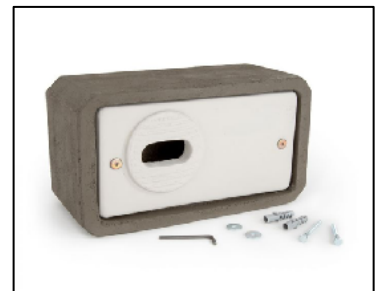
**10.11 The Vivara Pro Woodstone Swift Nest Box will be built into the new block work. These will not be situated on a south facing elevation..**
