Bryn Toilet Block  
Bat Survey Report  
Date: July 2021

Megan Price  
Consultant Ecologist  
Countryside and Wildlife Team  
Neath Port Talbot CBC

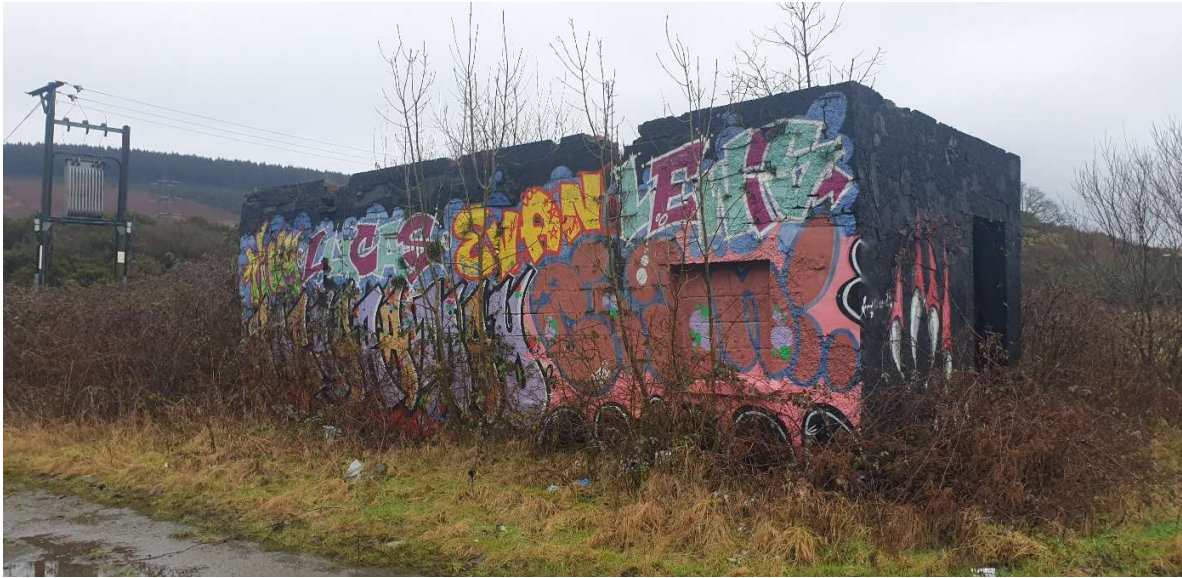
External view of the black building.

Concrete slab roof, solid walls. No cavities or crevices for crevice dwelling species and very open for the species that free hang. This building was considered to have no bat roost potential.

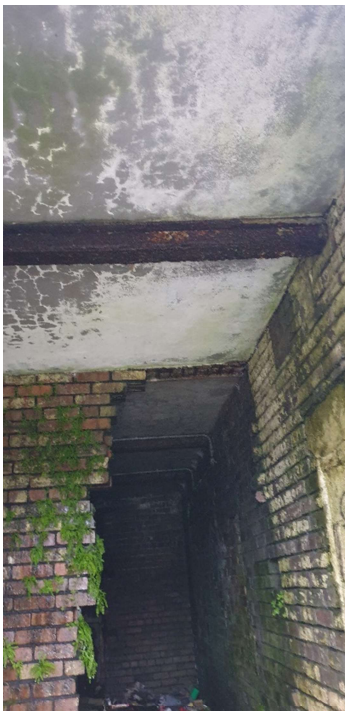
Internal view of the black building.

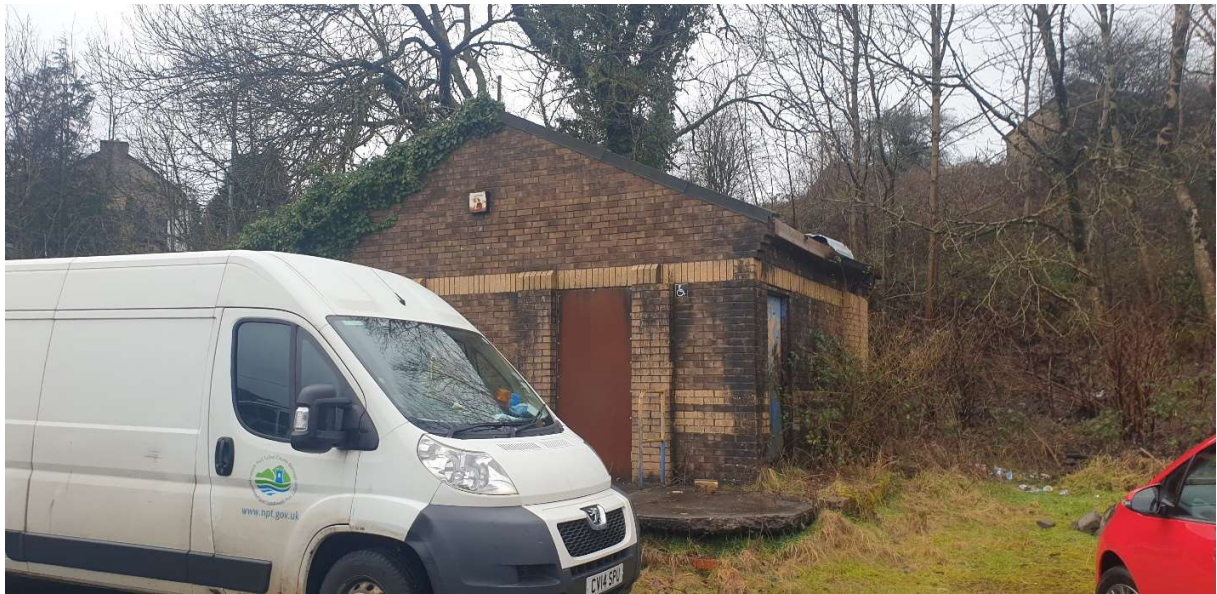
The old toilet block is of brick construction with cavity wall. Fascias are folded metal sheeting. Roof is concrete tile.

The building is in a very dilapidated state. Lots of the tiles are missing leaving the internal rooms open to the elements – these missing tiles also expose the cavity walls to rain.

There is substantial ivy coverage on the South West elevation of the building which provides nesting bird potential.

Front elevation of the old toilet block

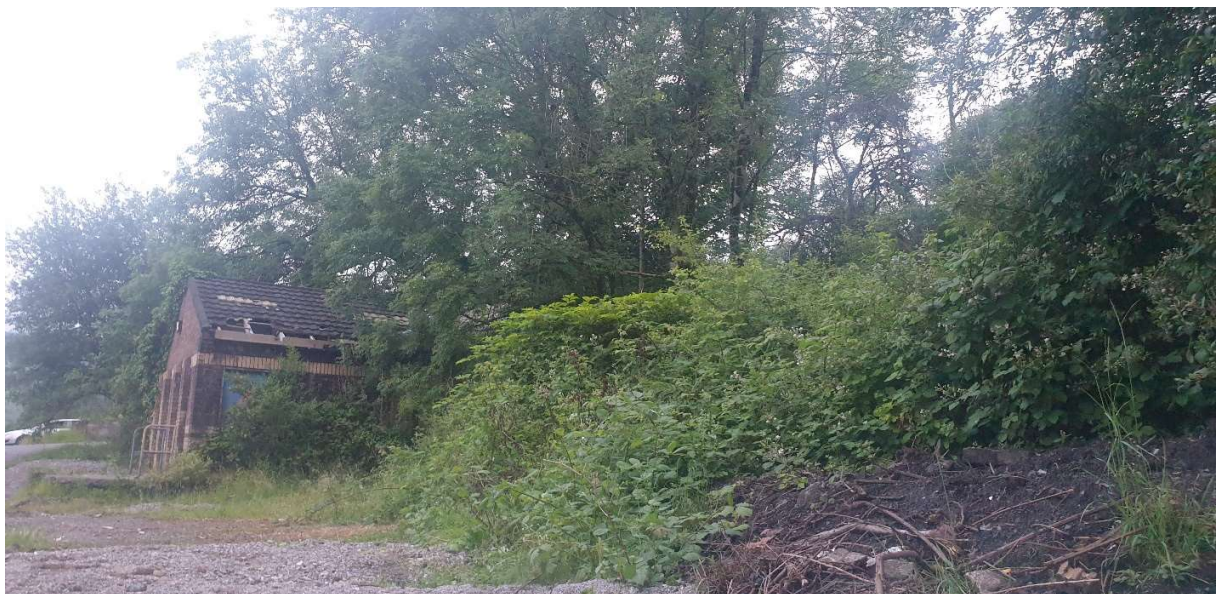
North elevation of the building showing the missing tiles and its position amongst an overgrown tree line.

This building has low potential to support roosting bats due to its dilapidated state, it is very open and exposed to the elements.

One emergence survey will be carried out on the toilet block and the black building will also be observed incidentally just to ensure that no bats are opportunistically taking advantage of the building for foraging/ roosting.
