# BAT SURVEY REPORT

CWMLLYNFELL

| Project: Cwmllynfell | | |
| Title | Bat Survey Report | |

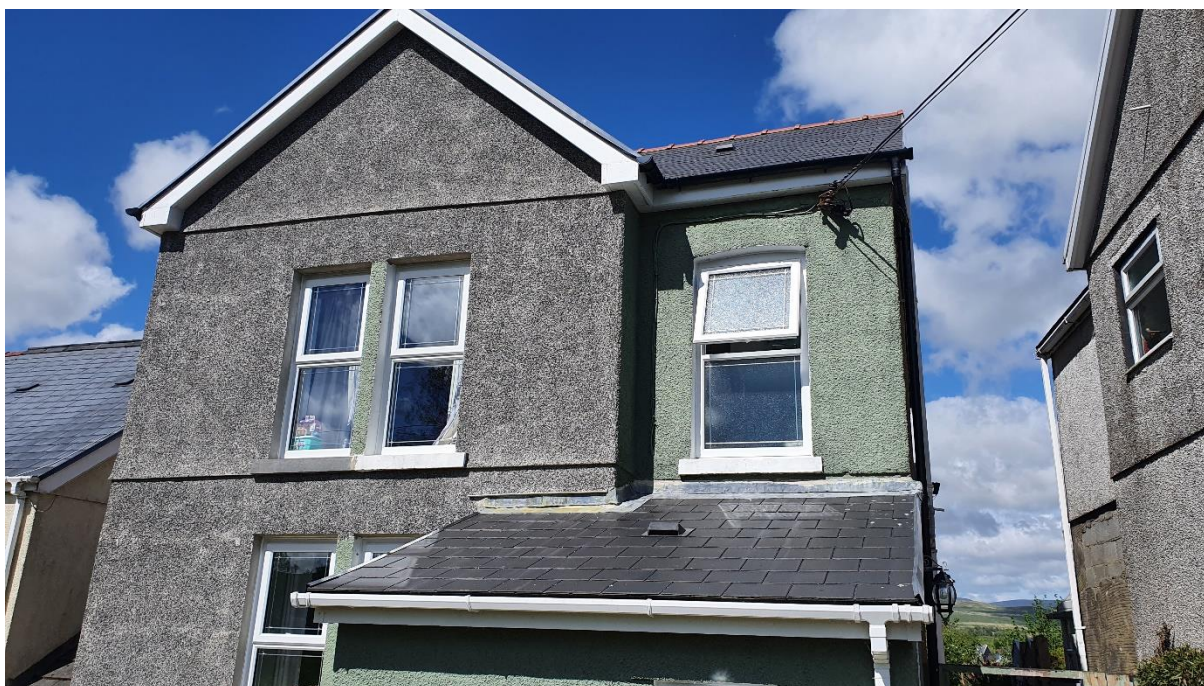
- 4.2 Photo 1: Shows an overview of the building. The external walls are rendered with negligible suitability for crevice dwelling bats, the roof tiles and fascia are new and in excellent condition.

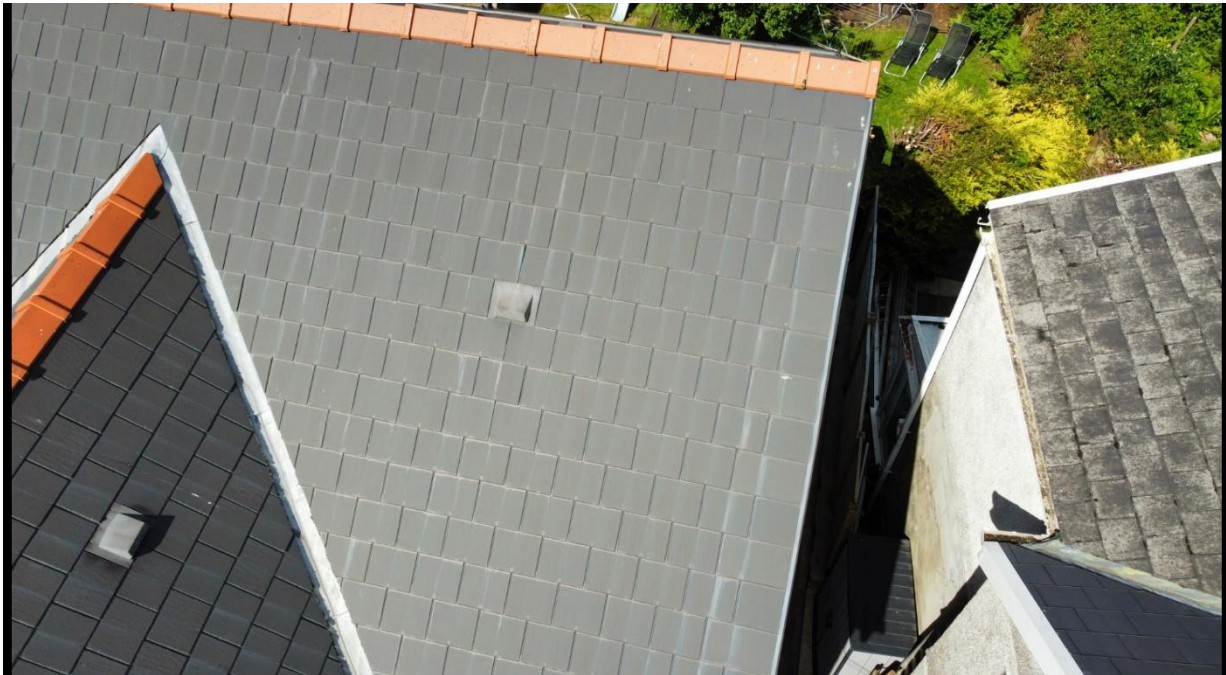
Photo 2: A close up of the roof tiles; the roof has been recently replaced and is in excellent condition, with no access points for bats.

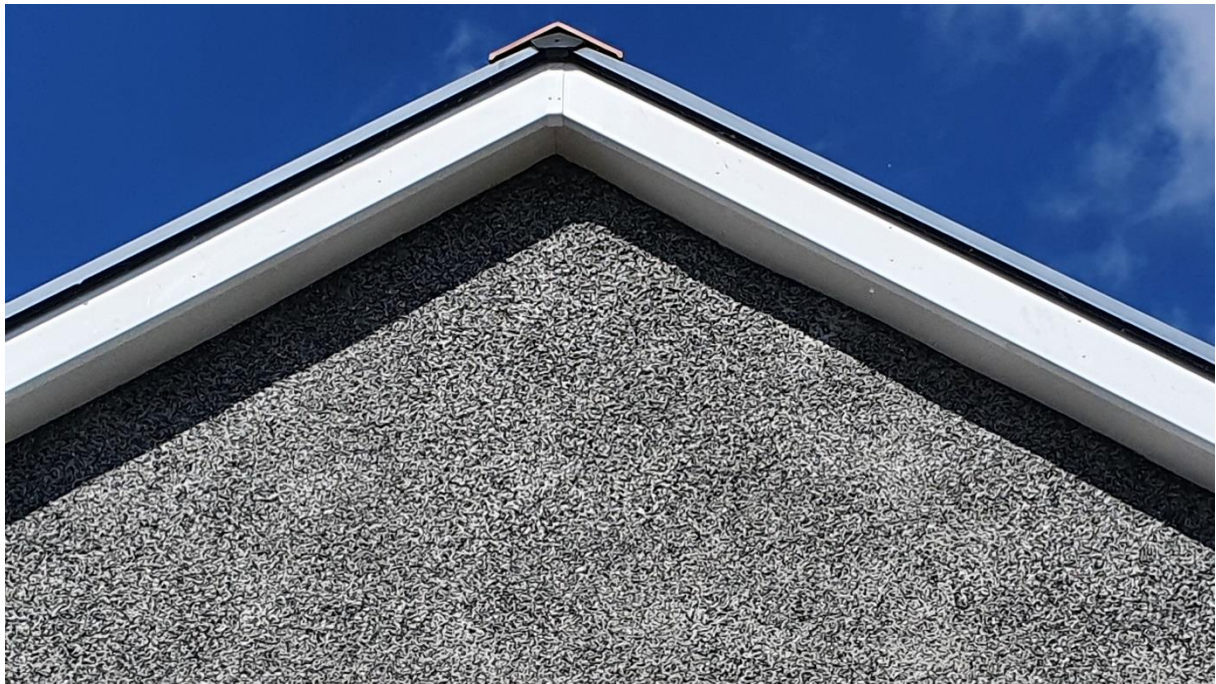
Photo 3: A close up of the soffits and fascias; they are new and in excellent condition, with no access points for bats.

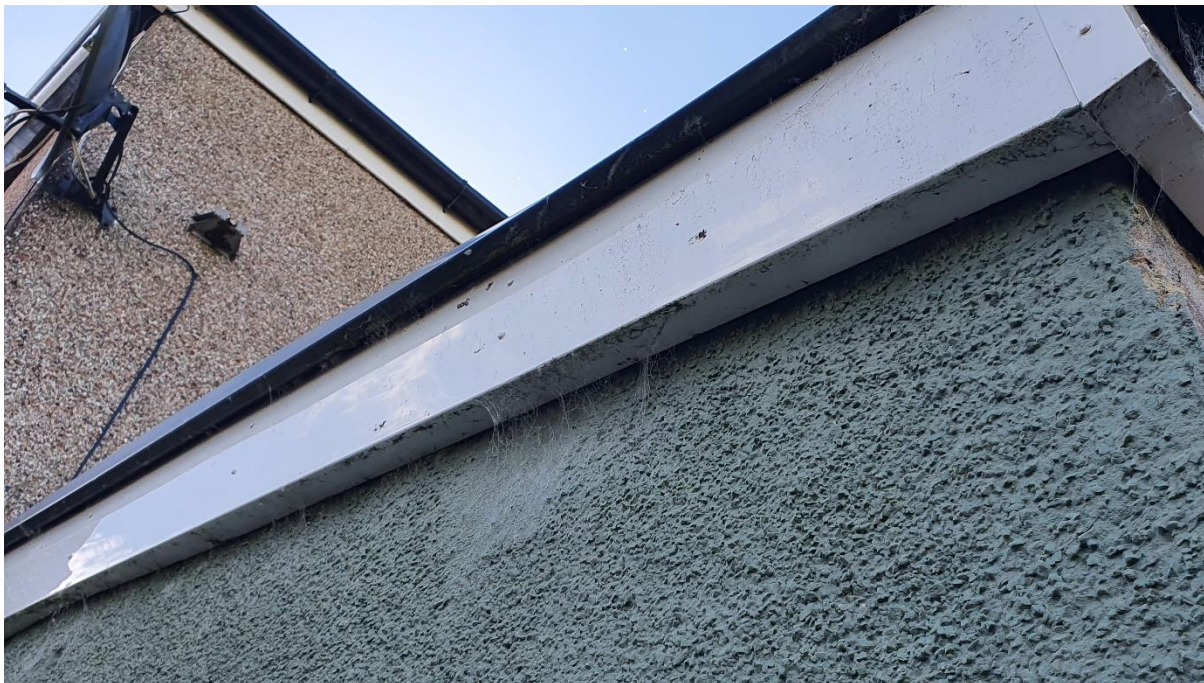
Photo 4: A close up of the soffits along the lean to extension to the rear. They are in good order with no suitability for bats.

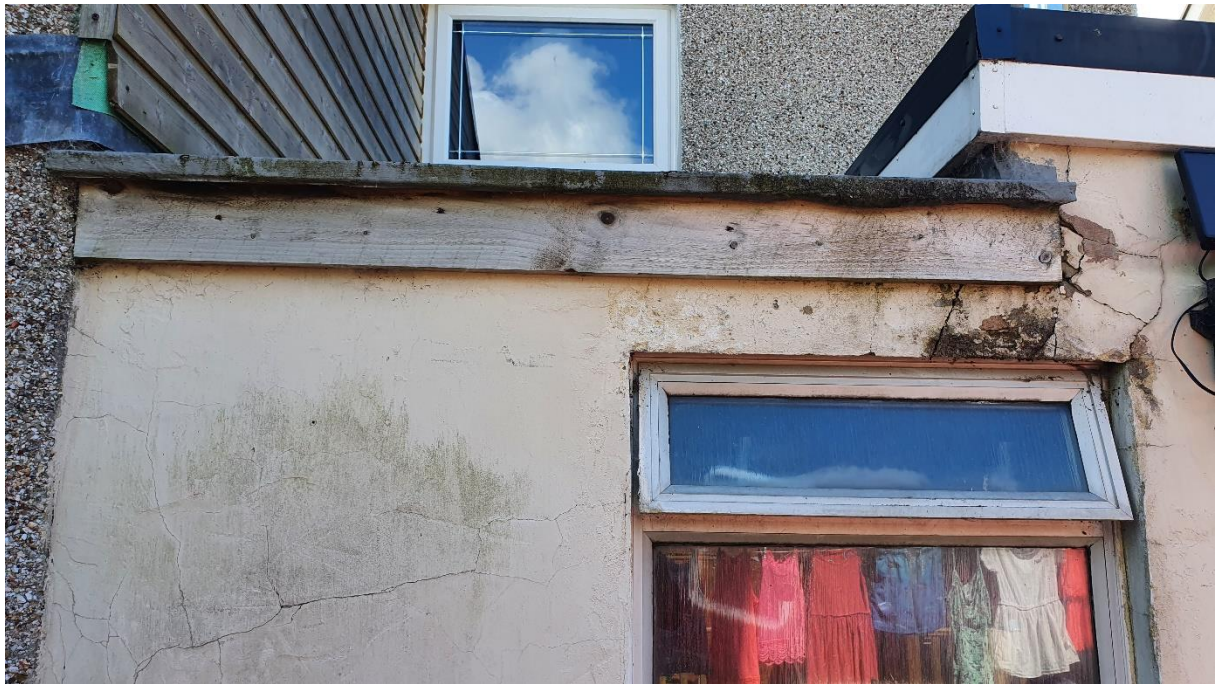
Photo 6: A close up of the soffits along the flat roof extension to the rear. They are in good order with no suitability for bats.

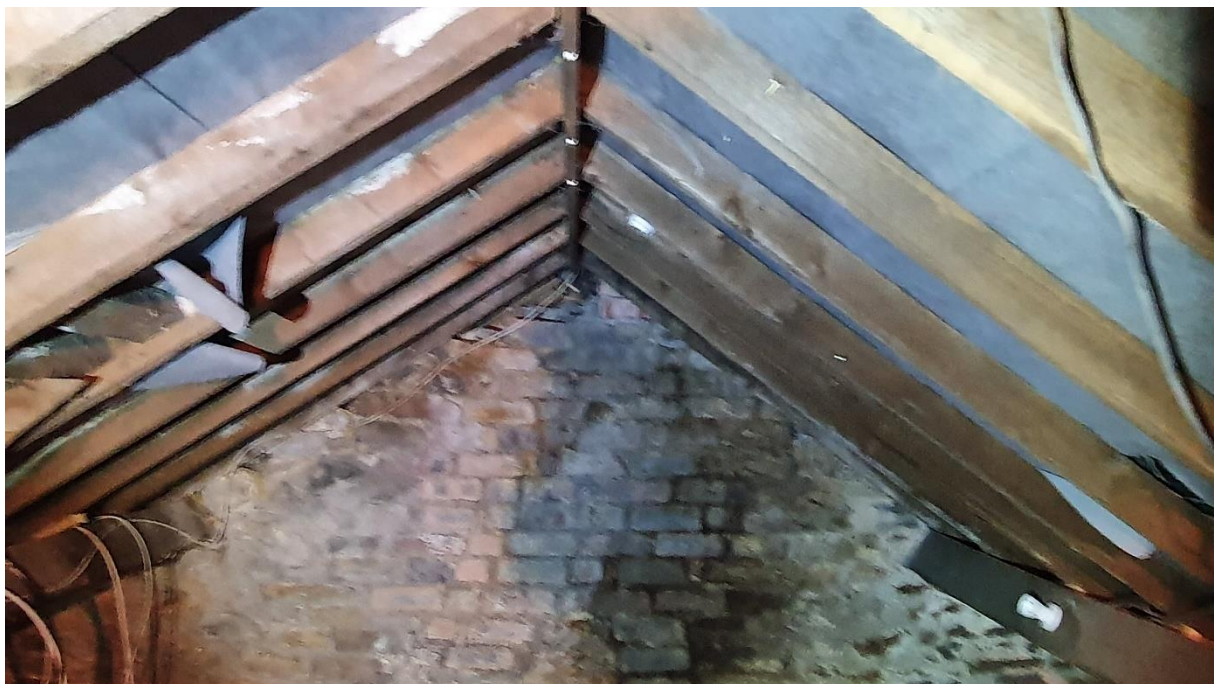
Photo 7: Shows the loft space, it has exposed beams, and lines with breathable membrane. The space is heavily cobwebbed indicating a lack of activity. No evidence of bats was found.

- 4.8 There are no visible potential access points, and the lack of any bat evidence implies the building is not being used by roosting bats; as a result, the building is considered of negligible interest for roosting bats.

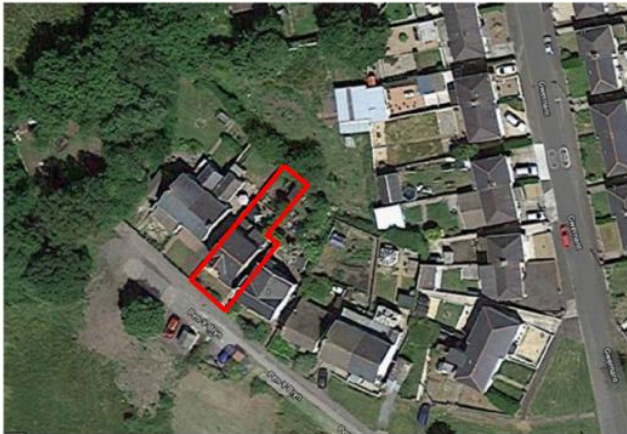
Figure 1: Site location

The site outlined in red is the relevant property for proposed development.

This is of a 2 storey private dwelling with a lower ground level floor that only houses a boiler. Located on Pen Y Bryn Road, Cwmllynfell..
