**Eagle House**

**Port Talbot**

**Bat and Nesting Bird Survey Report**

**August 2021**

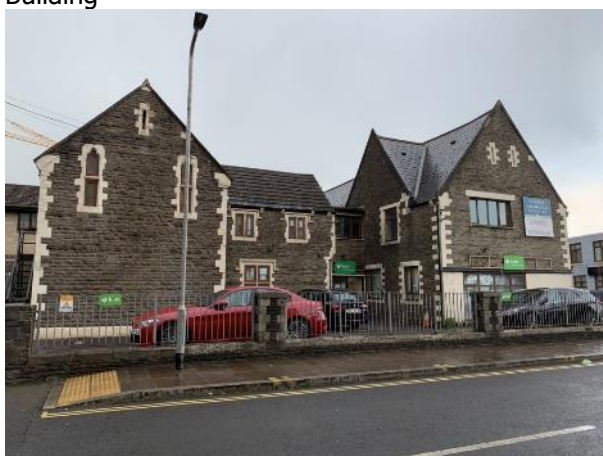
Photo 1: North Western Elevation of Commercial Building

| Roof | The commercial building has a complex roof shape with a mix of pitched roofs and flat roofs which join the northern body of the commercial building to the south (Photo 10). The northern body of the commercial building comprises an L-shaped pitched roof (Photos 1-2). It is constructed from concrete tiles that are generally in good condition, however the roof has some features that are lifted that bats may utilise as a roost, for example, there is a gap between the parapet on the north-western gable end of the L-shaped roof (Photo 11). Additionally, there is a lifted ridge tile adjacent to the valley of the L-shaped roof (Photo 12). The southern body of the commercial building has two intersecting pitches running on a north-east to south-west axis and the other on a north-west to south-east axis creating a cross shape. The south western pitch has a lifted ridge tile adjacent to the parapet on the commercial building (Photo 13). These pitches are constructed of slate and clay ridge tiles that are generally in good condition. Edge tiles at the eaves are impeded by close-fitting guttering on the north-western and south-western elevations. Edge tiles at the gable ends are capped by stone parapets which appear to be in good condition with no obvious cracks or crevices (Photos 1-3). The commercial building has been extended at some point on the north |

| Windows | <p>The wooden windows and doorframes are tightly fitted into their frames with no obvious gaps or crevices that bats could utilise, one of the windows on the north eastern elevation has been covered in metal barring (Photos 1-5).</p> <p>Ten windows on the eastern elevation of the outbuilding have been recently bricked up, the remaining windows have wooden frames and are covered with a metal mesh (Photos 6, 7, 8 and 9). The door frame on the south western elevation comprises a uPVC frame that is flush with the external wall, the doorway on the north eastern elevation of the outbuilding has been boarded up with wooden sheeting. However, there is a gap approximately 10cm in width between the wooden boards allowing access into the outbuildings' interior (Photo 8).</p> |

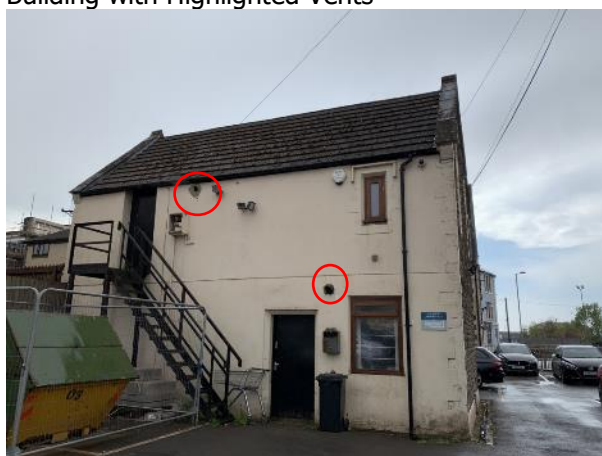
Photo 2: North Eastern Elevation of Commercial Building with Highlighted Vents

| Vents | There is a metal vent on the south-western elevation of the commercial building, this is in good condition with gaps which are not suitable for use by bats (Photo 20). A uPVC vent is located on the north-eastern elevation of the commercial building (Photo 2). |

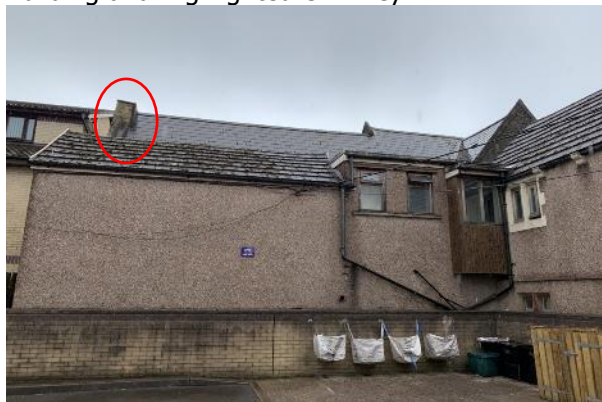
Photo 4: South Eastern Elevation of Commercial Building and Highlighted Chimney

| | <p>eastern elevation, this has a pitched roof constructed from concrete tiles and ridge tiles, these are generally in good condition (Photo 4).</p> <p>The roof of the outbuilding is constructed from slate with clay ridge tiles, additionally, it is symmetrically pitched and hipped at the gable ends which creates extended eaves (Photos 6-9). The eaves are tightly fitting to the external brick walls of the outbuilding. The slate is generally in good condition, however, there is a slipped tile on the south eastern elevation (Photo 14). Additionally, the clay hip tiles are lifted on the south eastern elevation creating gaps that bats may be utilising (Photo 15).</p> |

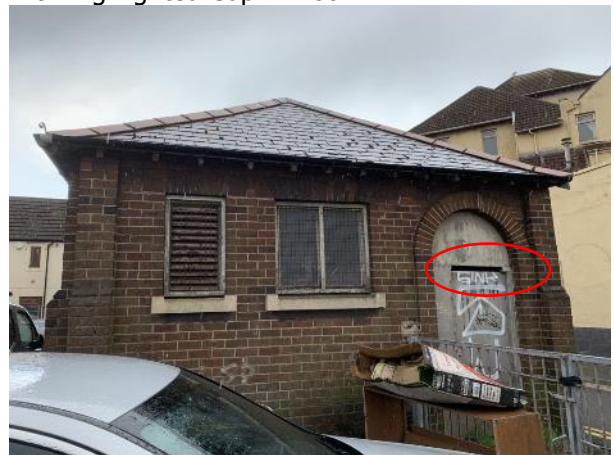
Photo 8: North Eastern Elevation of the Outbuilding with Highlighted Gap in Door

- R6 – Gap under slipped tile (see Photo 14);
- R7 – Gaps under lifted hip tiles (see Photo 15);
- R8 – Gap in brick arch (see Photo 21); and
- Interior of the outbuilding via the gap in the doorway (see Photo 8).

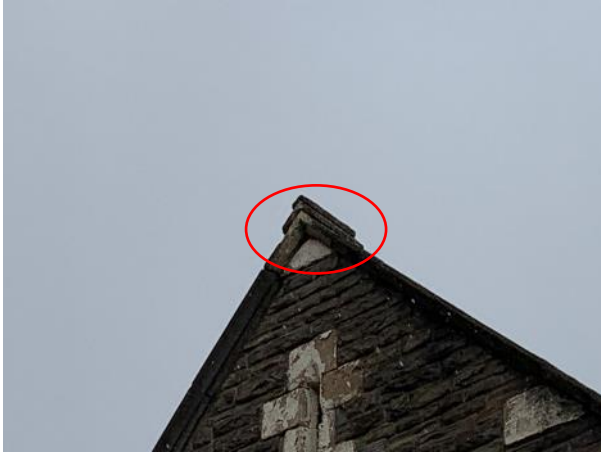
Photo 11: Lifted Parapet on Gable End of North Western Elevation of Commercial Building

- R1 – A lifted Parapet (see Photo 11);
- R2 – Gaps under ridge tiles (see Photos 12 and 13);
- R3 – Gaps under lead flashing (see Photos 17,18 and 19);
- R4 – Gap between wooden timber and external wall (see Photo 28); and
- R5 – Open foundation in timber feature (see Photo 29).

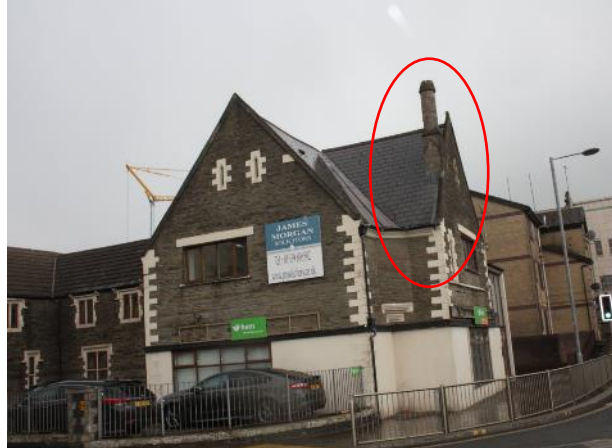
Photo 16: Stone Chimney on South Western Elevation of Commercial Building

| Chimneys | There is a stone chimney on the south western elevation of the commercial building that is in relatively good condition with no visible cracks or crevices (Photo 16). |

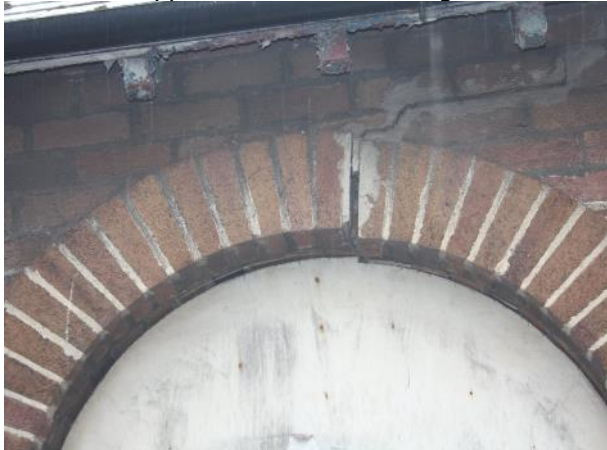
Photo 21: Slipped Arch on Outbuilding

| External Walls | <p>The north-western, south-western and south-eastern external walls of the commercial building are constructed of stone and mortar which are in good condition with no obvious cracks or crevices. The north-eastern elevation is rendered in concrete (Photo 2). The extensions on the eastern elevation are rendered in pebble dash on all elevations which are in good condition (Photos 4 and 5).</p> <p>The external walls of the outbuilding are constructed from red brick on all elevations, there are no obvious cracks or crevices within the brick work except for the slipped arch on the north-eastern elevation (Photo 21).</p> |

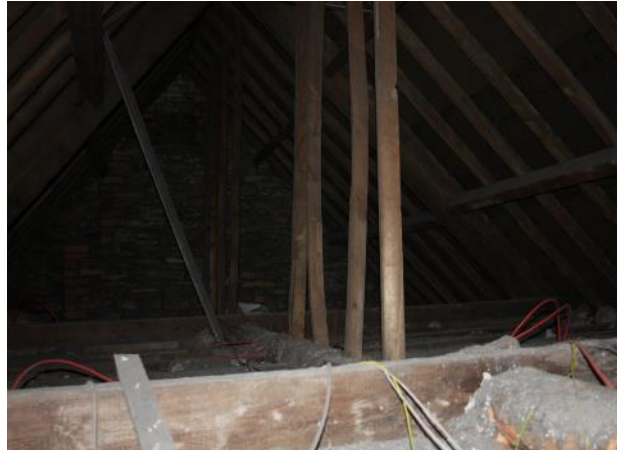
Photo 22: Roof Void One

| Roof Void | Roof void one is approximately 3 m high, 7.5m wide by 14m long (Photo 22). Roof void two is approximately 1.5 m high, 4m wide by 6m long (Photo 23). Roof void three is approximately 3.5 m high, 6m wide by 17m long (Photo 24). Roof void four is approximately 3m high, 8m wide by 6m long (Photo 25). |

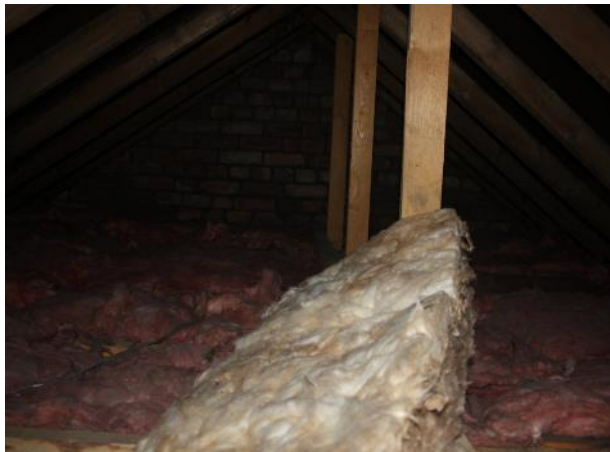
Photo 23: Roof Void Two

| Insulation of Void | Some fibreglass insulation is present in the roof voids, particularly in roof void two (Photo 23). |

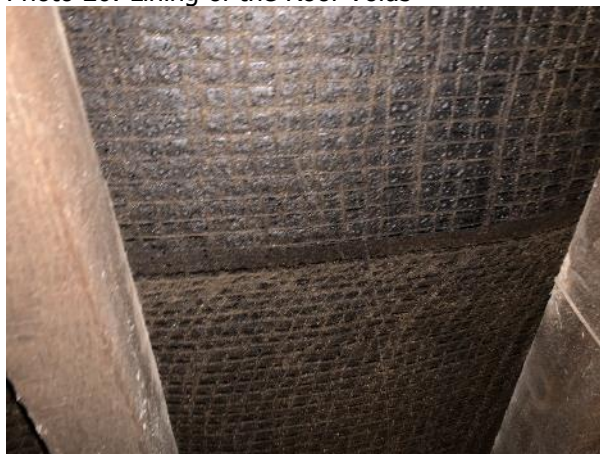
Photo 26: Lining of the Roof Voids

| Roof Lining | The roof voids are all lined with black bitumen felt (Photo 26). |

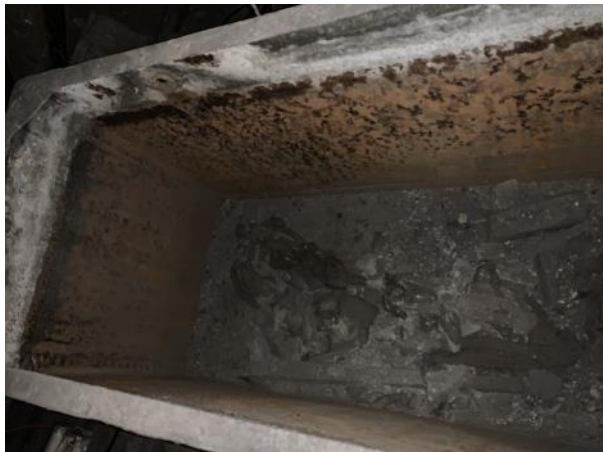
Photo 27: Water Tank in Roof Void Three

| Water Tank | There is a water tank within roof void three, it was empty and uncovered at the time of the survey (Photo 27). |

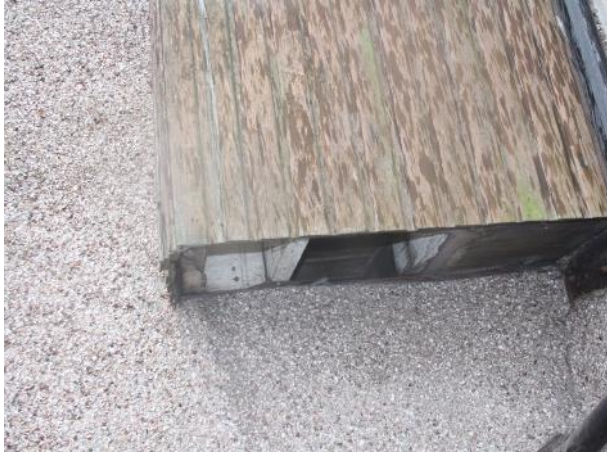
Photo 29: Damage in Foundation of Timber Cladding on North Eastern Extension

| Extensions/Lean-tos/Attached Garage | A mono-pitched extension exists on the south eastern elevation of the commercial building. Constructed of slate on the roof which appears to be in good condition. The external walls comprise a concrete render and timber cladding (Photo 28), These also appear in good condition, except where the timber frame has pulled away from the stone external wall leaving a gap suitable for bats to utilise which extends the length of the extension (Photos 3, 17 and 28). Additionally, the extension on the north eastern elevation of the commercial building has a timber cladding feature which has suffered damage, creating a large opening in its foundation (Photo 29). |

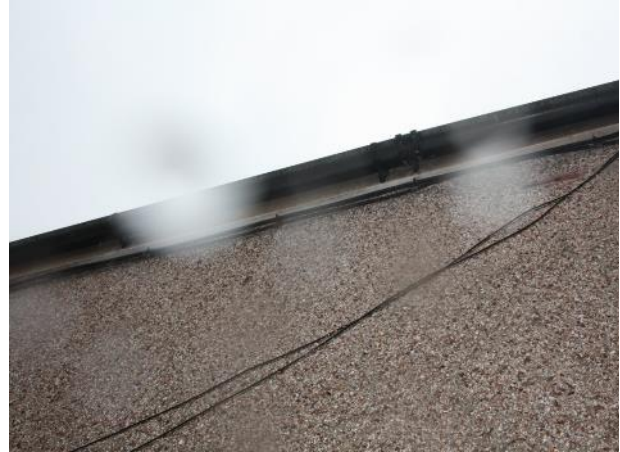
Photo 30: Sealed uPVC Bargeboards on Eastern Elevation of Commercial Building

| Soffits, Fascias and Bargeboards | The stone parapets on the commercial building are in good condition with no obvious gaps or cracks that bats could utilise. On the eastern elevation uPVC barge boards are tightly fitted to the external walls (Photo 30). |

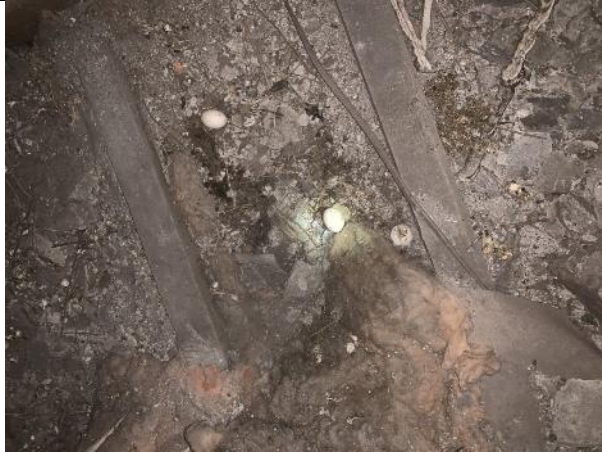
Photo 31: Defunct Eggs

No signs of birds having recently nested were found within or on the exterior of the commercial building. However, historic evidence of nesting was indicated by piles of guano and defunct eggs of feral pigeon (*Columba livia domestica*) in roof void four. Although it appears previous access points have been blocked and there is no longer access into the void.

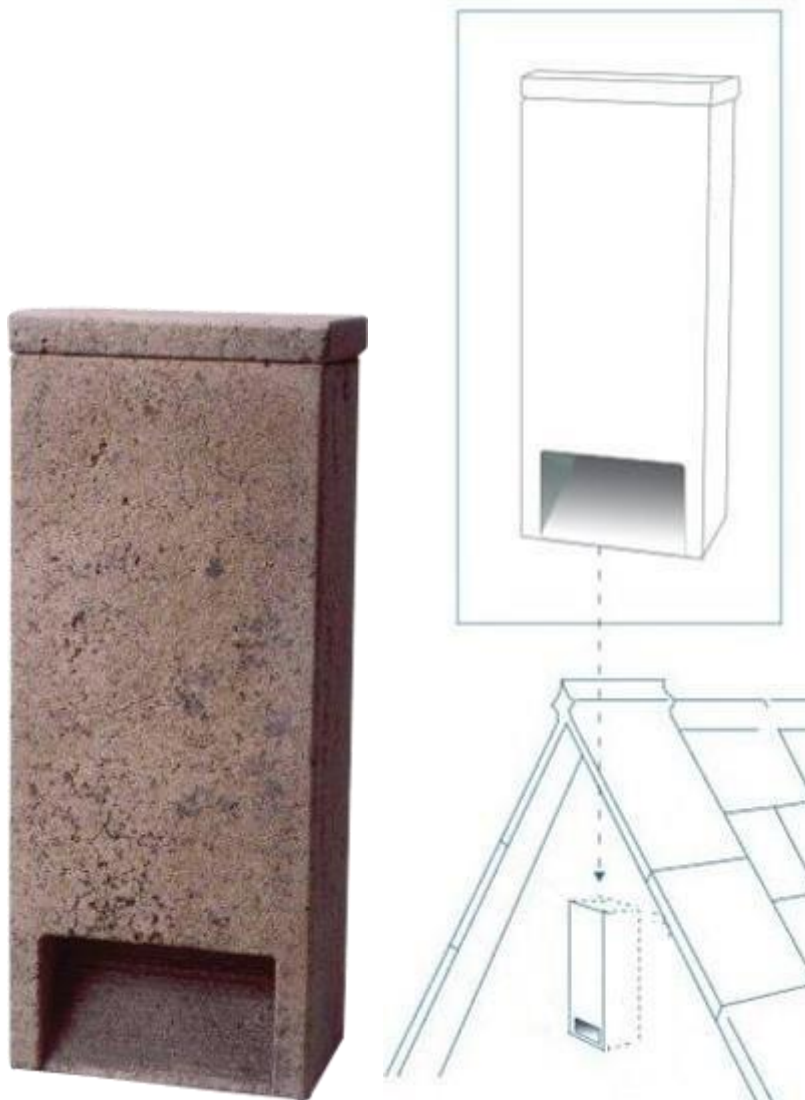
## Appendix 5: Schwegler 1FR Bat Tube

These are a well-known brand that have a low visual impact on the development because they can be built into the exterior wall and then rendered or painted.

The tubes should be positioned at least 0.5m below the eave or gable apex to prevent predation by domestic cats. It is also recommended that where practical, the tubes are not positioned above windows or doors.
