## Technical Note: Site Walkover and Recommendations Site: 87 Commercial Road, Rhydyfro

Our client (the Applicant) Mr Martin Evans has applied to Neath Port Talbot council for planning permission to reconstruct a river bank retaining wall at the above site.

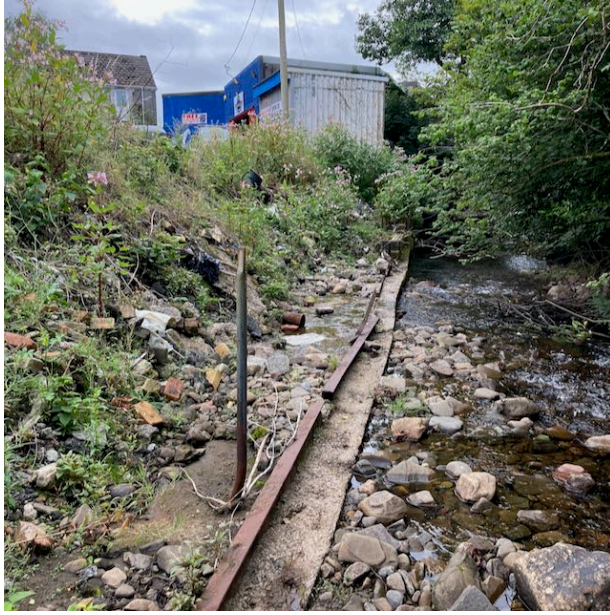
The site itself comprises a collapsed earth and stone bank with other debris present (see Figures 1 and 2). Vegetation is rather sparse in places, species include false oat-grass *Arrhenatherum elatius*, Yorkshire-fog *Holcus lanatus*, cleavers *Gallium aparine*, groundsel *Senecio vulgaris*, common nettle *Urtica dioica*, nipplewort *Lapsana communis*, herb-Robert *Geranium robertianum*, creeping buttercup *Ranunculus repens*, broad-leaved willowherb *Epilobium montanum*, dandelion *Taraxacum* sp., oil-seed rape *Brassica napus* ssp. *oleifera*, ivy-leaved toadflax *Cymbalaria muralis*, garlic mustard *Alliaria petiolata*, hart's-tongue *Asplenium scolopendrium*, spear thistle *Cirsium vulgare*, common ragwort *Jacobaea vulgaris*, redshank *Persicaria maculosa*, greater plantain *Plantago major*, ribwort plantain *P. lanceolata*, hedge bindweed *Calystegia sepium* and broad-leaved dock *Rumex obtusifolius*.

Figure 1. Collapsed bank, looking south.

1. **A Japanese knotweed and Himalayan balsam management plan must be agreed** prior to the works commencing, then carried out as stated. The plan should include a) methods by which the works will take place to ensure no spread of these species will occur (including precautions such as equipment washing, appropriate disposal of any material removed from the site etc) and b) methods by which any residual stands of either species will be dealt with following completion of the works. The management plan does not have to be complex and can be incorporated within an updated CMS if that is preferred.

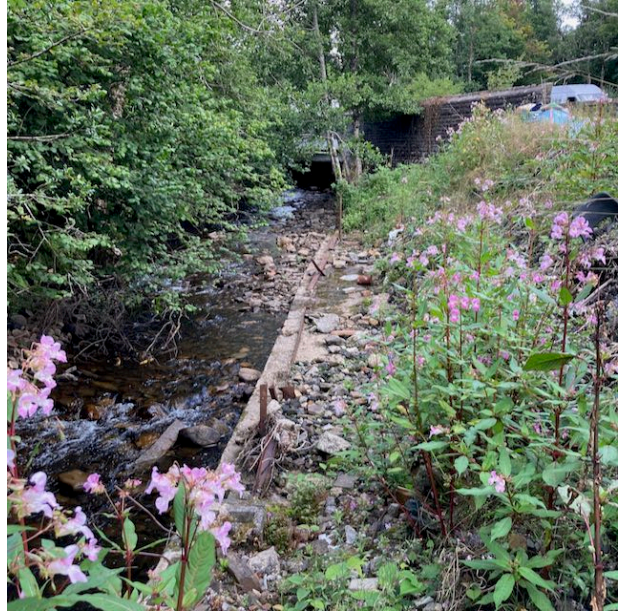
Japanese knotweed *Reynoutria japonica* and Himalayan balsam *Impatiens glandulifera* are present along much of the site length (see Figures 2 and 3), although it is noted that some of the knotweed to the north has been treated.

Figure 2. Collapsed bank, looking north.

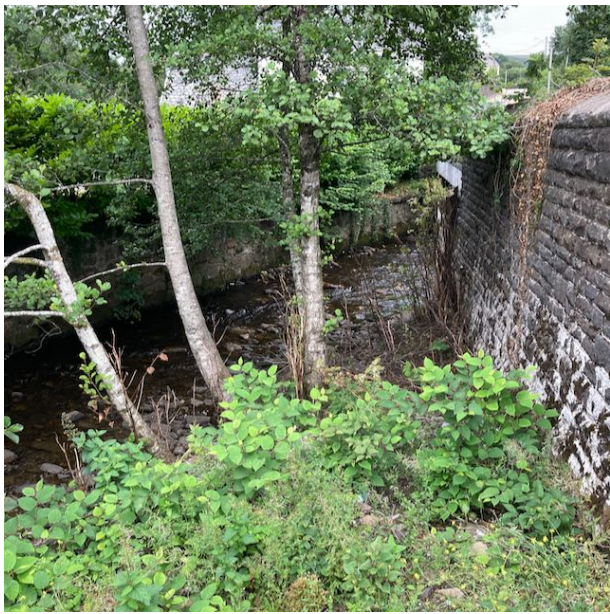
Several alder trees are present towards the northern end of the site (see Figure 3 below). None of these trees have any features suitable for roosting bats.

Figure 3. Alder trees to the north.

3. **Birds.** The woody vegetation and earth banks on the western side of the stream, together with the alder trees on the eastern bank have potential for nesting birds. However, the alder trees are not scheduled for removal, therefore impacts on nesting birds associated with this feature are not expected. Vegetation on the western bank will also be untouched by the works. The presence of dippers *Cinclus cinclus* has been highlighted within the local area. This species uses fast-flowing, often tree-lined rivers in upland areas, and may forage on the river bed. Due to the small site size and short-term temporary nature of the works, significant impacts on this species are considered unlikely, however additional comments in relation to potential disturbance on the western bank are given in the recommendations section below.

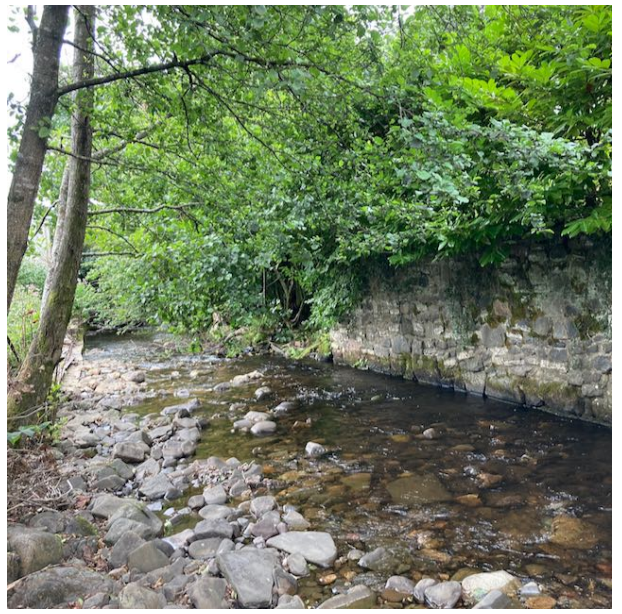
Figure 4. Stone wall to the north, on the western bank.

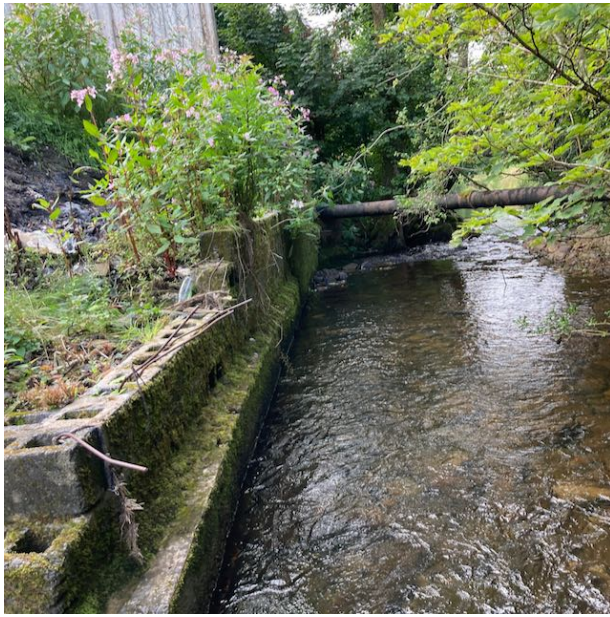
Figure 5. Breeze block wall to the south, on the eastern bank.

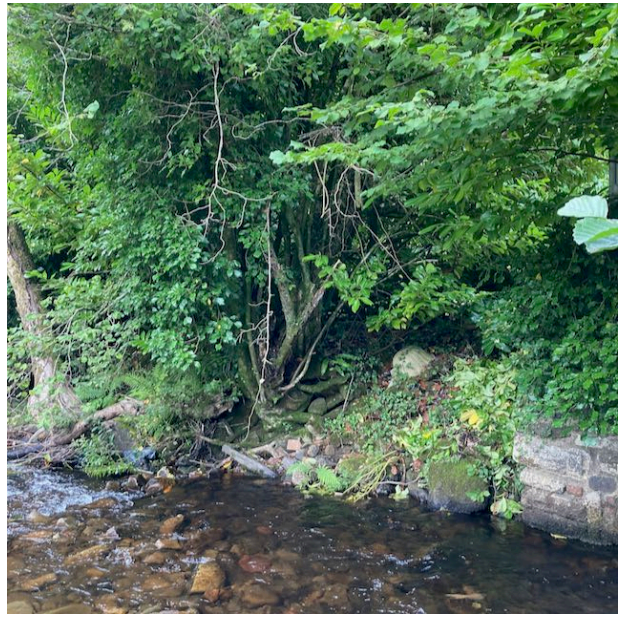
Figure 6. Woodland vegetation and exposed roots on lower western bank.
