RIVER NEATH SWING  
BRIDGE GRIP 4

PIER DEFECTS  
(IS1 AND IS2)

| 152093-ARC-DRG-ECV-000010 | A03 |

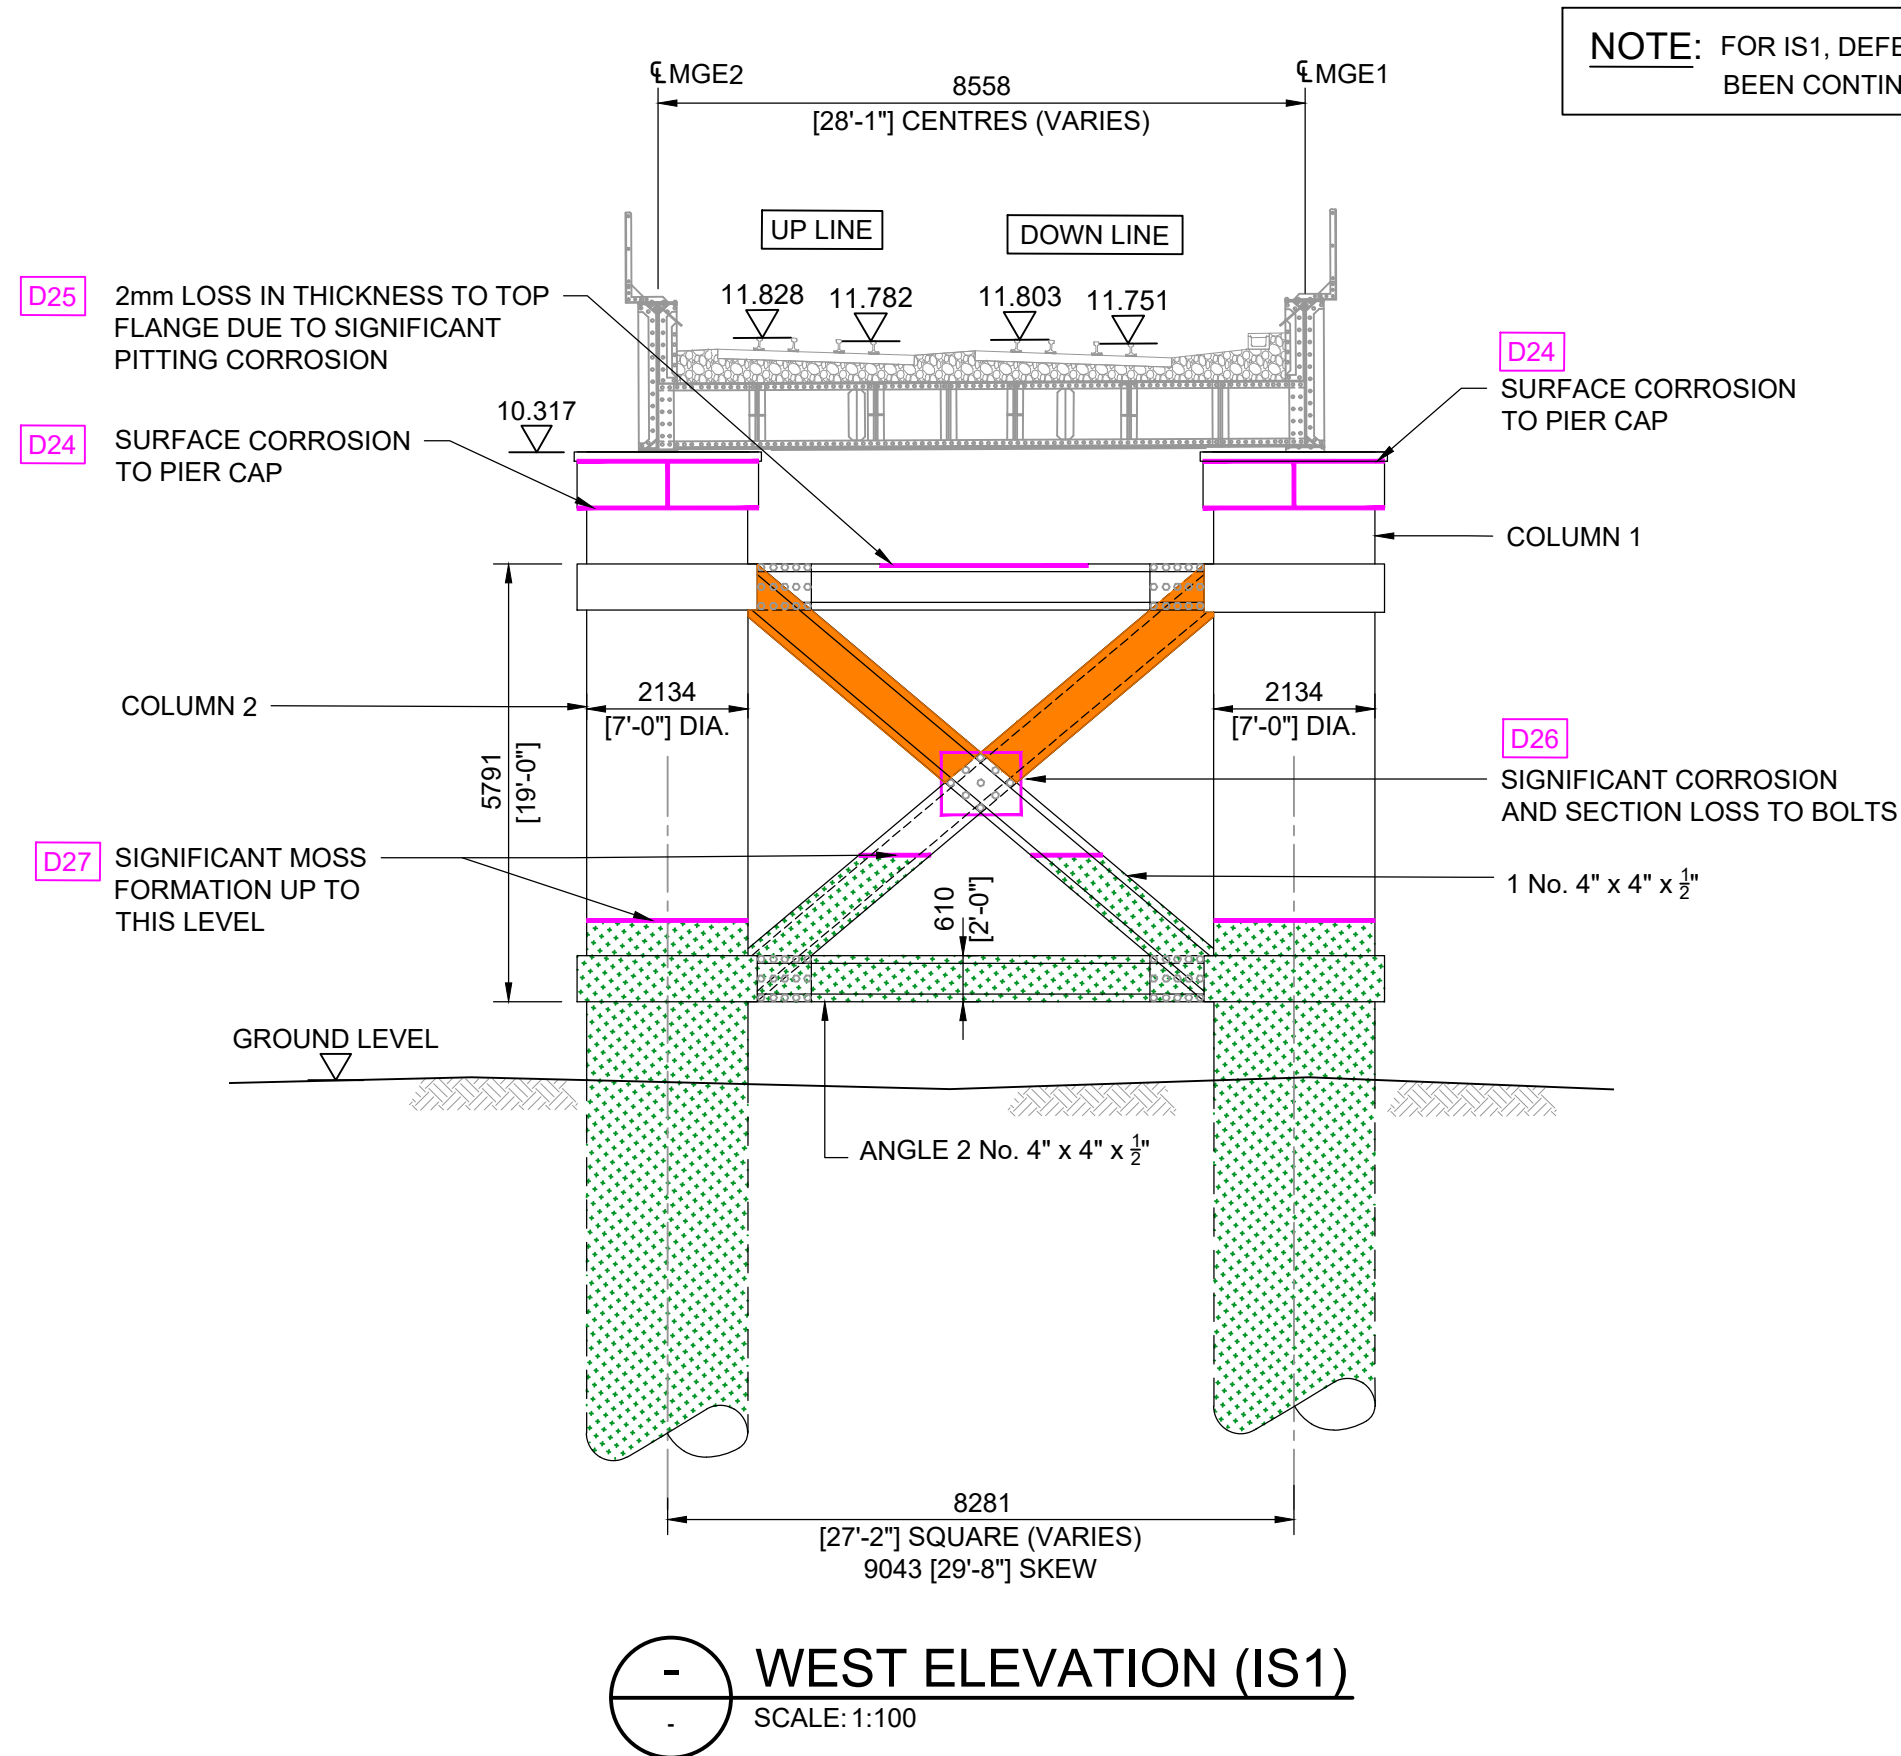
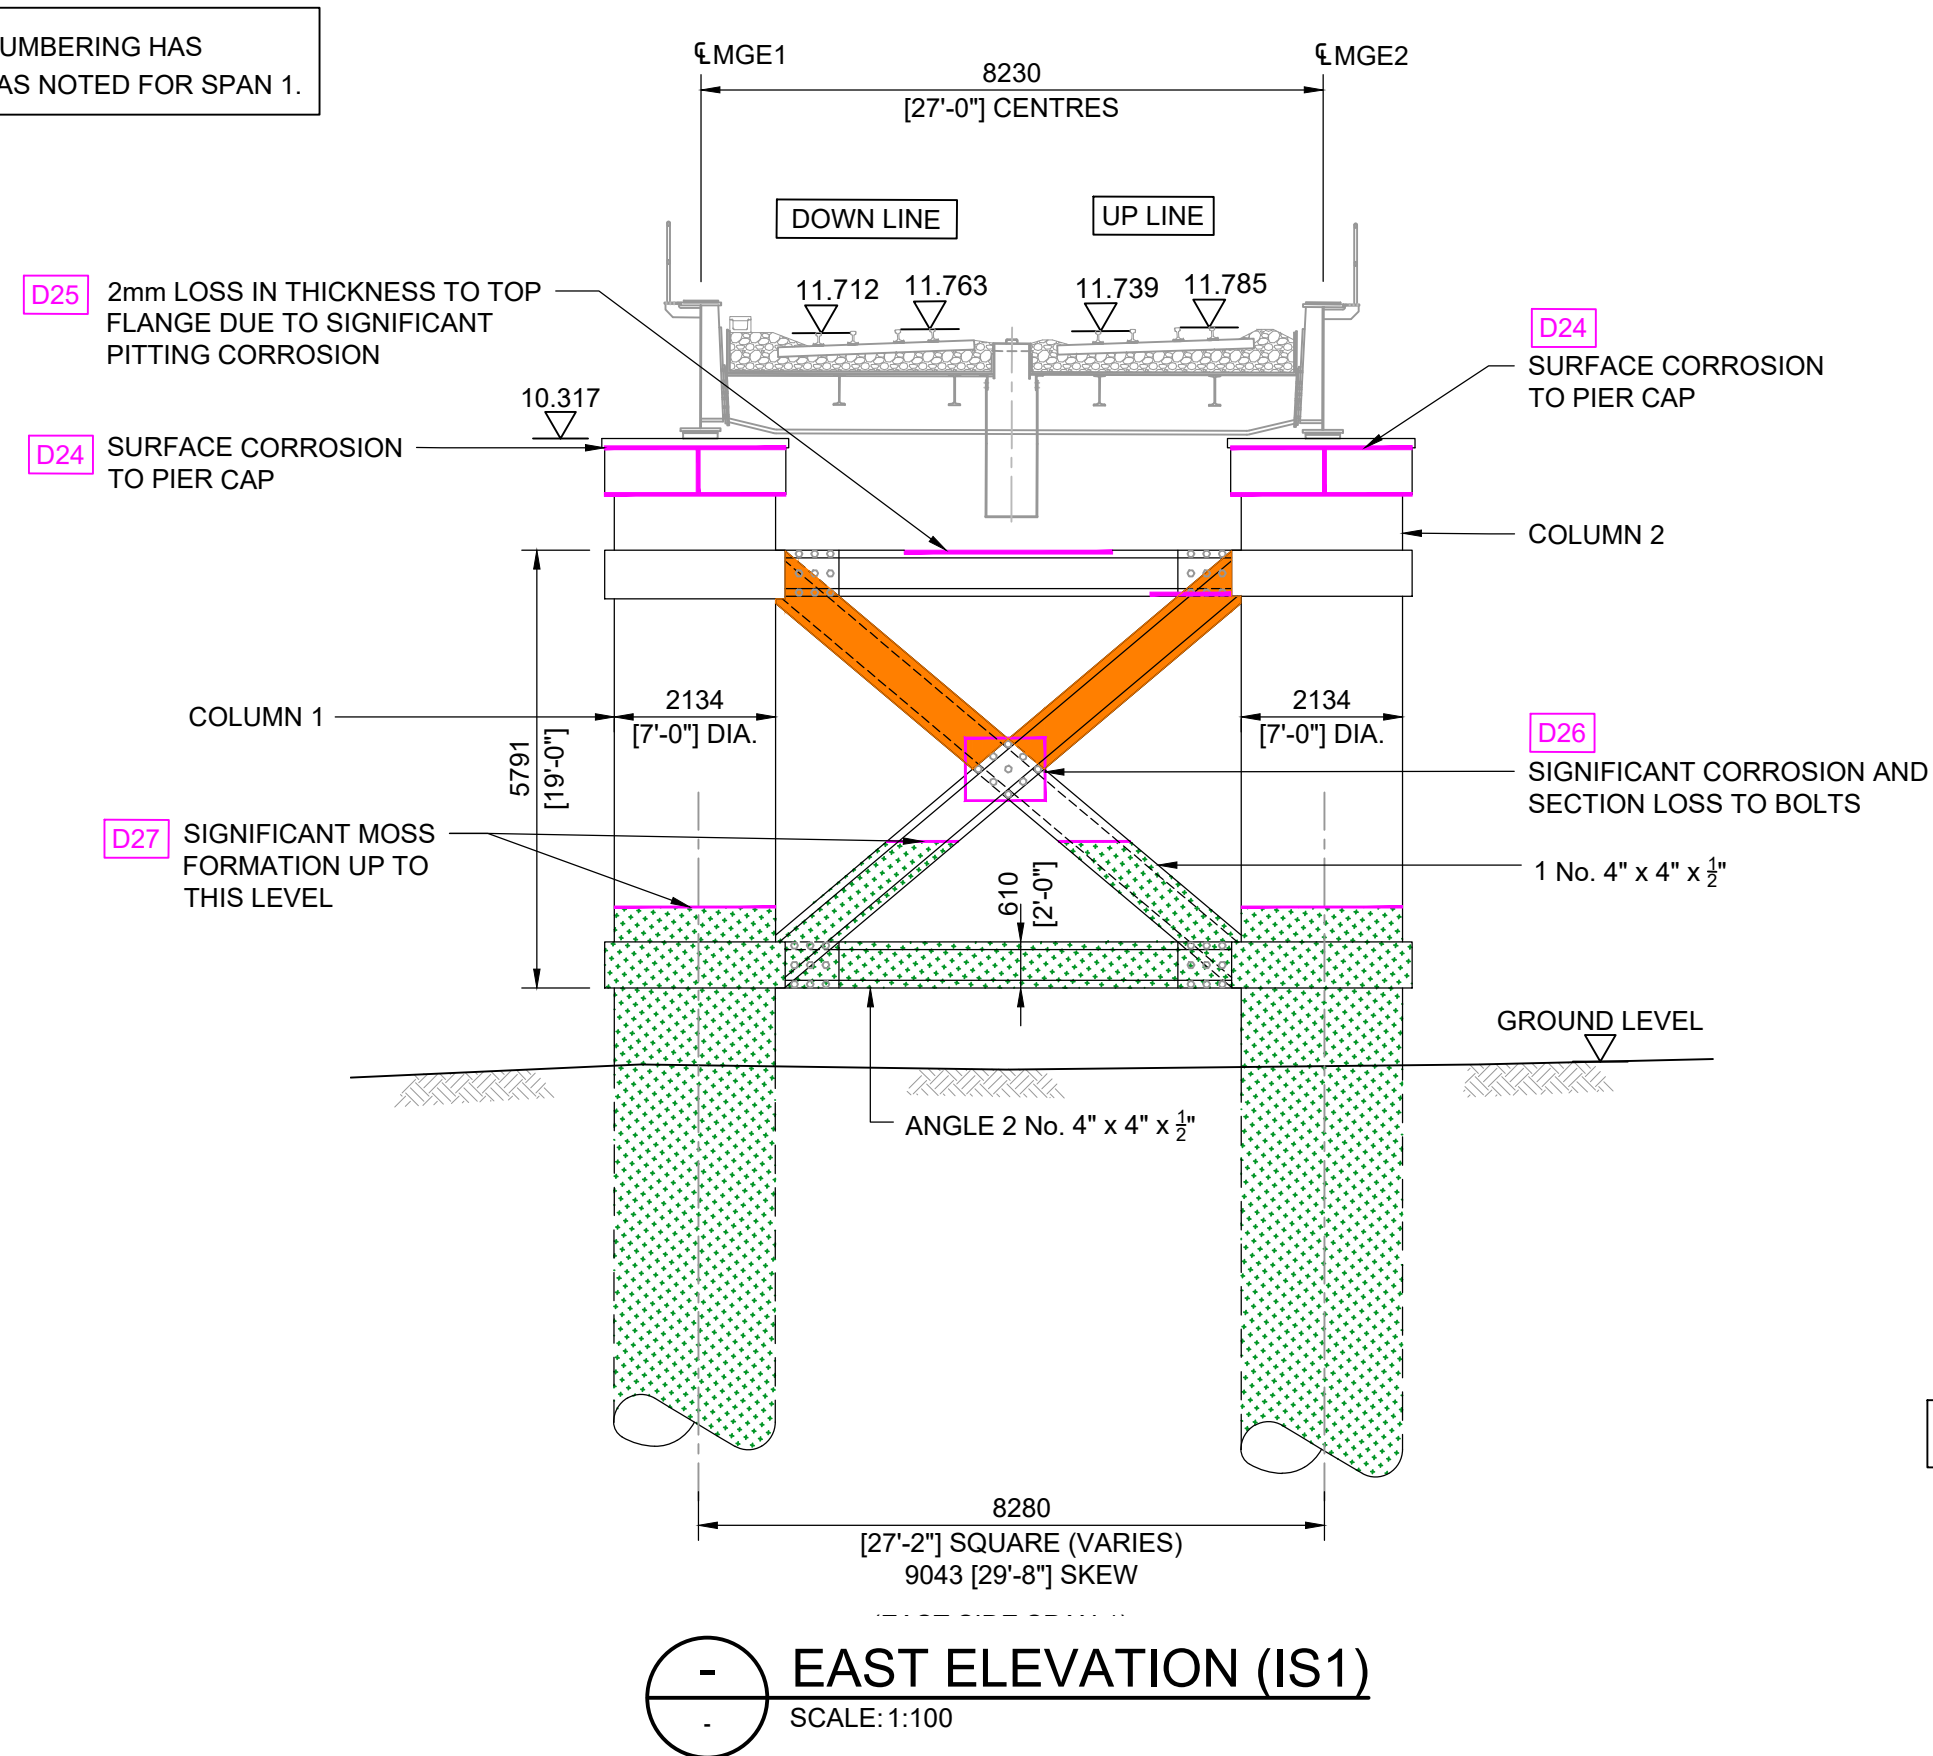
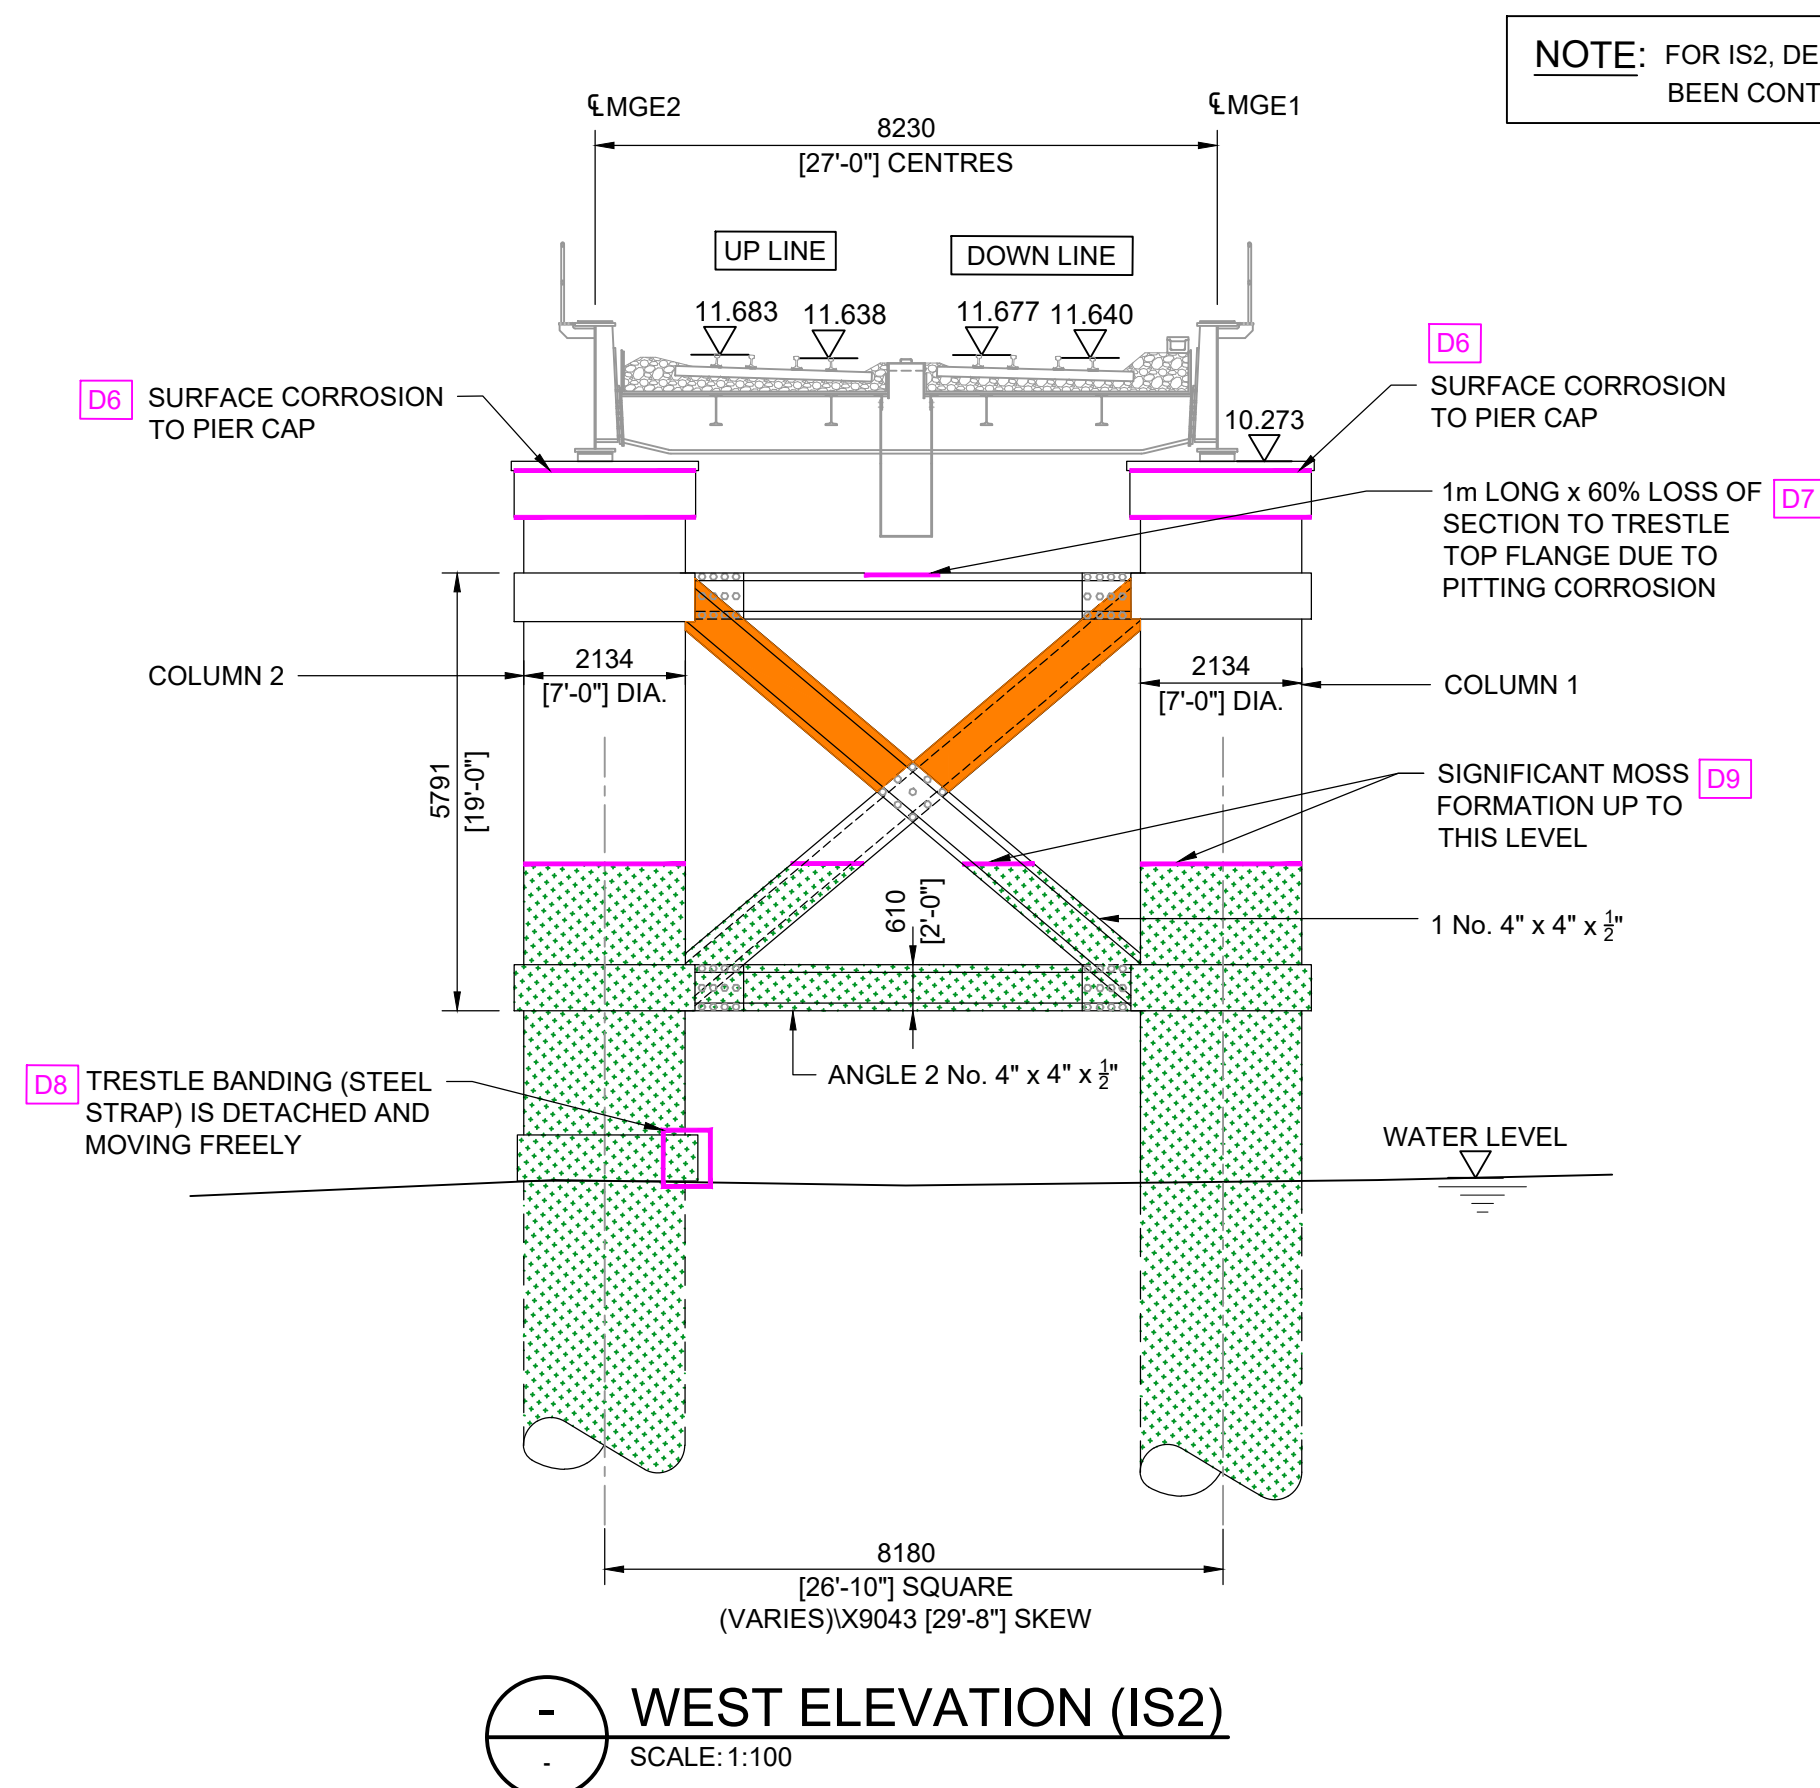
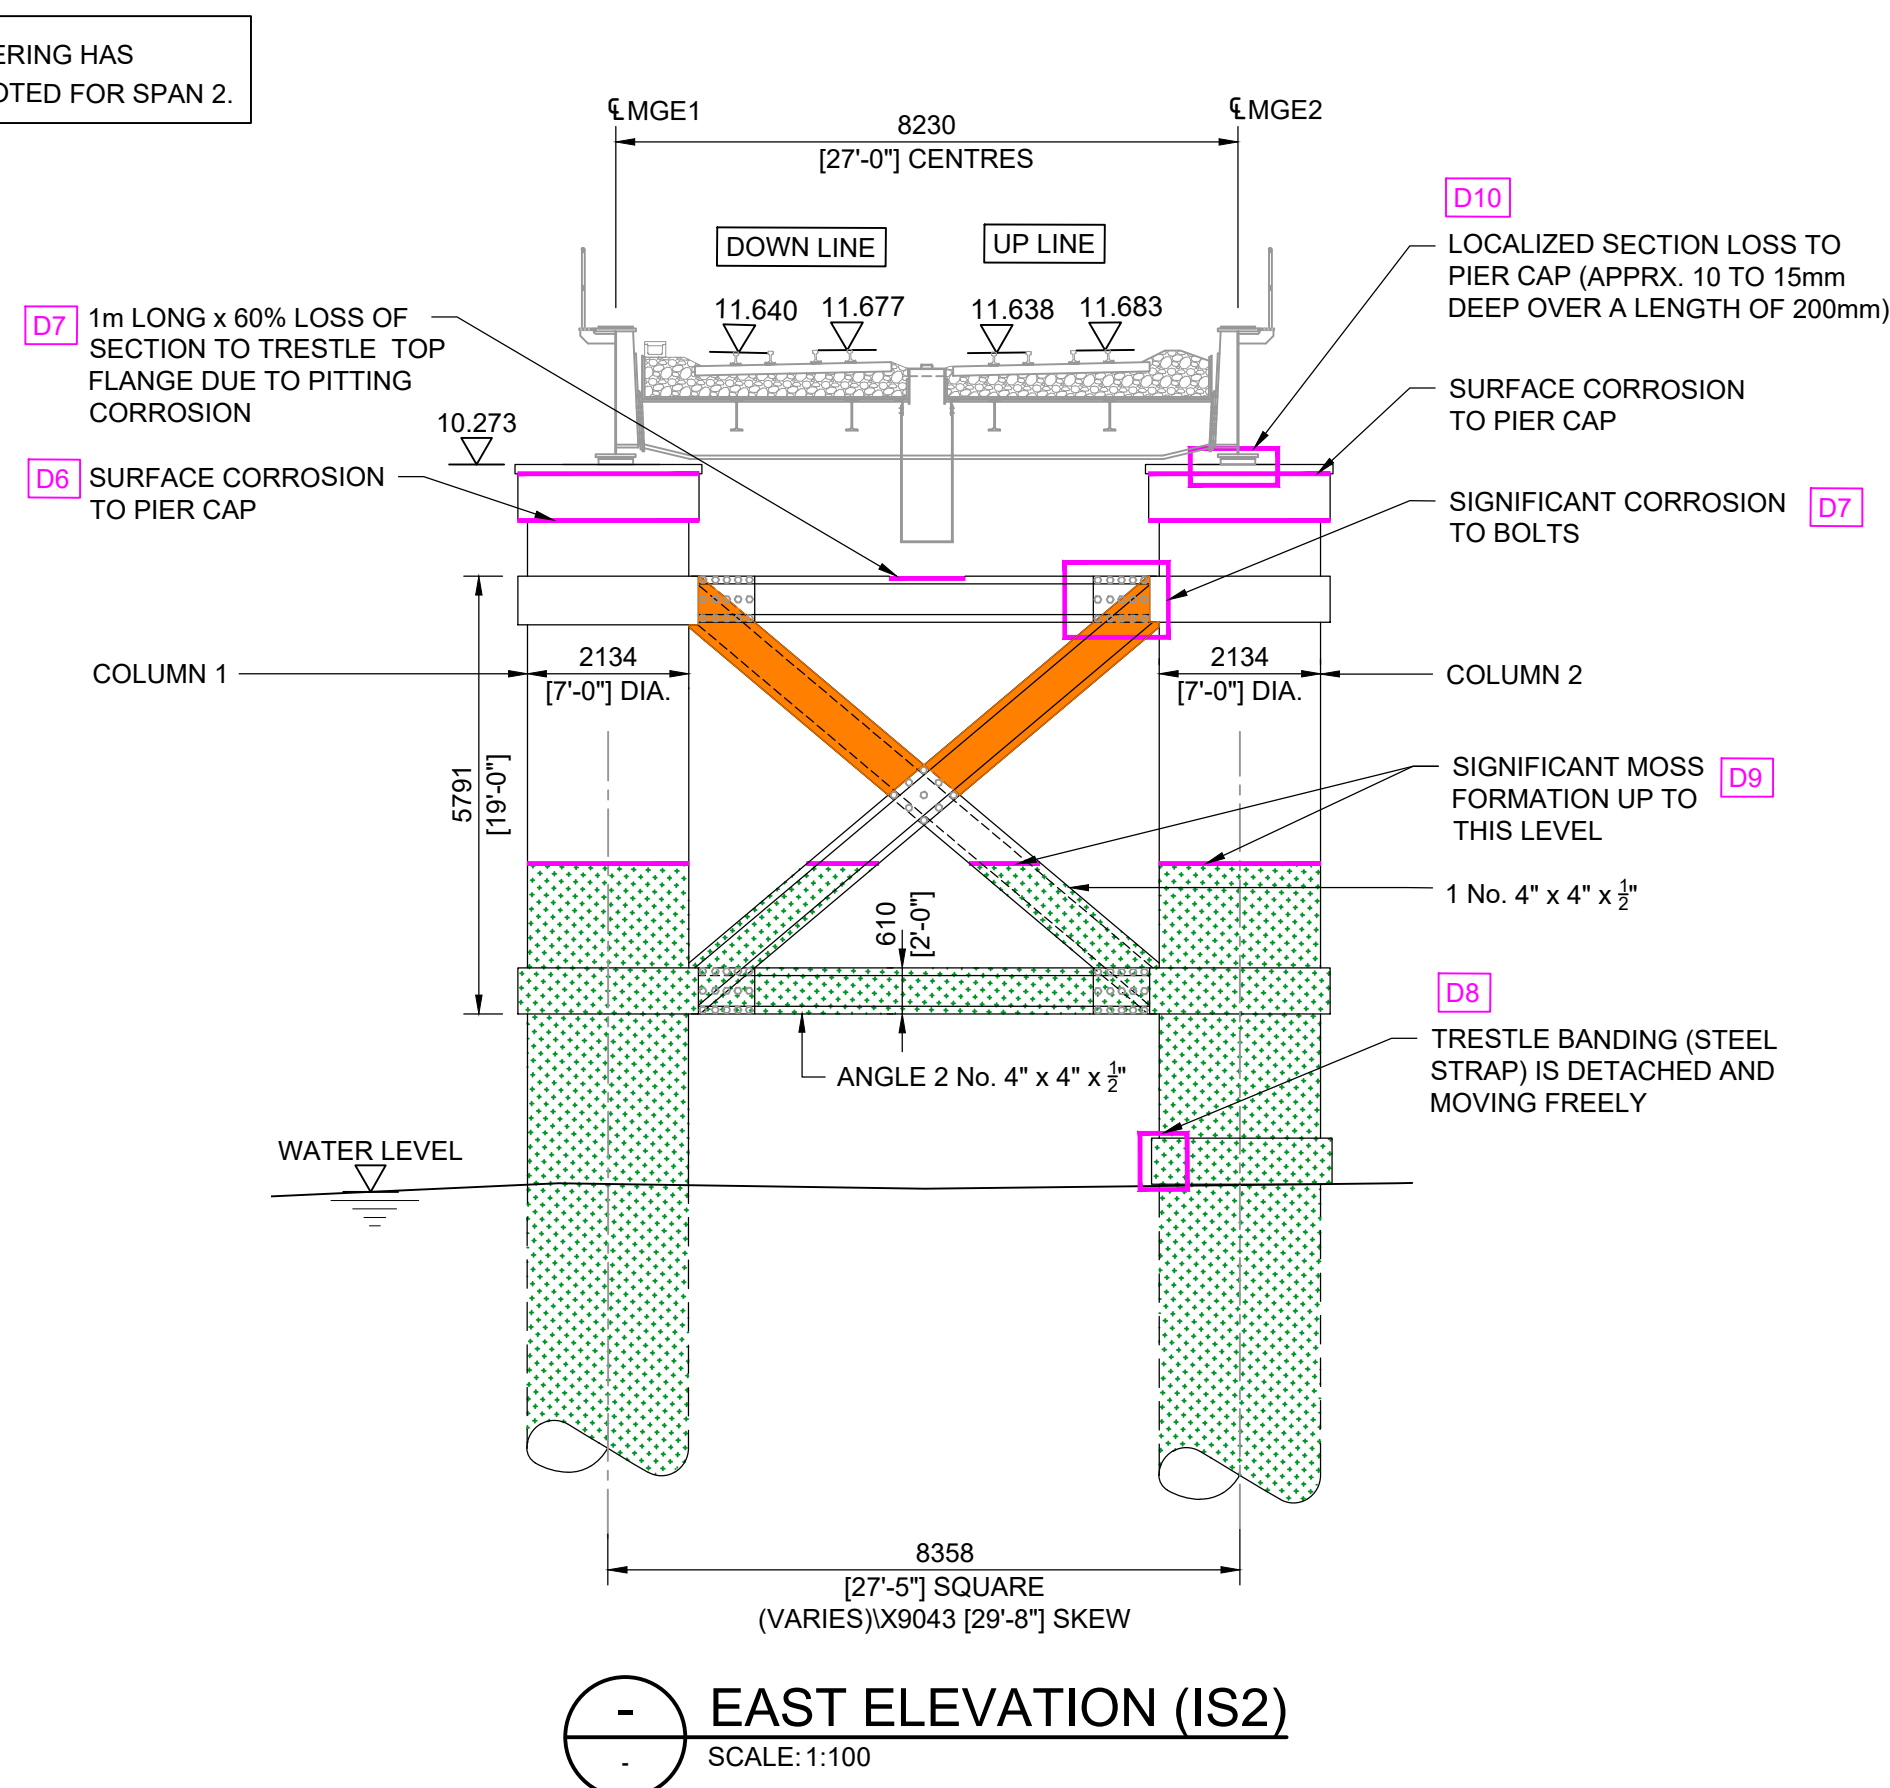
- SLIGHT VEGETATION GROWTH ON PIER CAPS.
- FLAKED PAINTWORK THROUGHOUT ON BOTH COLUMNS.
- GENERAL SURFACE RUSTING TO CROSS BRACING MEMBERS.
- SURFACE CORROSION TO PIER CAP VERTICAL JOINTS.
