RIVER NEATH SWING  
BRIDGE GRIP 4

PIER DEFECTS  
(IS3 AND IS5)

| 152093-ARC-DRG-ECV-000011 | A03 |

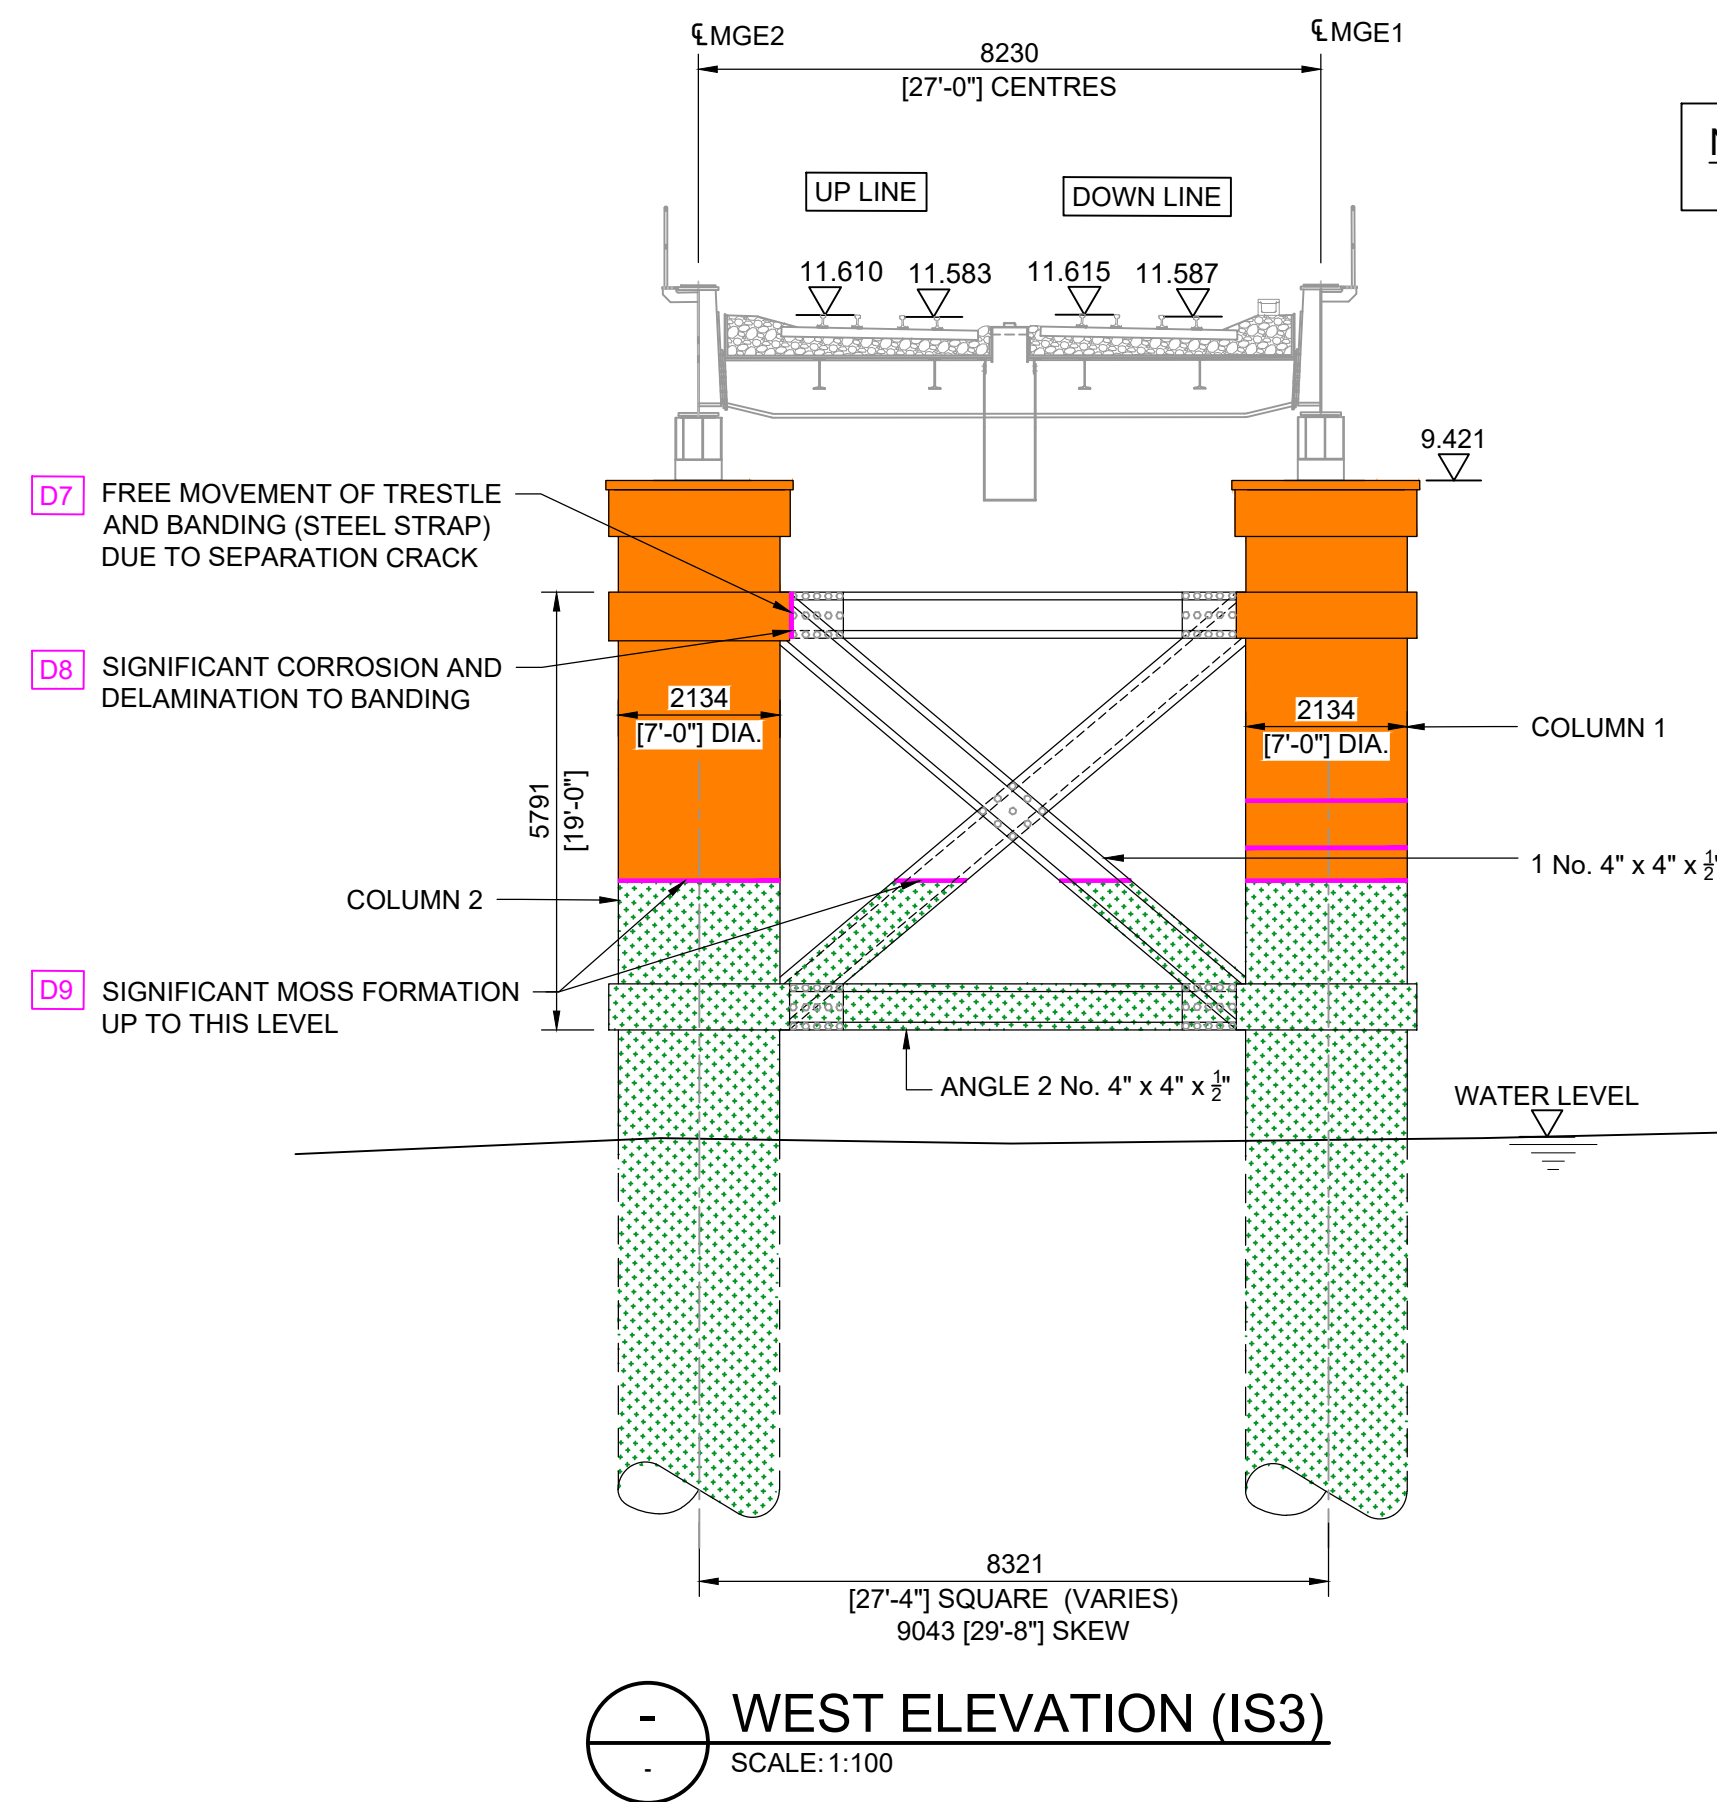
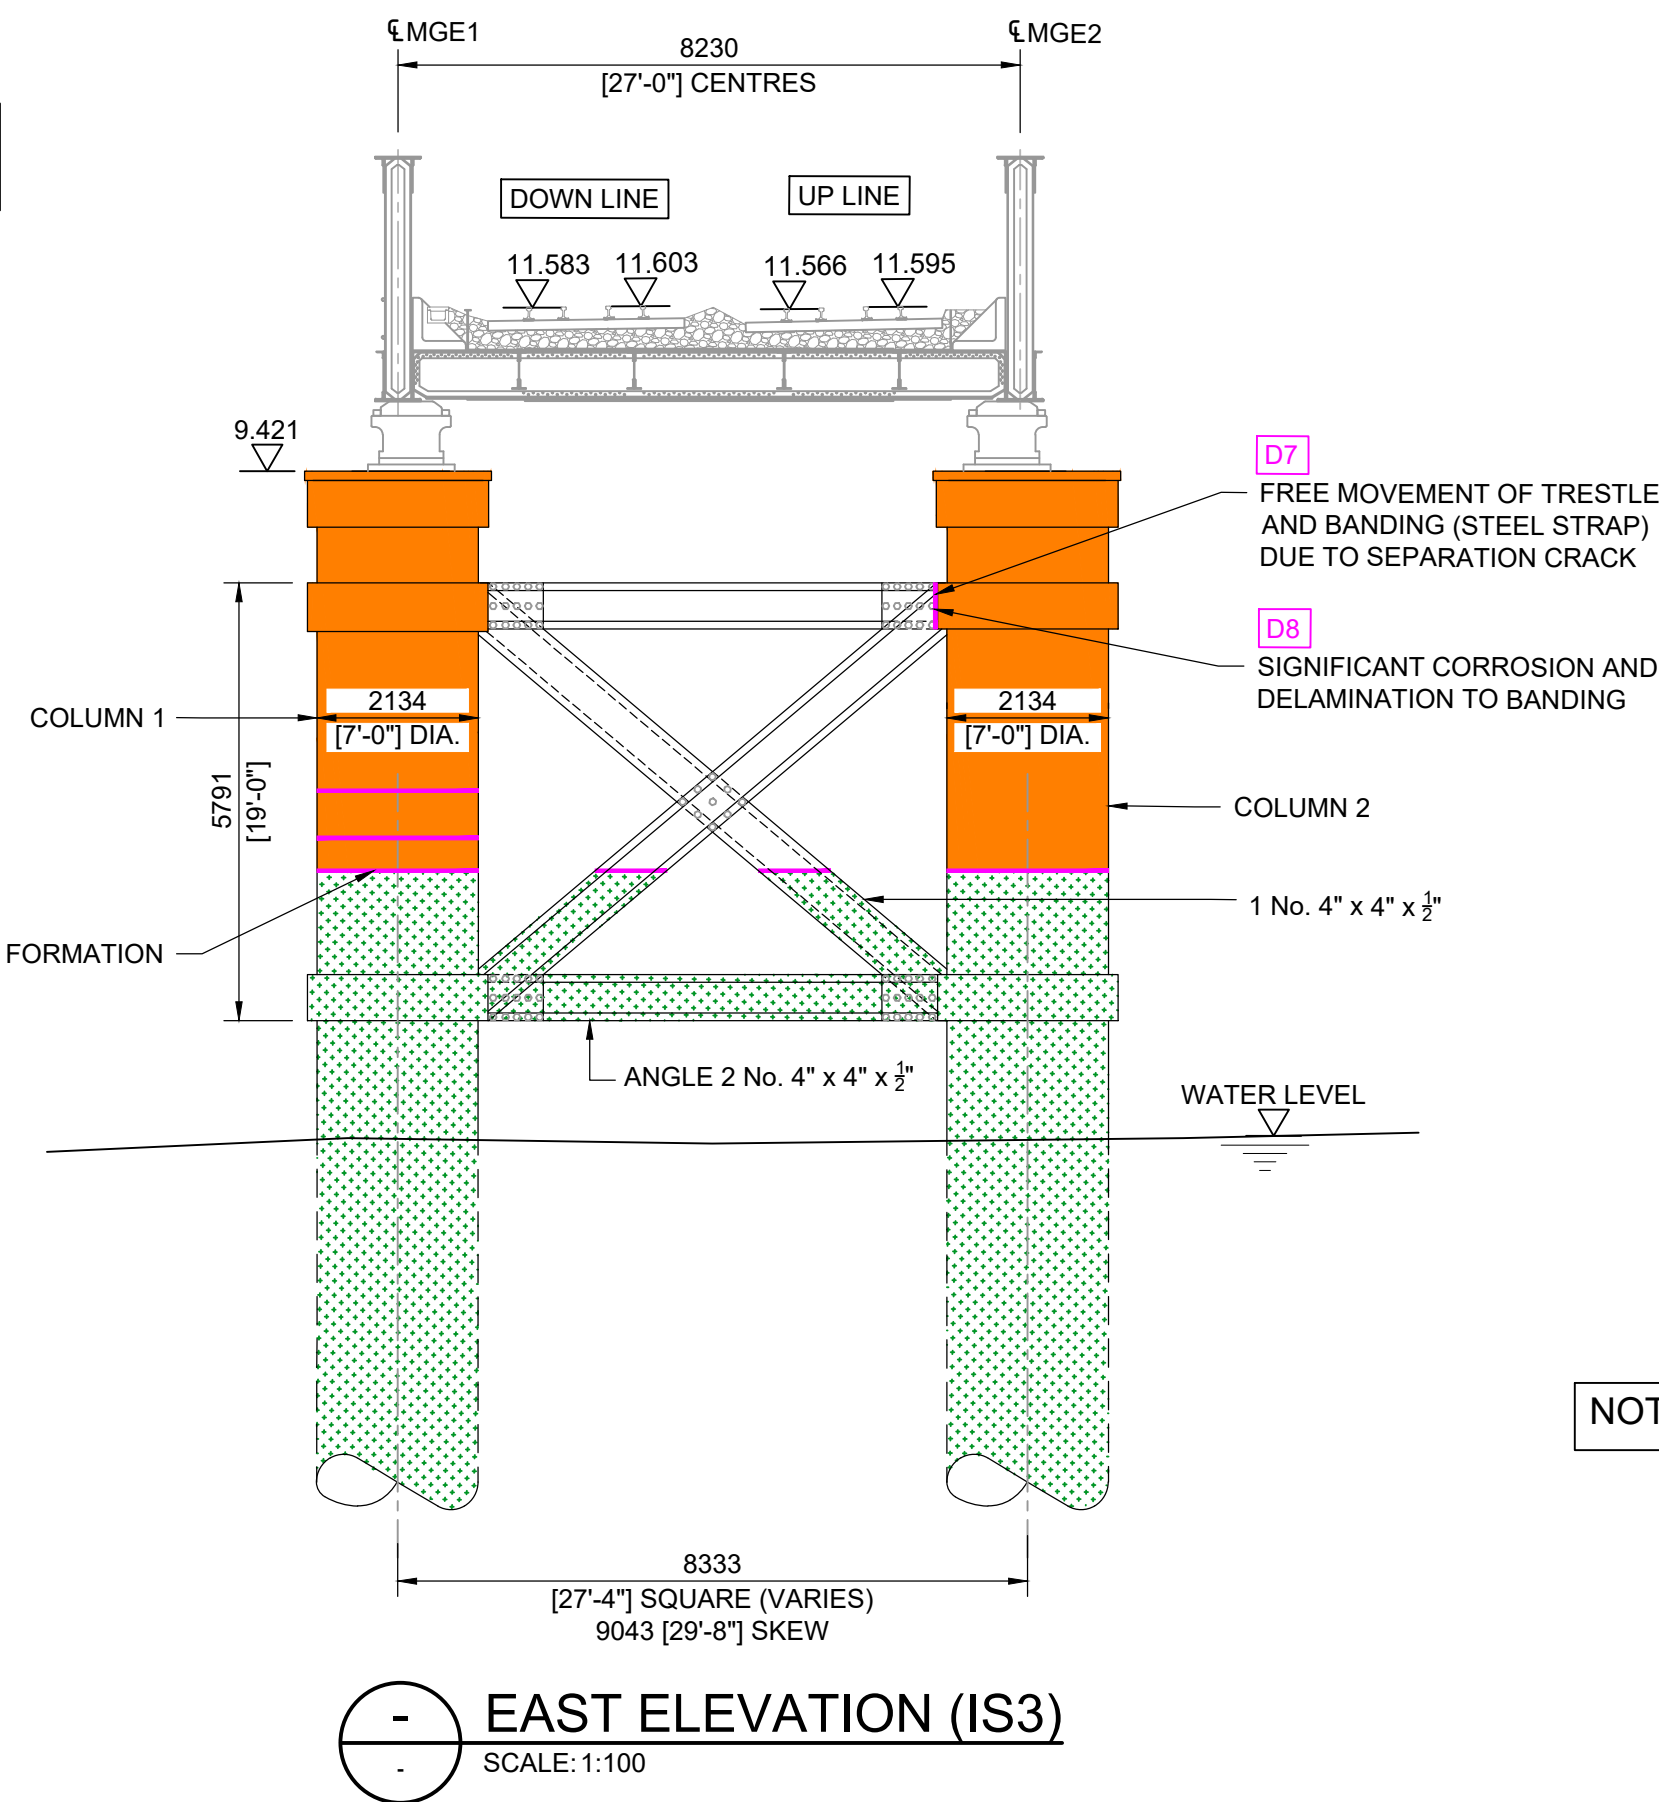
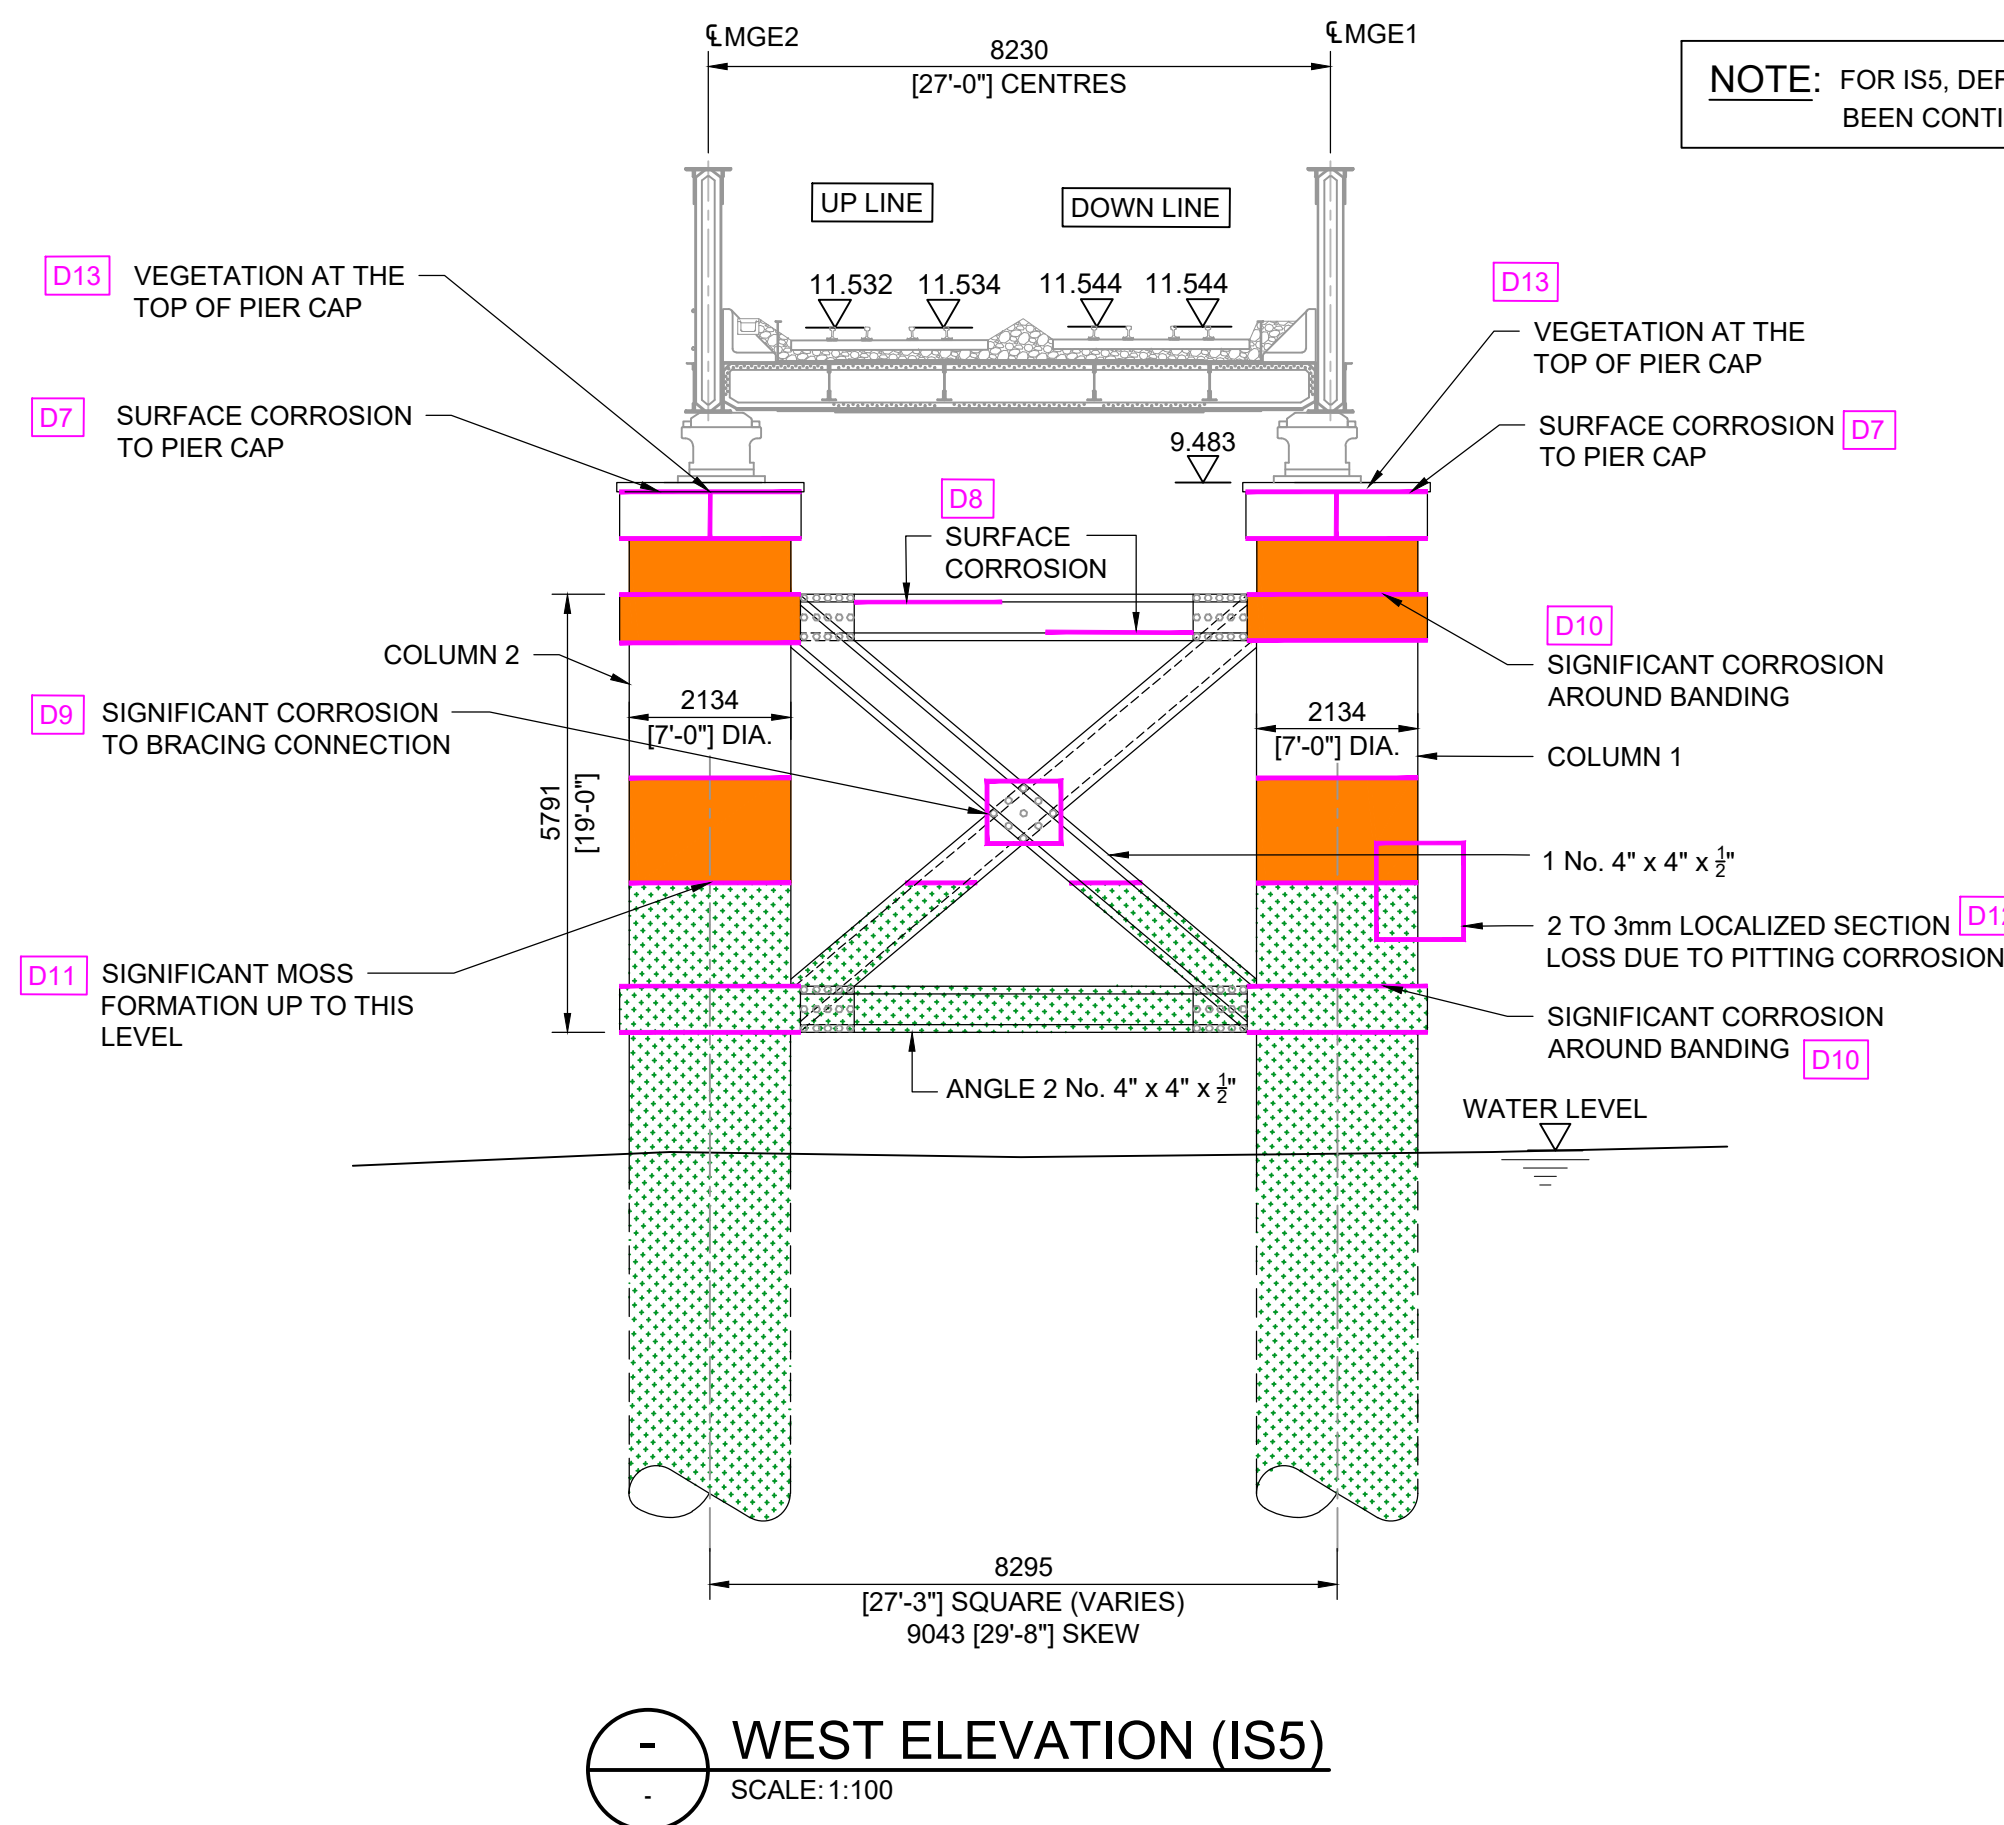
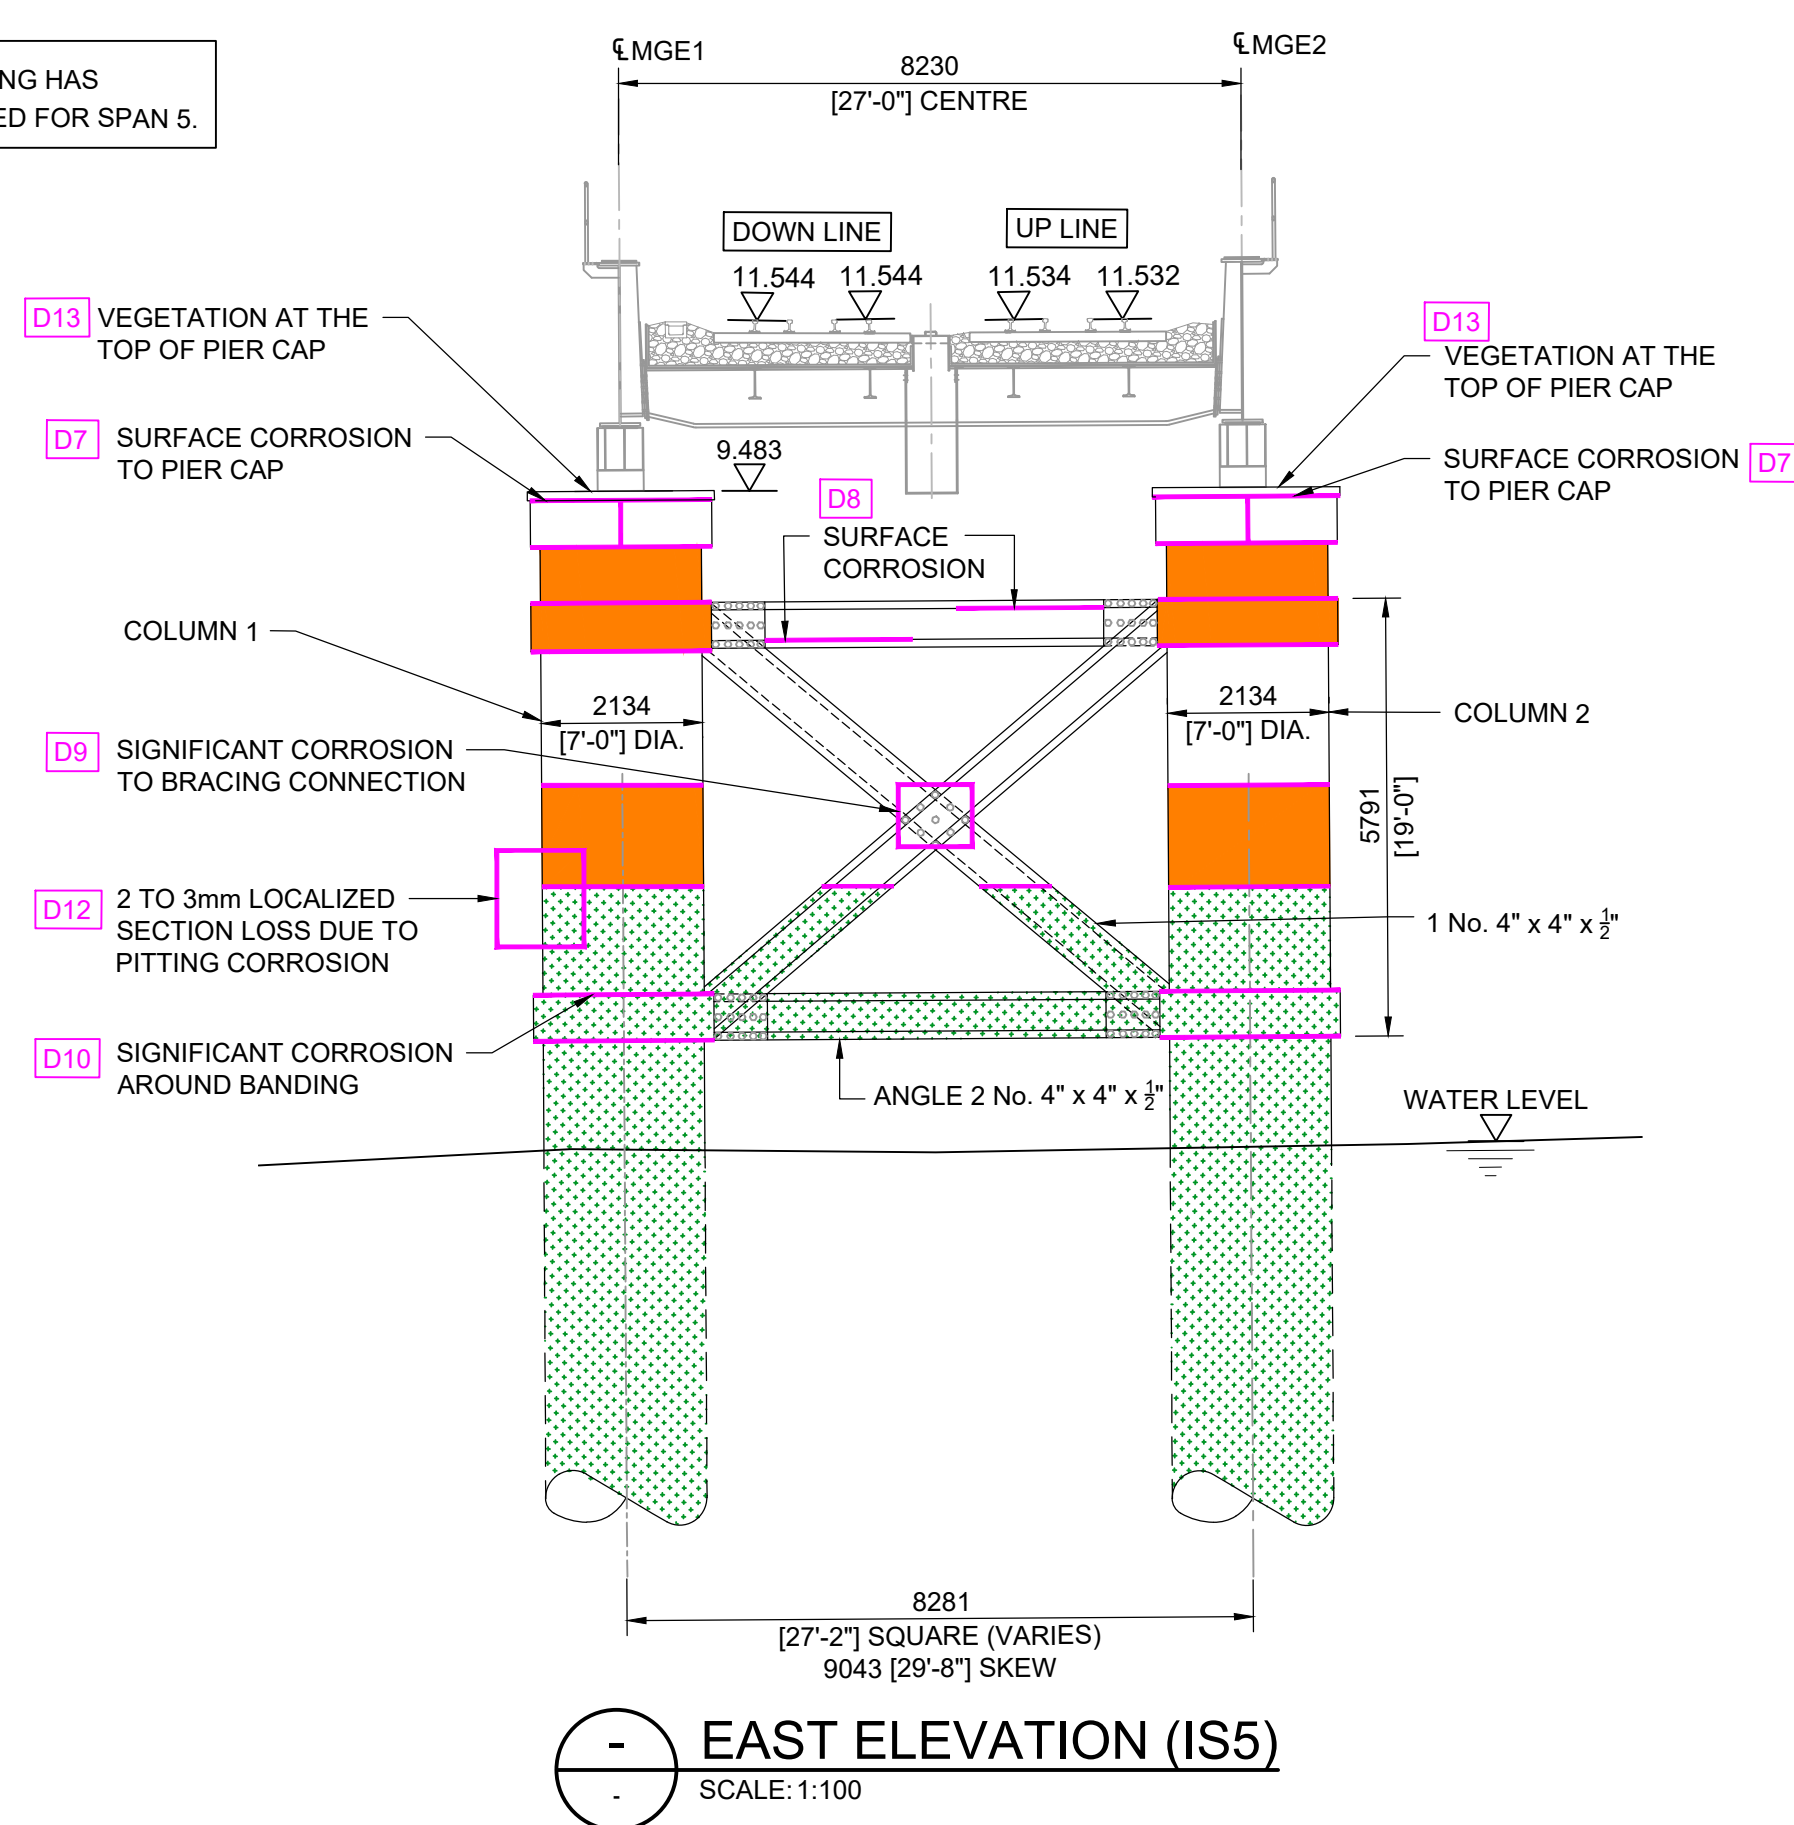
- SLIGHT VEGETATION GROWTH ON PIER CAPS.
- FLAKED PAINTWORK THROUGHOUT ON BOTH COLUMNS.
- GENERAL SURFACE RUSTING TO CROSS BRACING MEMBERS.
- SURFACE CORROSION TO PIER CAP VERTICAL JOINTS.
