Order Number: 283848248\_1\_1  
Customer Ref: 05474 - Coed Darcy  
National Grid Reference: 272320, 196840  
Slice: D  
Site Area (Ha): 131.44  
Search Buffer (m): 100

Coed Darcy Urban Village, Swansea  
Explosive Ordnance Threat Assessment Report

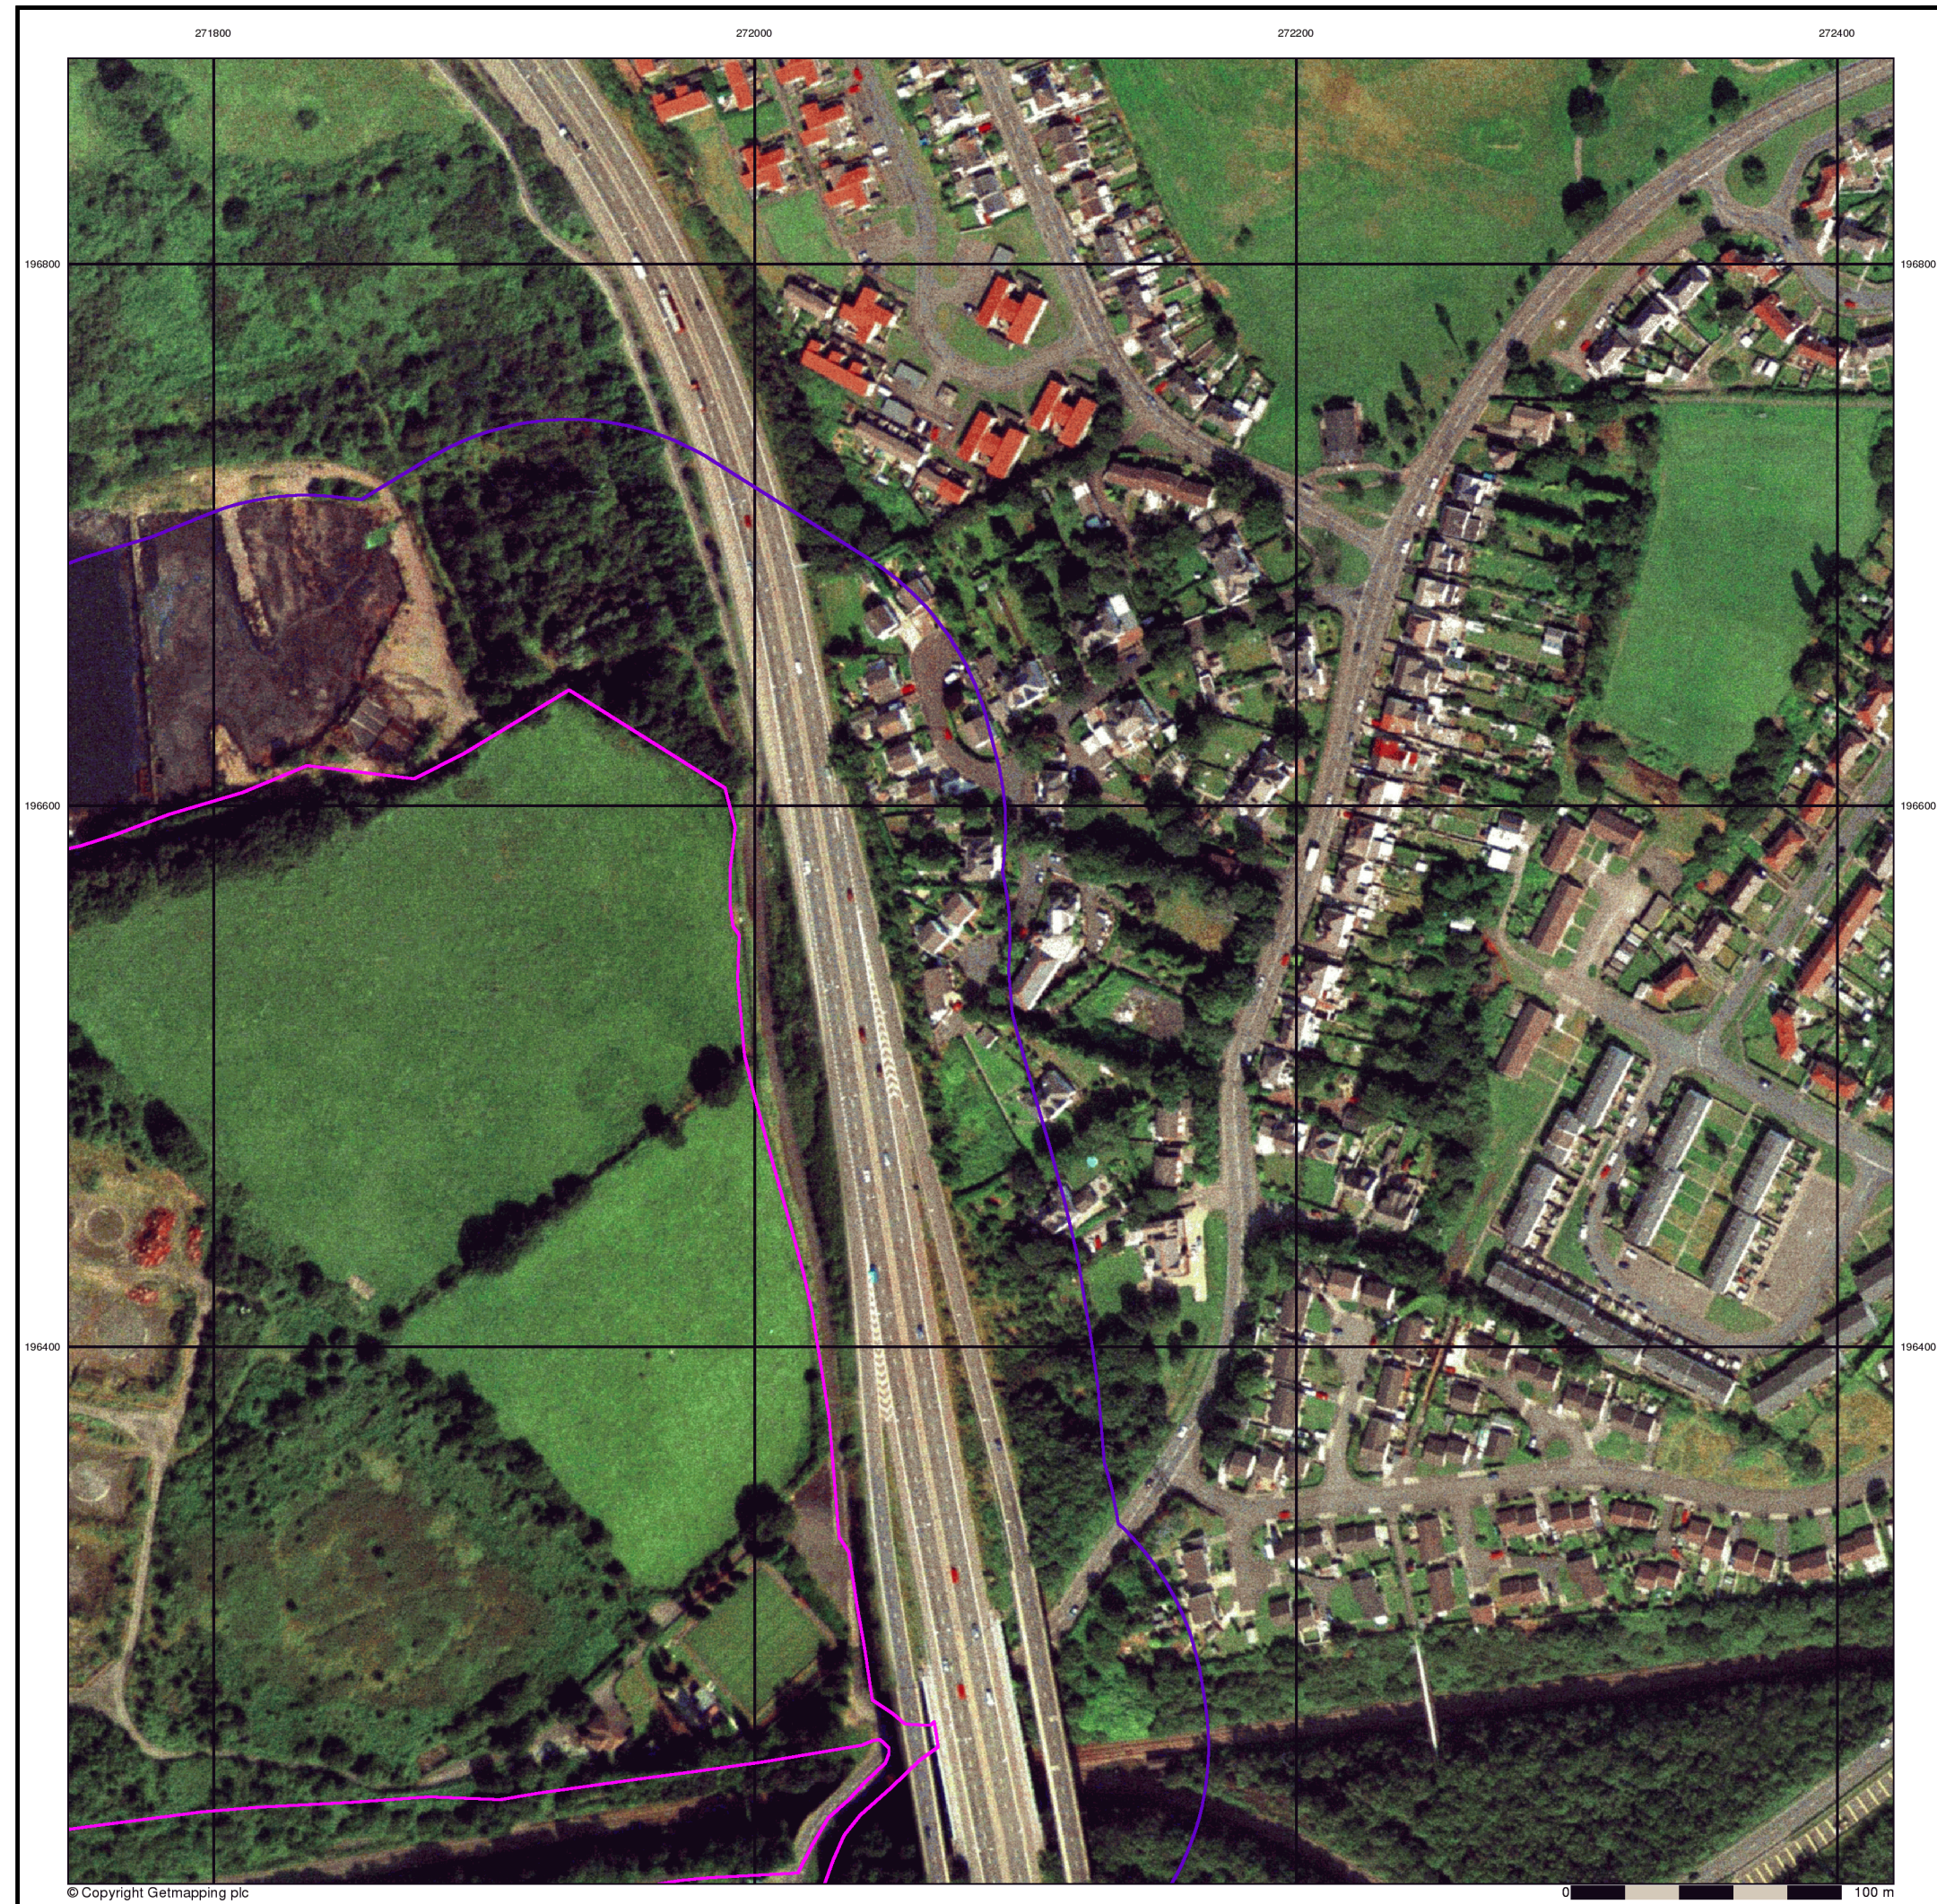
## Historical Aerial Photography

This aerial photography was produced by Getmapping, these vertical aerial photographs provide a seamless, full colour survey of the whole of Great Britain
