# **St. Modwen Developments Ltd**

**Coed Darcy**

| Section | Page |
|---|---|
| 2.8 Pre Remediation Ground Conditions | 10 |

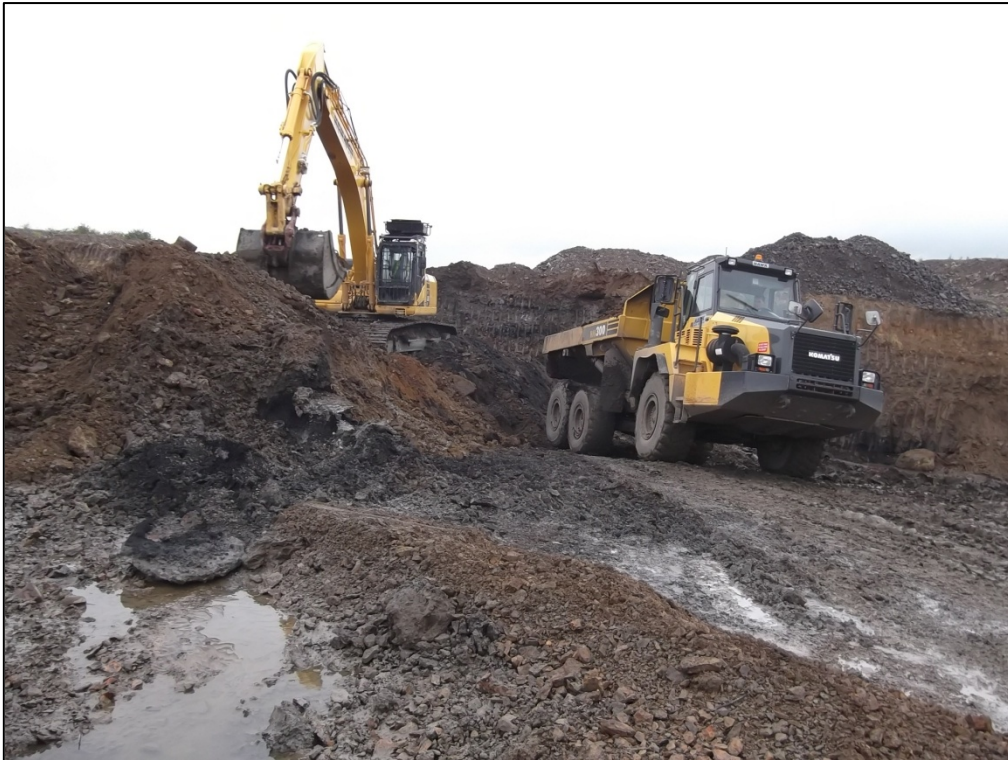
Photograph 1: Excavation of materials from within Monitor Phase 29

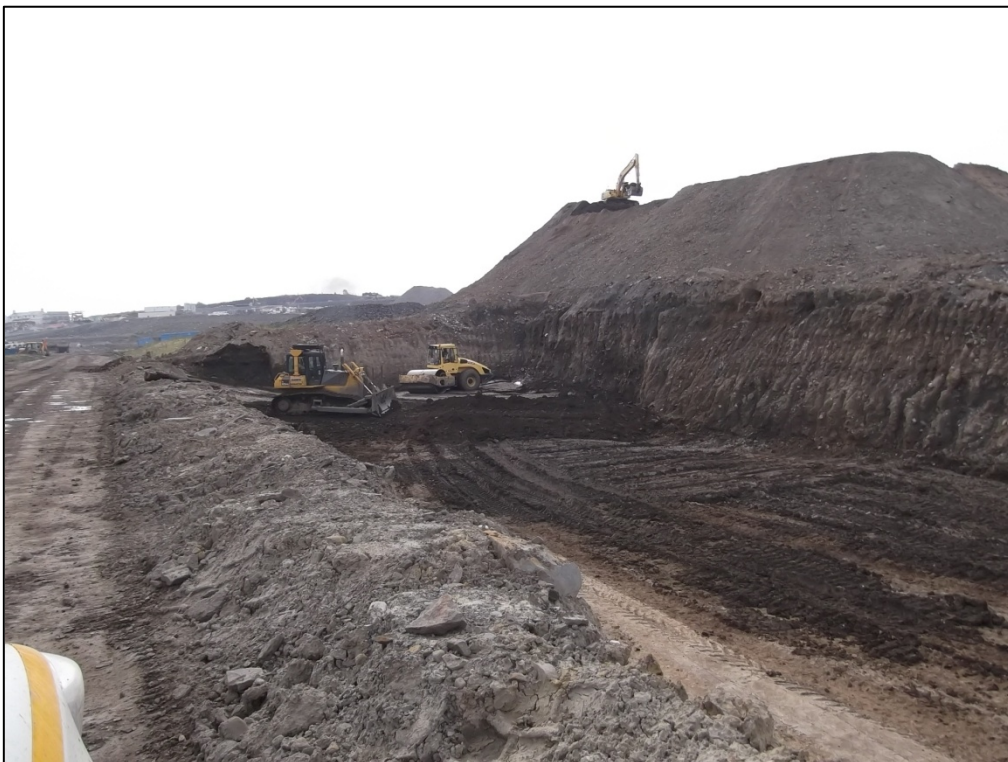
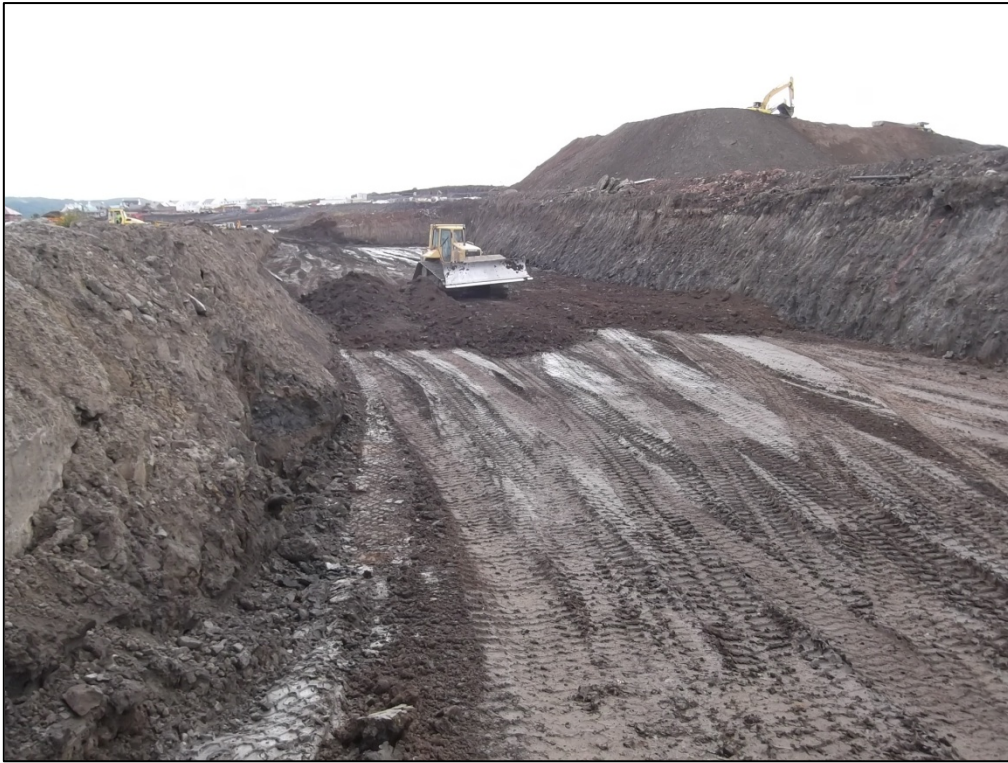
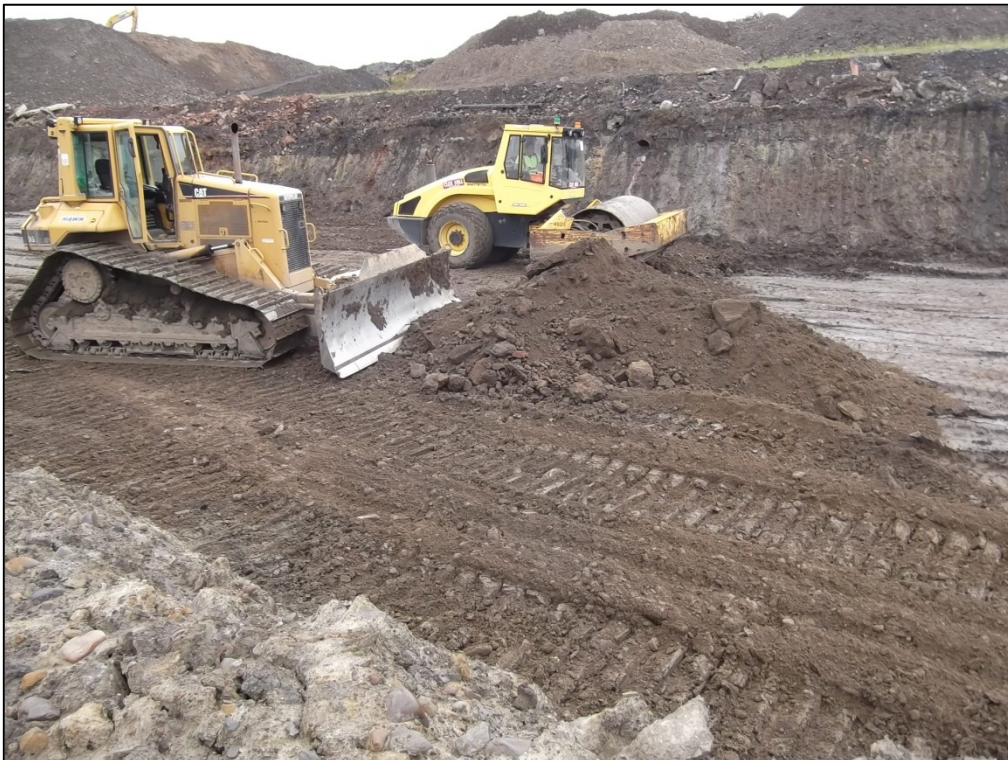
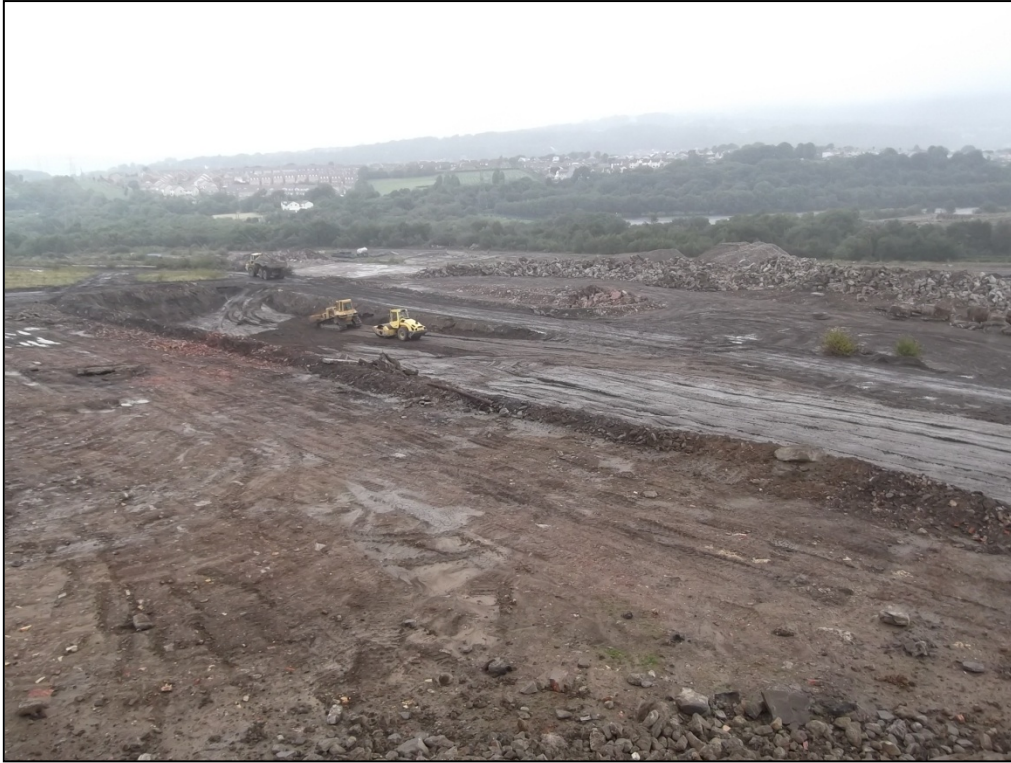
Photographs 2 to 5: Backfill of Monitor Phase 29

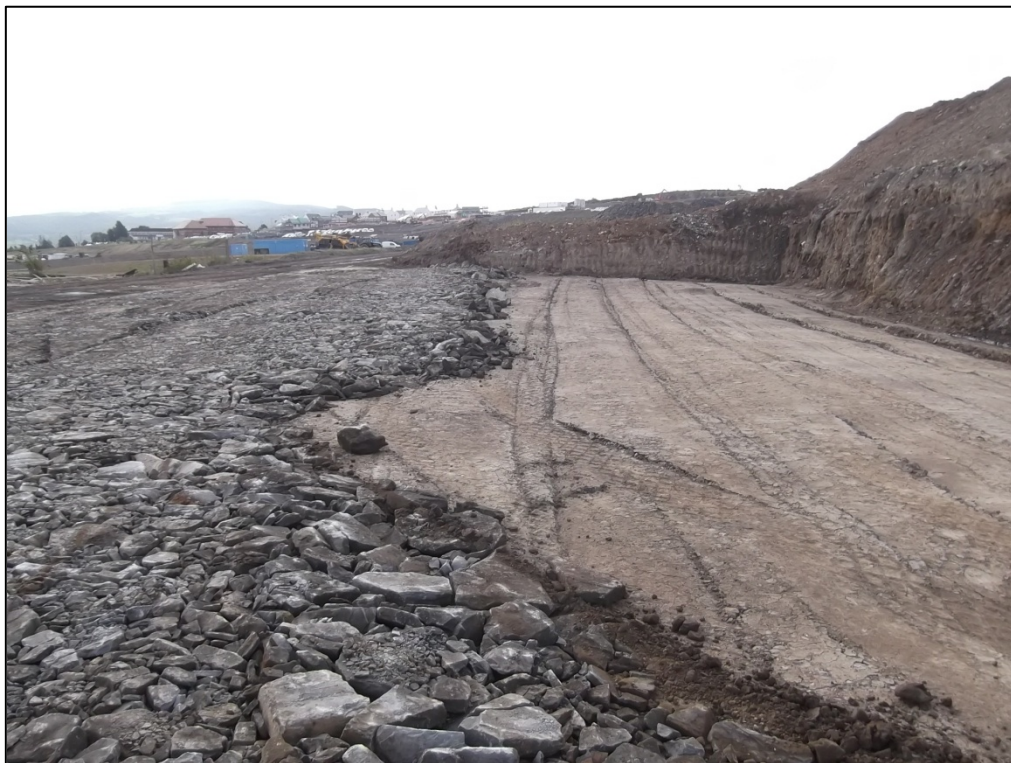
Photograph 6: Upfilling with top 0.5m of suitable fill materials
