**Coed Darcy**

**Upper Terrace (Monitor Phase 30)**

**Validation Report**

**October 2014**

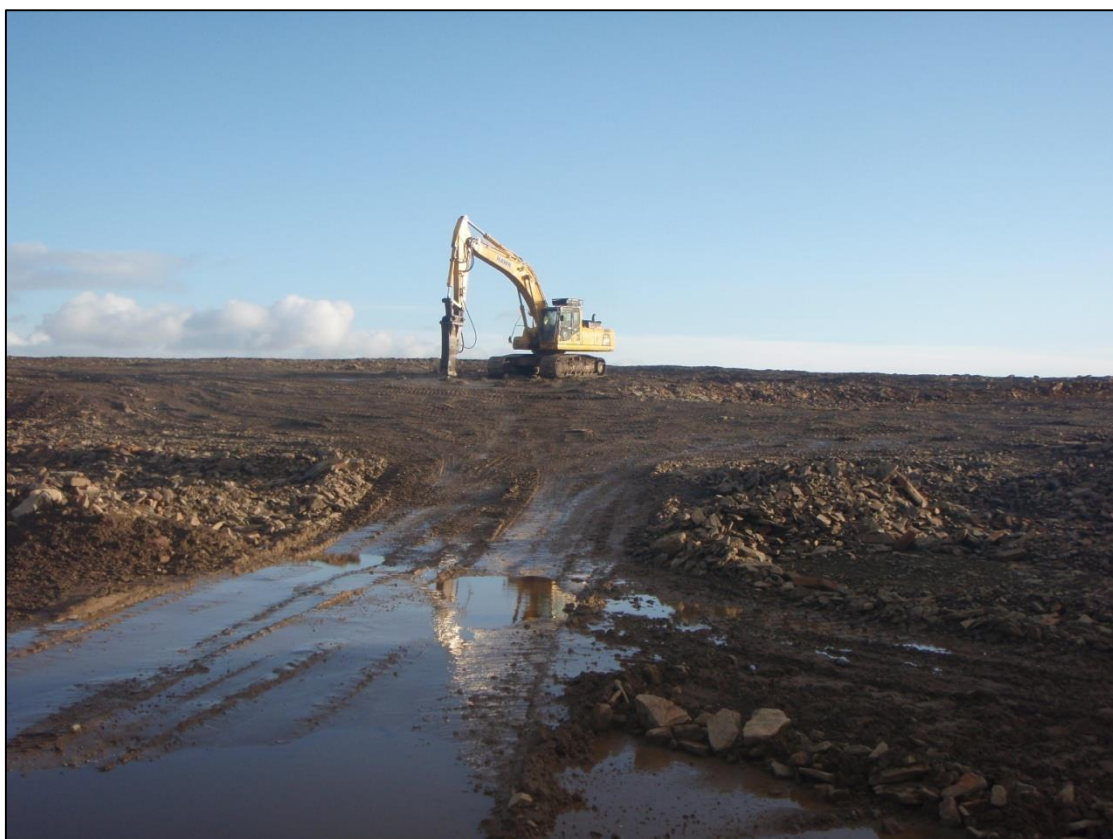
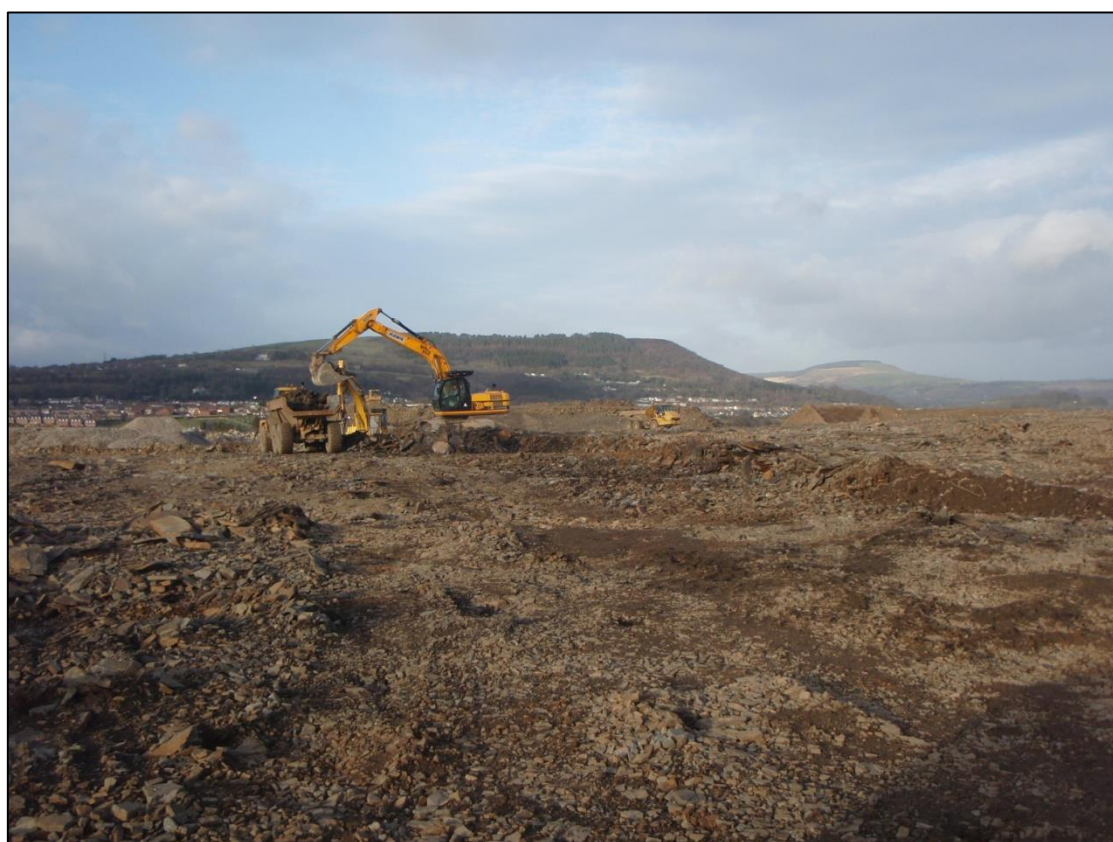
Photographs 1 and 2: Breaking and excavation of existing bedrock

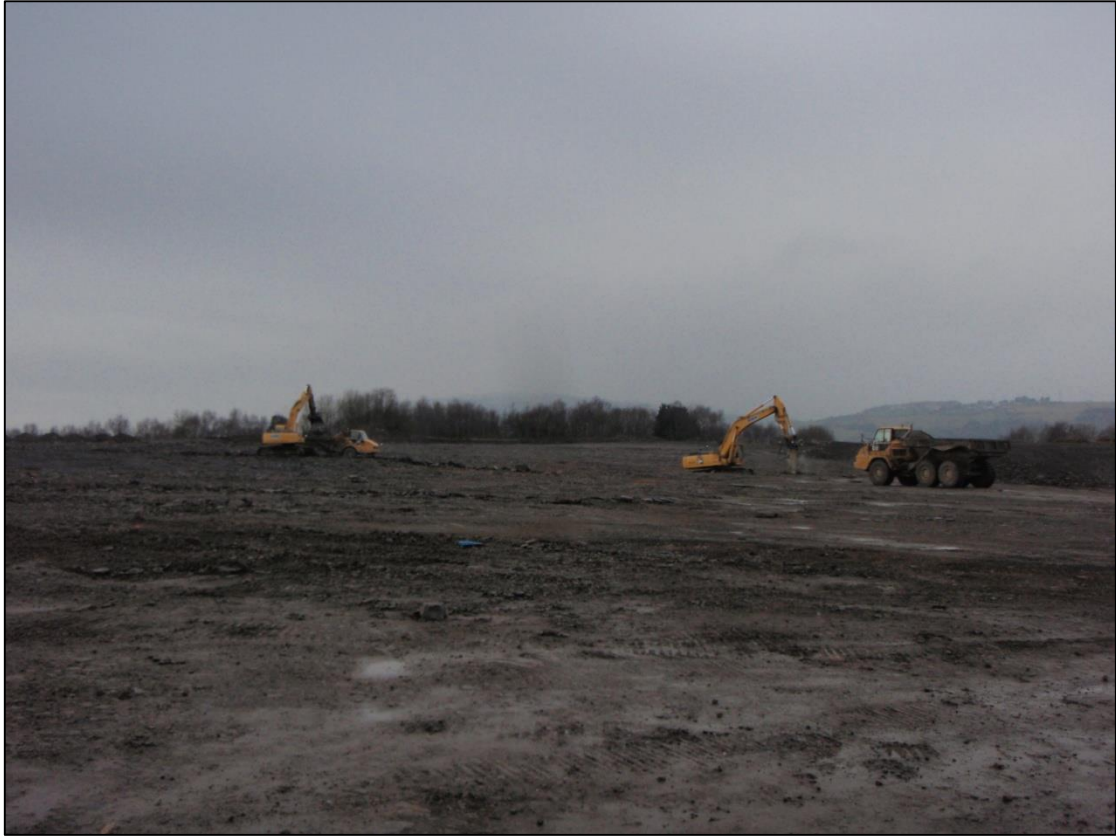
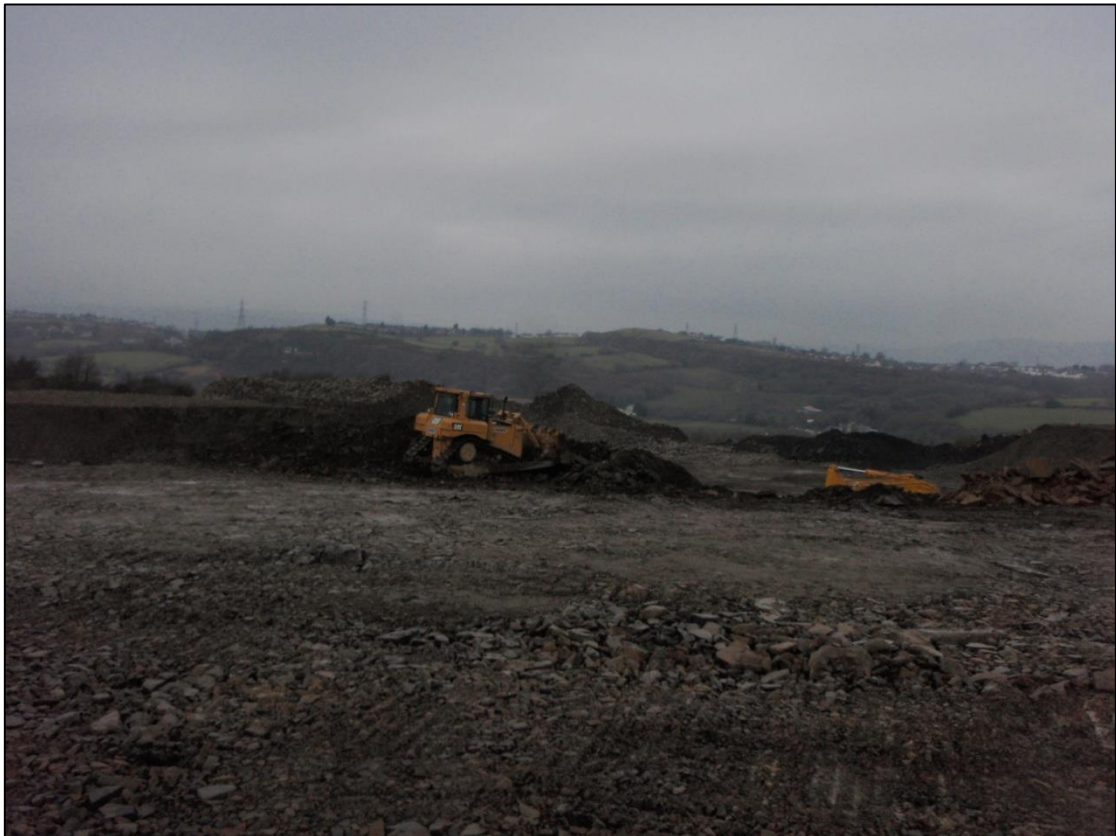
Photographs 5 and 6: Re-profiling of final surface to achieve the desired profile

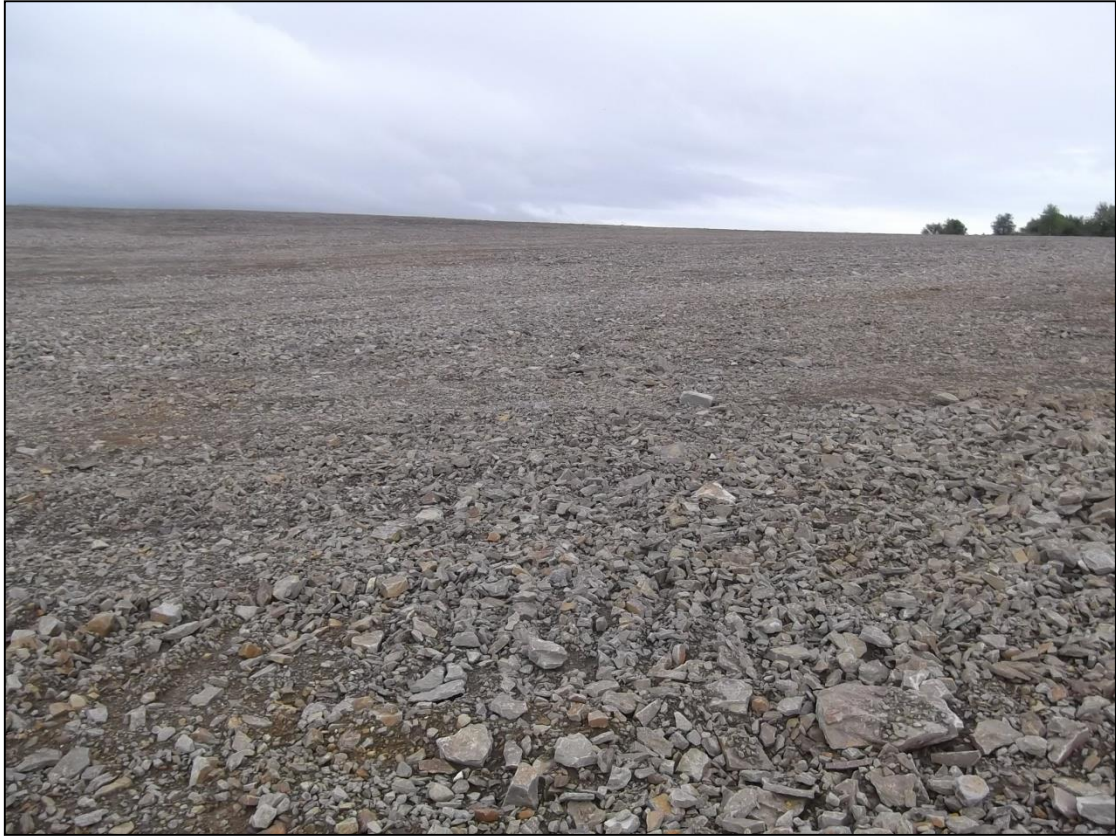
Photograph 1: Facing East across Monitor Phase 30 – Finished Profile

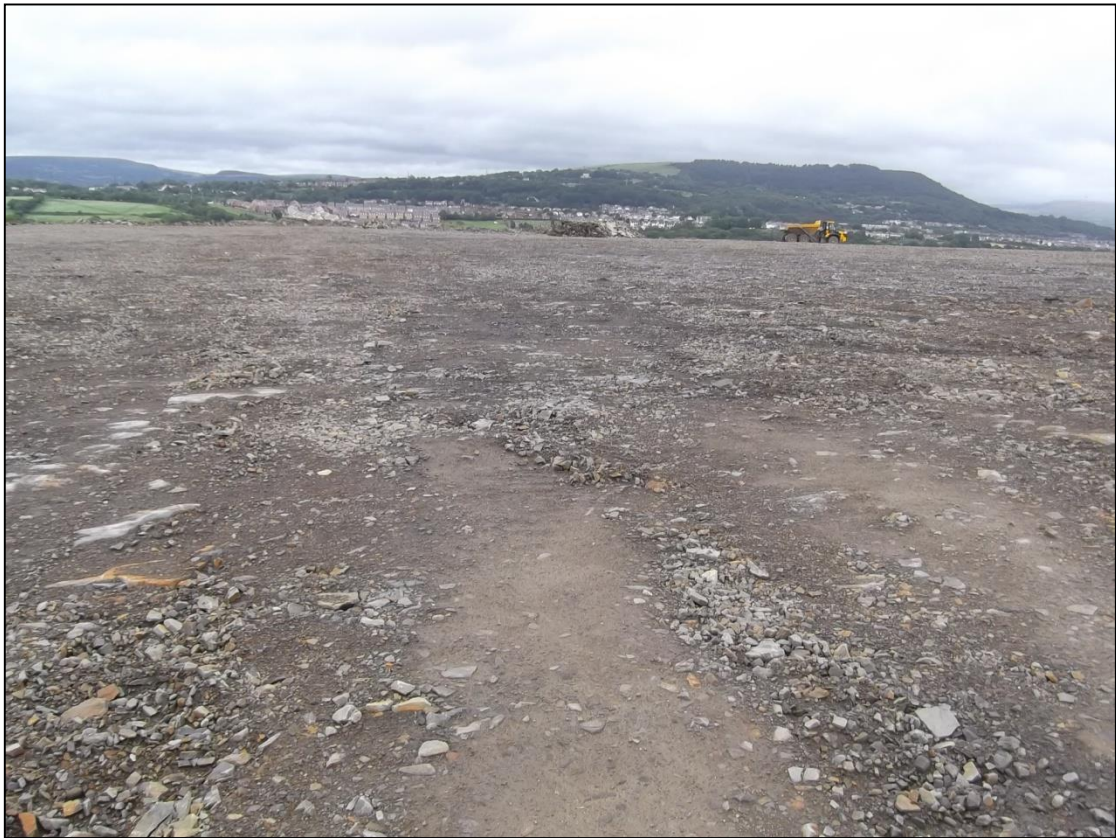
Photograph 2: Facing North across Monitor Phase 30 – Finished Profile

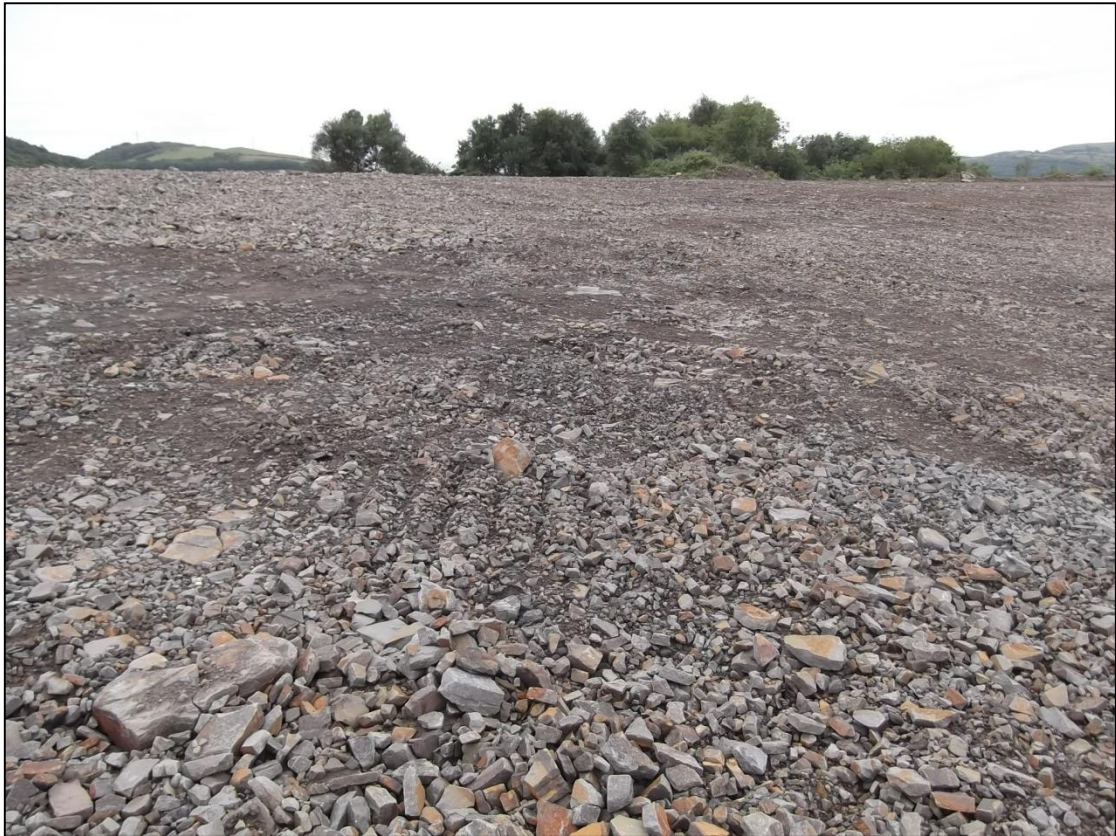
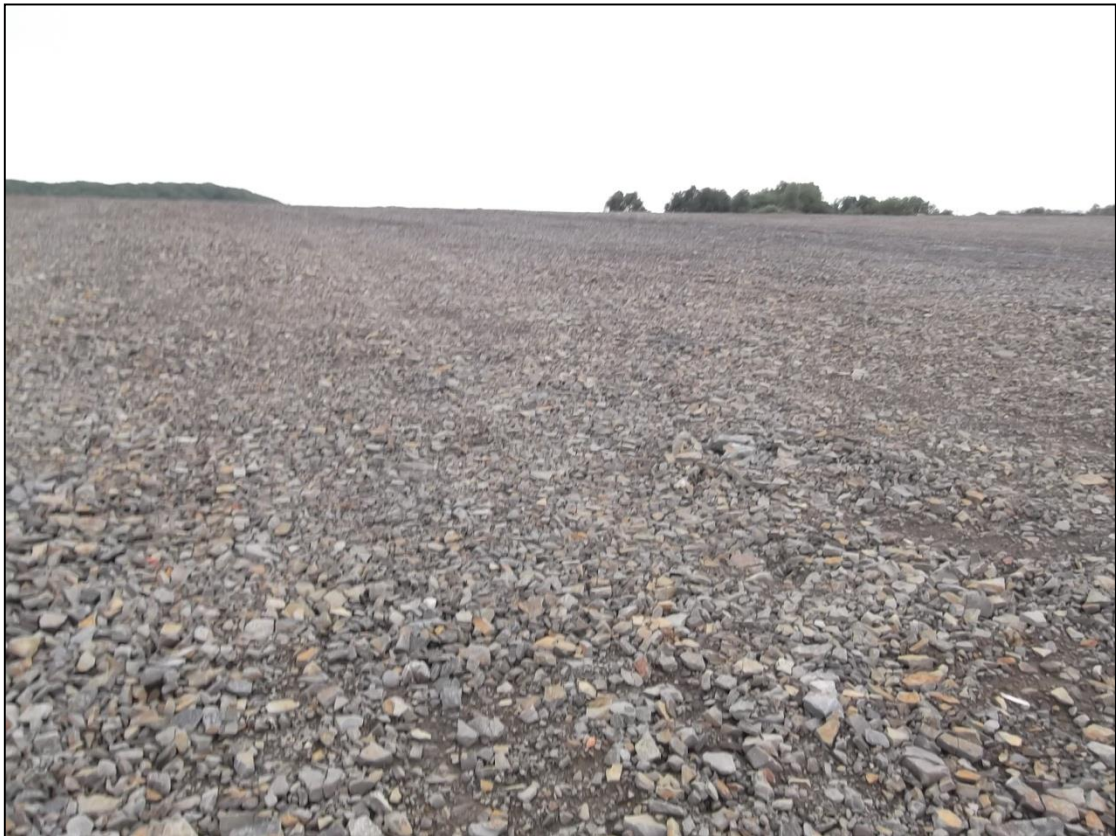
Photographs 3 and 4: Facing South across Monitor Phase 30 – Finished Profile

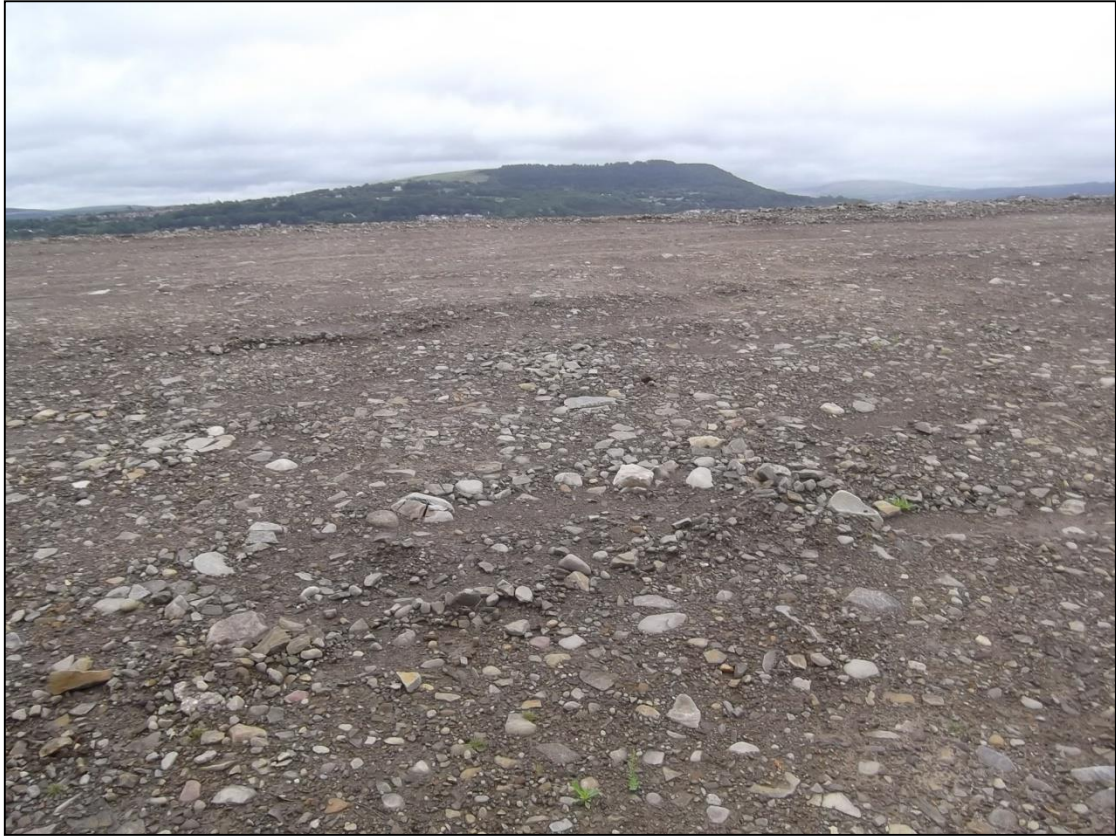
Photograph 5: Facing North across Monitor Phase 30 – Finished Profile

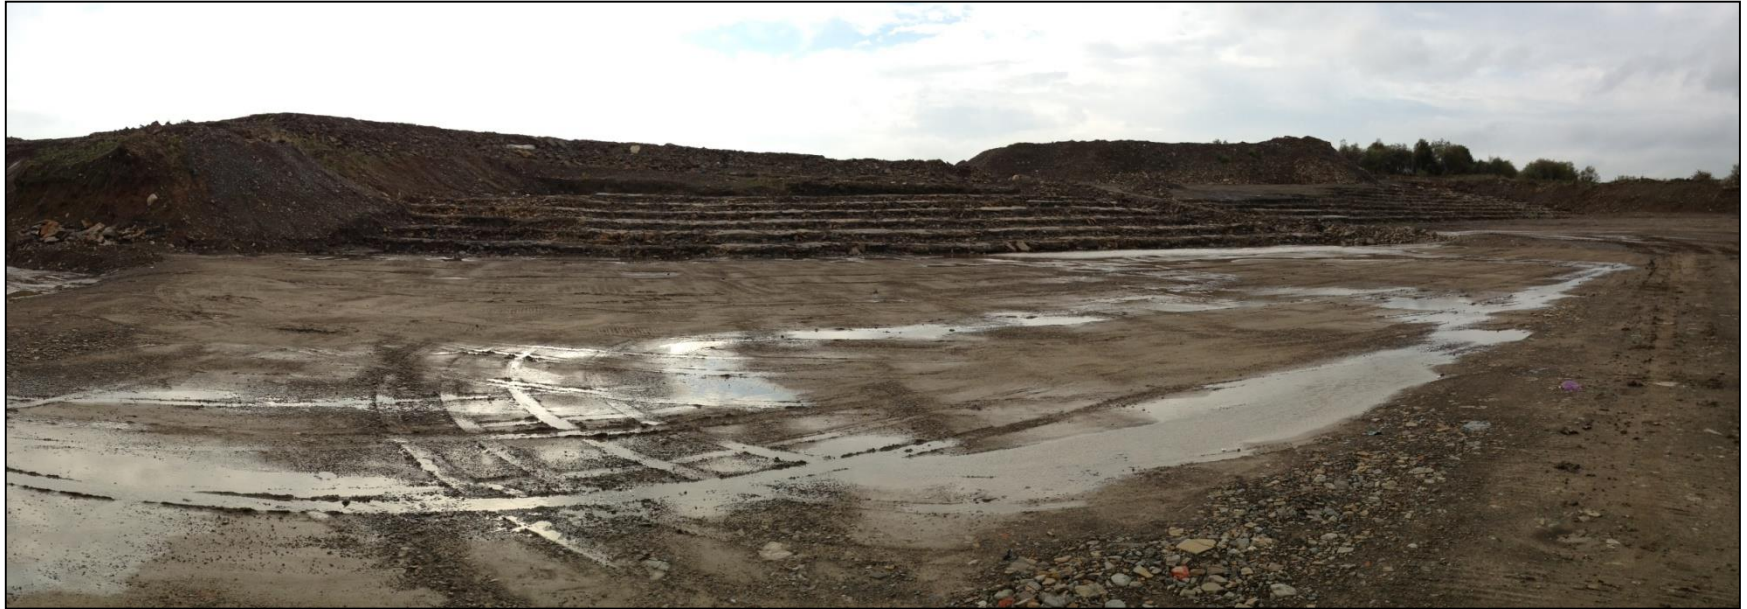
Photograph 6: Final 'stepped' profile along the northern boundary of Monitor Phase 30

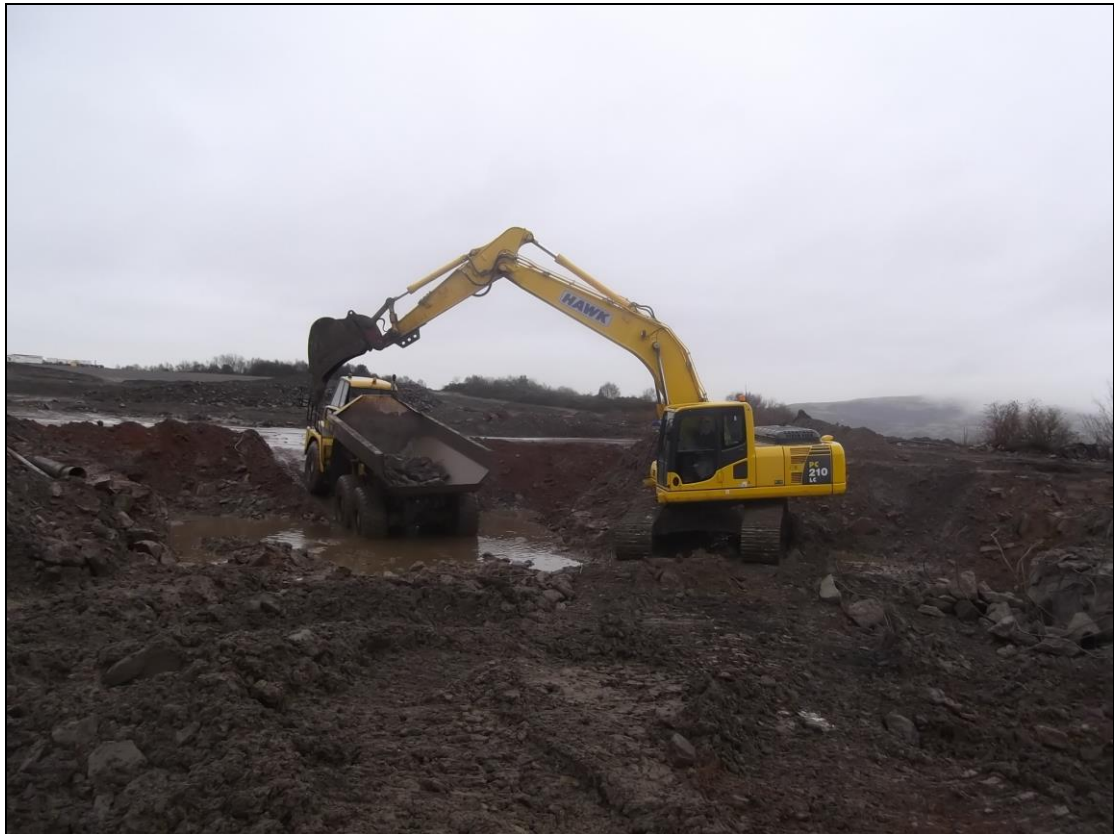
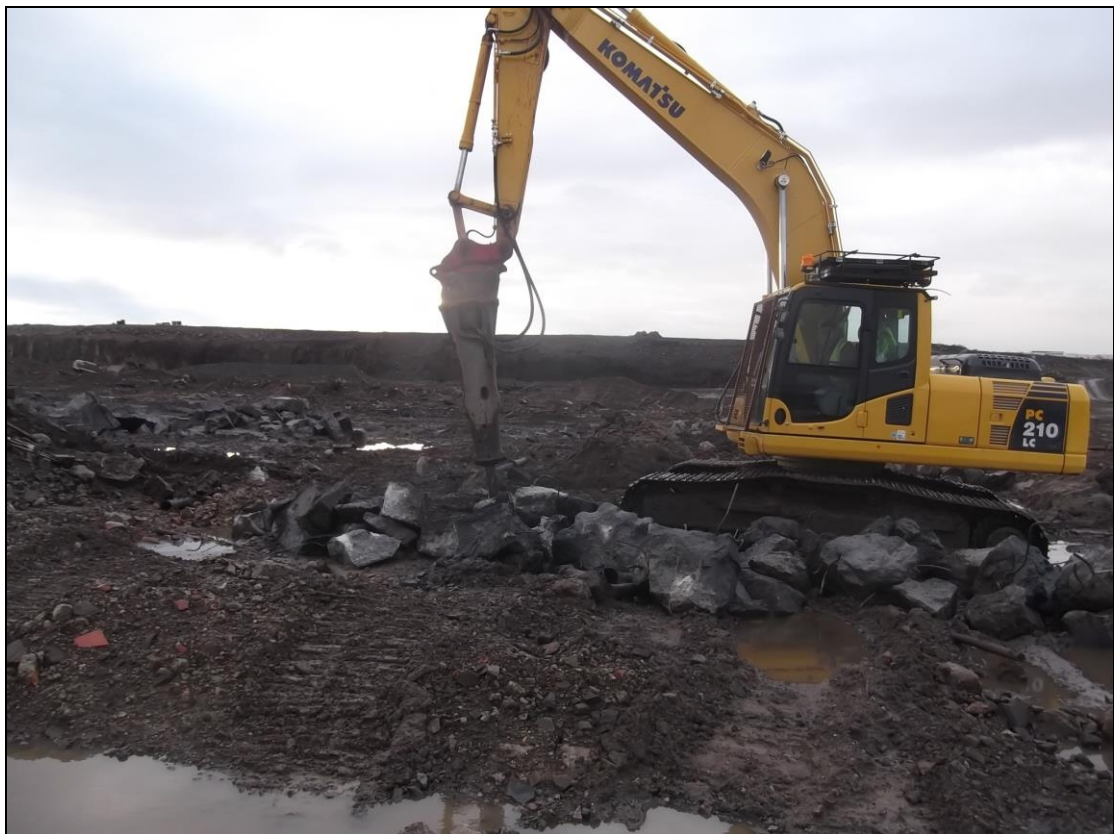
Photograph 1 and 2: Removal of impacted soils and concrete from Monitor Phase 31.

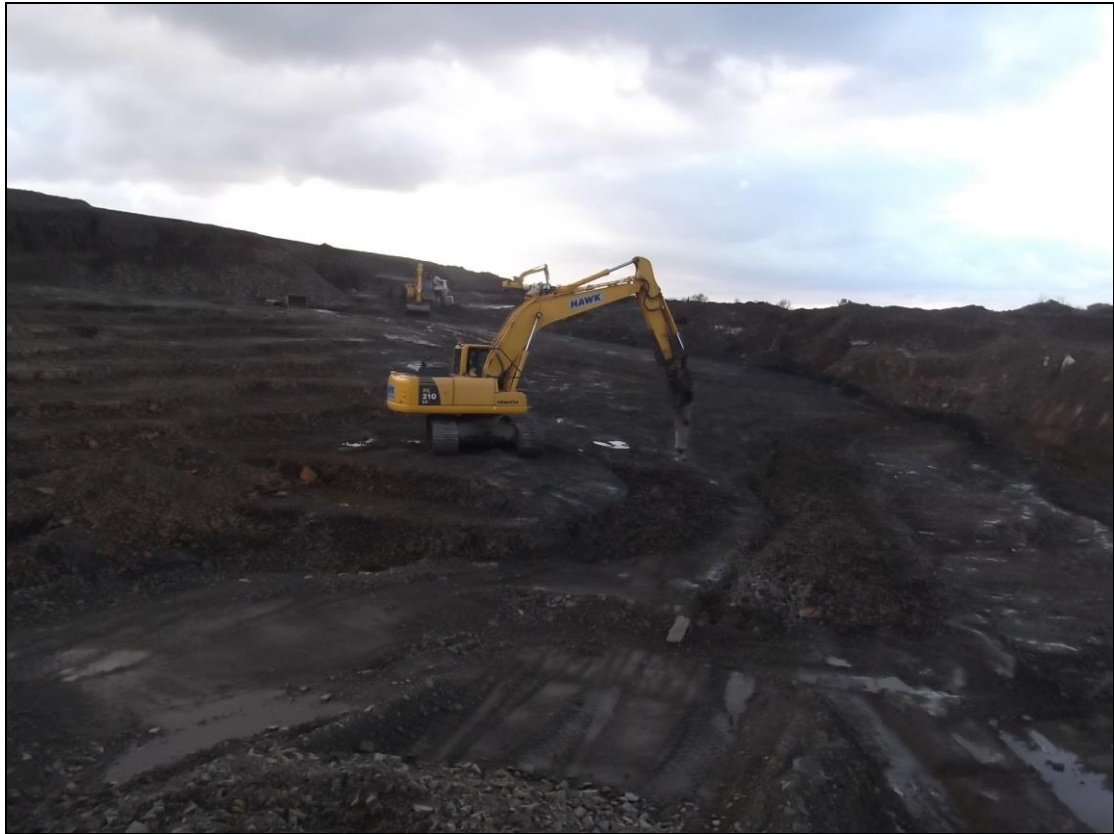
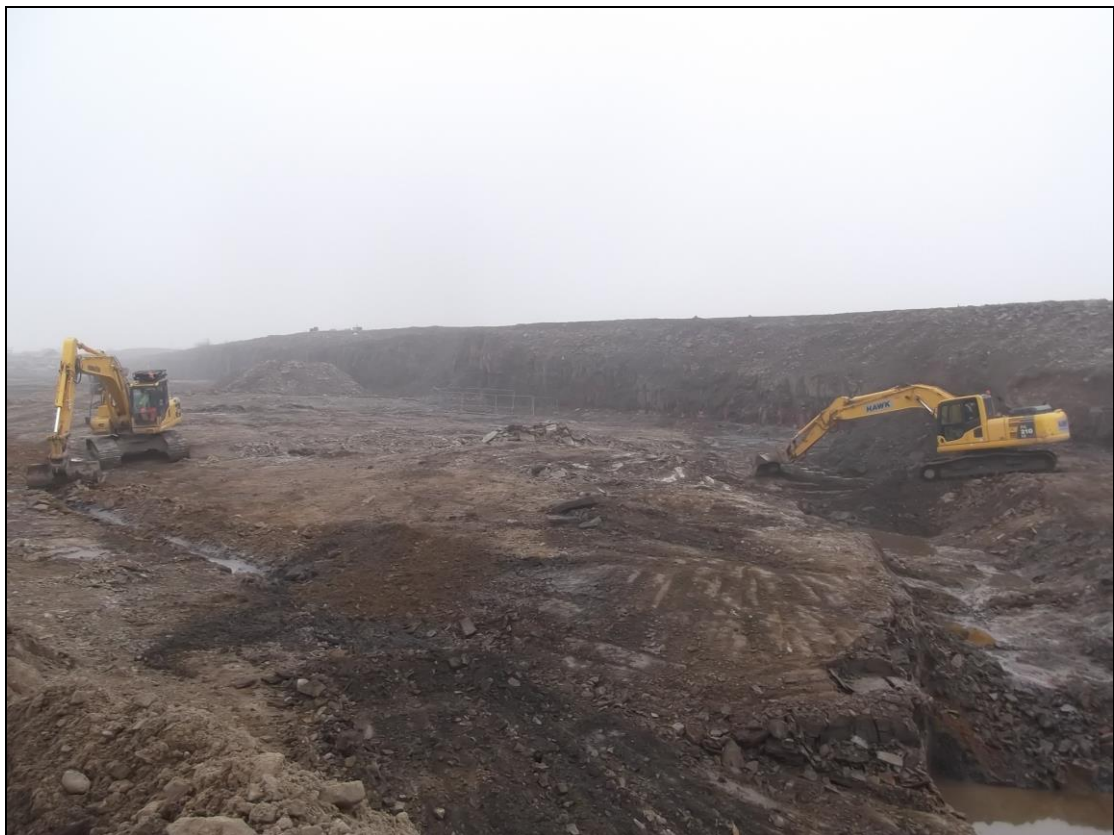
Photograph 3 and 4: Base of Excavation and benching of sandstone bedrock

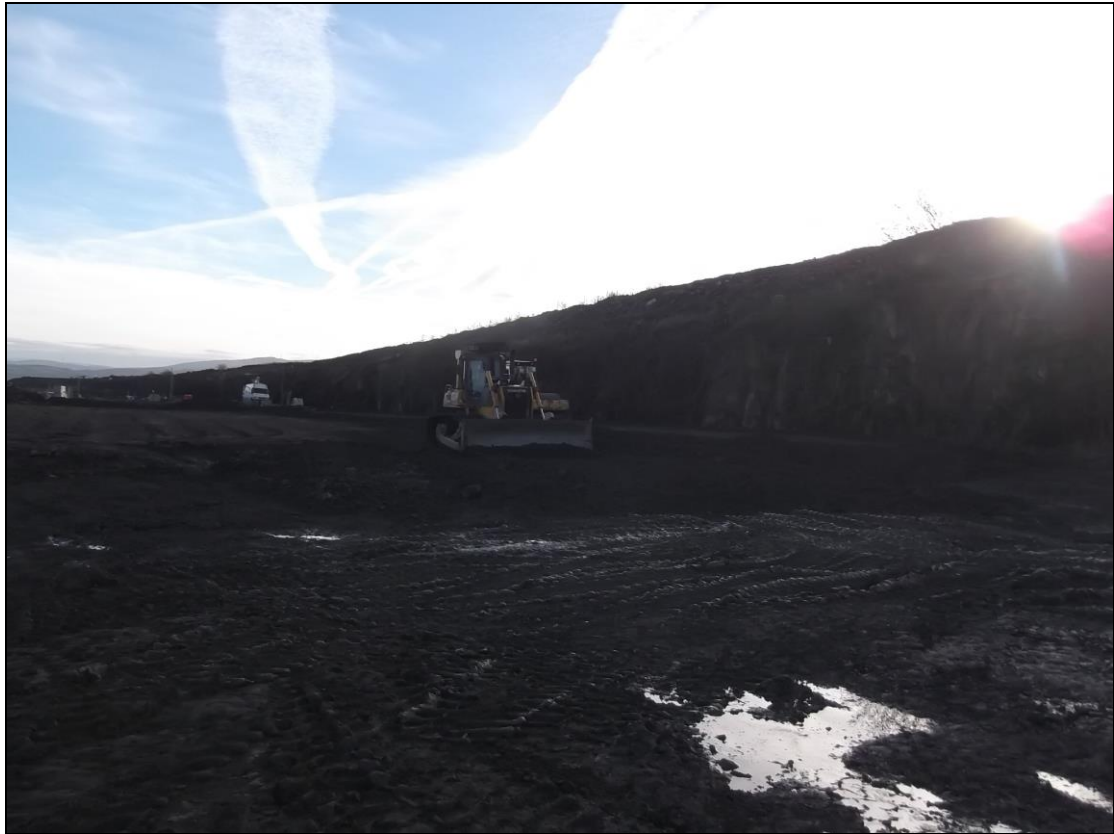
Photograph 5: Backfill of deep fill within excavations

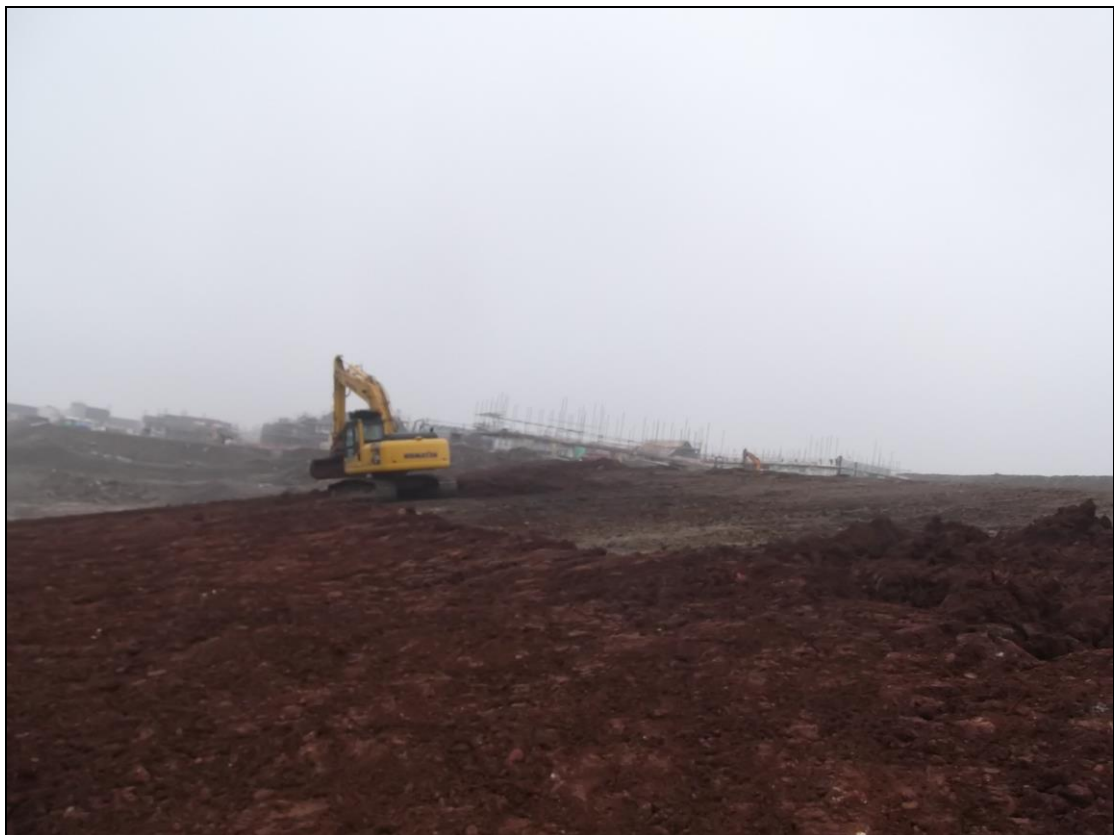
Photograph 6: Placement of shallow imported soils across Monitor Phase 31.
