# Appendix F. RBSL Failure Excavations

MONITOR BOUNDARY PHASE 32

Validation Report  
Monitor Phase 33

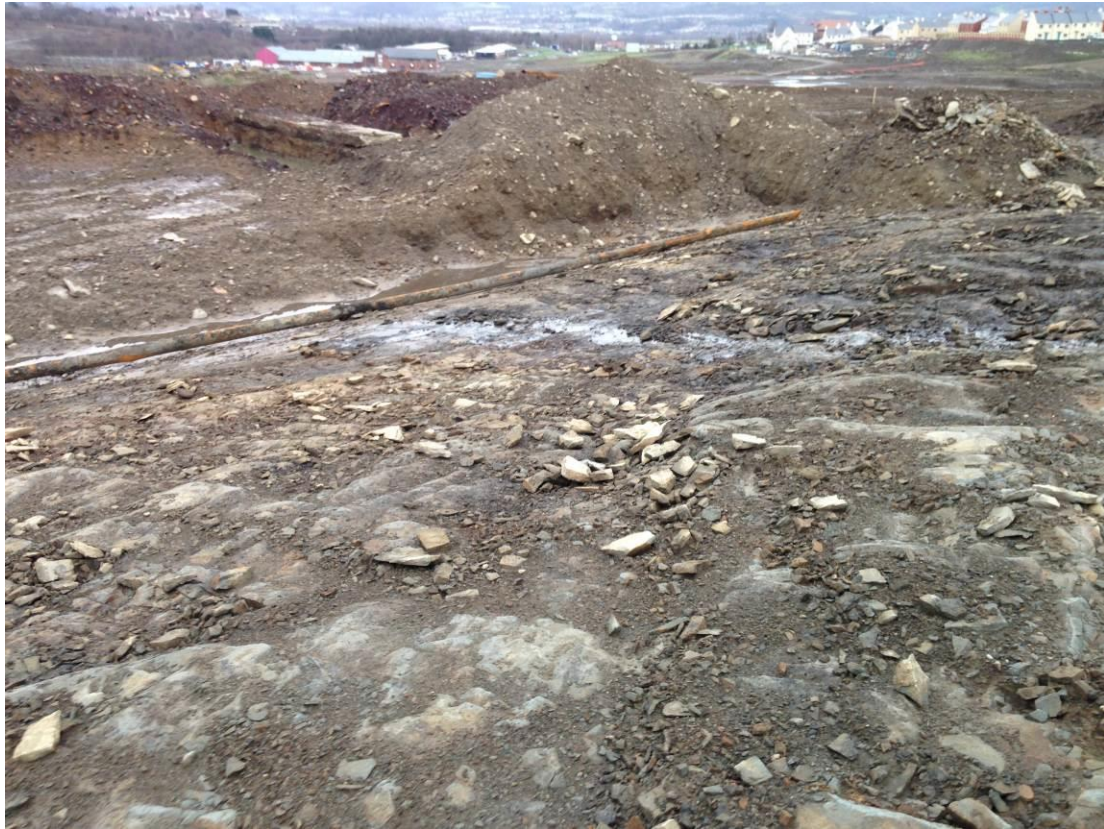
Photograph 15 – showing a north south running pipe located within a manmade recessed channel within bedrock.

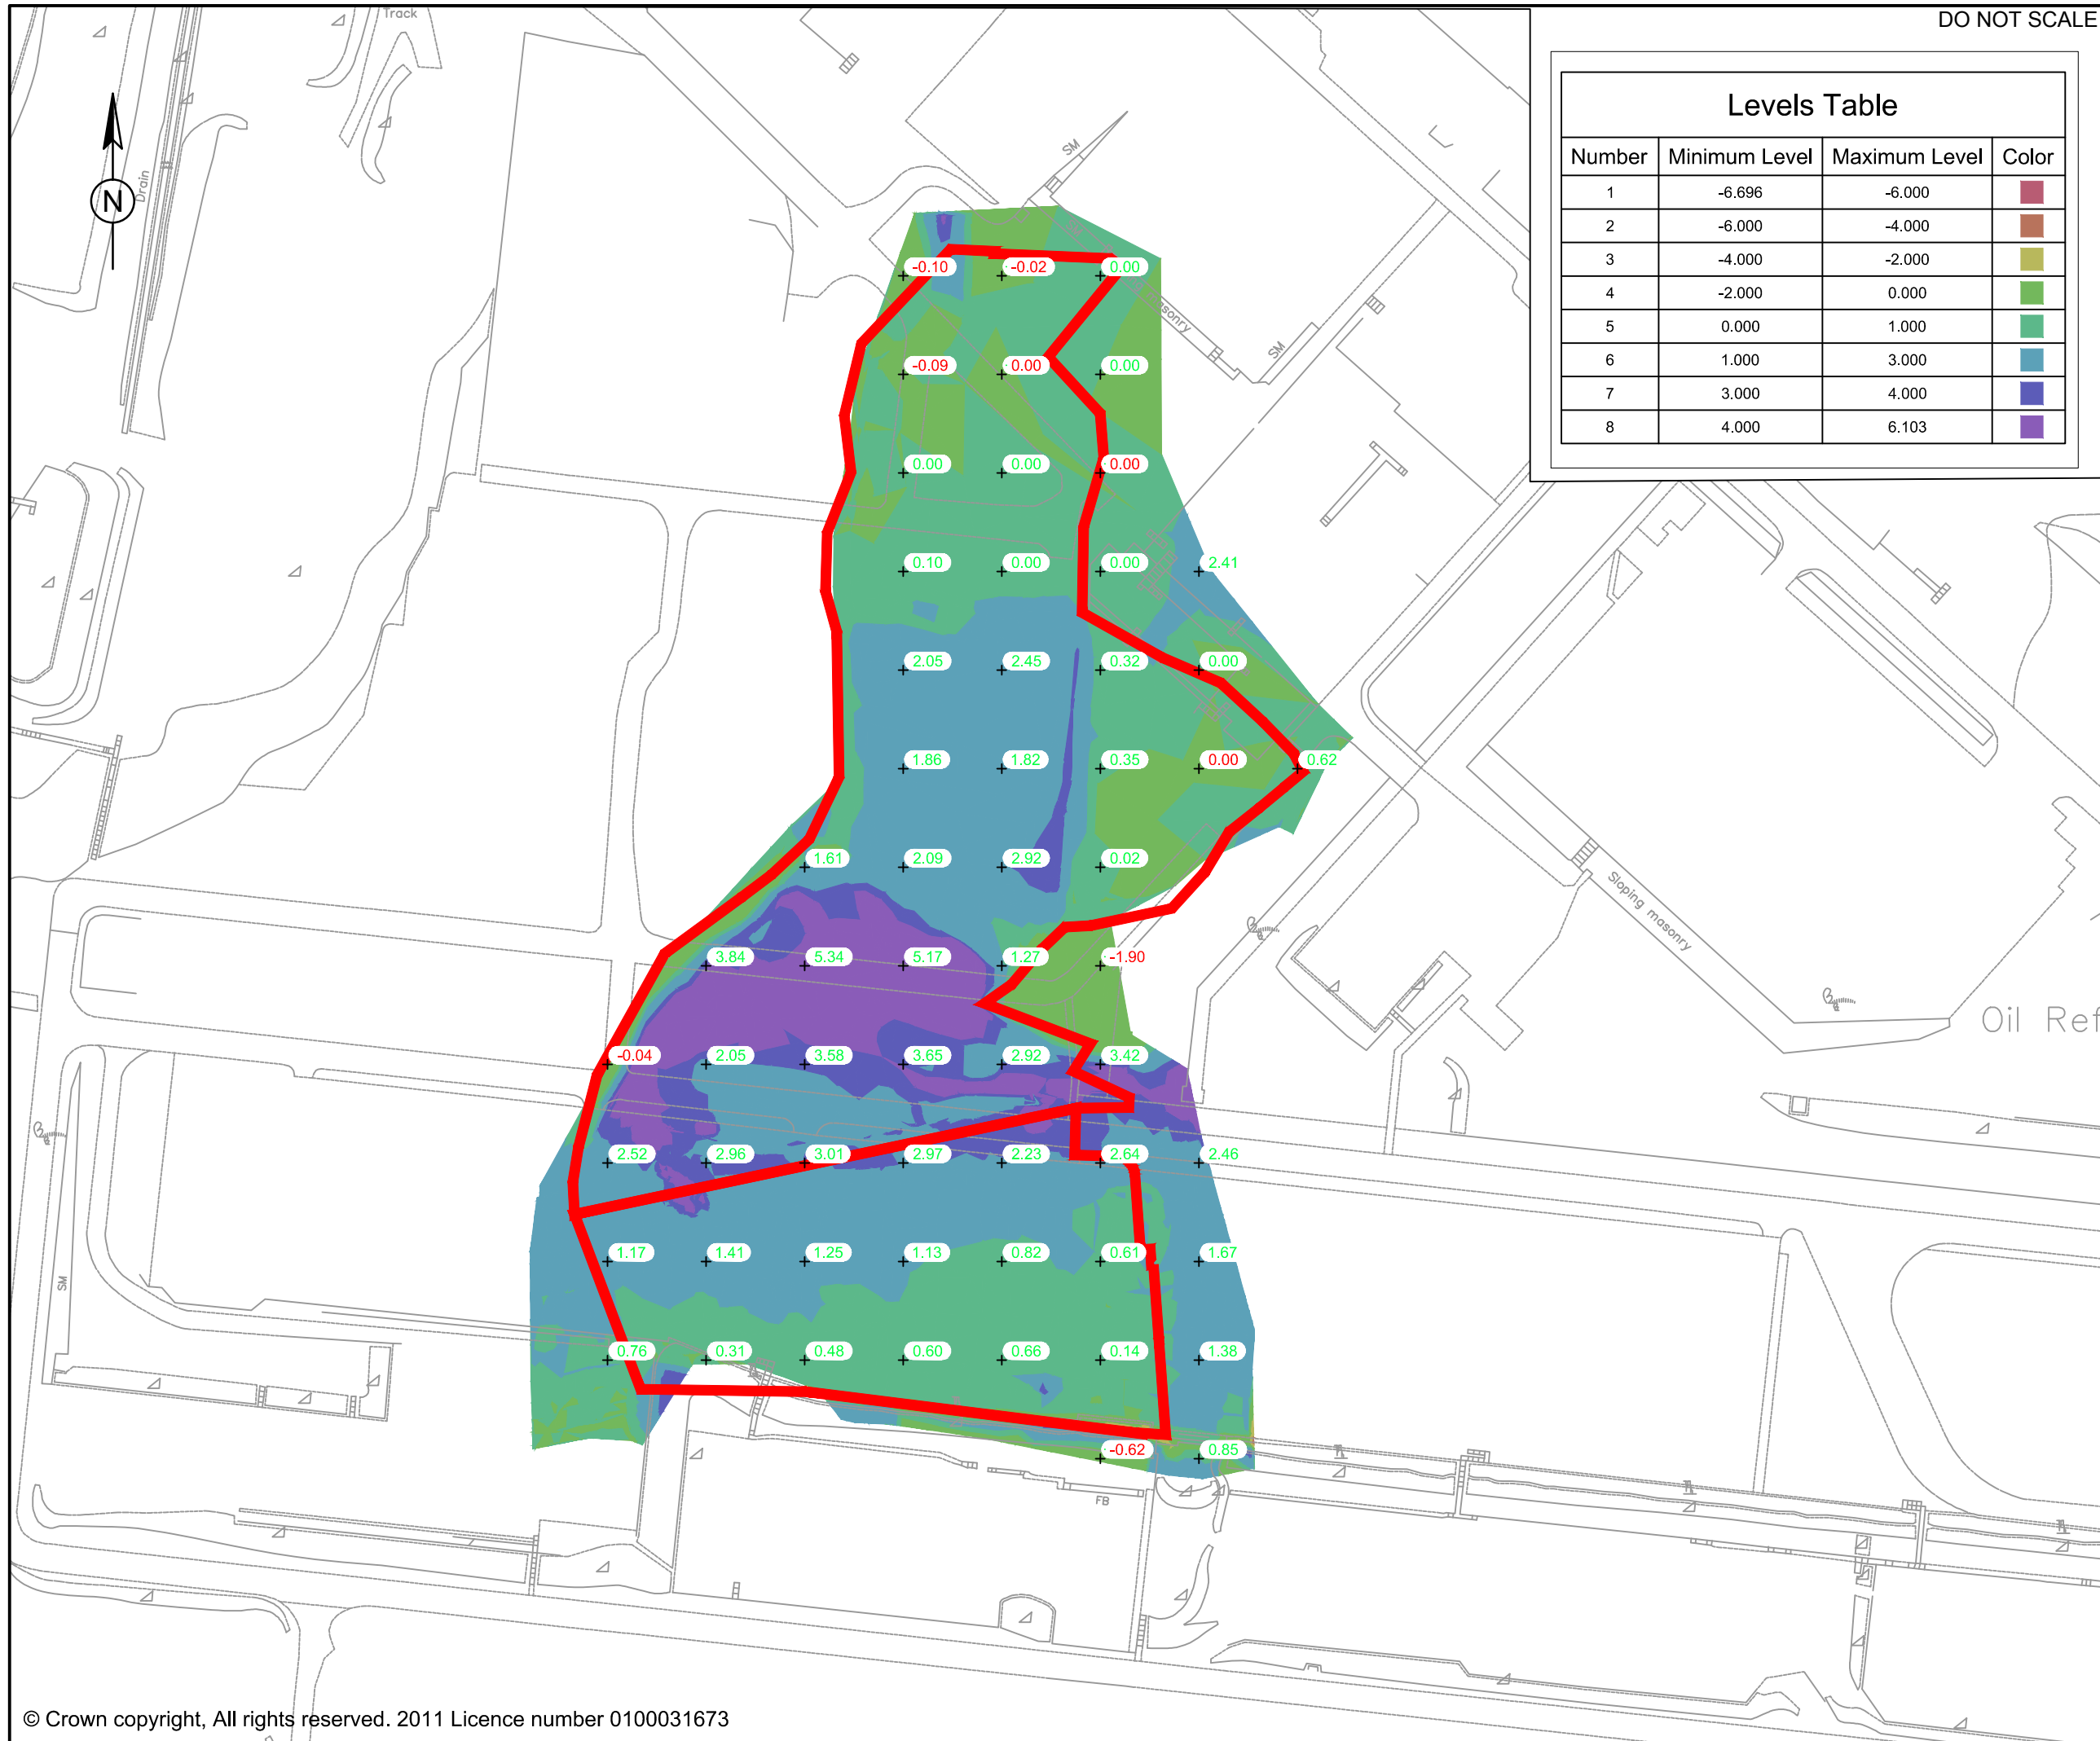
- THIS ISOPACHYTE COMPARES MP32 POST-WORKS SURVEY & MP32 EXCAVATIONS SURVEY PROVIDED BY HAWK OCTOBER 2015.

NORTH - CUT/FILL VOLUME WITHIN BOUNDARY:

CUT: 190m<sup>3</sup>  
FILL: 22,166m<sup>3</sup>  
NET: 21,976m<sup>3</sup>

SOUTH - CUT/FILL VOLUME WITHIN BOUNDARY:

CUT: 114m<sup>3</sup>  
FILL: 6,695m<sup>3</sup>  
NET: 6,581m<sup>3</sup>
