## **Appendix B. Atkins Technical note, dated November 2011**

# Technical note

A new road alignment is required to improve access into the northern part of the proposed Coed Darcy Urban Village development. As part of the design process Atkins Ltd has prepared a Preliminary Sources Study Report (PSSR) in October 2008. The report provided a summary of the available geotechnical information at the time and identified ground hazards that may impact on the scheme. Further to completion of the Preliminary Sources Study Report and subsequent design development of the proposed junction improvements and site access road at Coed Darcy, an additional ground investigation has been carried out to address the identified ground hazards and provide further information on the ground conditions underlying the site for the detailed design of the scheme.

This technical note has been prepared for issue to Dawnus Construction Limited (the Client) and summarises the findings of the ground investigation, identifies the ground conditions and material parameters, and provides an engineering assessment of the ground conditions encountered in relation to the proposed works and options to manage the geotec

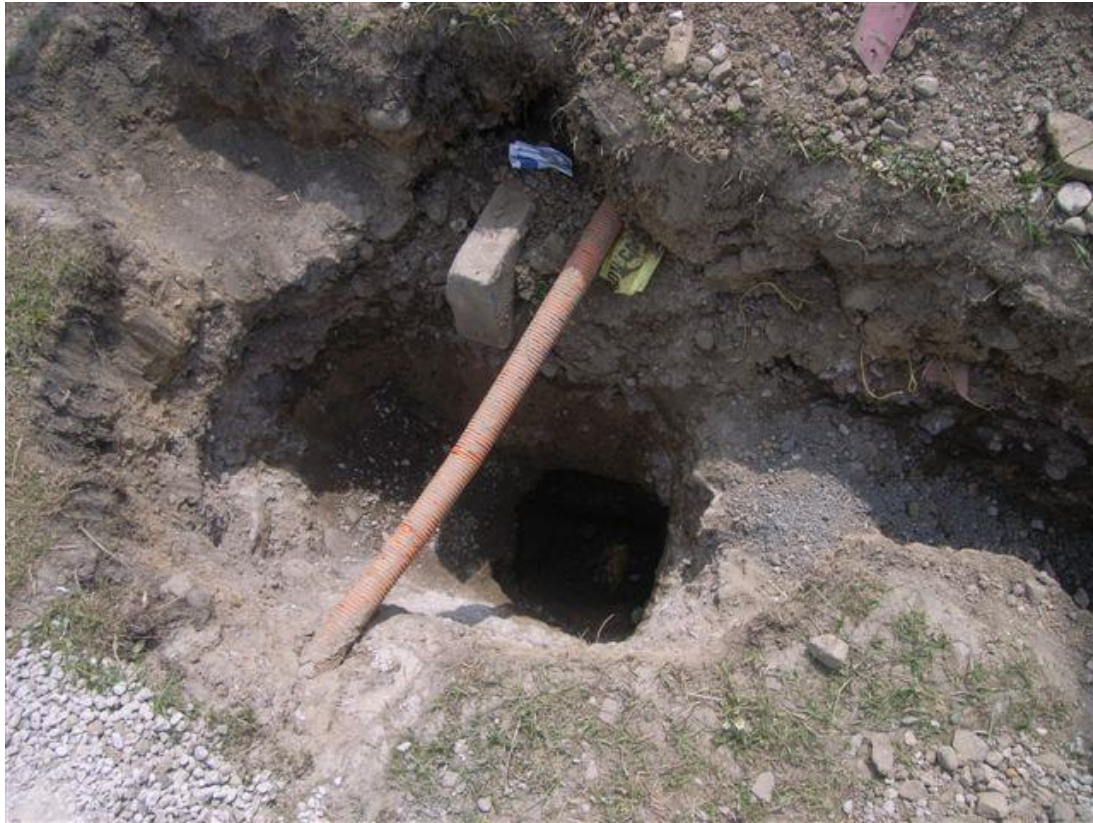
Photograph 1 : Street lighting with gas main underneath

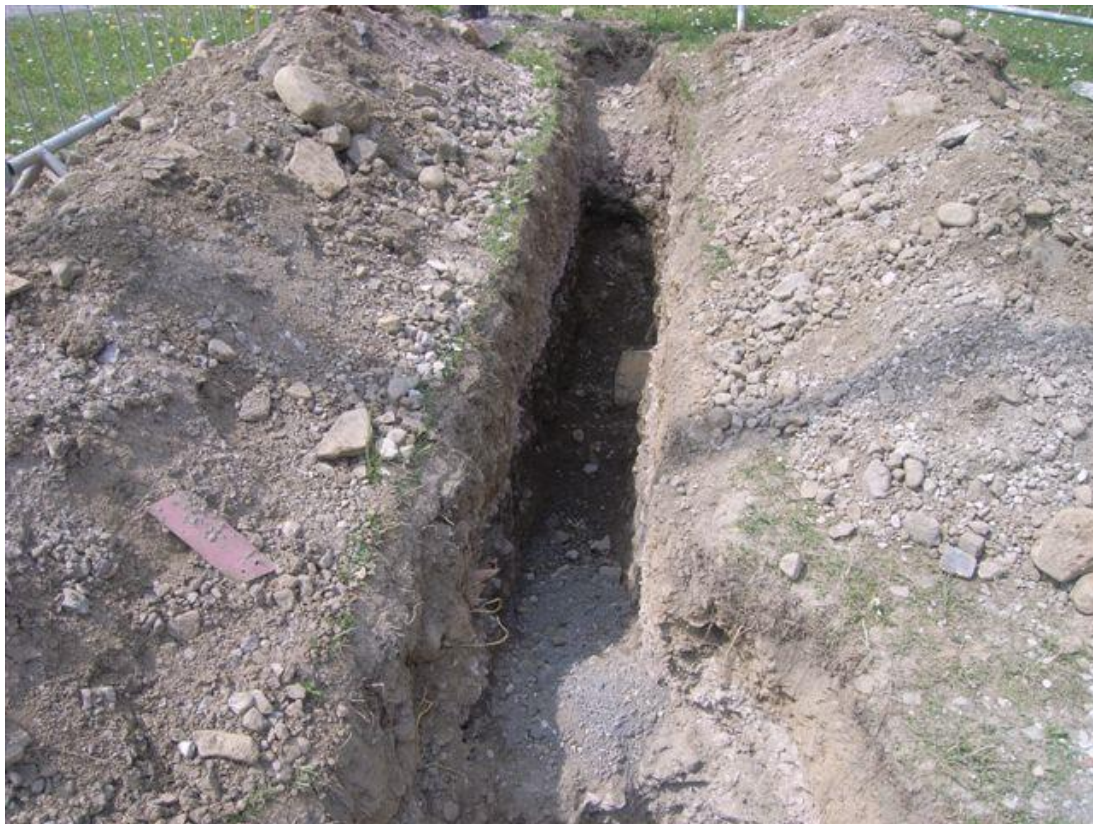
Photograph 2: Stable trench

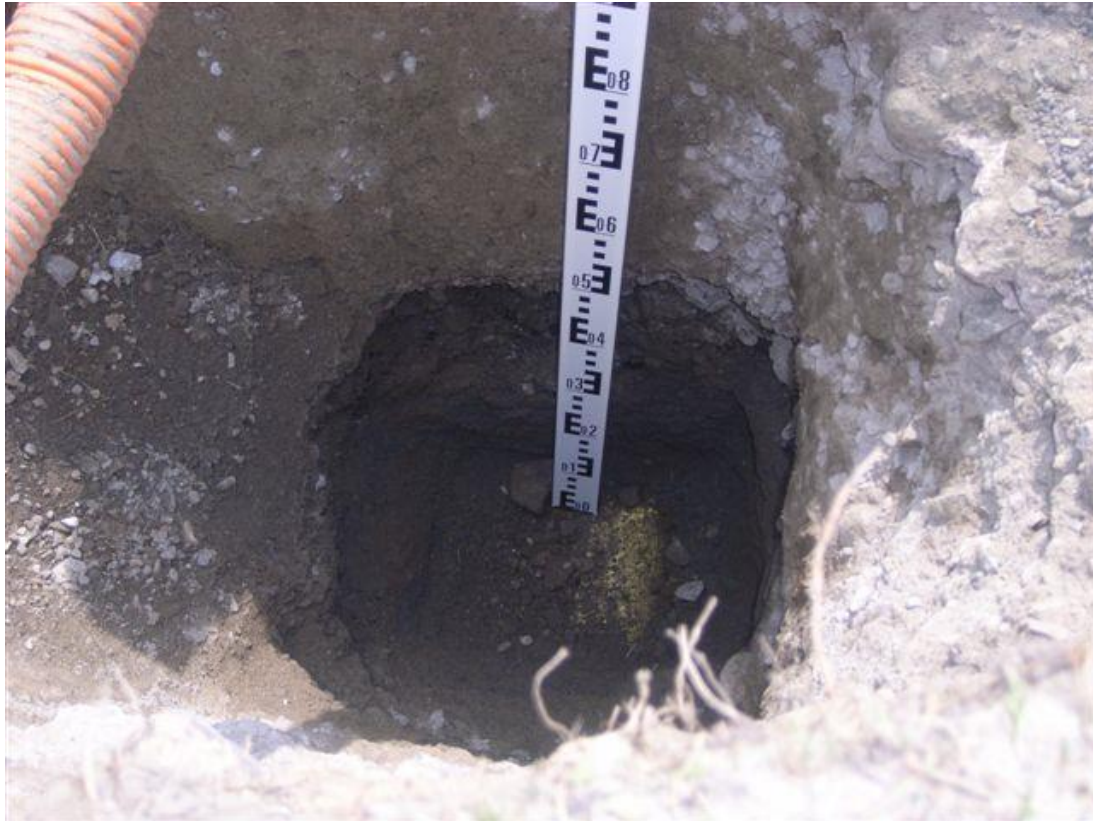
Photograph 3: Gas Main

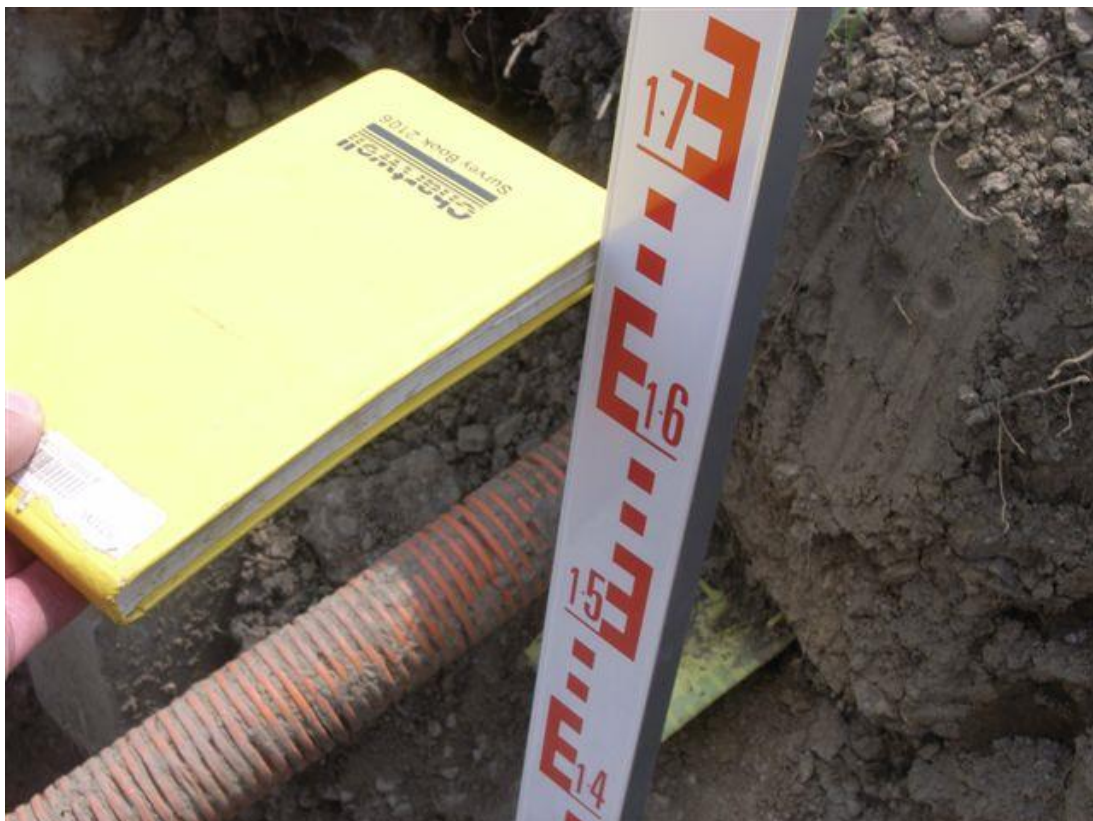
Photograph 4: Depth to recorded gas main

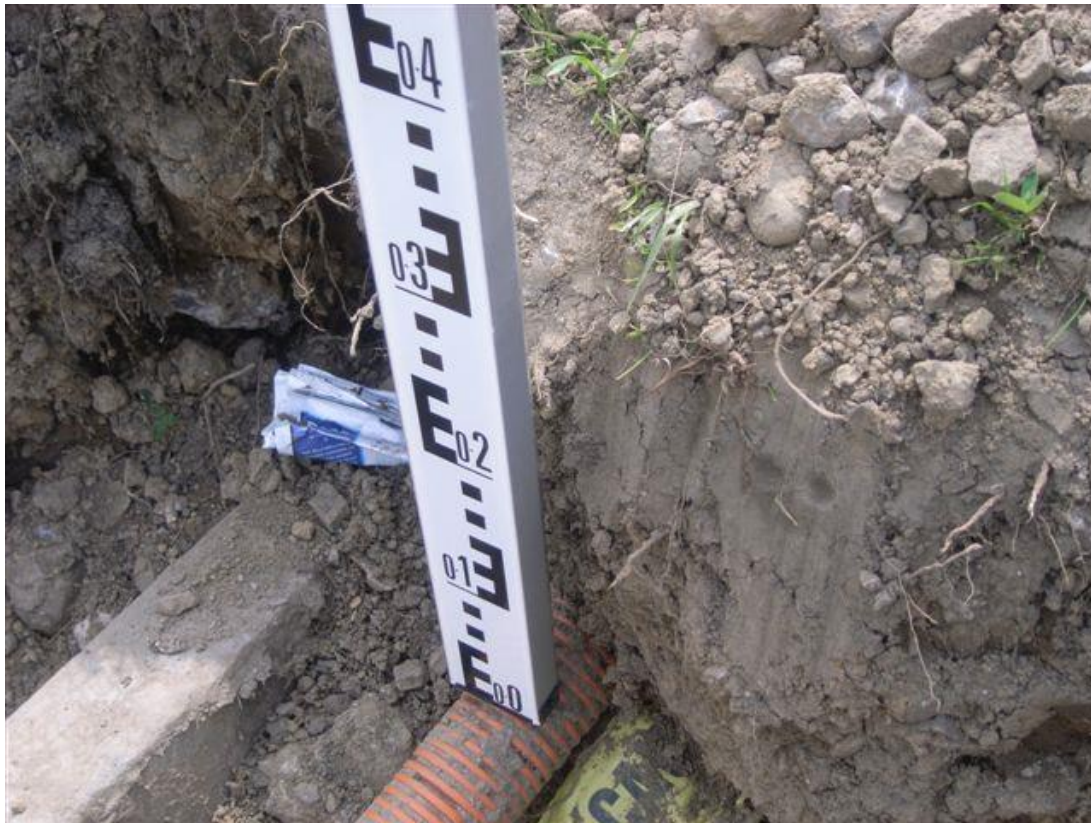
Photograph 5: Depth to street lighting

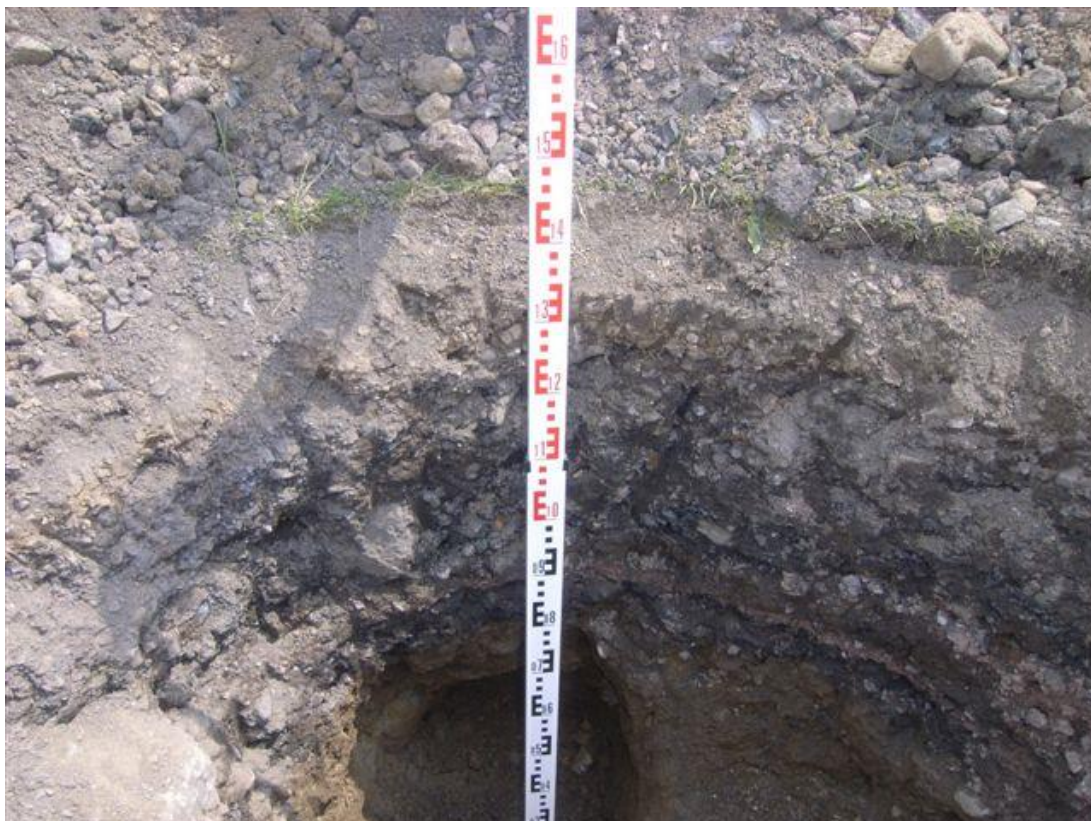
Photograph 6: Cast iron main

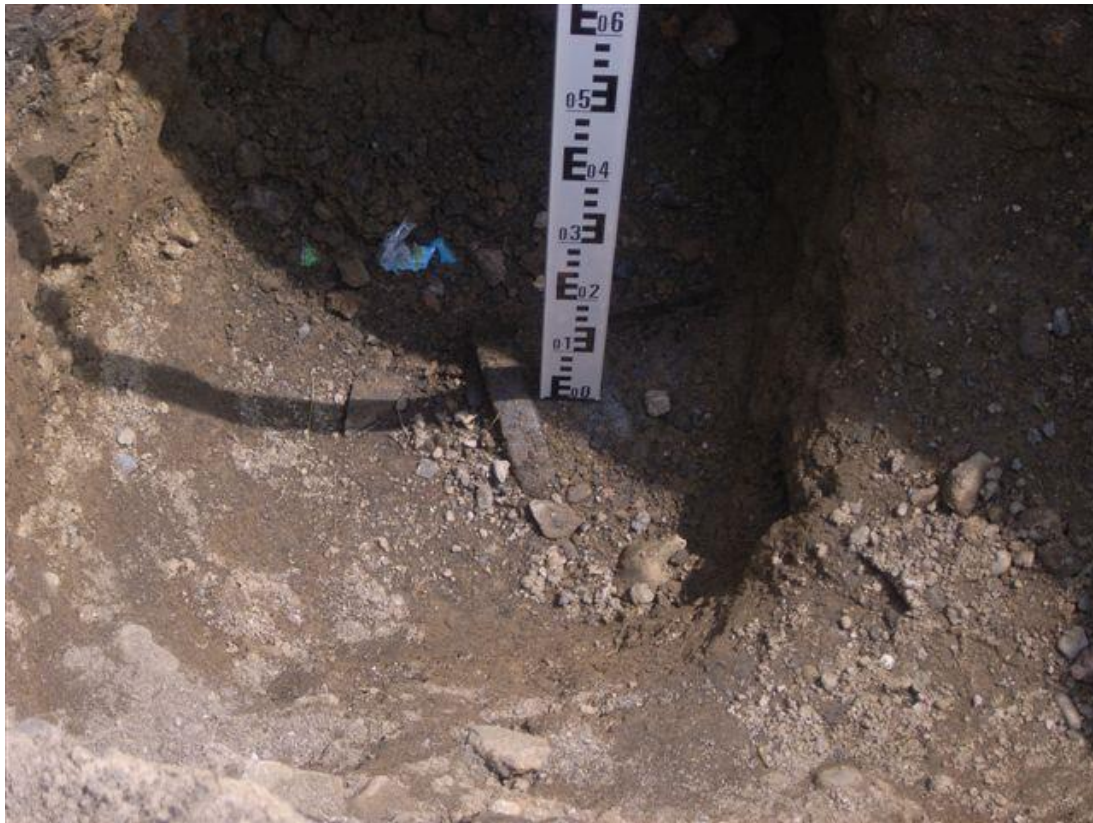
Photograph 7: Base of open trench

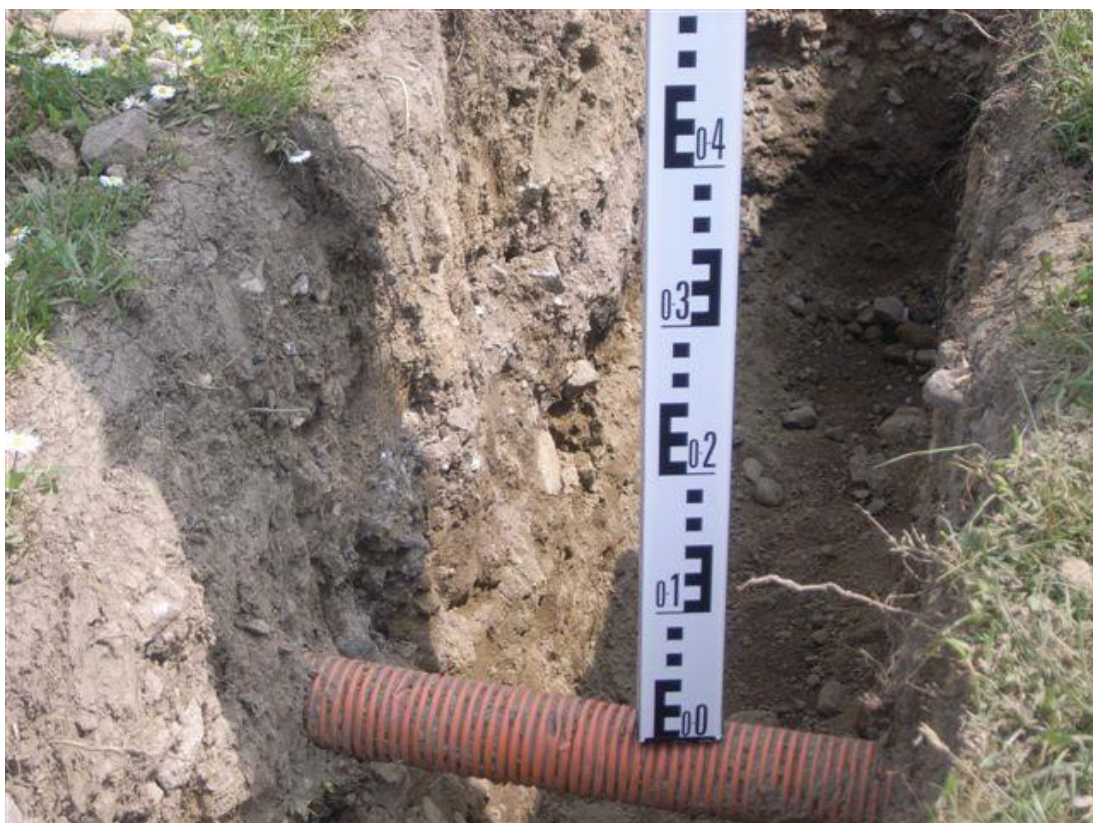
Photograph 8: Depth of identified street lighting

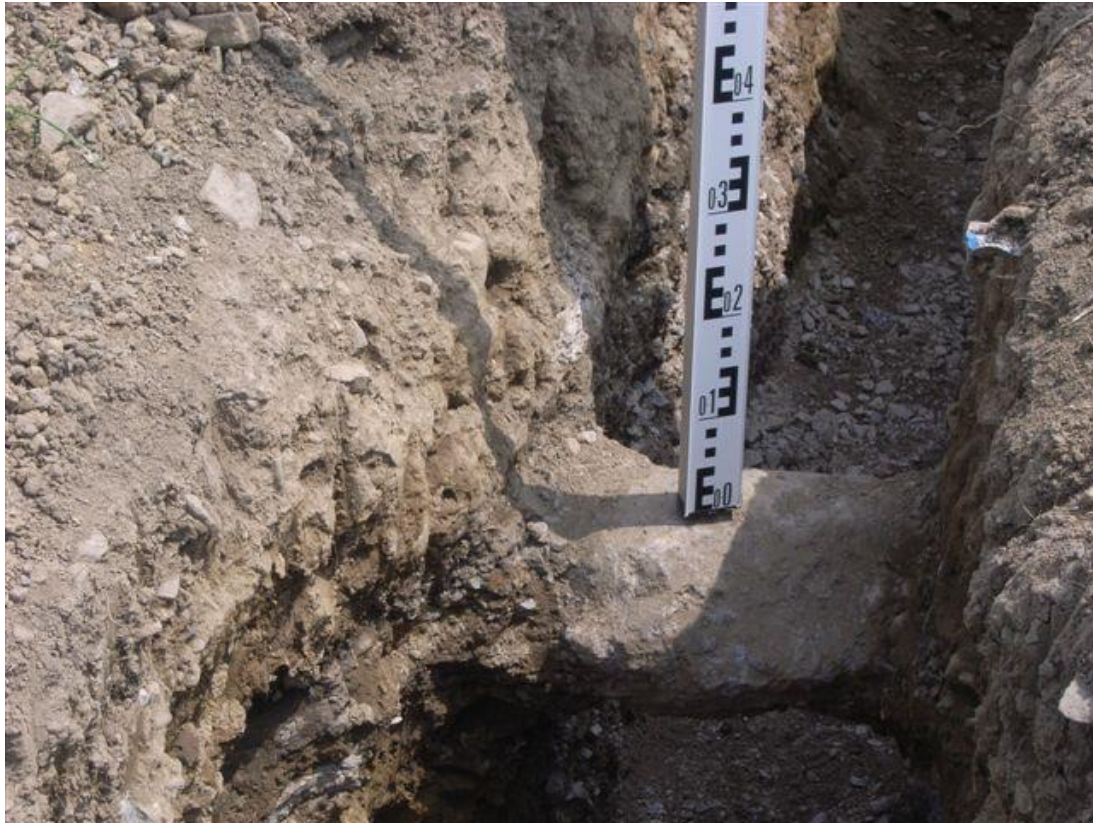
Photograph 9: Depth to main

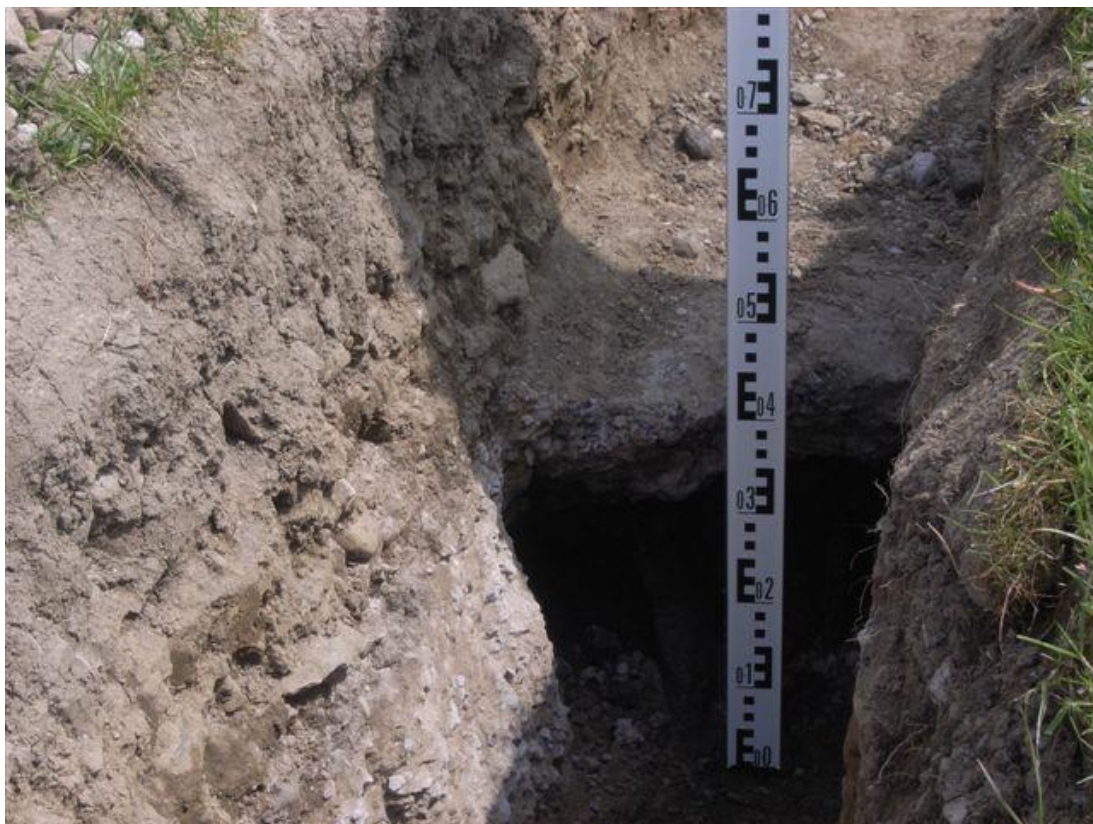
Photograph 10: Depth to base of excavations near to main

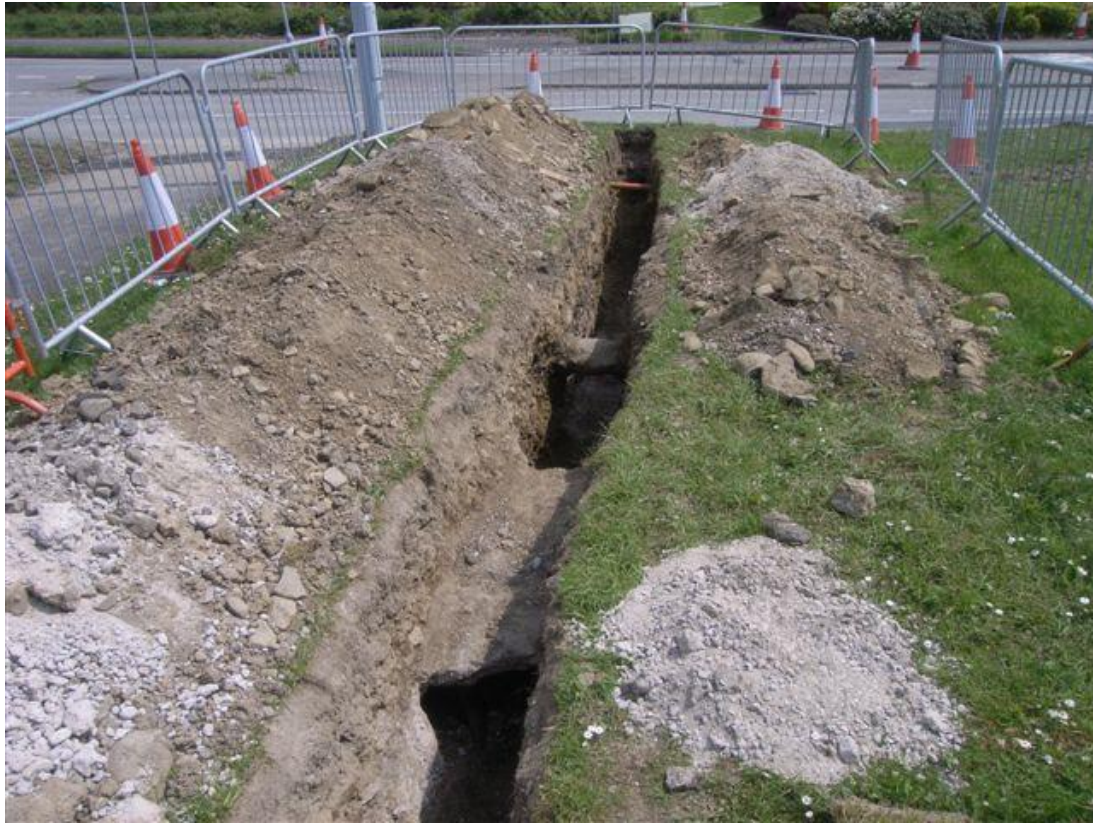
Photograph 11: Exposed services

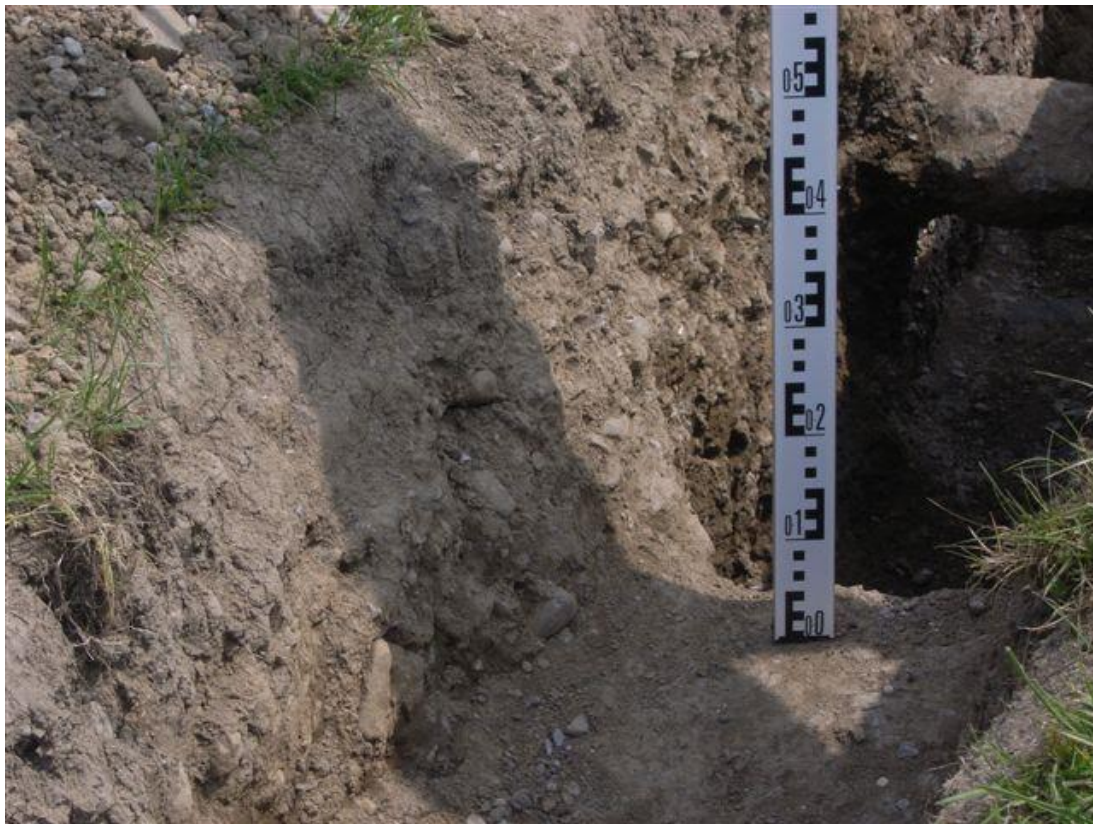
Photograph 12: Depth to concrete obstruction

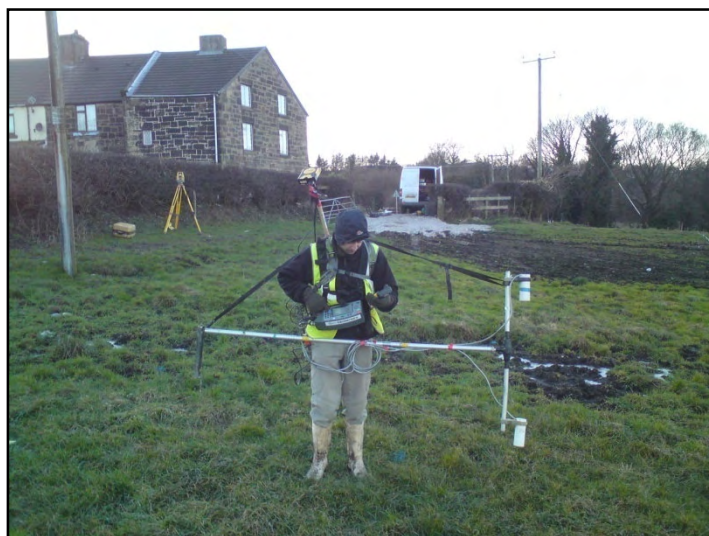
The magnetic survey technique is based on mapping localised variations in the Earth's magnetic field caused sub-surface magnetic materials, which range from naturally occurring

magnetic minerals to man-made ferrous objects. Data are acquired on a grid covering the area of interest and a contoured plan of the variation in ferrous material across the site is produced.

**Plate 1** – G858 Magnetic Gradiometer (library photograph)

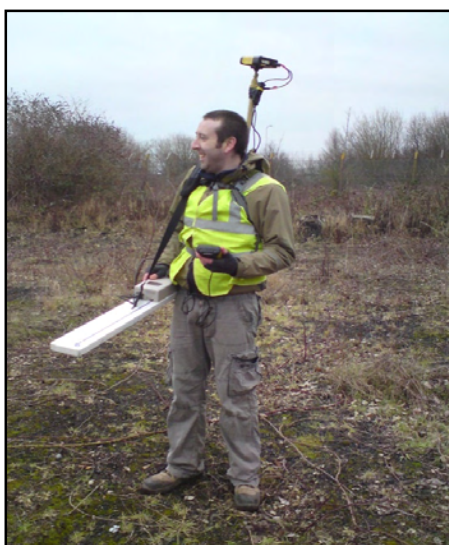
The instrument was configured to transmit five frequencies effectively investigating different depth ranges from approximately 0-7m bgl. The actual depth of investigation is a function of the selected frequency and resistivity of the underlying geology. Deeper frequencies tend to suffer from a high signal-to-noise ratio making the results uninterruptible. In practical terms a particular frequency is used for interpretation that most clearly shows subsurface responses.

**Plate 2** - Geophex GEM-2 with Trimble DGPS positioning (library picture)

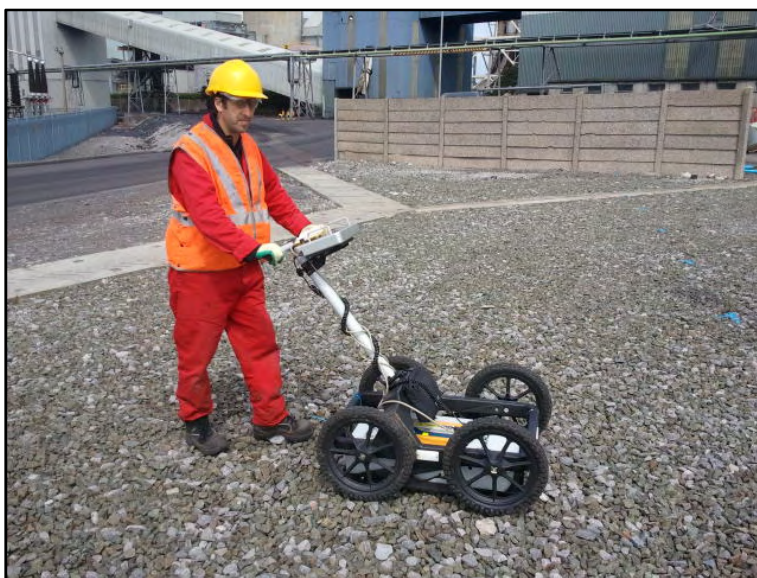
The data processing was carried out using GPR Slice v7 software. Each radargram is first processed with an appropriate gain function to enhance features of interest and increase the signal from weak responses at depth. The radargram is then 'time zero' corrected to allow a depth conversion to be calculated using a nominal velocity of 0.1m/nanosecond that is usually suitable for made ground conditions. Additional processing routines (e.g. background removal, deconvolution, FK filtering, migration etc) may be applied to improve the coherency of the reflection events and remove any multiple reflections and diffractions. The radargrams are then resampled to provide same size data blocks that can be gridded using a squared amplitude function to produce a 3D block of radar signal response. This block is then time sliced to produce interpretable depth slices between 15 and 20cm thick. All the depth slices are analysed and then specific slices showing significant features and anomalies are used for the interpretation plots. The final depth slice plots are exported to CorelDraw for annotation and presentation.

**Plate 3** – MALA RAMAC 250MHz GPR cart system (library photograph)

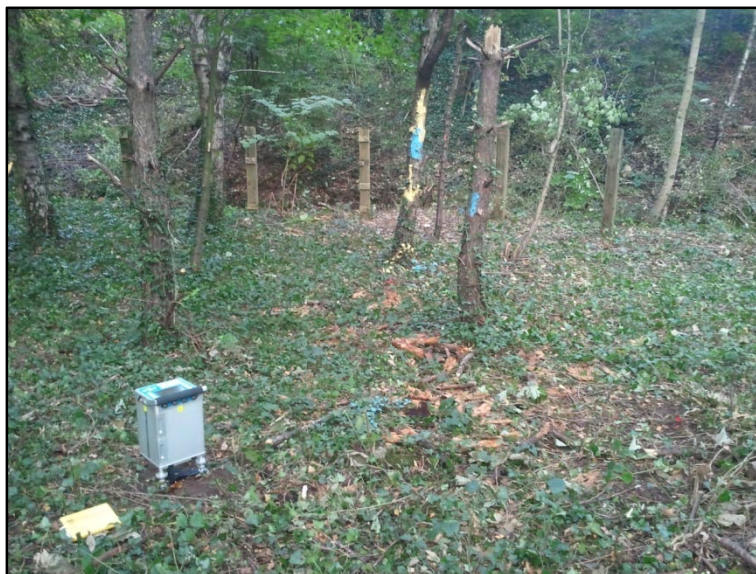
**Detrending:** A linear detrend was applied to the Bouguer anomaly results to remove long wavelength terrain and deep geological effects that mask subtle features. The detrended data highlights local density variations.

**Plate 4** – Scintrex CG-5 gravity meter being used in Shaft 2 area
