# Appendix E. Photosheet

Validation Report  
Monitor Phase 70

St Modwen Developments Limited

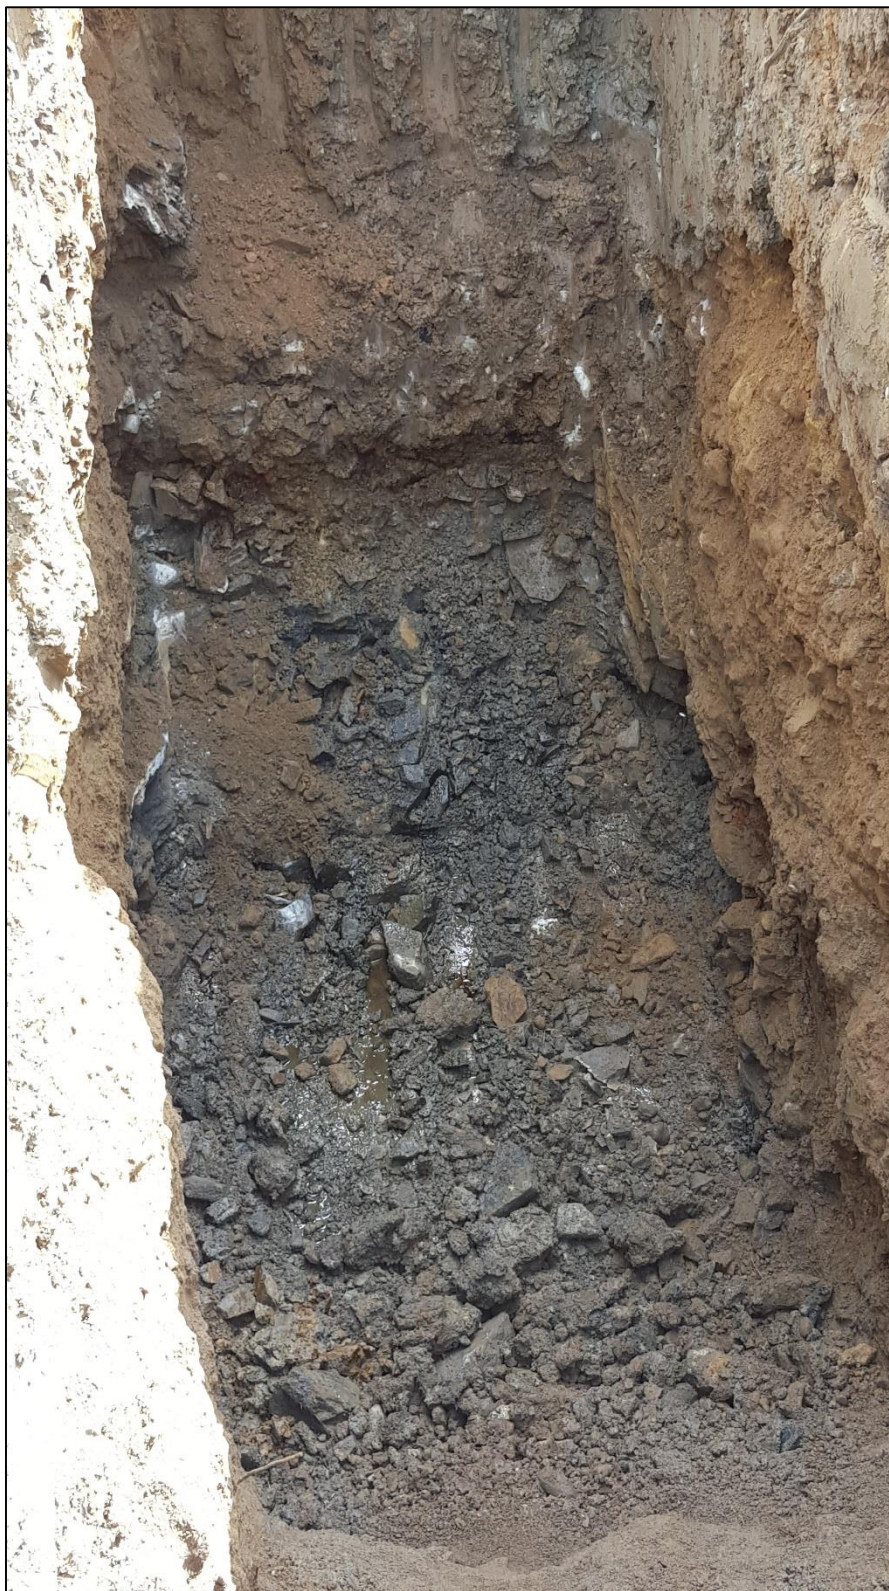
**Photograph 1** TPE2687 – Minor free product at base of trial pit

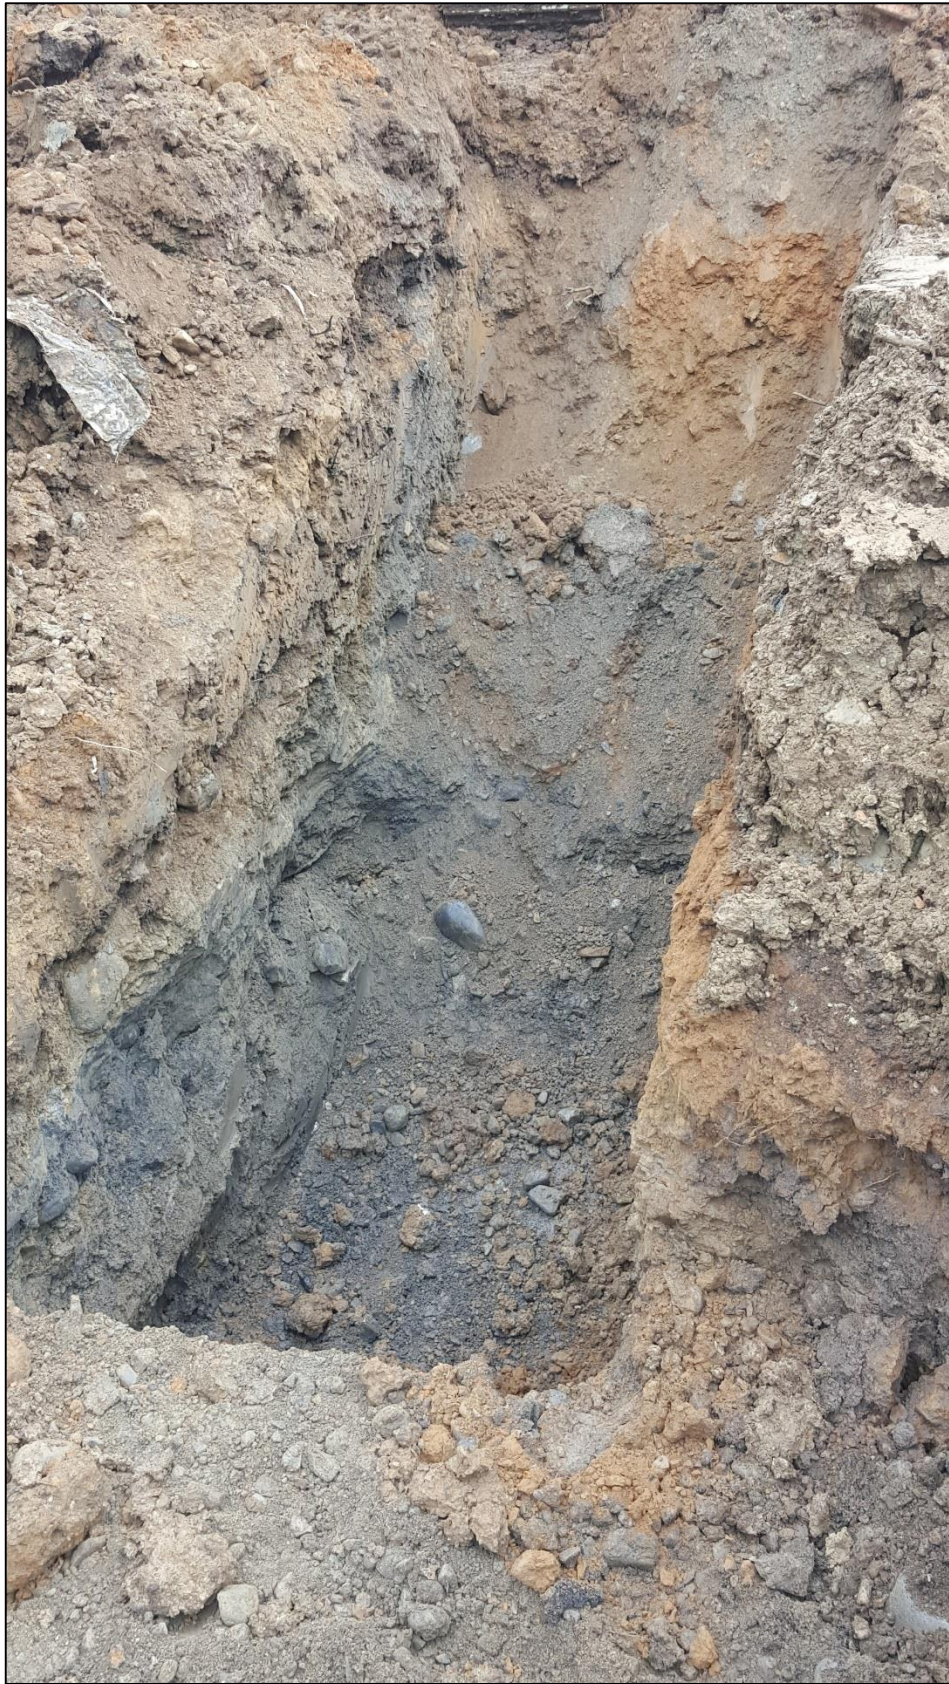
**Photograph 2** TPE2739 – Minor free product at base of trial pit

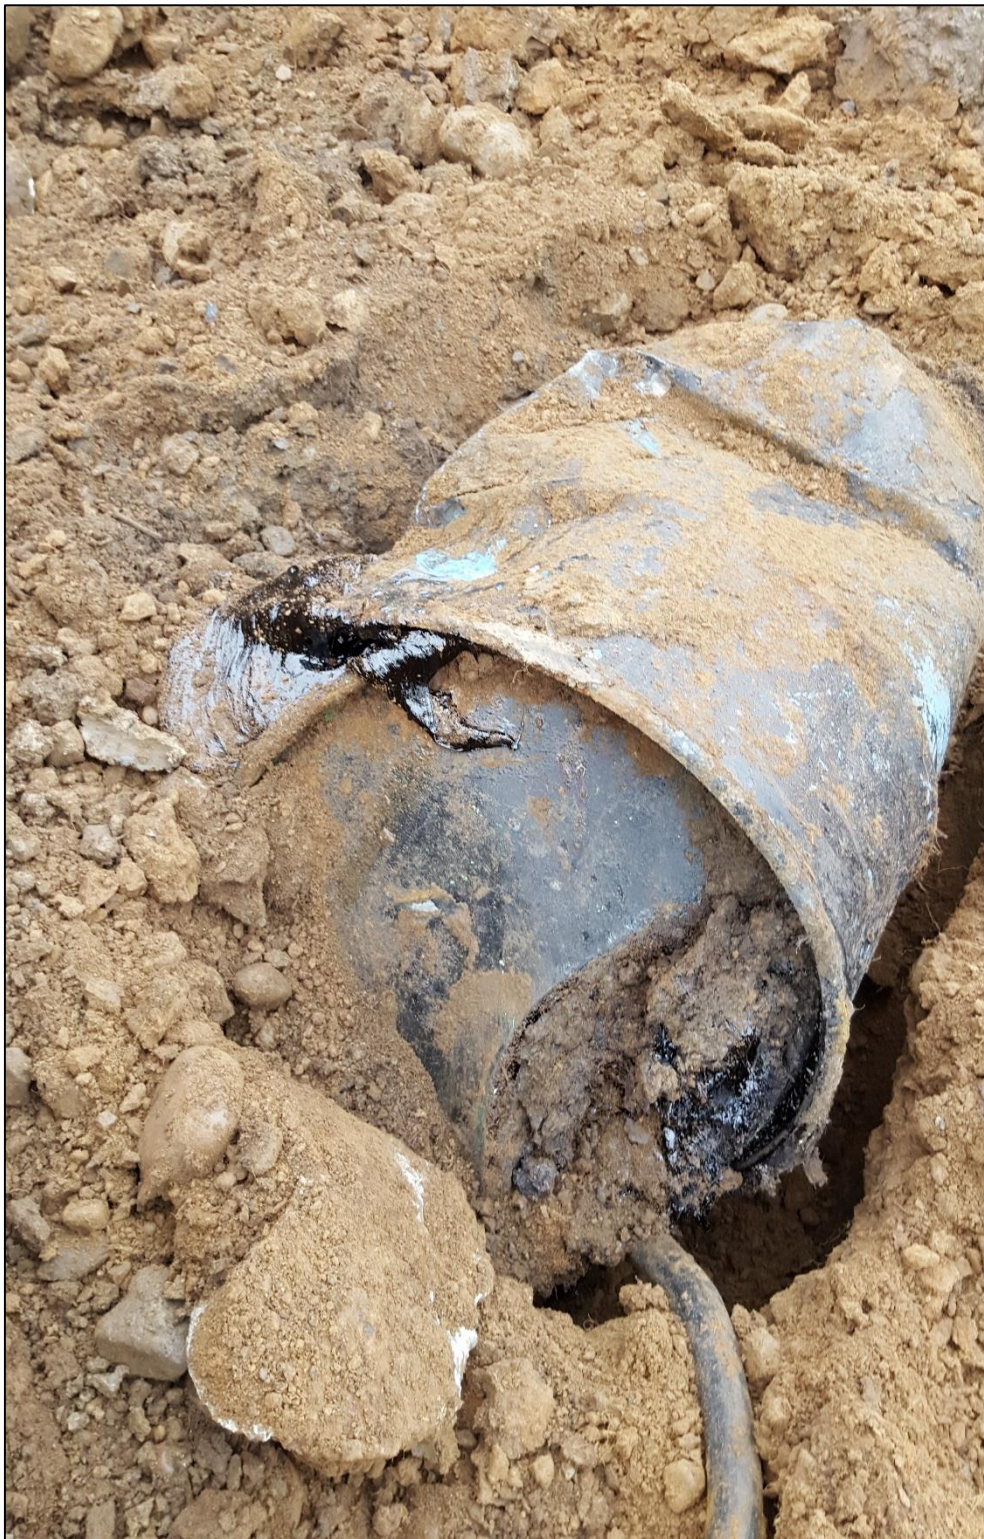
**Photograph 3** TPE2740 – Excavation of largely intact barrel of free product from trial pit.

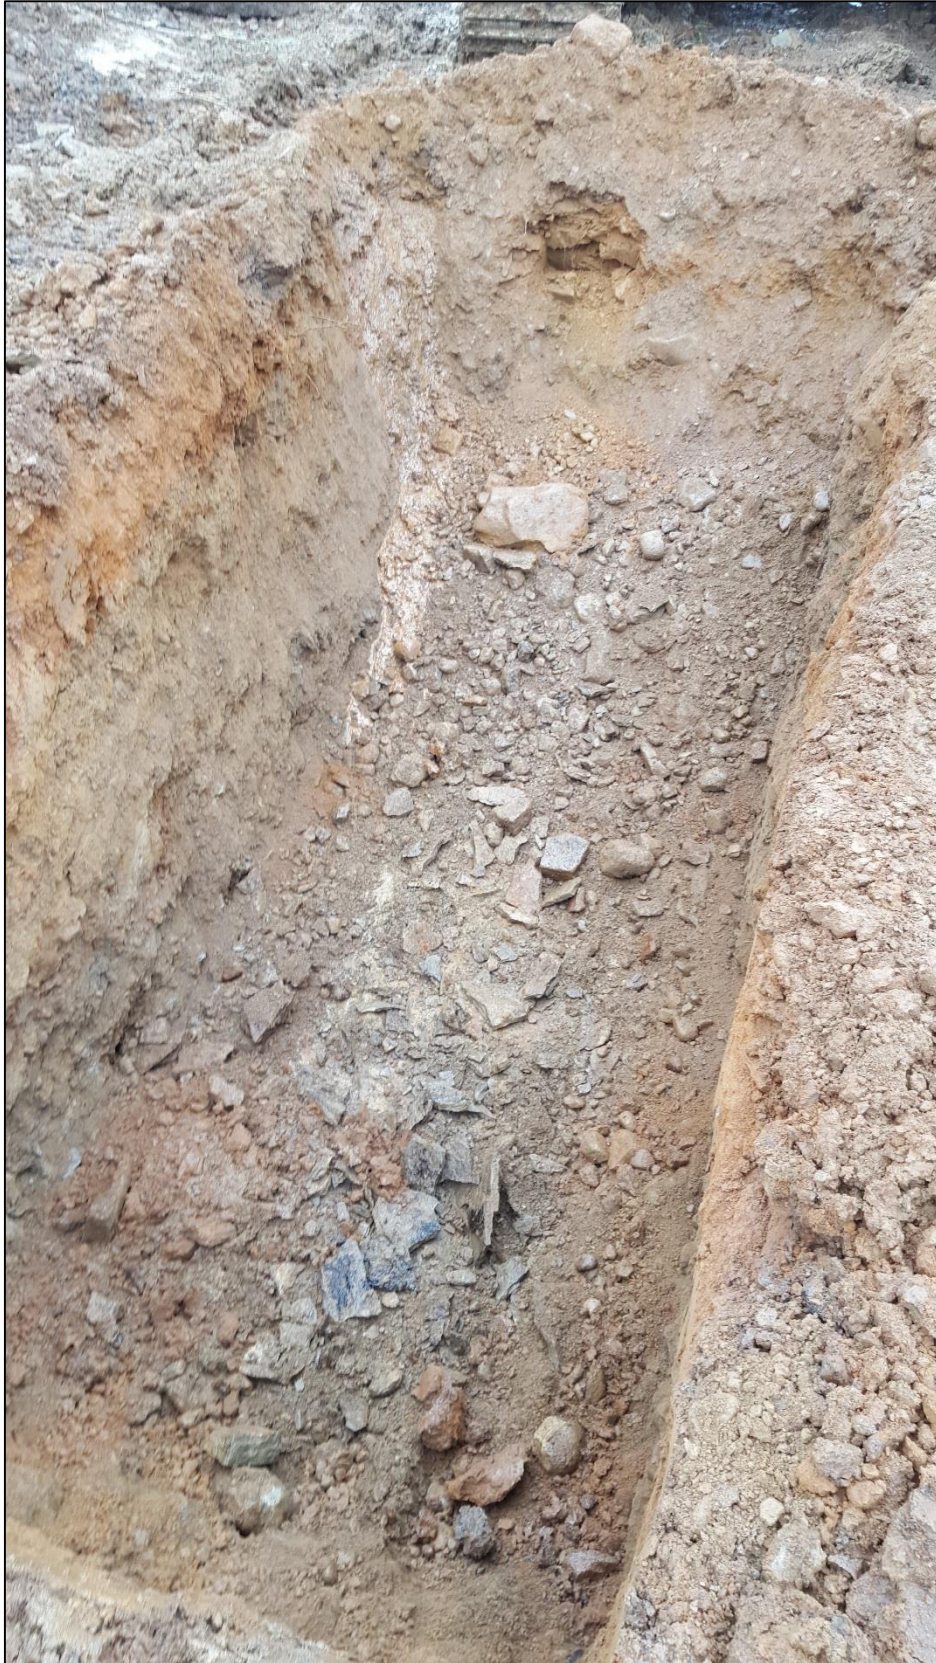
**Photograph 4** TPE2742 – Minor pockets of hydrocarbon staining on weathered bedrock gravel at base of trial pit

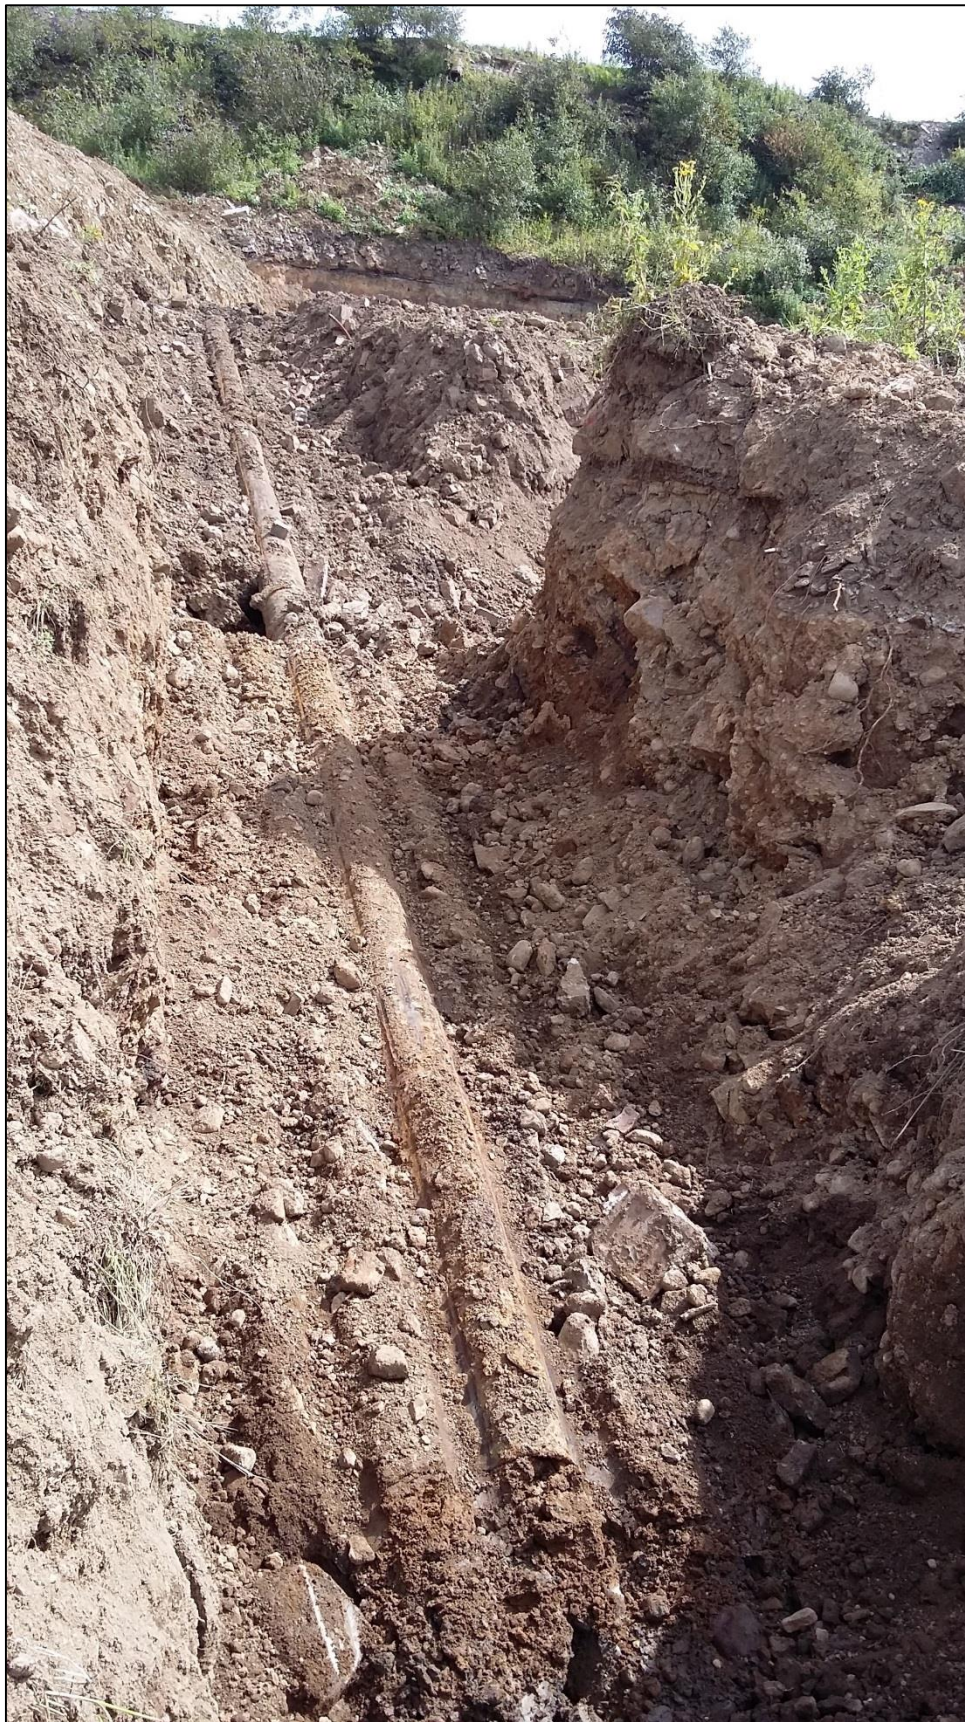
**Photograph 5** TPE2676 – Section of pipework to be removed from excavation

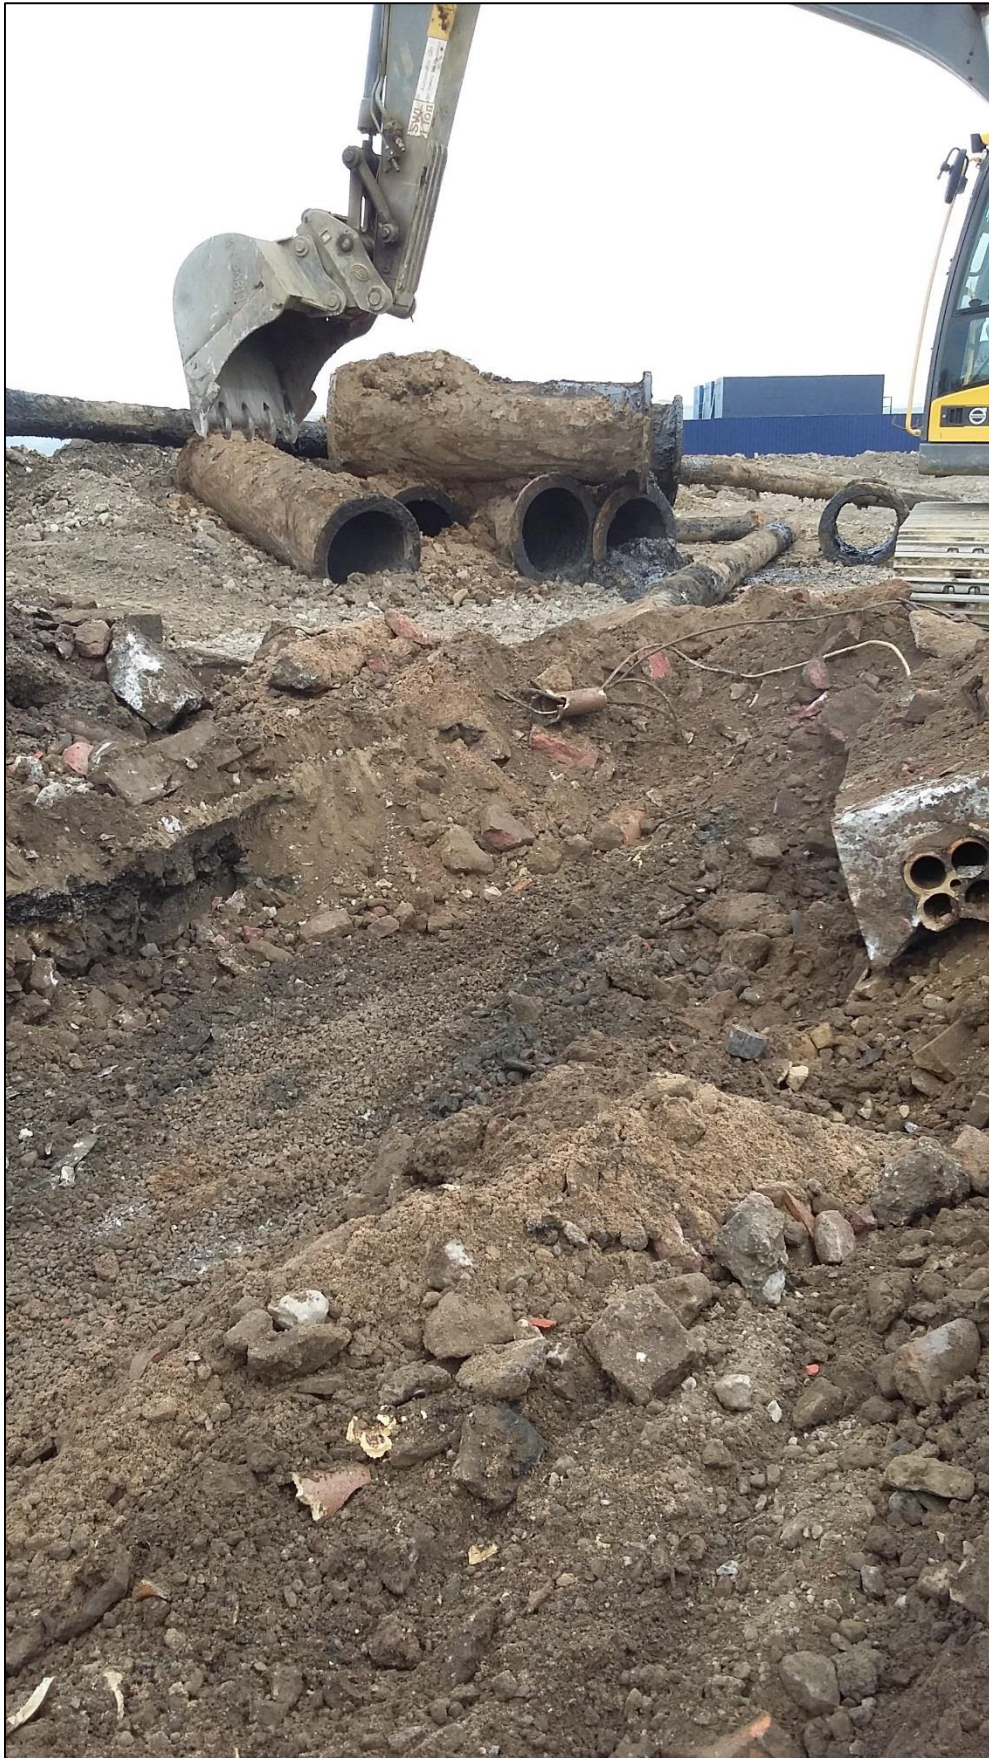
**Photograph 6** TPE2820 – Metal and clay pipework removed from excavation

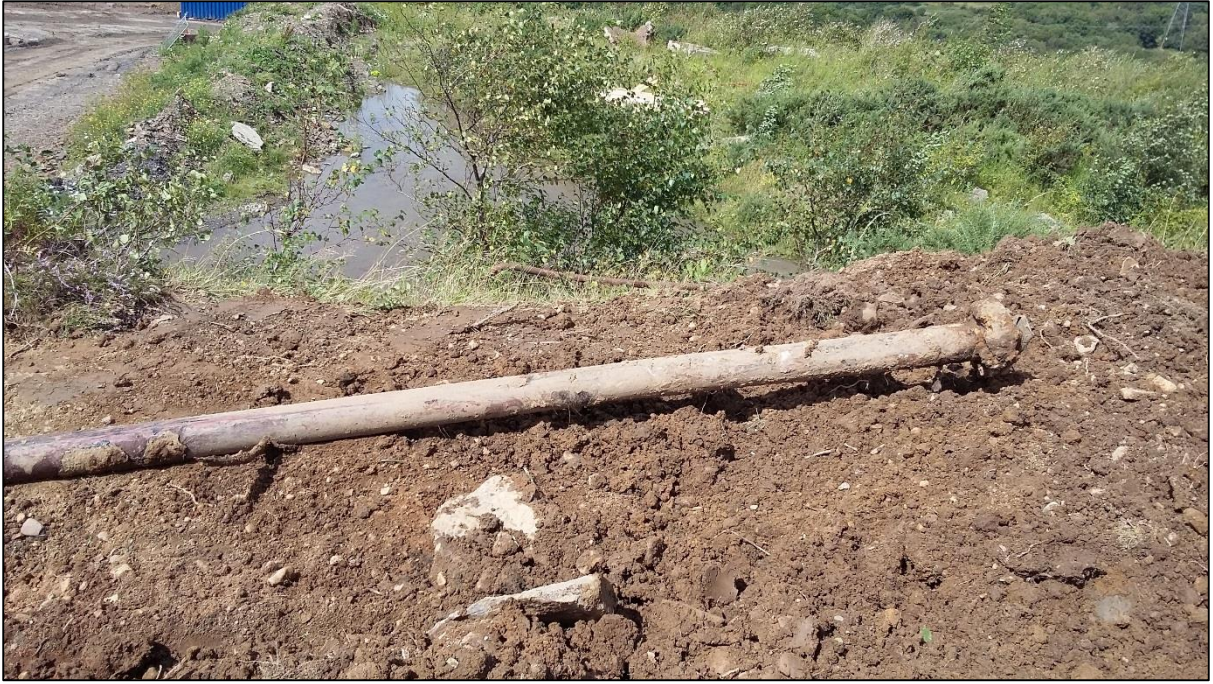
**Photograph 7** TPE2999 – Section of metal pipe removed from excavation
