# Cwmwernderi Valves and Pipework

## Bat Report

January 2022

B14504-123532-12-XX-RP-NB-  
EI0046

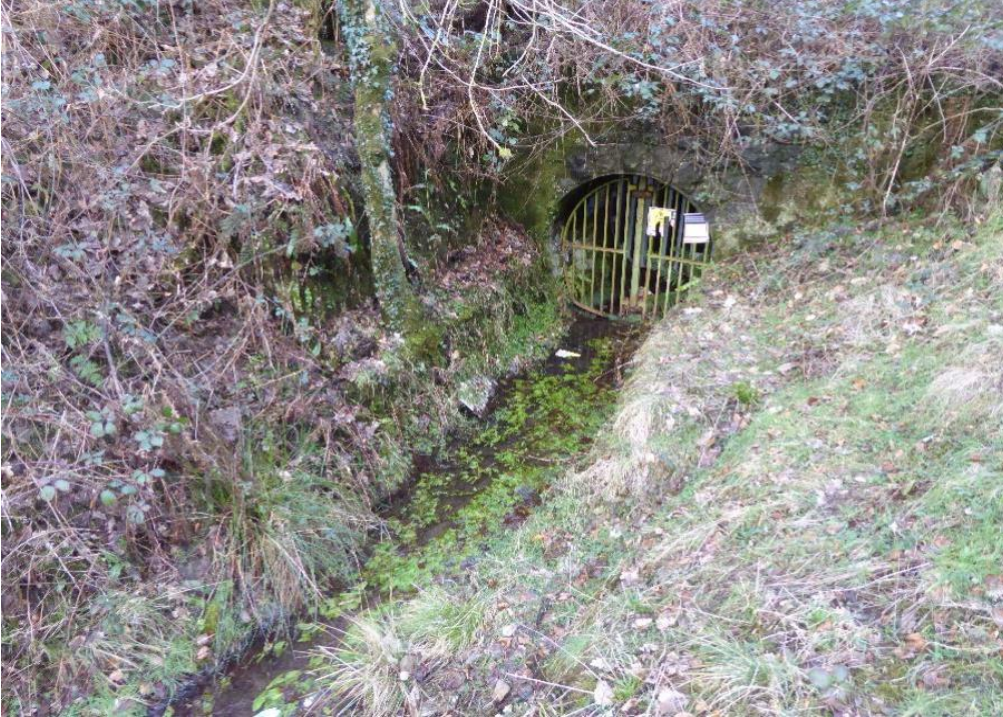
*Photograph 1: Scour tunnel portal and roost entrance*

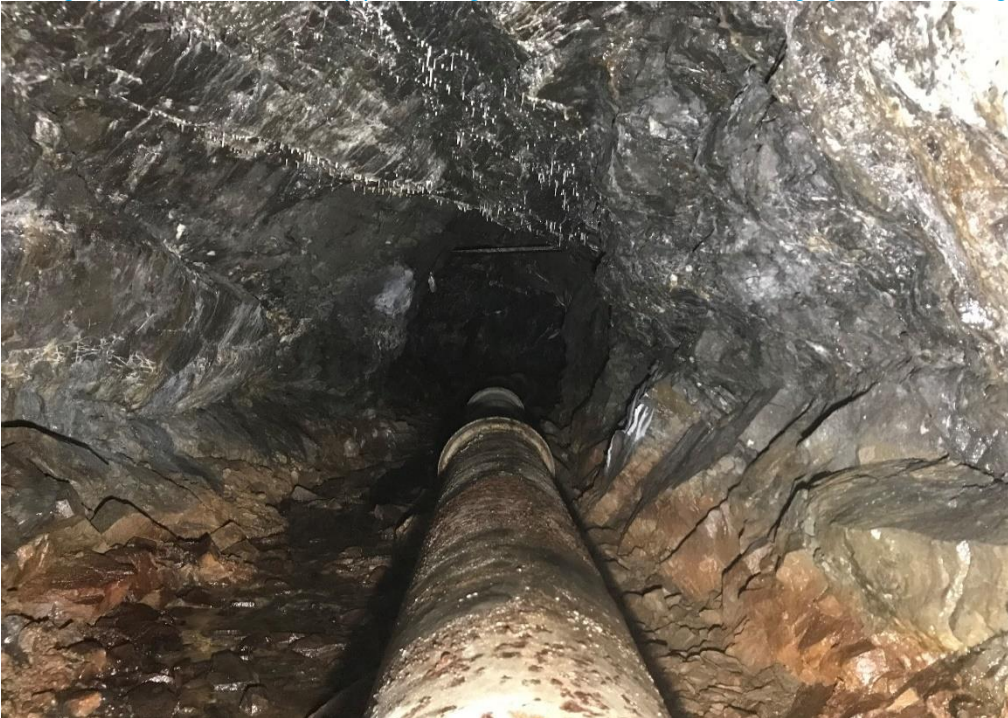
*Photograph 2: Scour tunnel and pipe – a single bat has been recorded hanging from the ceiling of the tunnel*

The eight scour tunnel entry visits recorded a peak count of one lesser horseshoe bat.
