**BEECHES BUNGALOW  
PRIMROSE BANK  
BRYNCOCH**

**BAT & PROTECTED Spp: PRELIMINARY SURVEY/ASSESSMENT**

**January 2022**

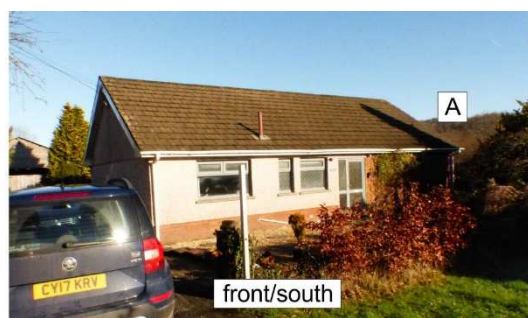
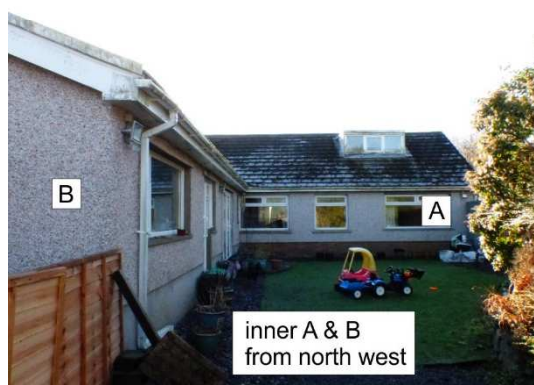
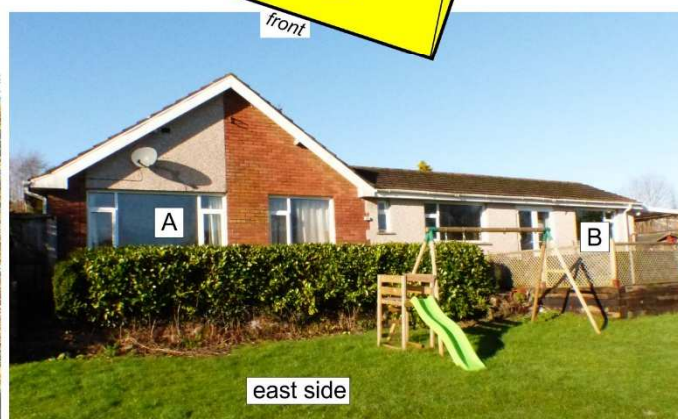
With the exception of half of the east gable, which is brickwork, and ground level/dwarf brickwork, all external walls are rendered/dashed: all are in good repair, with no possibility of bat-access intra-masonry; all (uPVC) windows/doors are securely tight-fitted. There is no potential fly-in bat-access opportunity.

All walltops- three gables, four longwalls- have wall render tight-sealed to (wide) uPVC soffits: there are no potential bat crawl-in access opportunities off-walls. Projecting purlin ends are mastic-sealed to wall render.

Both roofs have flat-tile cladding, with no inter-tile bat-accessible gaps visible. A very slightly uplifted east end ridge tile at the roof of A suggests a possibility of a gap under but any such (hypothetical) gap is moss choked (as are tile laps at most of the rear pitch of A and all of B); otherwise, both ridges are tight-sealed on mortar bedding and have no visible bat-access opportunity. A dormer window at the west end of the north pitch of A has tightly-fitted (and heavily mossed) lead flashings to the roof tiles, and intact/good repair uPVC planked walls below a flat roof; a flue pipe at the front pitch of A also has sealed lead flashings.
