# Preliminary Roost Assessment (PRA)

Bulldogs Development Centre, Port Talbot

| <b>Report title</b> | PRA report |

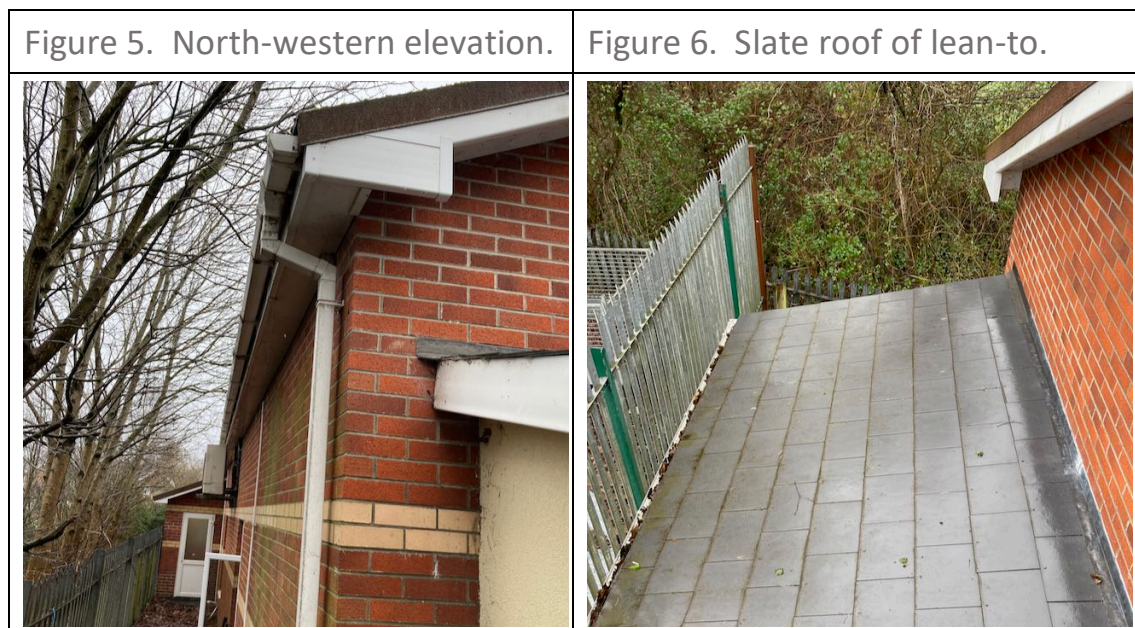
- 4.3.2 Figures 3 and 4 show the north eastern and south western view of the main building. Figure 5 shows the rear of the building (north-western edge).

- 4.3.3 The building is of block construction and largely faced with bricks, aside from the lean-to area which is rendered. The majority of the roof covering is well-sealed and of imitation clay tiles, likely Decra system or similar, which are extremely lightweight and based around a steel core. The roof covering of the lean-to area is of (likely composite) slate tiles, with lead flashing along the join with the main building (see Figure 6). The soffits, fascia boards, gutters, downpipes, windows and doors are uPVC, and are largely well-sealed. A number of solar panels are attached to the south east elevation of the main roof area, alongside several Velux windows.

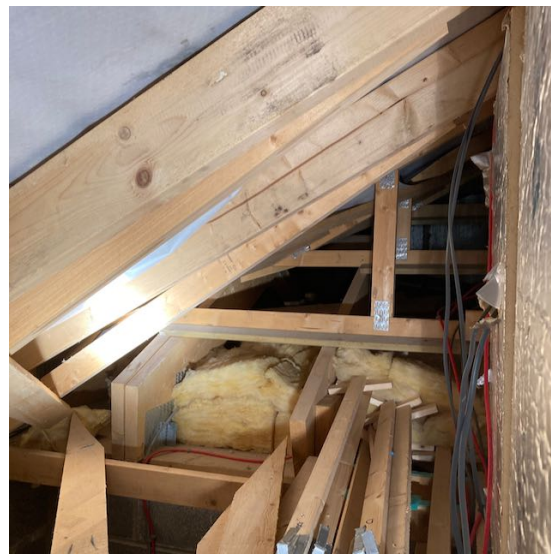
- 4.3.4 Internally, the majority of the roof spaces in the main part of the building have been lost to rooms built into the upper floor; only eaves cupboard spaces remain in the main roof structure. Some examples of these spaces are shown in Figures 7 and 8 below.
- 4.3.5 Modern truss structures have been used to create the main roof, resulting in multiple beams crossing these spaces. Breathable roofing membrane has been used underneath the tiling system, and all of the eaves cupboards are insulated with fibreglass.
- 4.3.6 The single storey section to the north of the building had its own specific hatch access and again was revealed to be constructed in modern truss style (see Figure 9 below). No insulation is present in this roof space.

Figure 7. Small eaves cupboard.

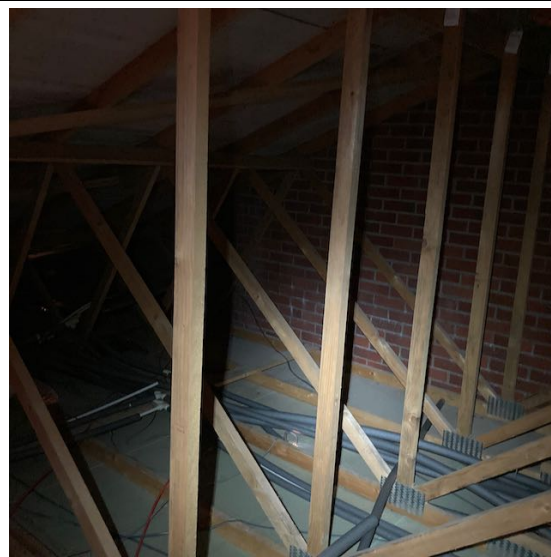
Figure 9. Loft space above single storey section to the north.

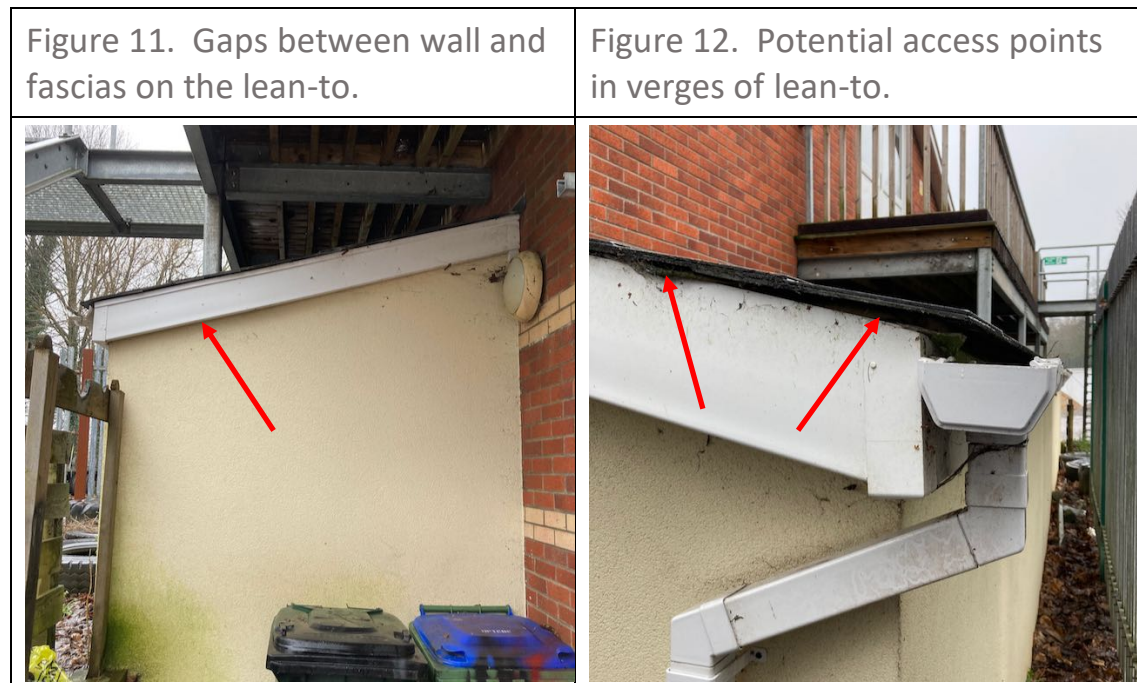
1. **Gaps between the soffits/fascias and the walls of the building.** Whilst the majority of soffits/fascias are well-sealed, there are several areas where gaps are present, in particular on the gable ends to the north-east and south-east, and the lean-to section (see Figure 10 above and Figure 11 below for examples).

2. **Gaps at the verges of the lean-to structure.** These are poorly sealed and allow potential access to the space between the tiles and any underlay in this part of the building (see Figure 12 below).

- 5.4.1 The suitability of the building for bats is generally considered to be low due to a) the largely well-sealed nature of the roof structure, b) the nature of the materials used to construct the roof covering and c) lack of high-quality features.
- 5.4.2 However, due to the presence of gaps between soffits / fascias and walls, together with gaps at the verges of the lean-to roof, the presence of bat roosts cannot be ruled out by the PRA alone. Further survey work is required in order to do this, and is described in more detail in Section 6 of this report.

- 6.1.1 In order to fully assess the impact of the proposed works on bats, additional survey work is required in relation to the building. The Bat Survey Guidelines (Collins, 2016) state that for low suitability structures at least one survey visit should be completed between May and August inclusive.
- 6.1.2 The number of surveyors used during each visit should be sufficient to cover all potential access points at the same time, without moving around. For this building, due to the complex nature of the roof covering, the presence of a balcony structure which obscures the view of some parts of the roof from the ground, together with the building's size, at least five surveyors will be required.
- 6.1.3 Once the additional survey work has been carried out, a full assessment of the use of the buildings by bats can be completed.
