## NRW response – Cwmwernderi – Secondary 23/02/22

## NRW response – Cwmwernderi – Initial 19/01/22

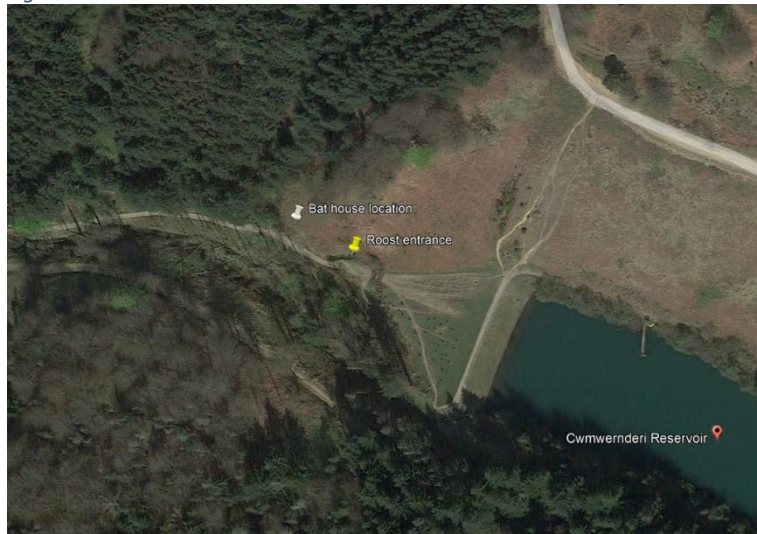
Figure 3 Bat house location

- *In addition, we previously asked for a description of the habitat surrounding the proposed location of the bat house, which hasn't been provided. This is required to ensure suitable habitat and flight lines are present around the structure and therefore should be submitted in support of the application. We included this information in our original response. **"The bat house will be located approximately 35m from the existing roost entrance at the bottom of a deep shaded valley. The surrounding habitat comprises plantation woodland, scrub, grassland and a watercourse (to the south)."** There is also a small stream the runs immediately to west of the proposed location that runs into the main watercourse to the south. Please see the plan and photographs below.*

- The mitigation has been designed in this way to ensure the structure is also as secure and non-descript as possible due to the levels of vandalism in the area.
- The bat house will be located approximately 35m from the existing roost entrance at the bottom of a deep shaded valley. The surrounding habitat comprises plantation woodland, scrub, grassland and a watercourse (to the south).

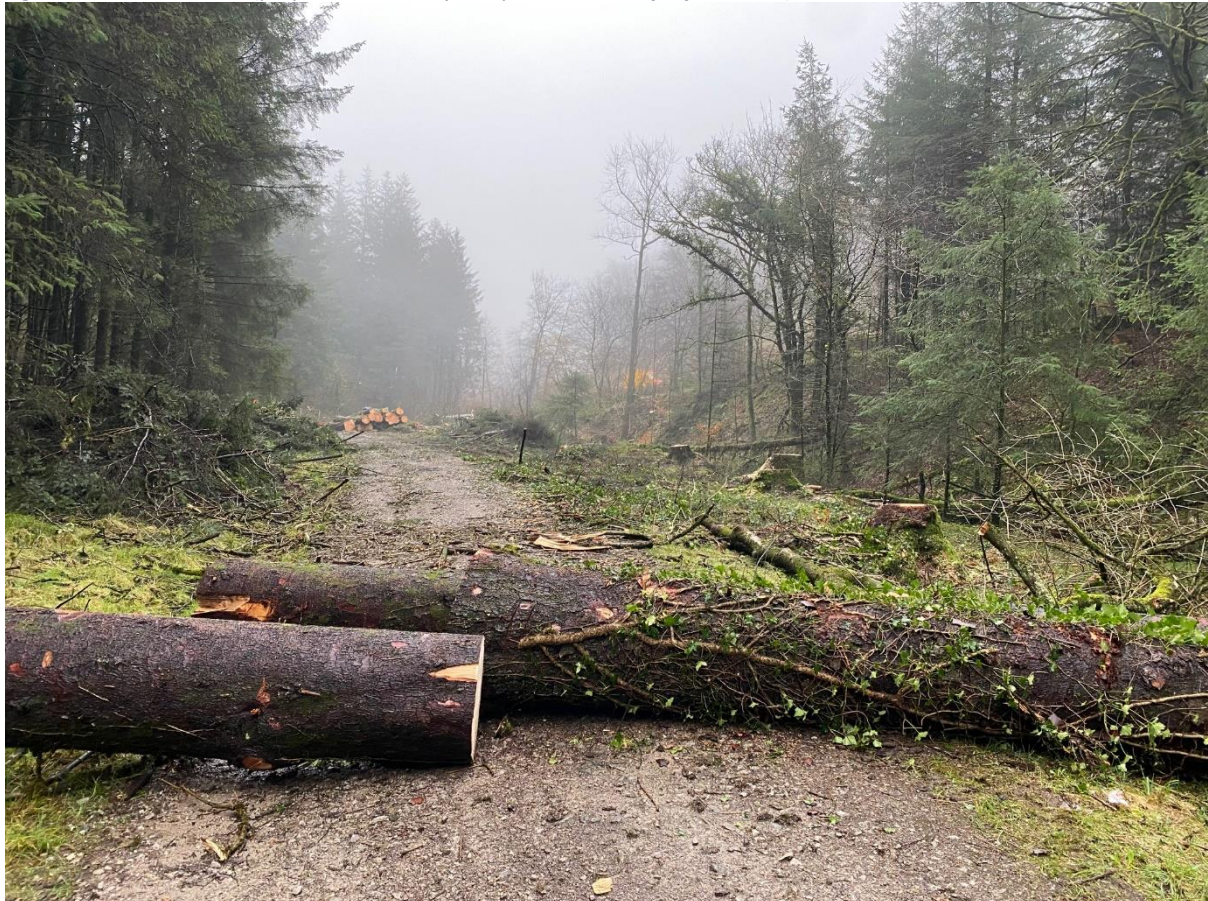
Unfortunately, during the February bat hibernation survey, it was noted that these twelve trees and several more have been cleared by NRW Forestry. As a result, there will now be no tree or scrub removal required as part of this application.

*Figure 6 Felled woodland (proposed secondary compound on the left of the track)*

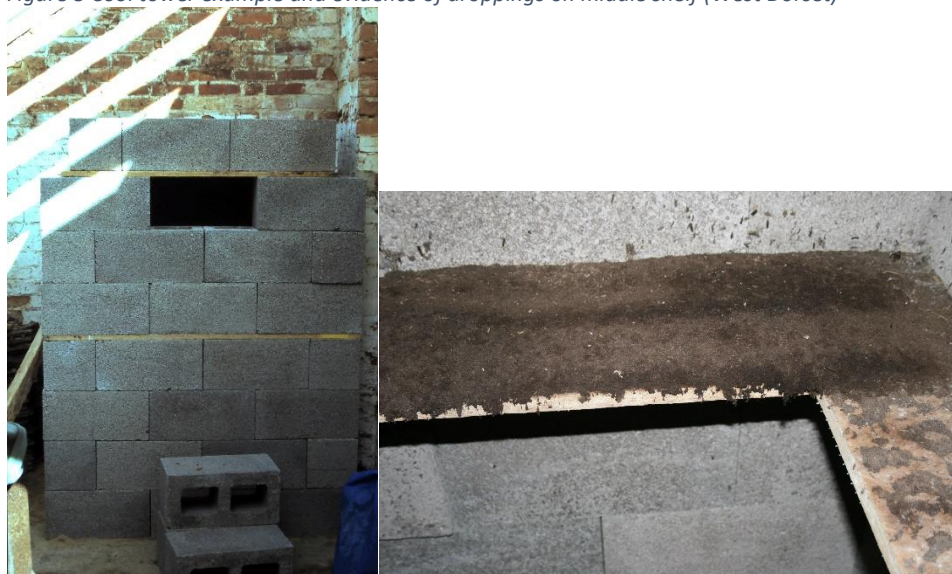
- A digressionary advice service request was completed to discuss the design prior to the planning application being submitted; however the SW planning team informed us that they had insufficient resources to review the request. The mitigation was designed by bat licenced ecologist Elliott Hughes, with input from additional licenced ecologists within Mott MacDonald. It is hoped that the design can be repeated on other Welsh Water schemes.
- The proposed bat house design is a modification on the LHS night roost design used in the Forest of Dean<sup>1</sup>. The addition of a second smaller 'cool tower' structure inside will provide a cooler, stabler environment for hibernating bats. Cool towers are often used to compensate for the loss of hibernation roosts and have been shown to be effective<sup>2</sup>.

*Figure 3 Cool tower example and evidence of droppings on middle shelf (West Dorset)*
