# Lidl Store Site

**Briton Ferry Road  
Neath  
SA11 1AS**

| <b>Report Title</b> | <b>A Preliminary Ecological Appraisal</b> |
| <b>File Reference</b> | <b>JM15121 (Revision 1)</b> |

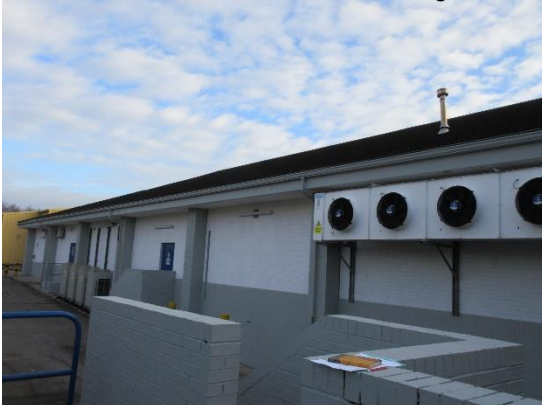
**Plate 13: Rear of Lidl store with narrow ledge above fans**

- 8.4 The Lidl store was carefully examined externally and the roof structure and tops of walls appear in good order. No features suitable for bats to exploit were identified and materials are modern with tight fitting roof tiles and ridge capping. Soffits and fascias are a well-maintained cladding material with a metallic finish. Materials applied to the building are generally of a kind unlikely to be attractive to bats. No historic breeding bird activity was found. Ledges above ventilation fan fittings on the rear (north-west side) may be suitable for nesting birds to exploit but the location is noisy and likely to vibrate to some degree, which might deter birds from using these features (see Plate 13).

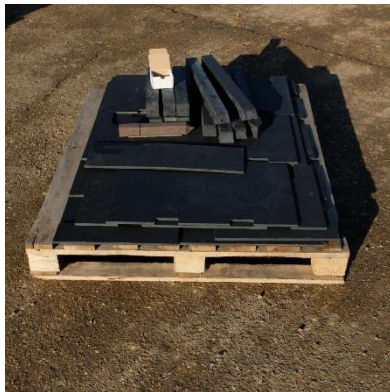
Figure 6: Sketch of otter holt with brash coverings.

This design has been created in conjunction with Surrey Wildlife Trust. The holt has both front and rear entrance holes, and an internal chamber 600mm x 600mm. While this may appear small, research has confirmed that female otters prefer a confined space in which to rear their young. The top is crenelated to improve ventilation, so the holt can be partially buried and the top covered in turf or brash. It is a safe, low cost, easy to install and longer lasting than alternative timber log holts.

The holt location will be planted with hazel, elder, holly and hawthorn shrubs to camouflage its location and screen it from people and dogs. Lightweight brash can be placed over the roof or around the edges to soften the contour and conceal it.
