# PHASE 2 GROUND INVESTIGATION

Lidl Great Britain Ltd  
Briton Ferry Road, Neath

Client: Lidl Great Britain Ltd

769.02.02  
March 2022

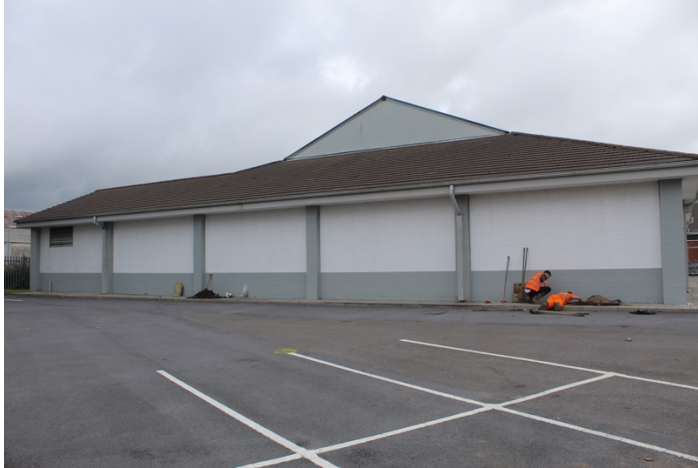
**Photo 1:** View northwards of the southern façade of the existing Lidl store building in July 2020.

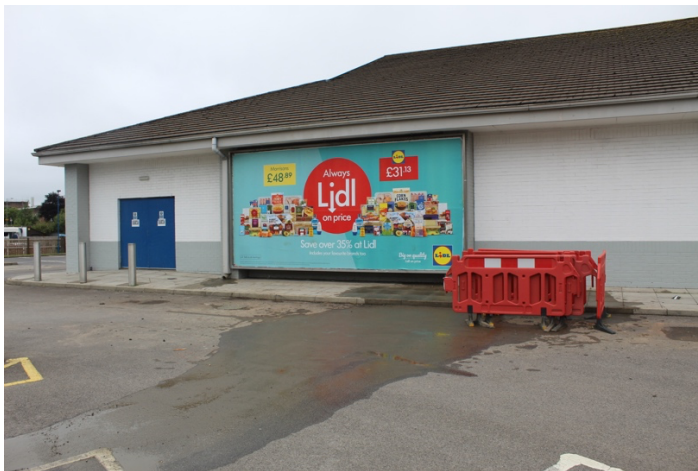
**Photo 2:** View westwards of the eastern façade of the existing Lidl store building in July 2020.

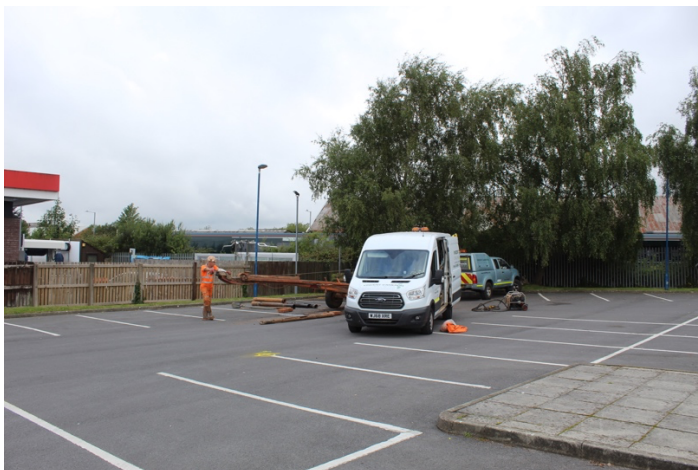
**Photo 3:** View south-westwards across the southern car park area in July 2020, with the off-site Esso Mile End fuel filling station beyond.

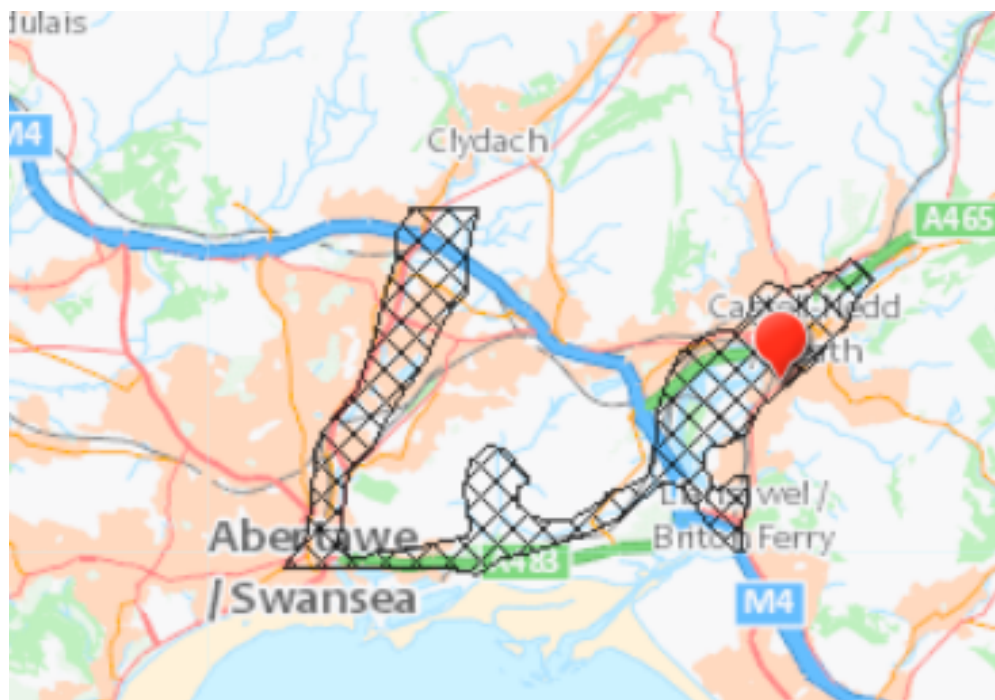
The information contained on the BGS website was further reviewed in order to provide an interpretation. The BGS Geoindex indicated that the site was located on the margins of a buried channel as indicated below:

Further information was provided on the 1:50,000 Scale map sheet 247 'Swansea', Bedrock and Superficial Edition, 2011. A plot of the thickness of superficial indicated that beneath the site the superficial deposits were likely to be in the order of 5 to 10m deep. In addition, a schematic cross section indicated that Glaciofluvial Sheet Deposits (sand and gravel) or Glaciolacustrine Deposits (silt and clay) could be present within the buried channel.

Given that the materials encountered comprised predominantly angular or subangular mudstone and shale it is considered that this material is more likely to represent a zone of weathered bedrock. It is considered that if the material had been moved then other material types would be present along side the presence of mudstone and shale. The site is indicated to lie on the margins of the buried channel with the anticipated thickness of superficial deposits being in the order of 5 to 10m. The Alluvium was found to extend to depths of 3.45 and 5.0m, which is slightly less than predicted but not significant enough to cast doubt on the interpretation.

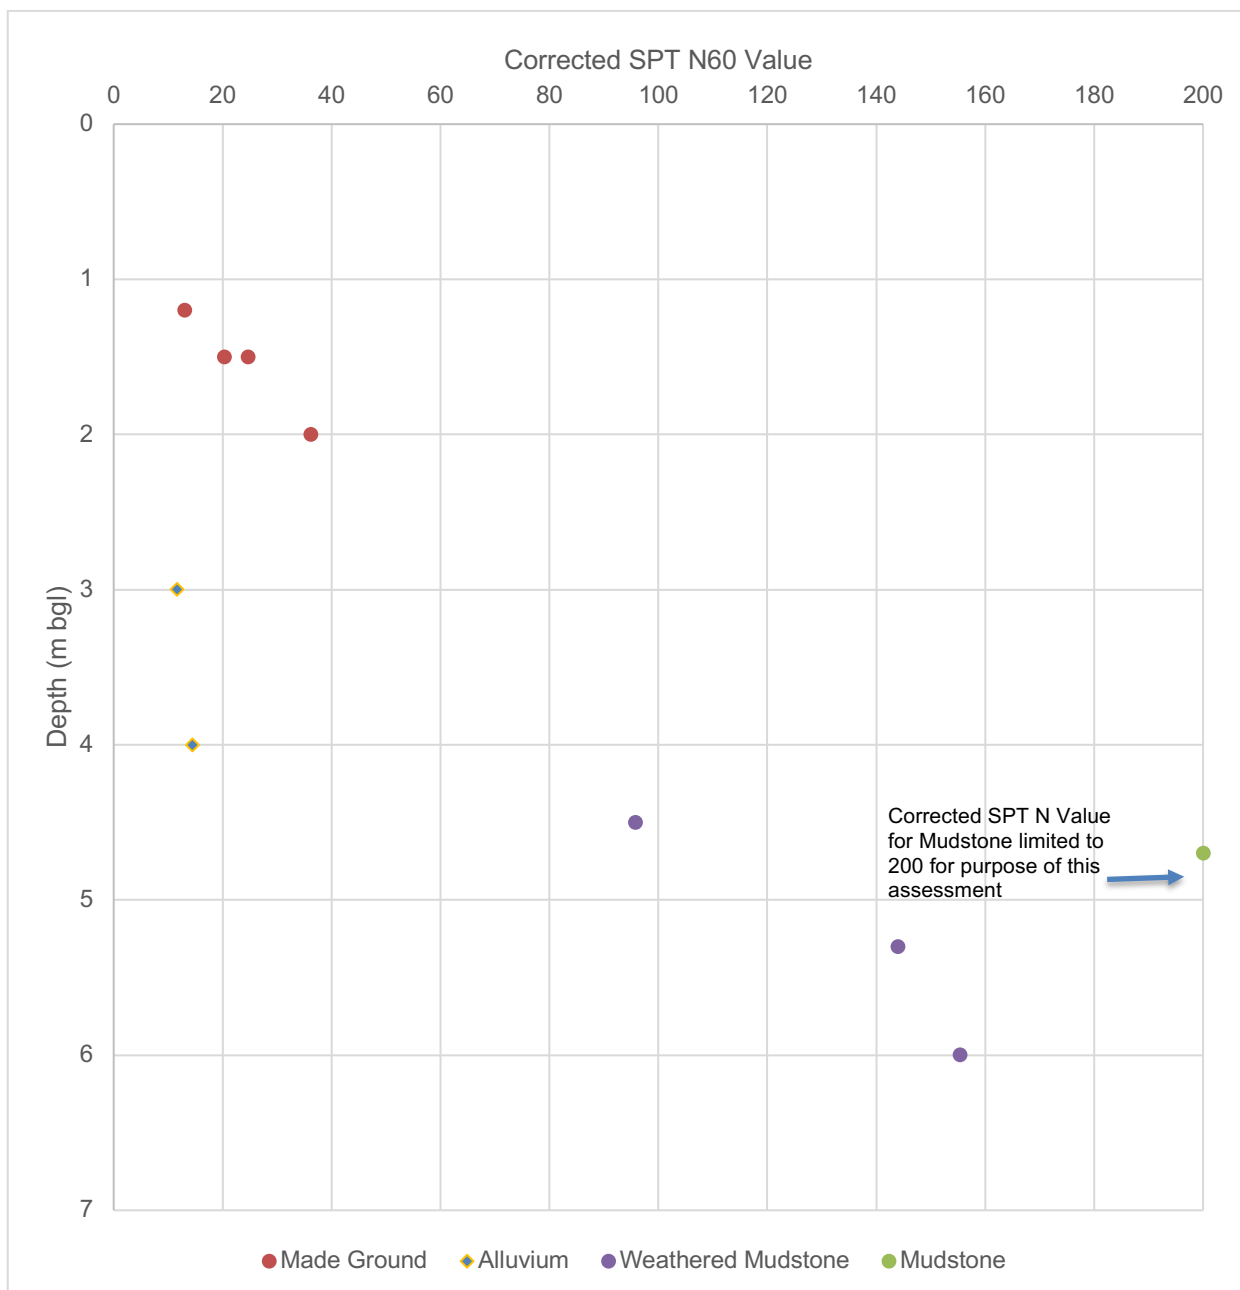
**Graph 1: Plot of Corrected SPT N-Values Versus Depth**

In-situ SPTs were undertaken to assist with the interpretation of strata encountered. The results of corrected N-values versus depth are plotted in the graph below:

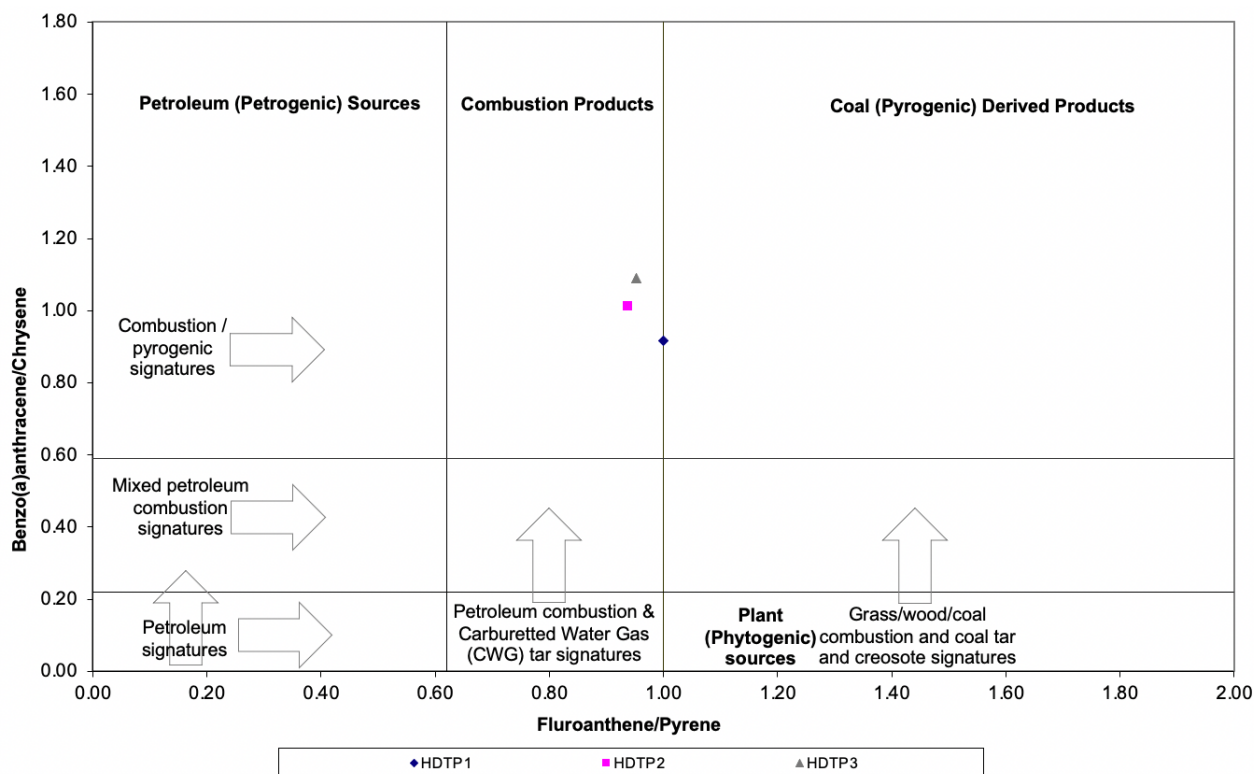
Graph 2: PAH Double Ratio Plot

In addition, the PAH concentrations have been plotted on a double ratio plot to provide an indication of the likely source of the PAHs. All of the samples that had detections of the four PAHs used have been plotted and all are indicated to be combustion/pyrogenic related PAHs.

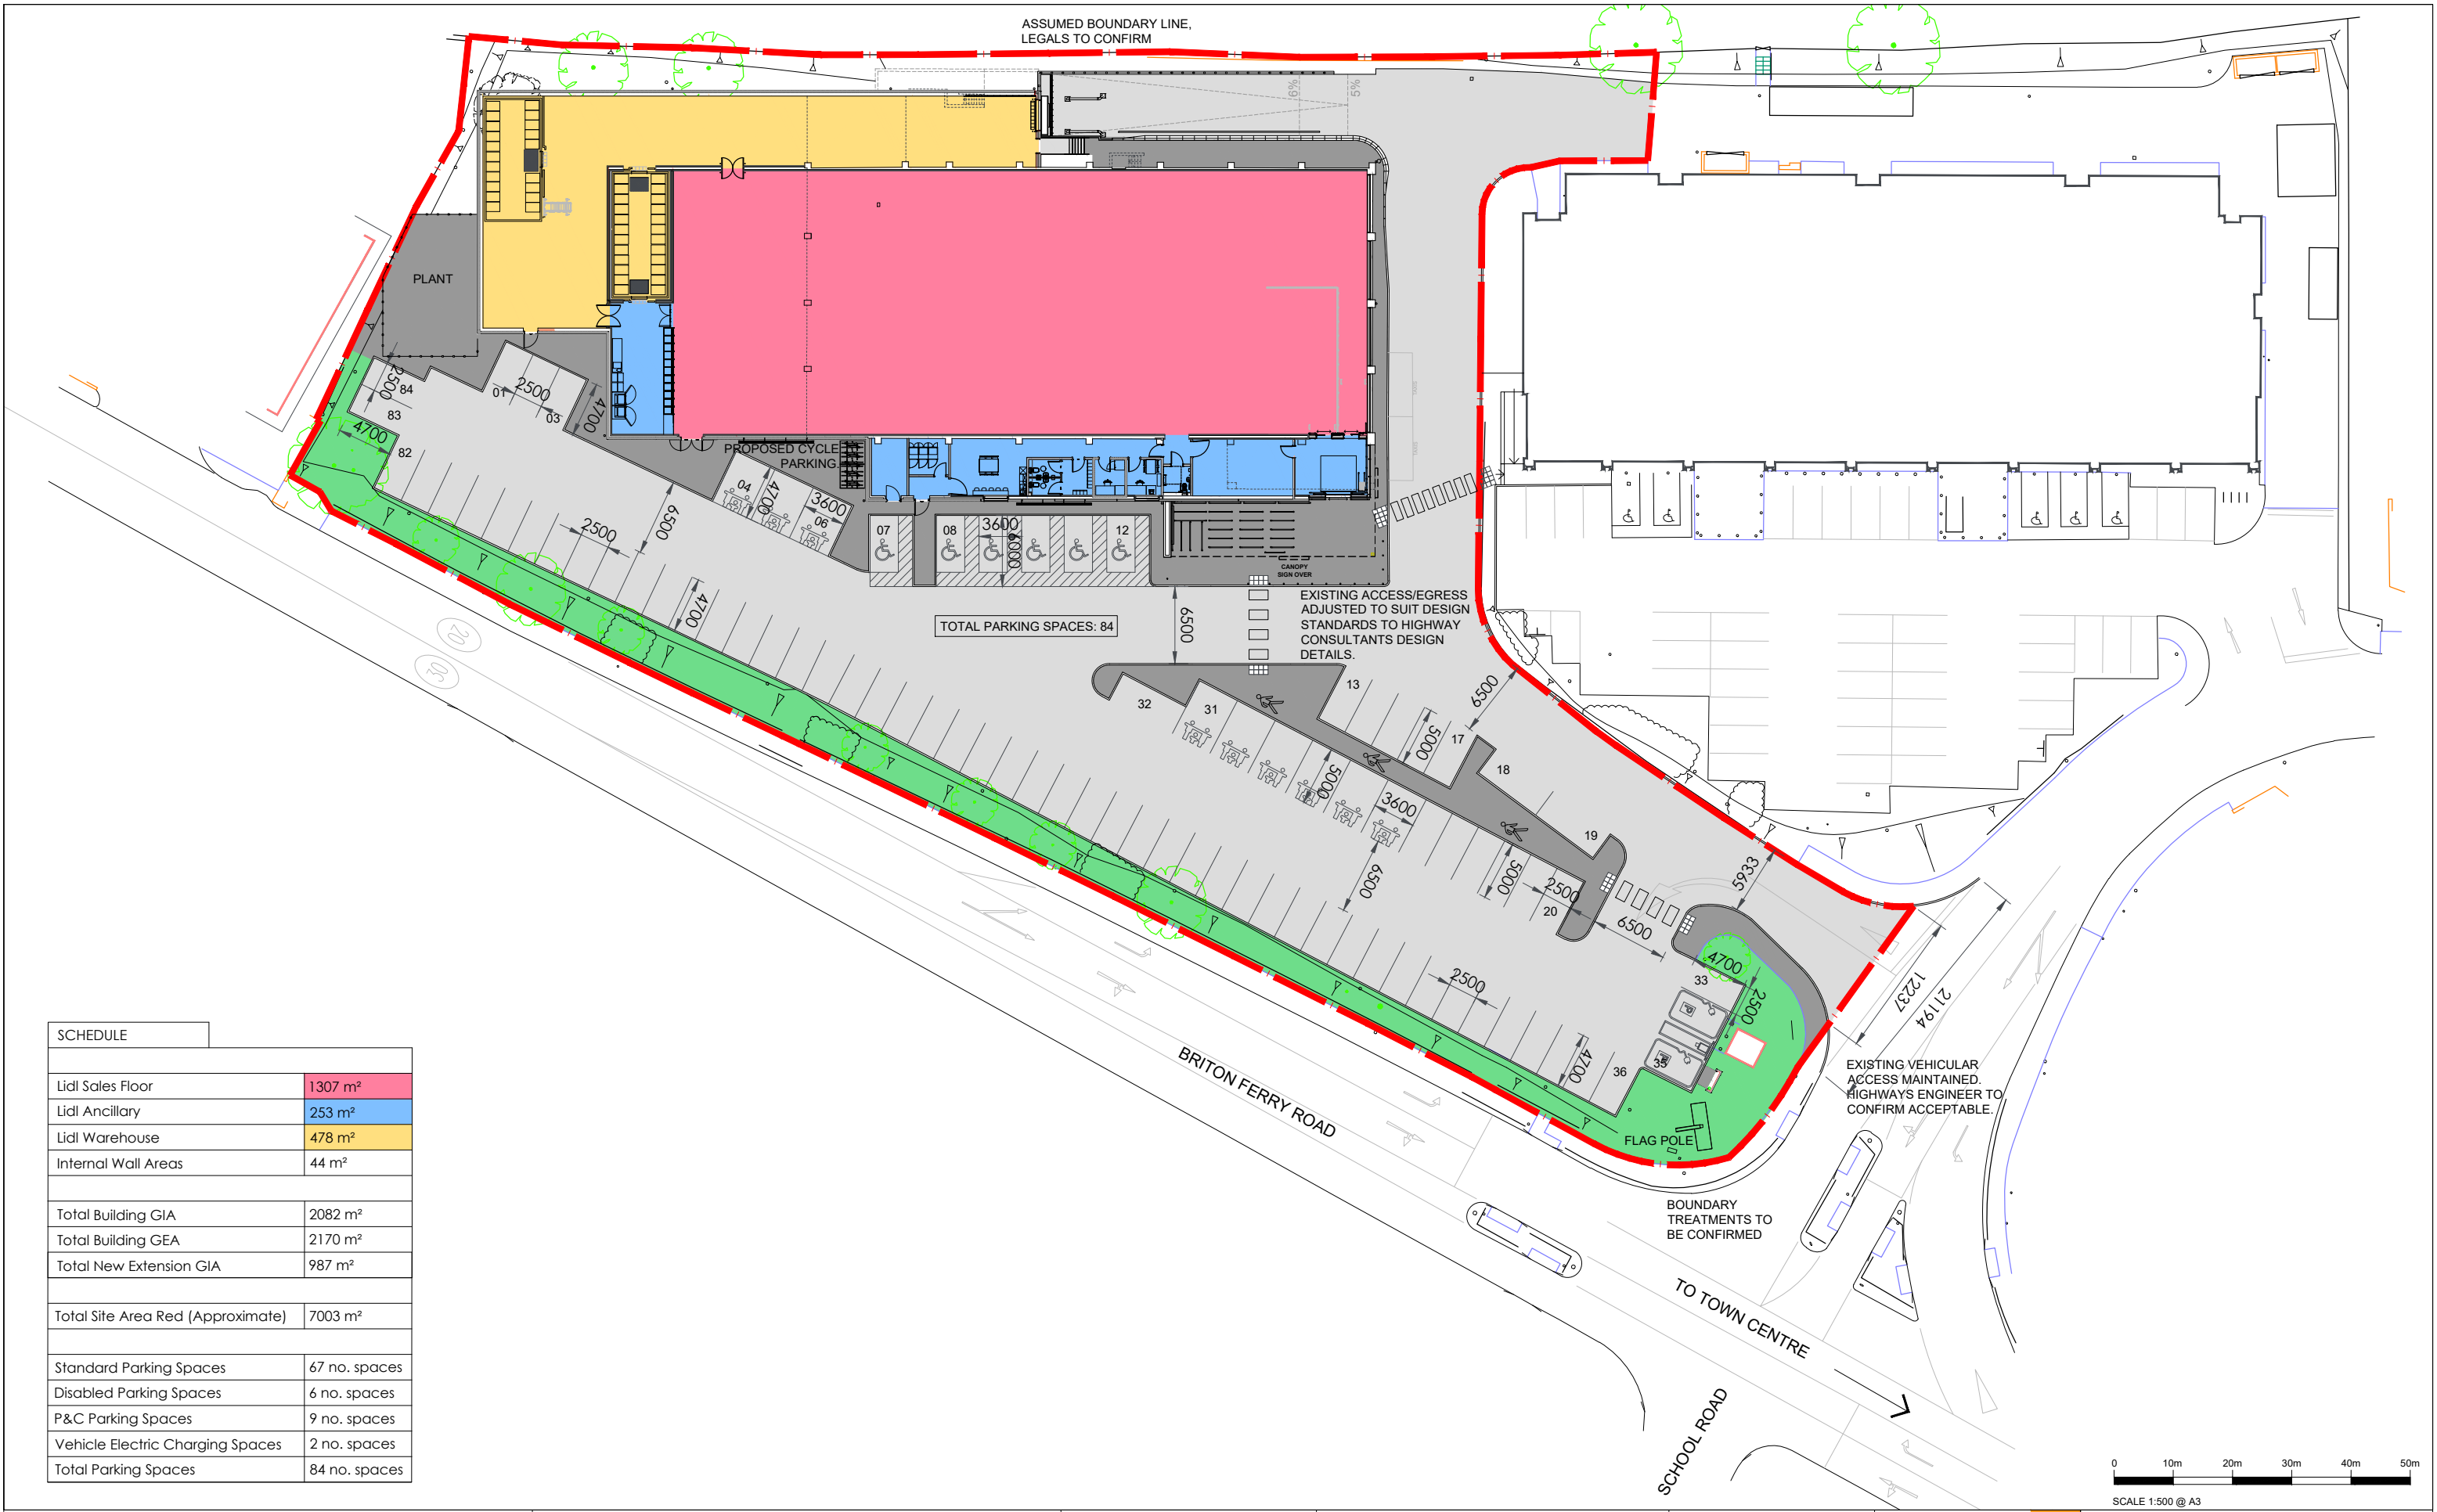
However, since the completion of Remada's investigation, the proposed layout of the site has been modified which has resulted in the updating of this Phase 2 Ground Investigation Report. The proposed development at the time of writing in March 2022 is for '*demolition of existing buildings [Lidl store and adjacent Poundstretcher store] and replacement with a Class A1 foodstore with associated carparking, landscaping, engineering and drainage works*'. The position of Remada's exploratory holes and the previous Opus window sample boreholes in relation to the proposed new layout is indicated on **Figure 2**.

The investigation comprised three (3 No.) cable tool boreholes and three (3 No.) trial pits to expose existing foundations. The investigation was undertaken on the 23<sup>rd</sup> and 24<sup>th</sup> July 2020 at the locations indicated on **Figure 2**.

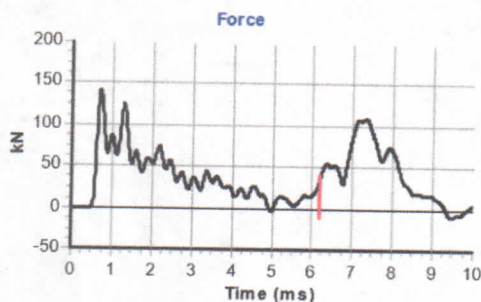
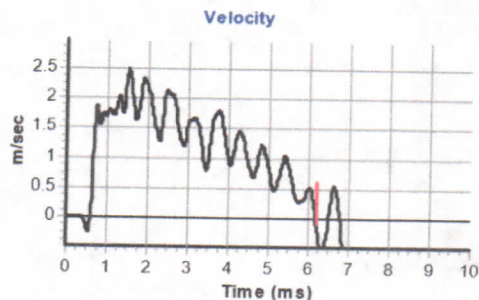
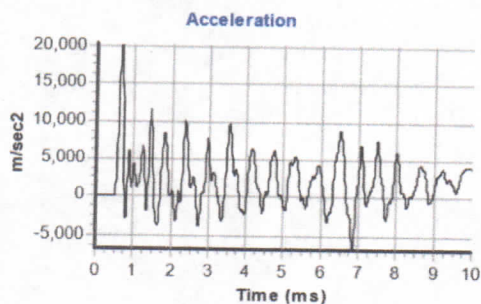
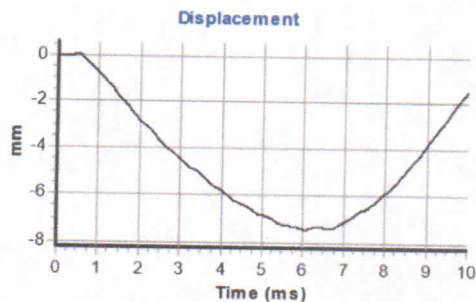
Area of Rod  $A$  (mm<sup>2</sup>): 970  
Theoretical Energy  $E_{theor}$  (J): 473  
Measured Energy  $E_{meas}$  (J): 411

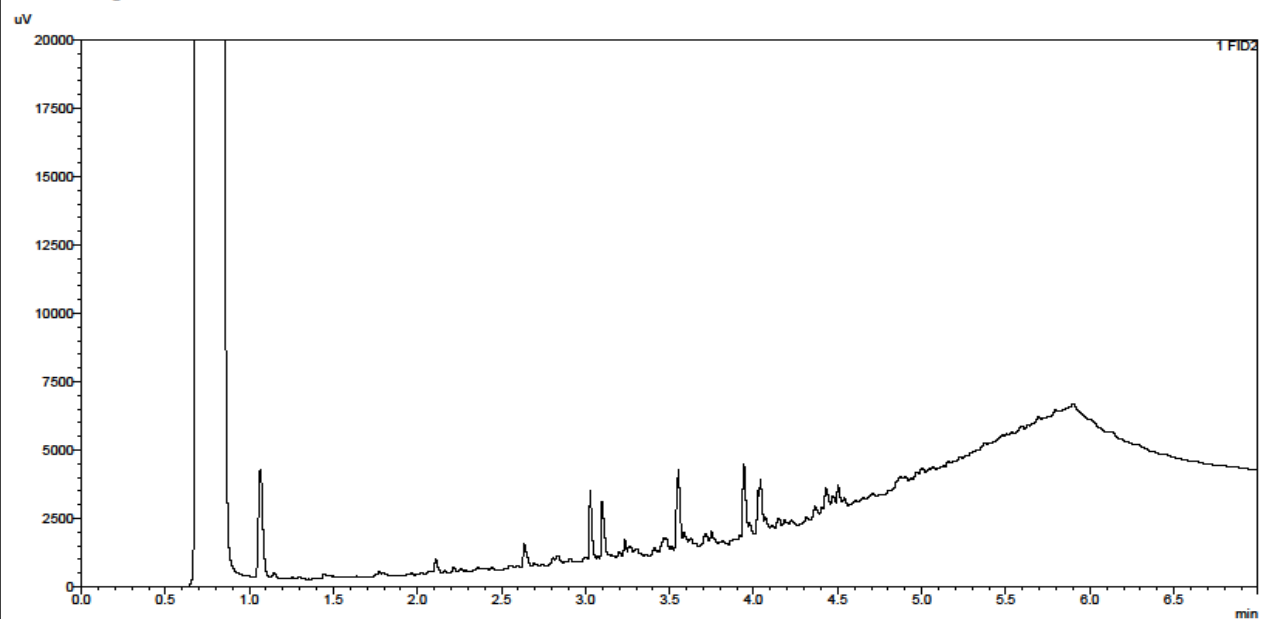
# TPH Chromatogram on Soil Sample: 1040113

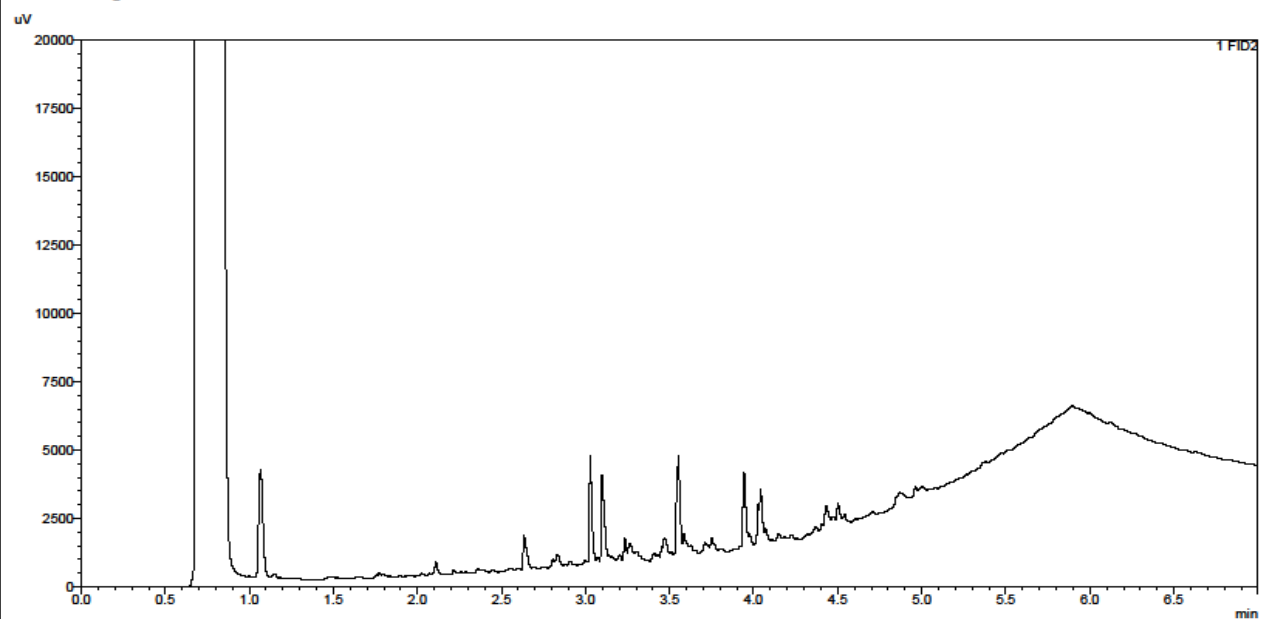
# TPH Chromatogram on Soil Sample: 1040114
