# **5 Varteg Row**

Bat Preliminary Roost Assessment

**September 2020**

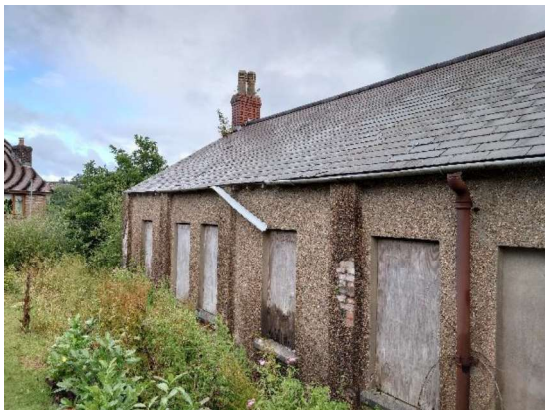
The roof is a pitched timber construction with slate tiles (see photographs 1 and 2 in Appendix A). Due to the elevation of the surrounding land it was possible to clearly see the roof and all tiles appeared to be closely fitting and in good order. The slate tiles appeared to all be close fitting to the timber construction beneath, although, there is the potential for small voids beneath. However, at the time of the survey no access to this area could be identified with all tiles in good order and soffits and barge boards present on all aspects of the pitched roofed sections of the building. These were constructed of timber were generally tight fitting. Two chimneys were present on the building, however both are fitted with cowl that blocks access to the building.

Photograph 1: View of the house from the east.

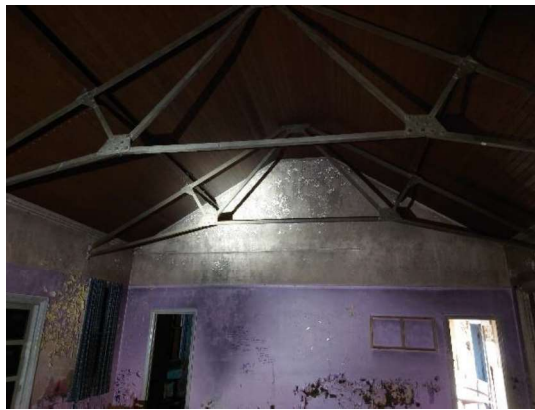
The roof consists of the timber boards (see photos in Appendix A) supported by a metal frame.

Photograph 2: Interior roof space

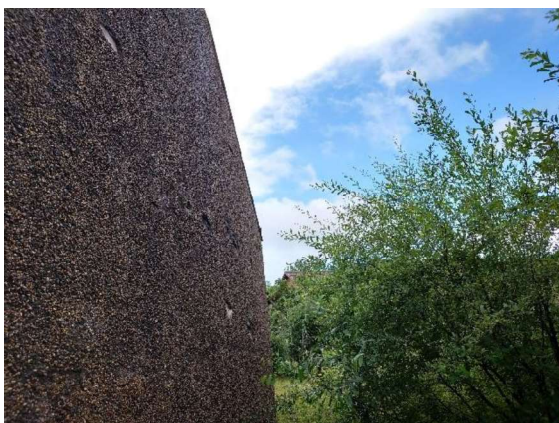
The building is a single storey with a small attic space at the southern end of the building. It is constructed from brick with a concrete and pebble dashed render which for the most part is in good condition with a couple of areas where the bricks are exposed on the north western exposure. No openings to large voids between the bricks and concrete render had resulted in these exposed areas.

Photograph 3: Areas of exposed brickwork where concrete render has fallen off.

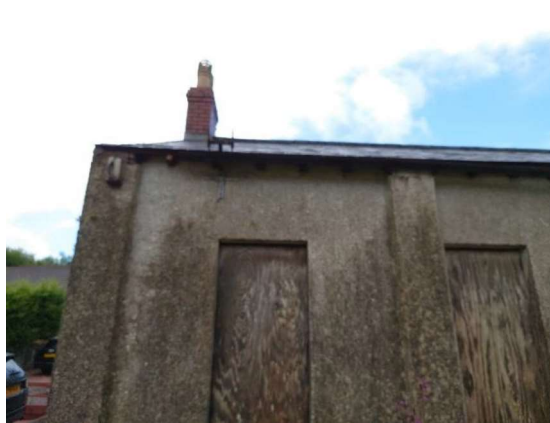
There are numerous windows along each aspect of the building, however, these are currently boarded up with plywood.

Photograph 4: Chimney on the central roof and windows boarded up.

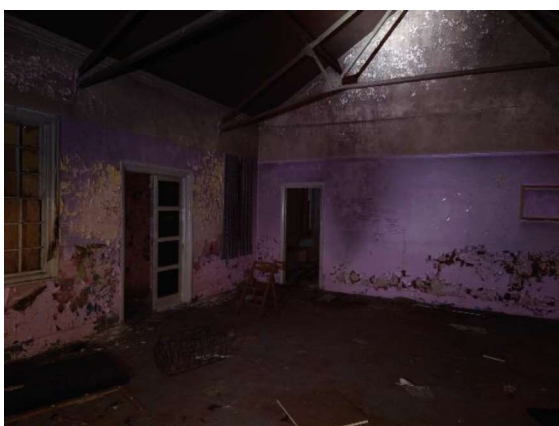
Photograph 5: Interior showing intact window frames.
