**SWANSEA HOLIDAY COTTAGES, PONTARDAWE**

**BUILDING INSPECTION SURVEY & BAT ACTIVITY REPORT**

25<sup>th</sup> November 2019

Document Ref: Doc 01 – 25/11/2019

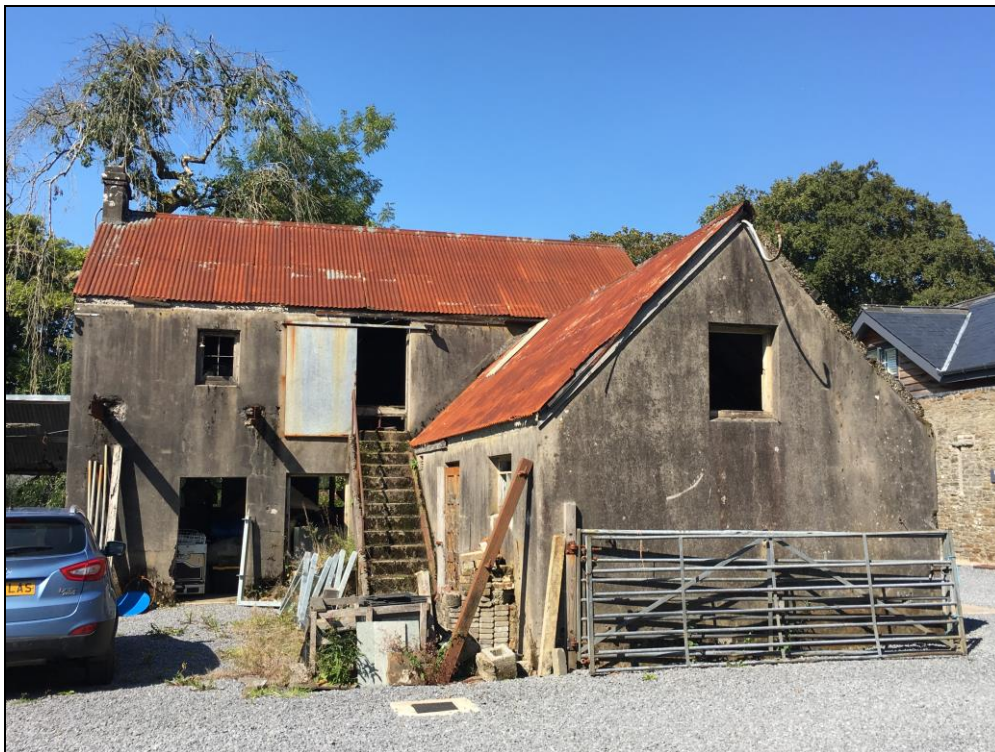
- 3.4 The main cottage structure was a two storey was constructed from rendered stone with a corrugated metal roof, a single storey annex was located on the eastern elevation at its northern extent (Photo 1).

***Photo 1: Main cottage structure and annex eastern elevations (view looking west).***

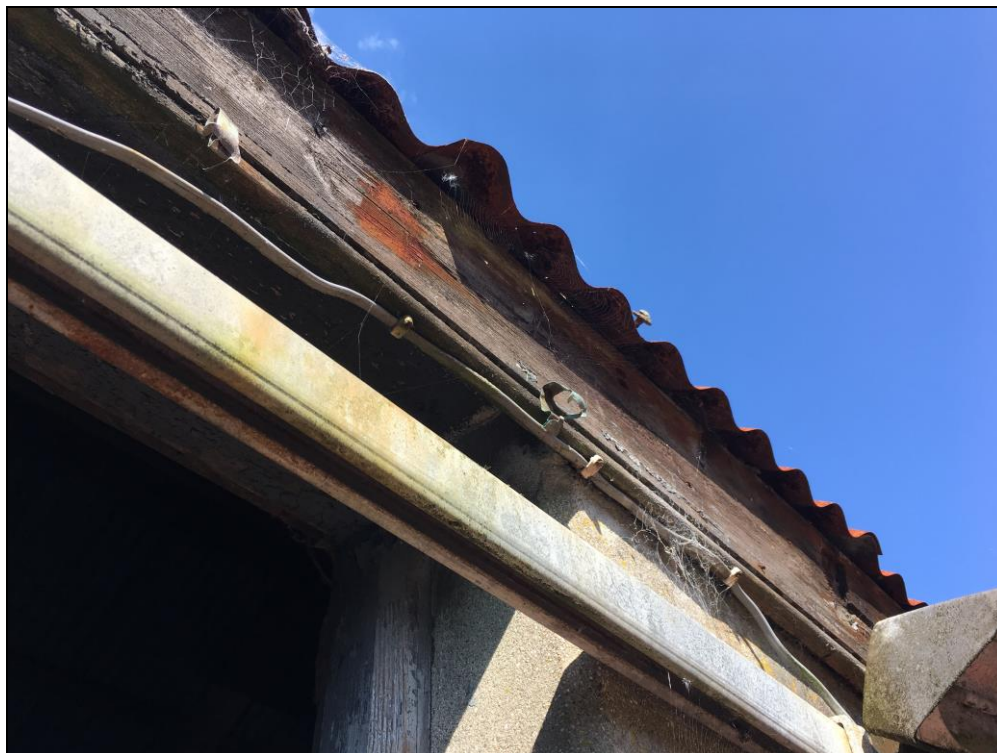
- 3.5 The ground floor interior was accessed via an open doorway on the eastern elevation, whilst the first floor interior was access via steps located on the eastern elevation. Multiple potential access points to the internal structure was evident on the eastern elevation of the main cottage and annex, with open doors and window identified. Further potential bat roosting features (PRFs) were evident beneath the wooden fascias and corrugated metal roof on the eastern elevation (Photo 2).

**Photo 2: Gaps beneath fascias and corrugated metal roof on eastern elevation (view looking west).**

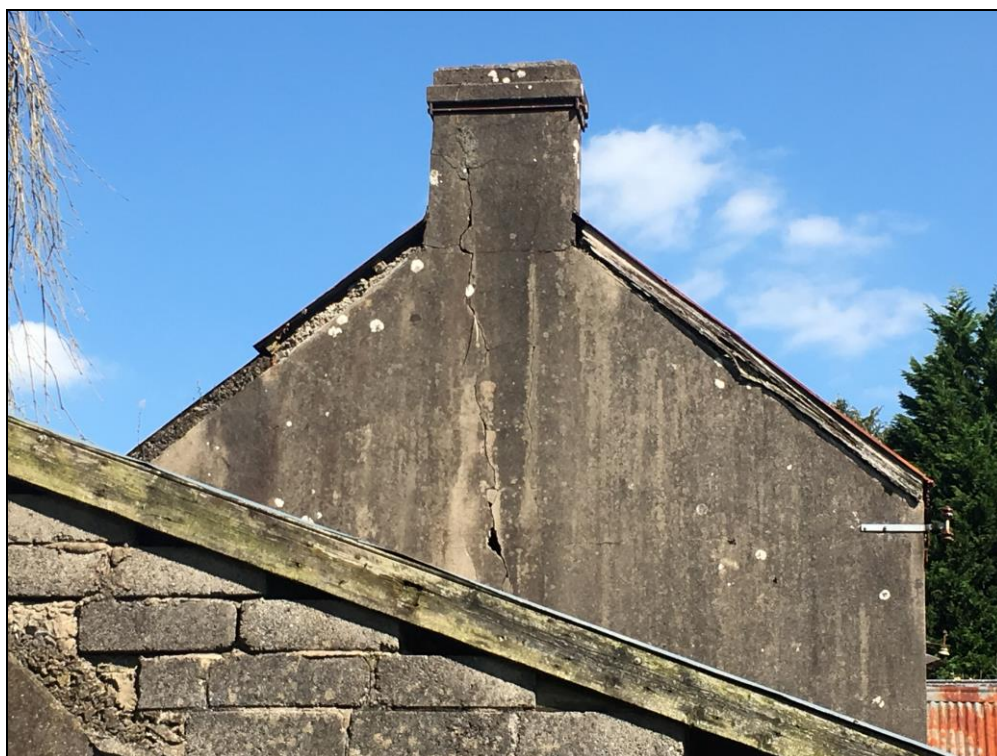
- 3.6 The southern elevation of the structure possessed a number of PRFs associated with the rotten wooden fascia and crack in the exterior chimney breast which ran vertically down the southern gable end (Photo 3). A number of bat droppings indicative of *Pipistrelle* sp. were identified on the southern gable end wall beneath the wooden fascias at the eastern extent.

***Photo 3: Southern gable end with rotten fascias, vertical crack down chimney breast and droppings identified on wall at eastern extent of elevation (View looking north).***

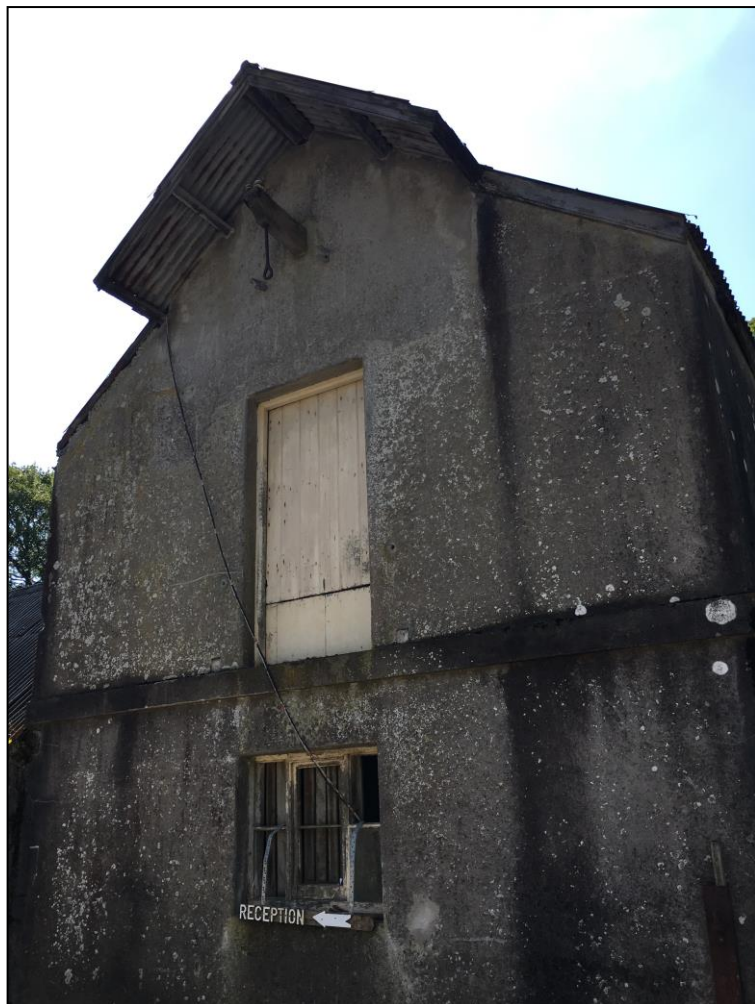
- 3.7 The northern elevation of the main cottage structure possessed a first floor wooden door beneath an overhanging corrugated metal roof (Photo 4), PRFs were associated with the gaps beneath the metal roof. Wooden access doors to the single storey annex were located on this elevation with large gaps located above them providing potential access points to the interior (Photo 5).

***Photo 4: Northern elevation with wooden and overhanging roof (view looking south).***

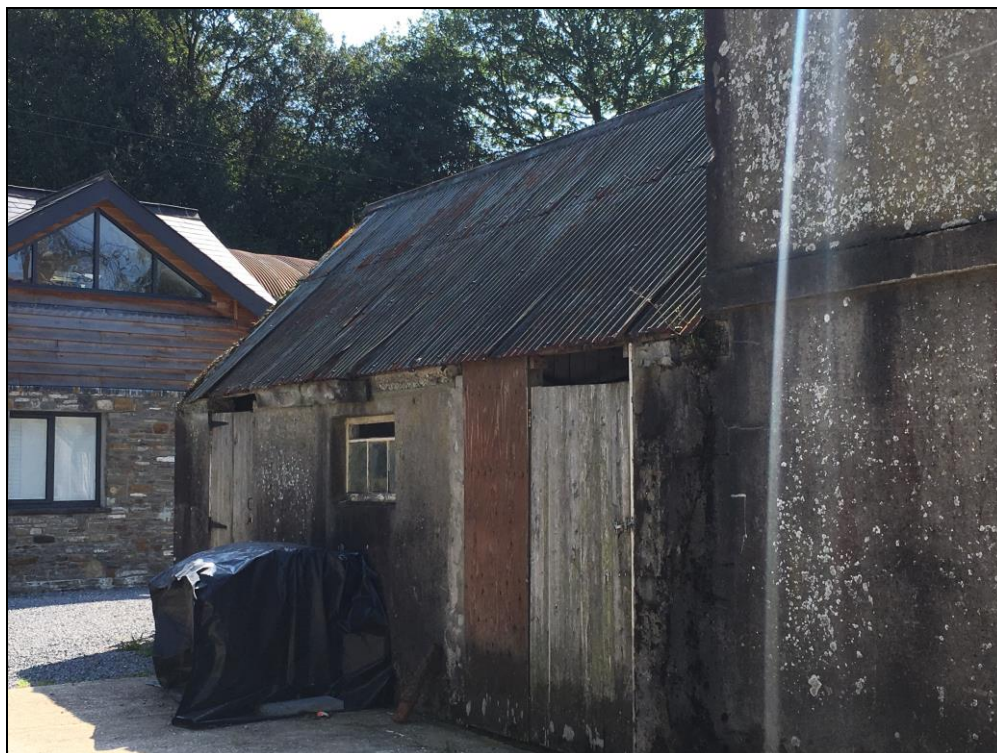
***Photo 5: Northern annex elevation with gaps above doors and open window (view looking east).***

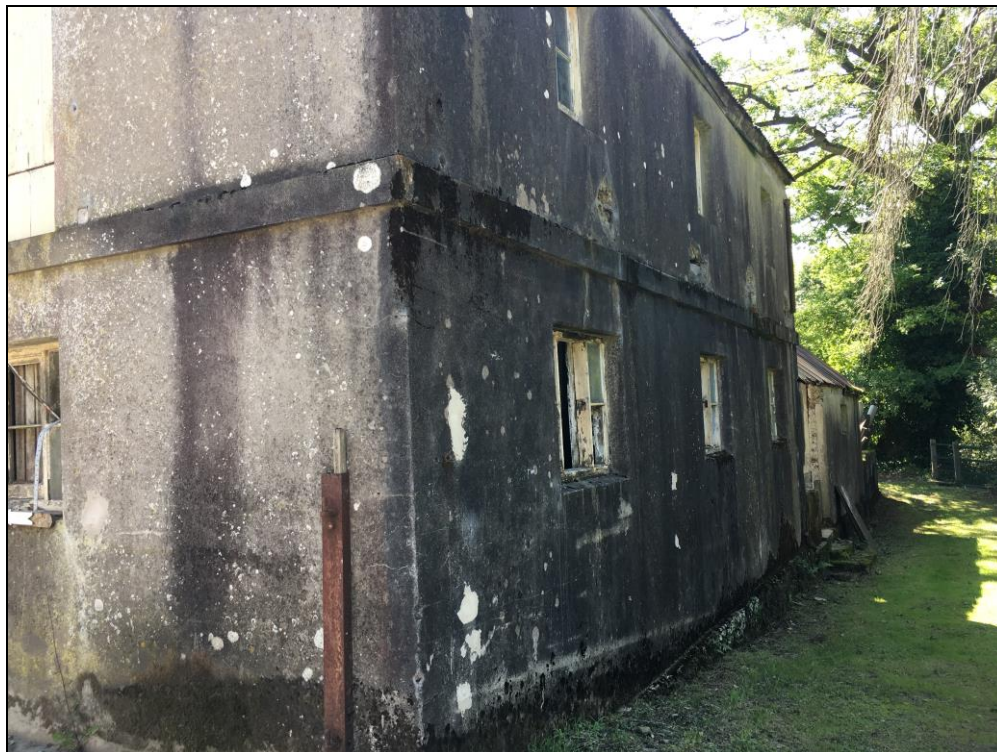
3.8 The eastern elevation of the building (Photo 6) was located in close proximity to the River Clydach and associated riparian corridor (Photo 7) and possessed an open window to the ground floor and PRFs beneath wooden fascias and in cracks in the lintels (Photo 8).

***Photo 6: Eastern elevation with open ground floor window and gaps beneath wooden fascias (view looking south).***

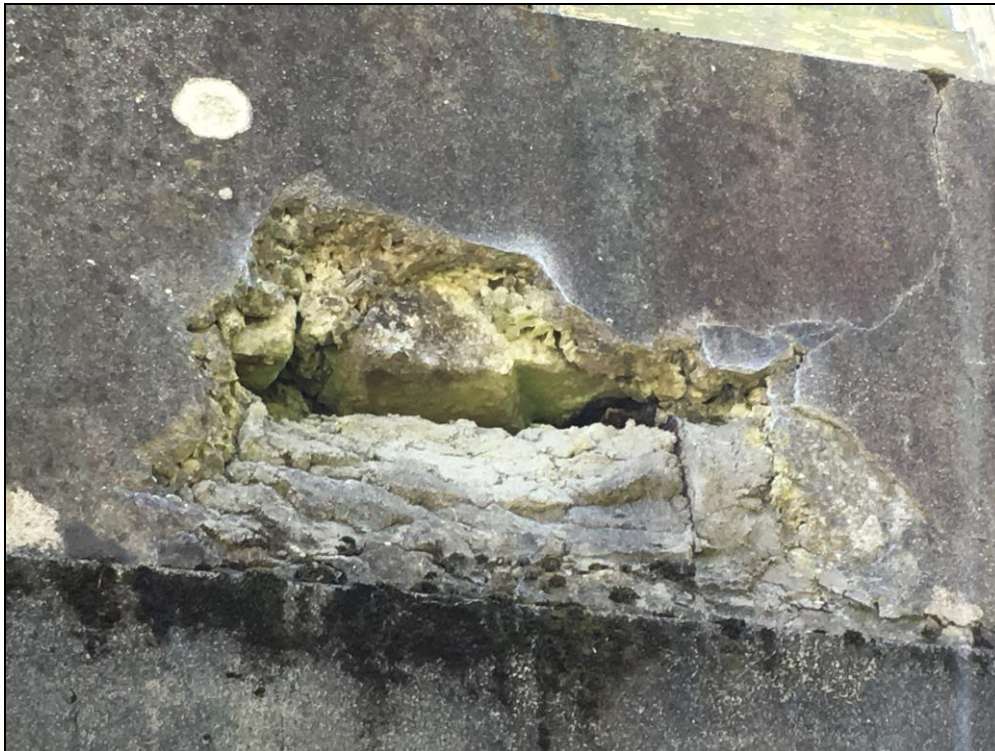
***Photo 8: Crack in lintel on eastern elevation.***

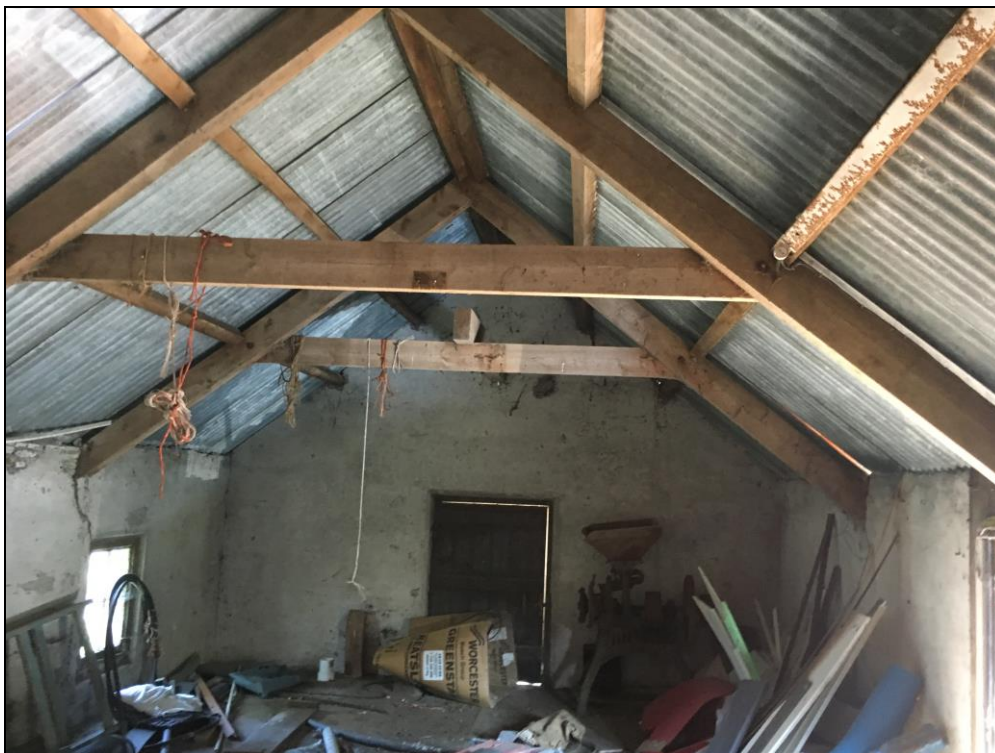
- 3.9 The first floor was a single open plan room that was generally well lit from an open doorway on the eastern elevation and draught free. The exposed corrugated metal roof and wooden beams were evident and the room was being utilised for storage (Photo 9). Scatterings of bat droppings were identified throughout the first floor and were indicative of Brown Long-eared bat and Pipistrelle sp.. However, the Pipistrelle droppings were concentrated down the wall of the southern elevation beneath the corrugated metal roof and wooden beam (Photo 10). Audible sounds of roosting bats were evident. Evidence of feeding active was identified within the first floor with Small Tortoiseshell wings identified (Photo 11).

**Photo 9: First floor interior (view looking north).**

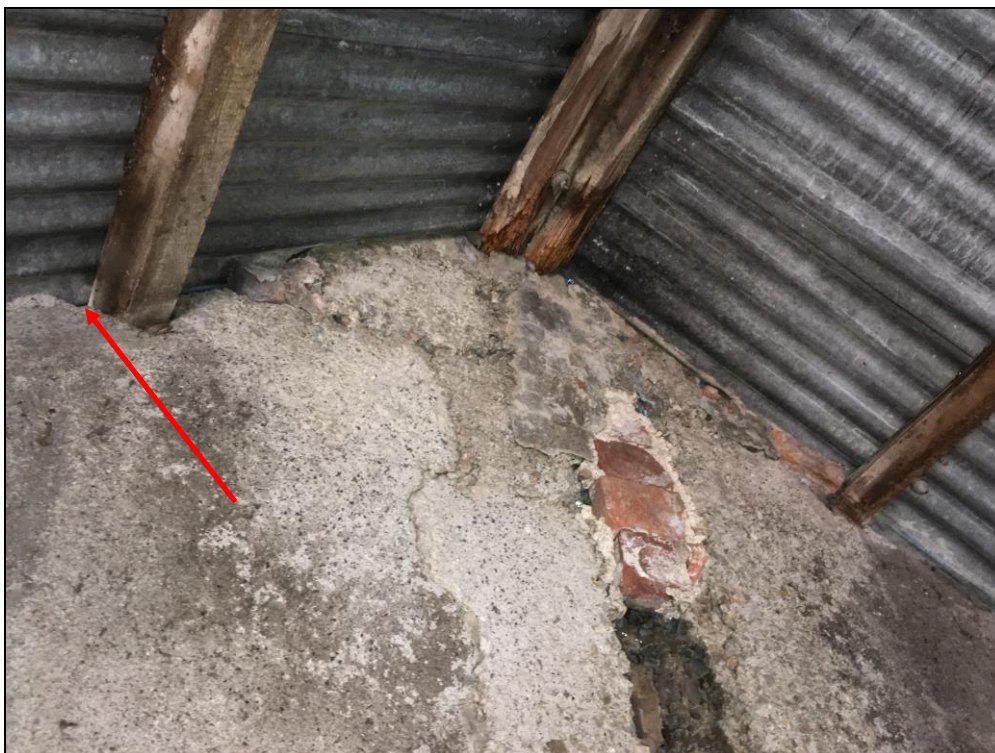
- 3.10 A crack within the southern gable wall was evident (Photo 10) and penetrated into the interior of the chimney stack. However, no roosting bats or evidence of roosting bats was evident when examined (Photo 12), although multiple crevices between the stone construction was evident. The first floor room also possessed an active Swallows nest.

**Photo 10: Southern gable end of interior with roost location and crack in chimney breast (view looking south).**

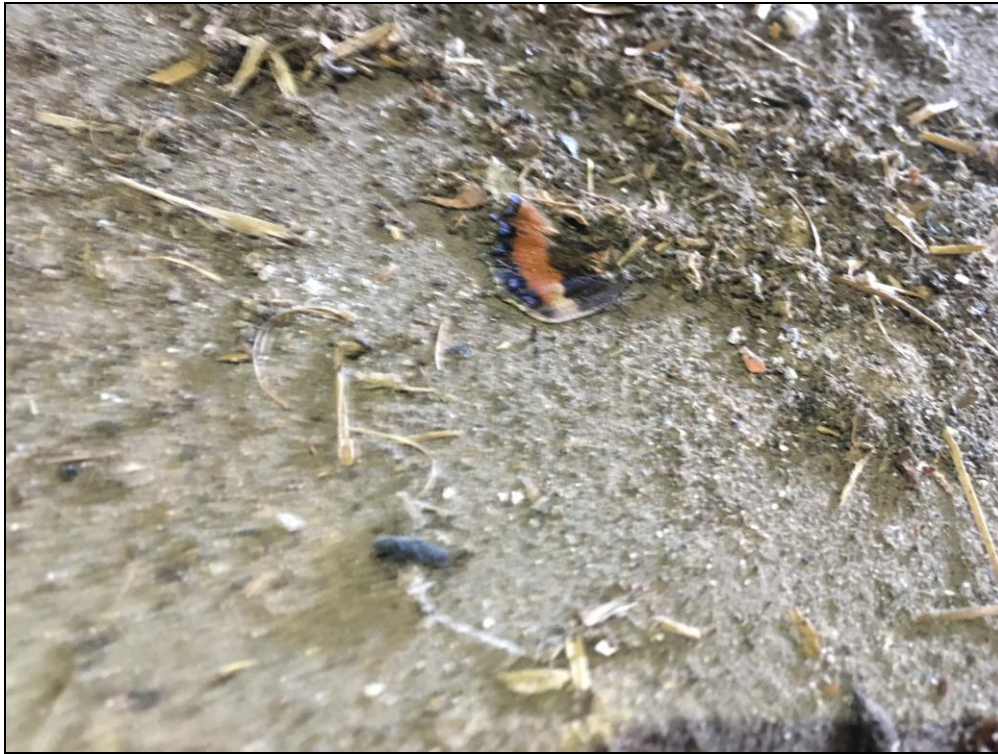
***Photo 11: Feeding remains on first floor of cottage.***

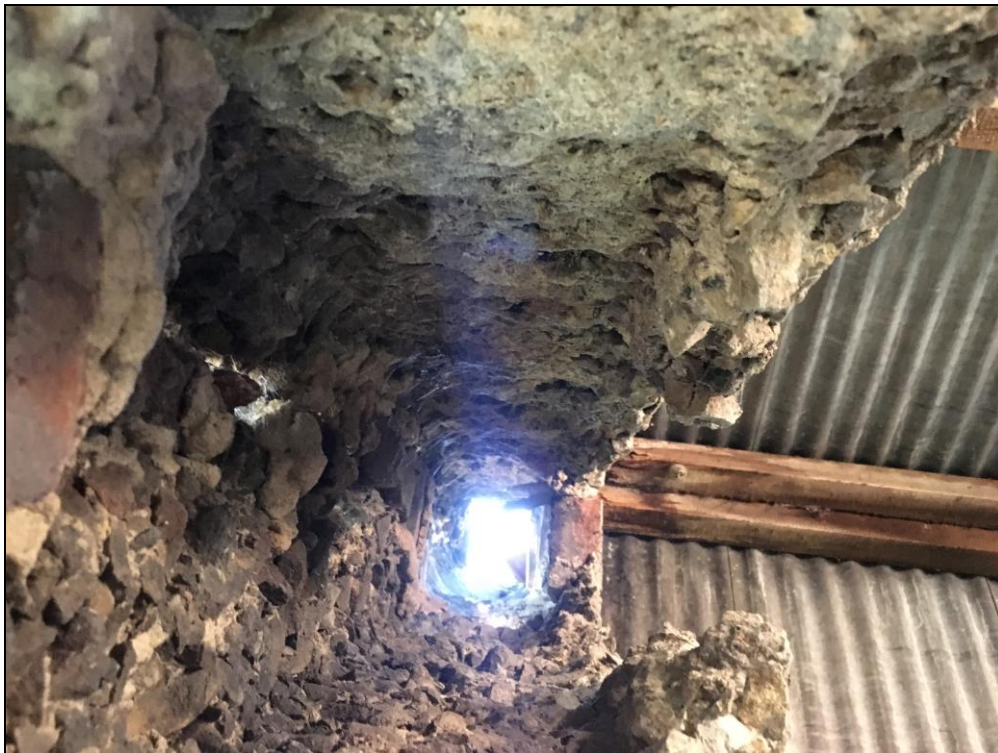
***Photo 12: Interior of chimney breast through crack in wall.***

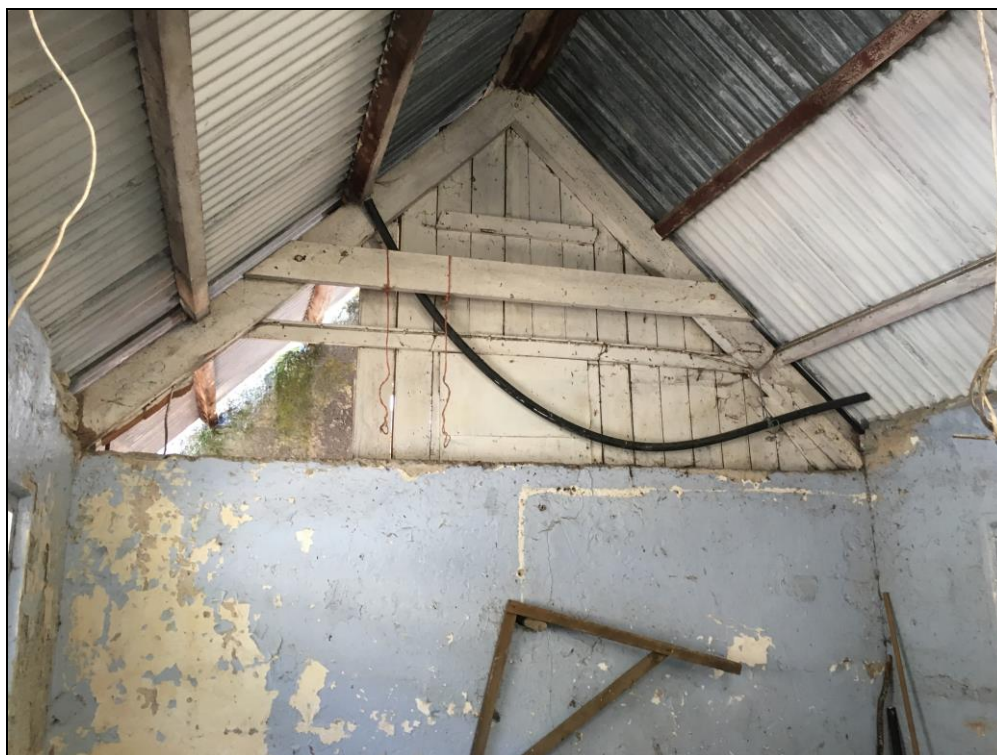
- 3.11 The ground floor of the cottage and annex was in constant use as storage and both were light (from multiple access points) and draught free (Photo 13), and only small numbers of droppings indicative of Brown Long-eared bat were identified. However, multiple PRFs were identified in the annex interior and were associated with the stone walls. Evidence of nesting Swallow were identified on the ground floor, whilst an artificial Swallow nest identified in the annex.

**Photo 13: Interior of annex (view looking east).**

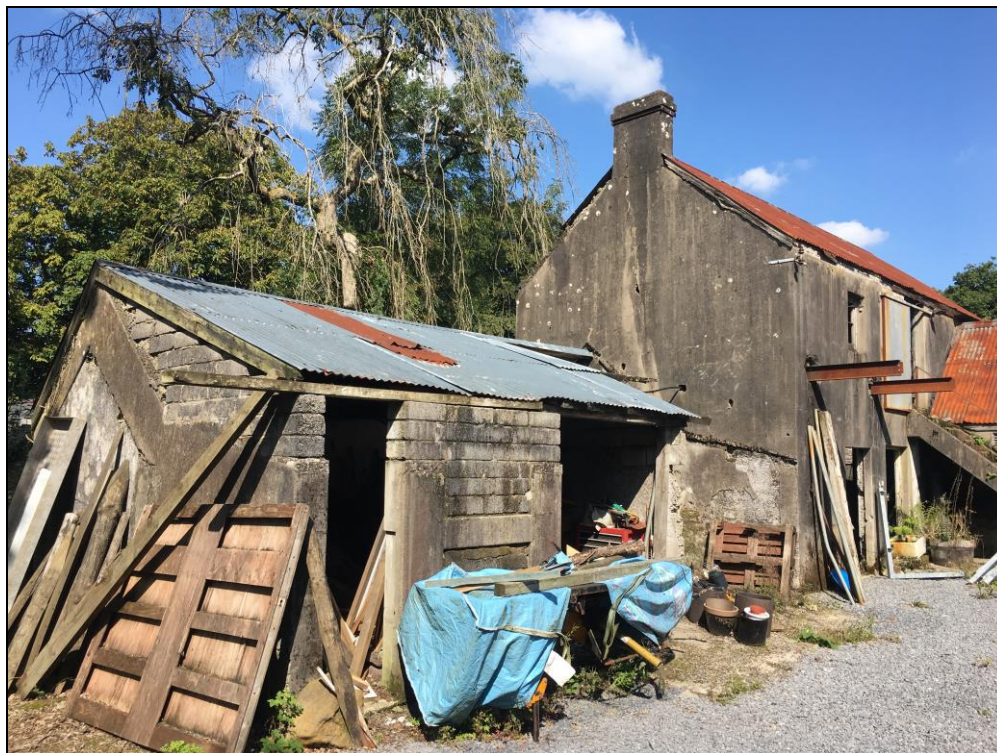
- 3.12 A single storey breeze block fire wood storage shed was located south of the cottage (Photo 14). The roof was constructed from corrugated metal sheeting, whilst the walls were single skin. The structure was very light and draught free with no roofing insulation present. No evidence of roosting bats was identified externally or internally and the structure was considered to be of negligible bat roosting potential.

**Photo 14: Storage shed (view looking west)**

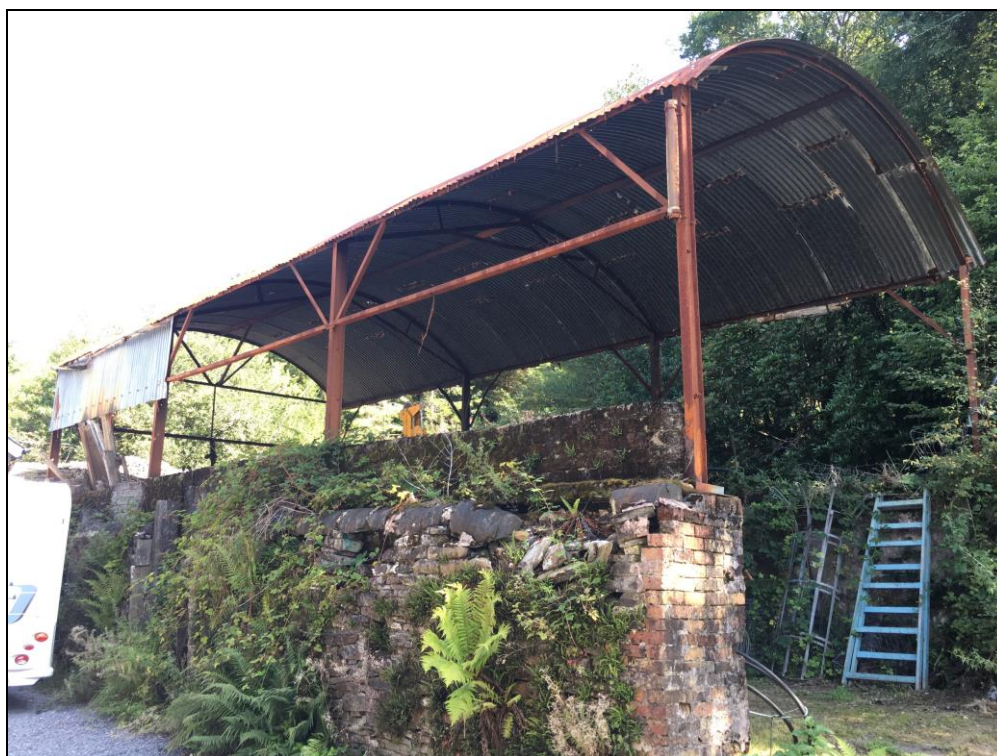
- 3.13 A Dutch Barn was located at the south eastern extent of the Swansea Holiday Cottage complex. The Barn was open sided and was constructed from corrugate metal and steel girders (Photo 15). A low stone wall was part of the structure's western elevation. The structure was light and airy and was considered to be of negligible bat roosting potential due to its prefabricated open nature and lack of PRFs.

**Photo 15: Dutch Barn (view looking east).**

- 5.3 The identification of roosting bats within the cottage means the renovation works will require a European Protected Species (EPS) derogation licence, which will require appropriate mitigation built into the proposed cottage structure. The EPS licence application will require an accompanying bat method statement that will detail timings of works, required watching briefs, sensitive working methodologies, required mitigation and monitoring. The EPS licence will not be required to cover the demolition of the Dutch Barn.

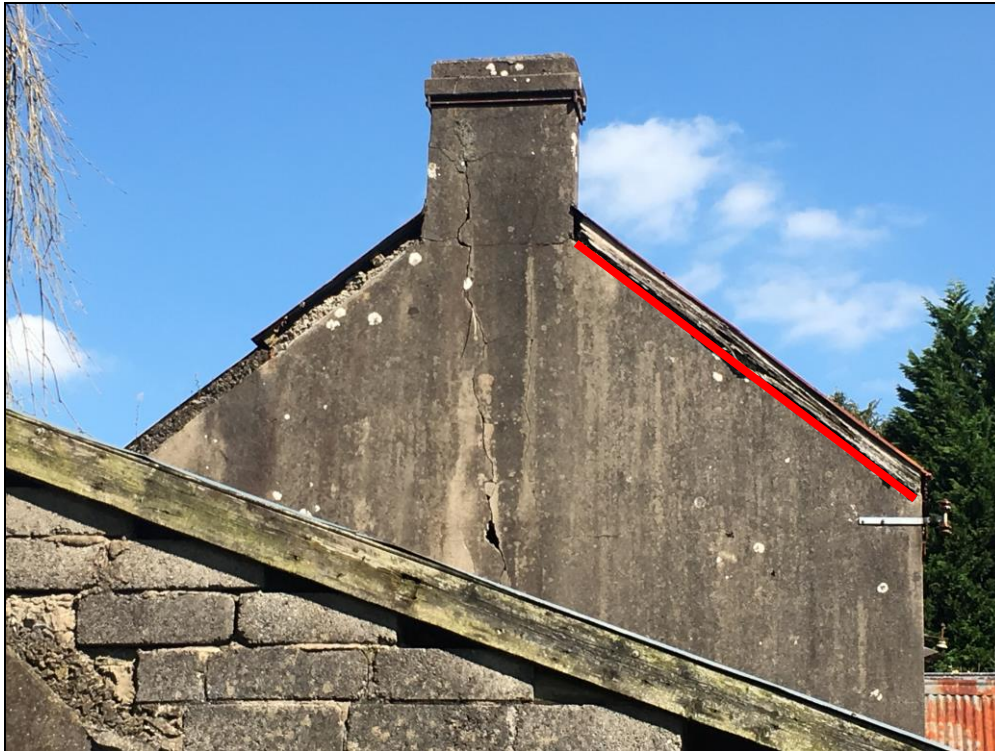
- 3.14 During the evening emergence survey 12 Common Pipistrelle and 2 Soprano Pipistrelle bats were recorded emerging from beneath the fascias and roof of the main cottage structure on the southern and eastern elevations (Photo 16 & 17). The first Common Pipistrelle bat recorded emerging at 19.50h approximately 14mins before sunset (20.04h) with the last Pipistrelle bat recorded emerging at 20.18h approximately 14mins after sunset. A bat was recorded emerging through the open window of the structure on the western elevation (Photo 18)(closet to the river) at 20.15h, no calls were detected by the northern surveyor. However, the bat was considered to be a Brown Long-eared bat from its flight characteristics. Moderate – high levels of bat activity was recorded along the western elevation in close proximity to the riparian corridor, which decreased around the eastern elevation and the artificial lights of the surrounding tourist cottages. From both in-field and sonogram analysis it was determined that the majority of the calls were made by commuting/foraging Common Pipistrelle, Soprano Pipistrelle, and individual Daubenton's and Brown Long-eared bats.

**Photo 16: Emergence locations along red line (below fascia)(view looking north).**

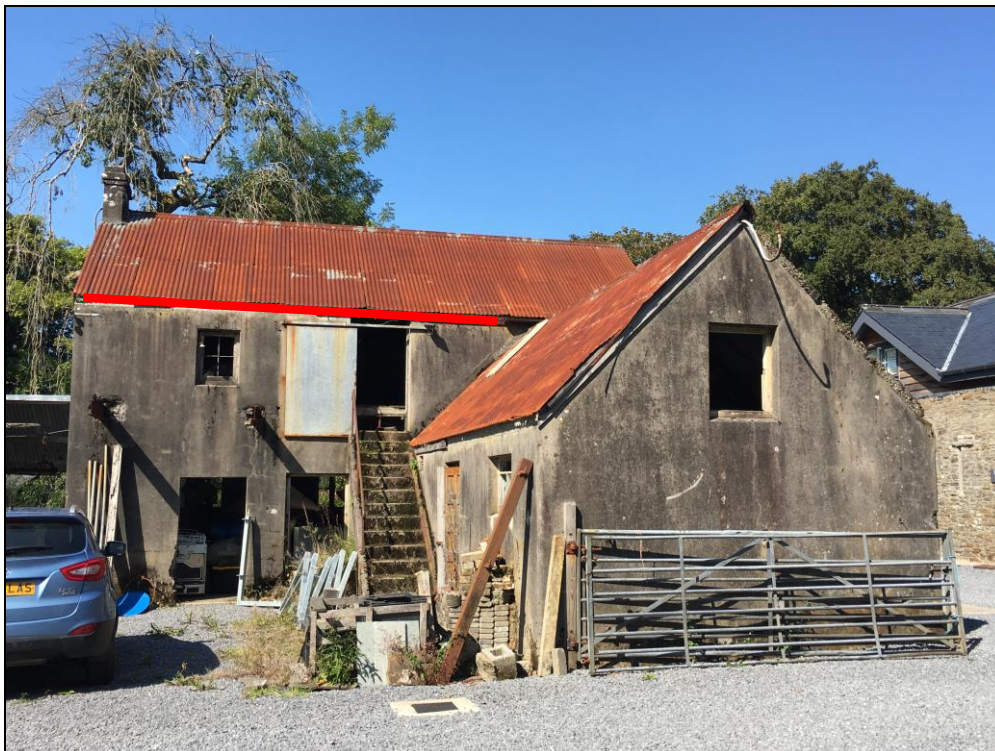
**Photo 17: Emergence locations along red line (below fascia) (view looking west).**

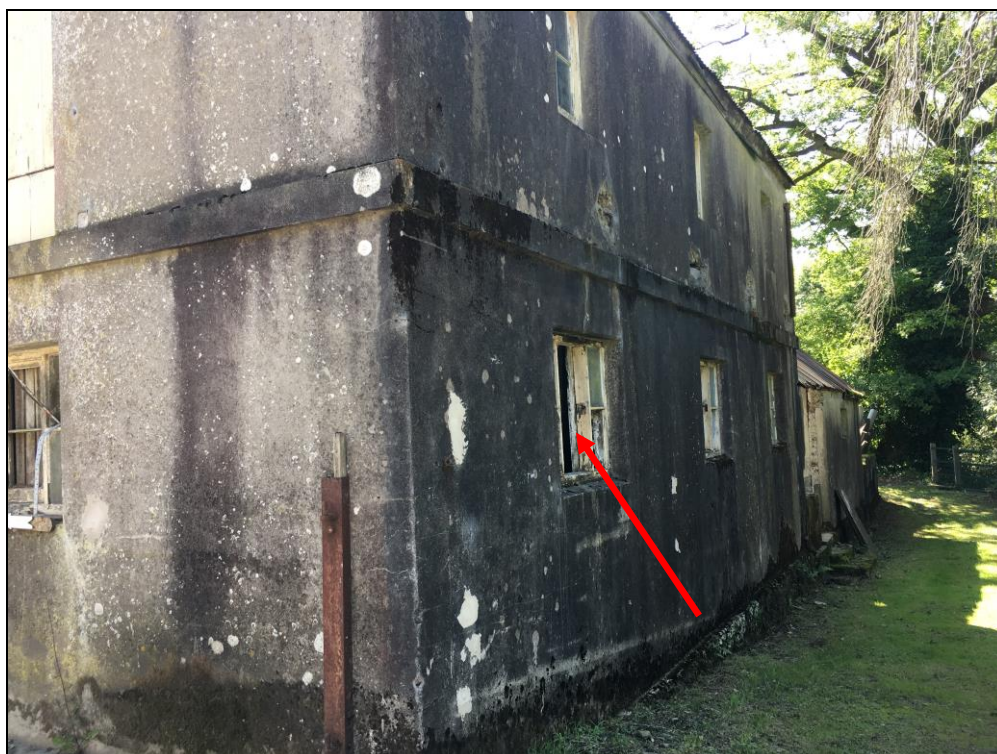
***Photo 18: Emergence from open window (view looking south).***
