Neath Port Talbot  
Hospital  
**Baglan Way**  
**Port Talbot**  
**SA12 7BX**

A **Preliminary**  
**Ecological Appraisal**  
By:

March **2022**

| <b>Report Title</b> | A Preliminary Ecological Appraisal |

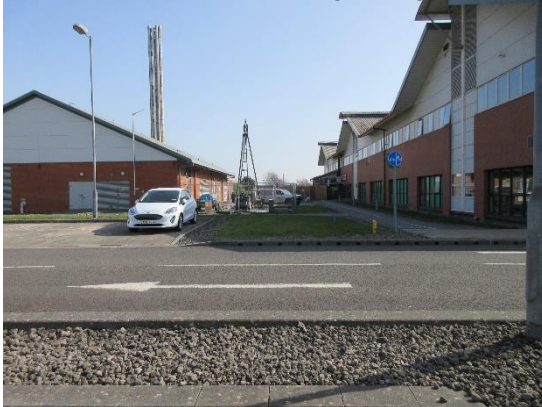
Plate 1: Location for new building looking south-east

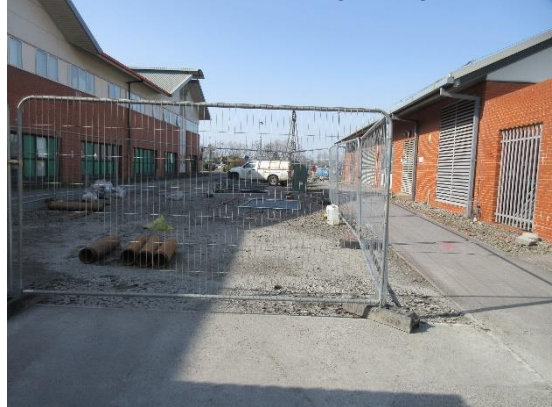
Plate 2: Location for new building looking north-west

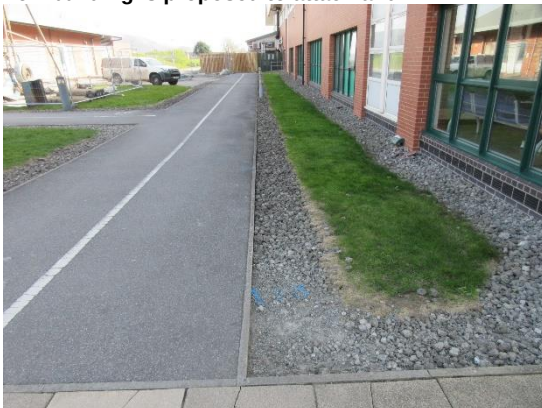
- 9.2 No potential roost features for bats were identified on the two buildings either side of the proposed development. No evidence for breeding bird activity was noted. Along the north-east side of the main building, where the new building will attach and link at ground floor and first floor level, there are no features suitable for providing bats the opportunity to occupy a resting place that risk damage, destruction or obstruction of a roost. The Energy Centre will remain the same with no modifications and it is not affected in the same way as the main building, no features suitable for bats were noted here. No bird activity indicative of holding a breeding territory or nest building was detected around the buildings in the development zone.

Plate 3: North-east elevation of main building where new building is proposed to attach and link

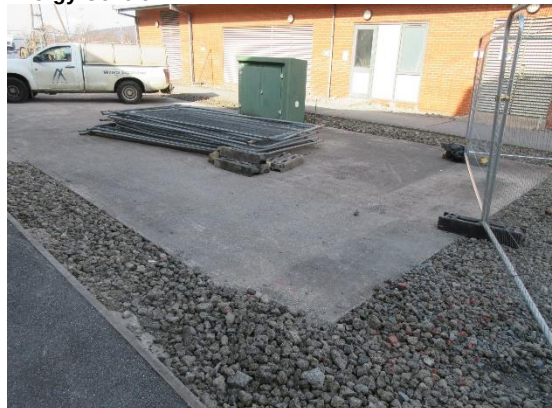
- 5.3 At ground level, the zone of the footprint for the new building contains a flat concrete plinth related to former infrastructure that is now removed (although these installations still appear in aerial images of the site as shown in Appendix 1). Also there are hard surfaces of pedestrian paths, a

Plate 4: Concrete plinth between main building and Energy Centre

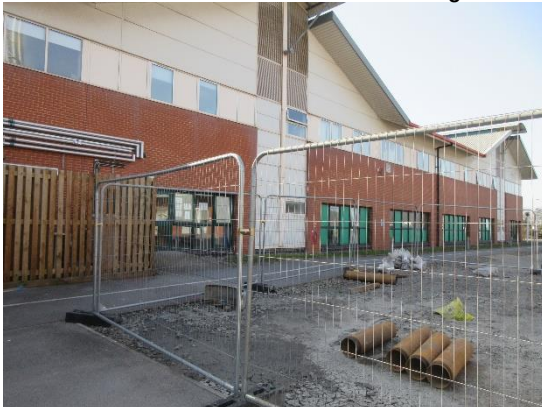
Plate 5: North-east elevation of main building

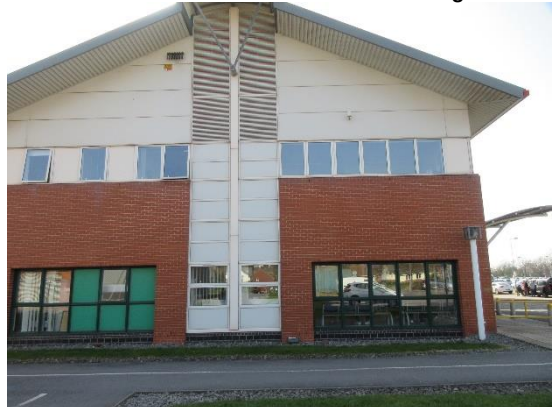
Plate 6: North-east elevation of main building

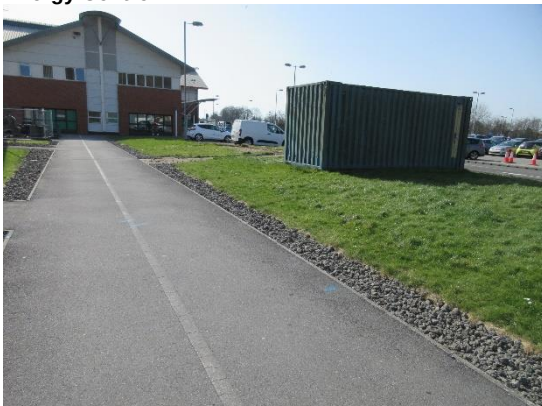
Plate 7: Pedestrian path at north-west NW end of Energy Centre

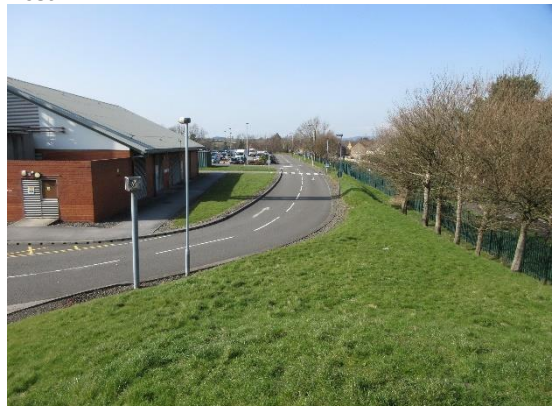
- 5.4 The Energy Centre is a rectangular shaped single storey modern structure standing on a north-west/south-east alignment. It is built in a style of brick and wall cladding that matches the main hospital building: it has a pitched roof covered with metal sheeting material. To the south-west, north-west and north-east of the Energy Centre there are small areas of short cut amenity grassland each fringed with a narrow band of stone chippings.

Plate 8: North-eastside of Energy Centre looking north-west
