**SWISS GABLES,  
DYFFRYN,  
NEATH  
HERITAGE IMPACT ASSESSMENT**

March 2022

Nathan Goss Conservation

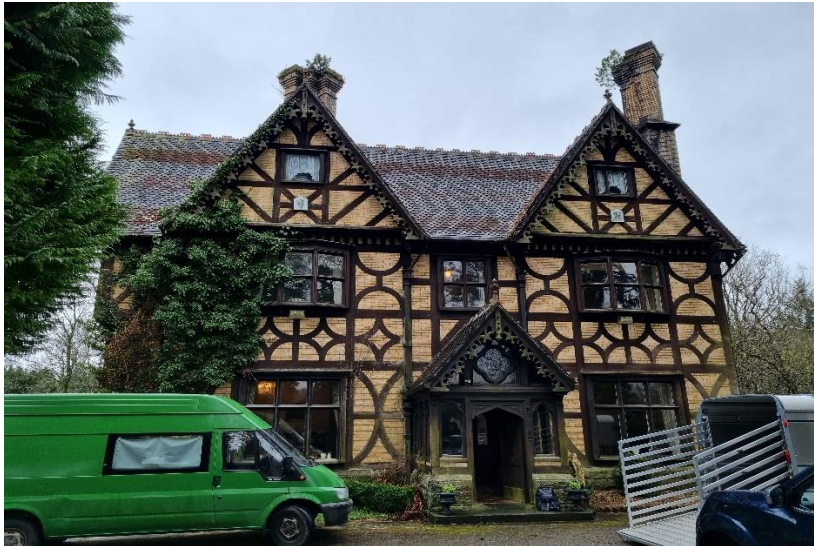
Fig.4 East Elevation

The east front of the three bays has two gables, a large three-light window each side of timber porch, there is a smaller three-light window each side of the jettied gables, while the centre window has two small fixed lights. Right up in the top of the gables you find two little

attic windows. There is some decorative framing to the front gable that includes diagonal beams, opposed curved beams and panelling. There is a timber-framed porch which also has a Tudor-arched front door with cusped traceried side lights, with quatrefoil with coloured glass.

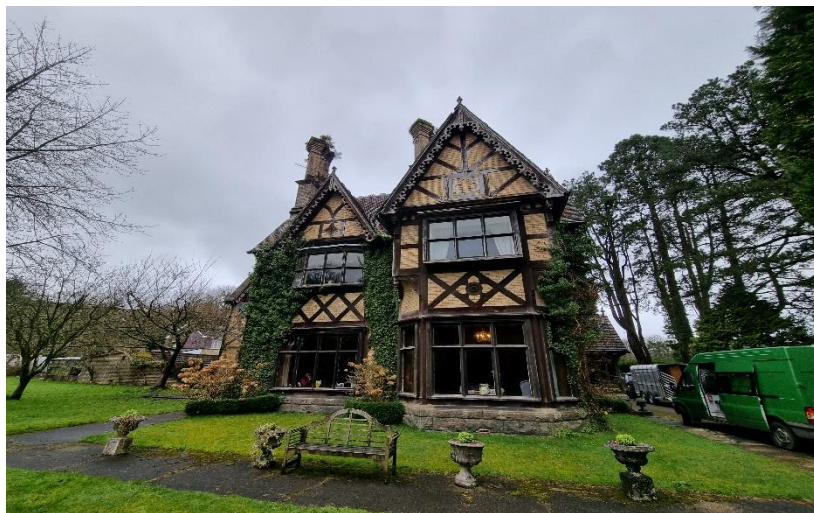
Fig.5 South Elevation

The south elevation has a projected gable to its right with a canted ground floor. There is some wooden diagonal cross bracing and a carved rosette in a centre panel just under the first floor three-light oriel window. The carved brackets carry the jettied attic gable, this has a quatrefoil pattern panel and herringbone bracing. There is some patterned framing below the oriel window and to its sides on both floors. The majority of the tall chimney shafts on the ridge can be seen on the west end.

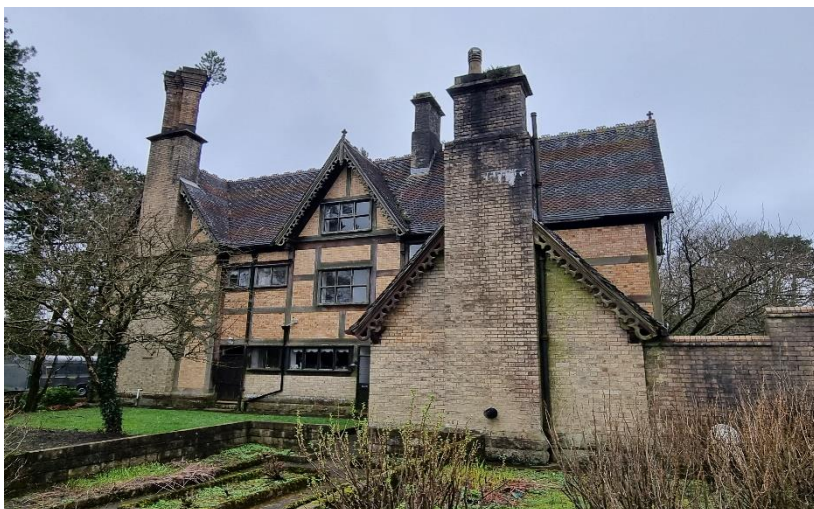
Fig.6 North Elevation

To the rear of the building is the service range this has a band of decorative framing between floors, carved rosette in its gable. Two tall ridge stacks can be seen. W end of service wing has two big three-light kitchen windows, diagonal bracing in the panels above and a first floor three-light. There is a two-light attic window in the gable.

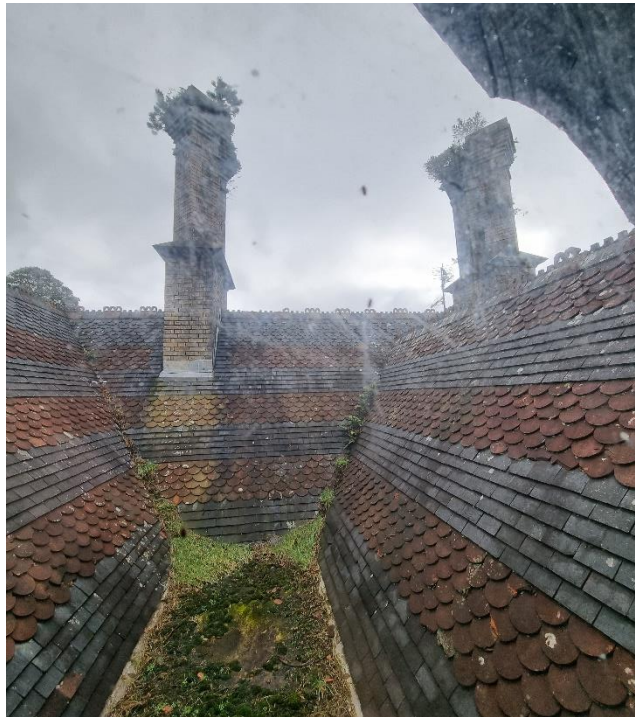
Fig.7 Centre gutter with foliage growth to chimneys

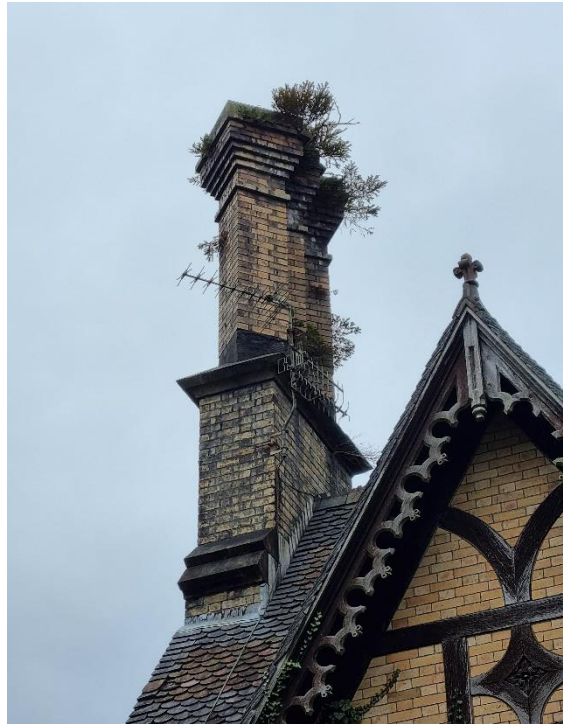
Fig.10 Chimney foliage growth (South Elev)

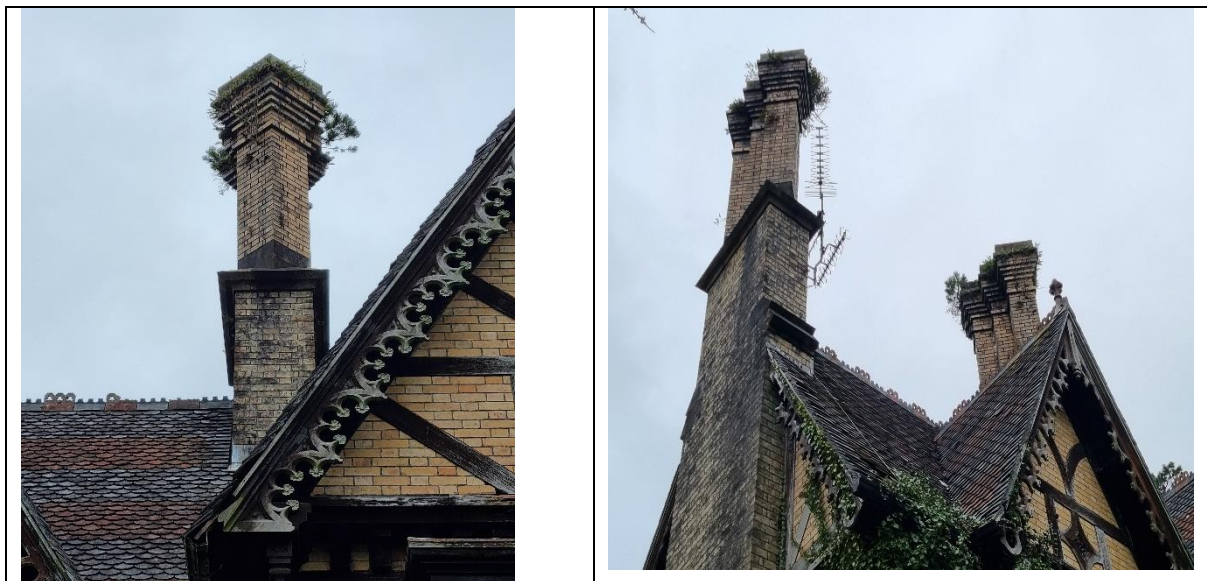
Fig.18 Chimney foliage

As you can see from the pictures above the many chimneys that rise up into the sky above the mansion have had no maintenance allowing buddleia and Scots pine to take root.

- Remove and repoint all the defective lime pointing to all the chimneys (Photo ref 1.1) – matched to pre mixed Rhondda lime mortar (Ty Mawr)
- Remove and renew defective flaunching to all the chimneys (Photo ref 1.1 and 1.2)

- Carefully dismantle any loose bricks, remove the foliage, rebuild using the same bricks bedded in lime mortar - matched to pre mixed Rhondda lime mortar (Ty Mawr) (Photo ref 1.1)

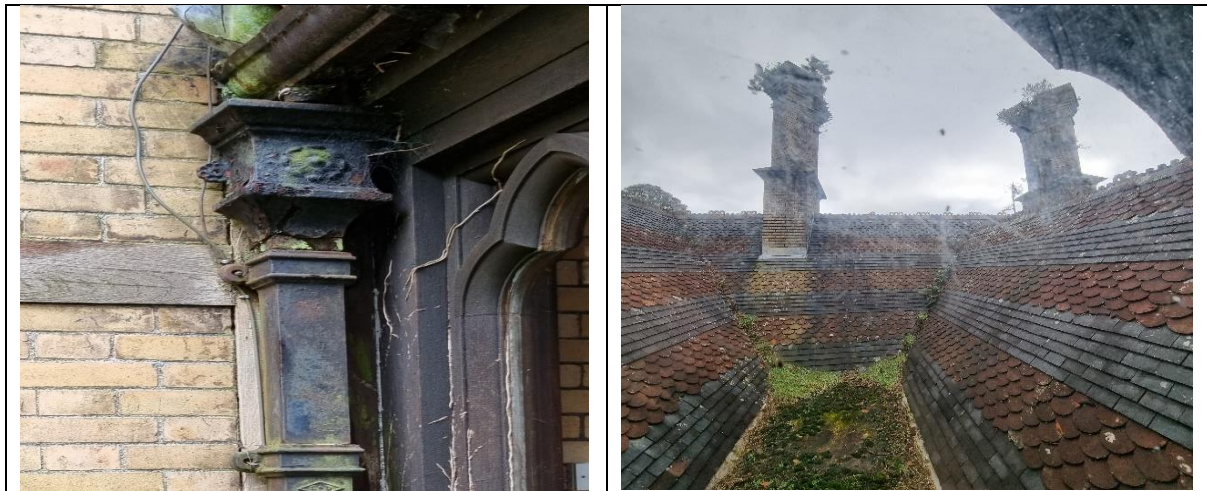
There are numerous areas where the cast iron guttering has split, this is due to lack of maintenance. The gutters have been allowed to block mainly with leaf foliage from many of the overhanging trees, the leaf foliage holds water and then freezes during a cold spell, expands and splits the cast iron.

Fig.19 Split cast iron guttering and blocked drains on the roof

As you can see from the photo above the secret lead valley gutter within the many pitches of the roof is blocked with foliage (assumed damaged) and grass has started to grow. There is a drain that feeds down via the attic and down through a fake wall within the property's walls.

- Re-new 1no concealed lead valley, they are approx. 1m wide x 2.5m long, new code 5 sand cast lead, dressed to fit the gutter, returned up the roof and over the tilting fillet and fixed according to LSA best workmanship guidelines (photo ref 1.2)

- Remove broken sections of cast iron guttering and replace with matching new cast iron guttering – 150mm x 100mm moulded ogee (photo ref 1.3)
- Remove, repair (weld) and re-fix the cast iron hoppers – approx. 380mm x 230mm x 150mm (photo ref 1.3)

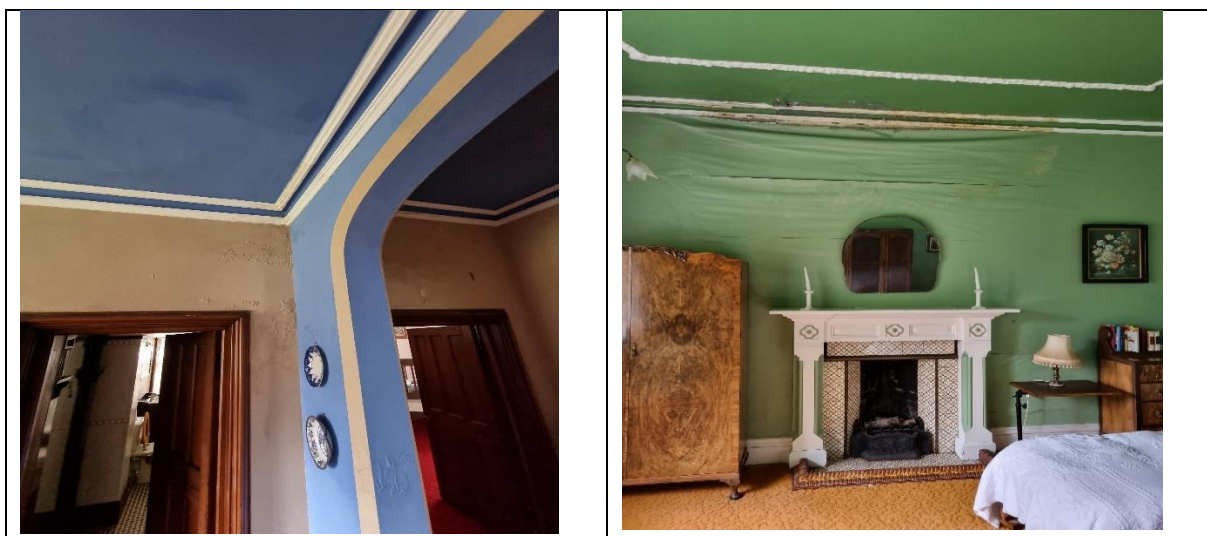
There are several places where the gutters, downpipes and secret valley are affecting the internal decor of the building. Paint, plaster and floor tiles are being damaged through water ingress.

Fig.21 Water ingress damage to walls and ceilings

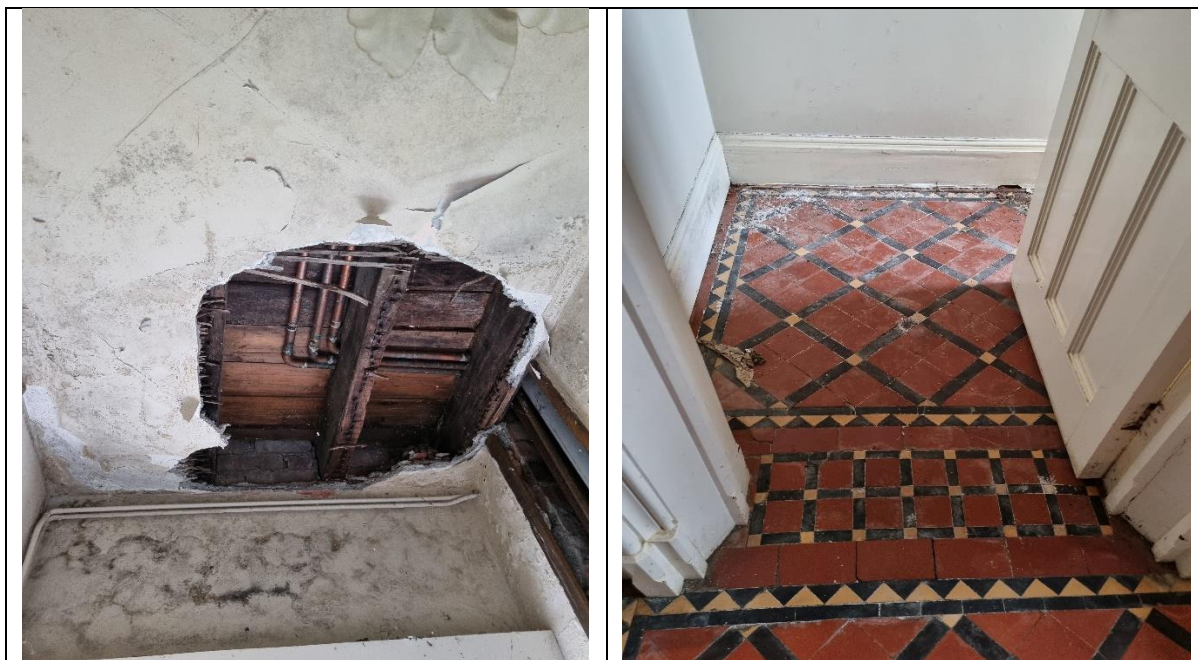
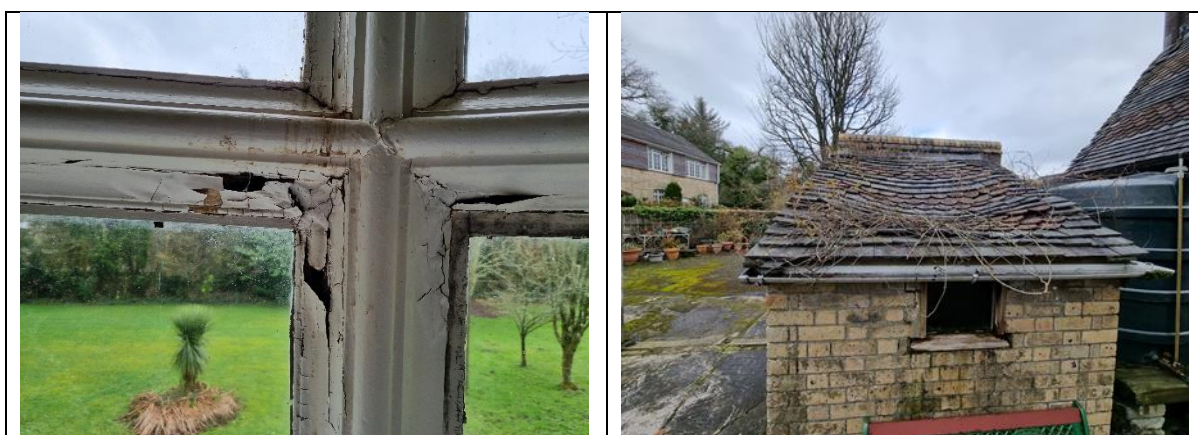
Fig.22 Water ingress damage to ceilings and tiled floors
