**Bat and Nesting Bird Survey Report**  
**96 Gnoll Park Road, Neath, SA11 3DD.**  
Surveys conducted May and June 2022

This report presents the findings of dusk emergence and dawn re-entry bat surveys of 96 Gnoll Park Road, Neath, SA11 3DD, (Ordnance Survey Grid Reference: SS 75744 97751). The main building and rear outbuilding are situated within the boundary of Neath Port Talbot County Borough Council.

The main building is a semidetached stone-built town house with a small one storey flat roofed side porch extension, a rear two storey extension and a rear one storey lean-to extension. The rear extensions have rendered and painted walls. The front main roof is made of interlocking concrete tiles, while the rear main roof areas and all rear extension roof areas are made of slates. There is also a one storey brick-built outbuilding with a slate roof located in the rear courtyard to the west of the main building.

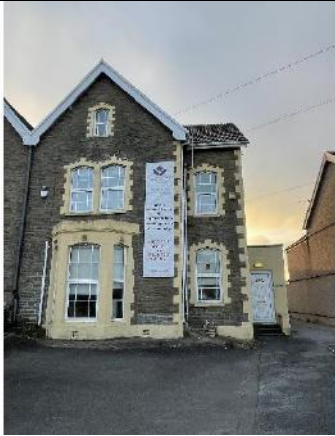
| <p>Photo 1: East facing front – note one-storey side porch to be demolished.</p> | <p>Photo 2: Interlocking concrete tile front roof</p> |

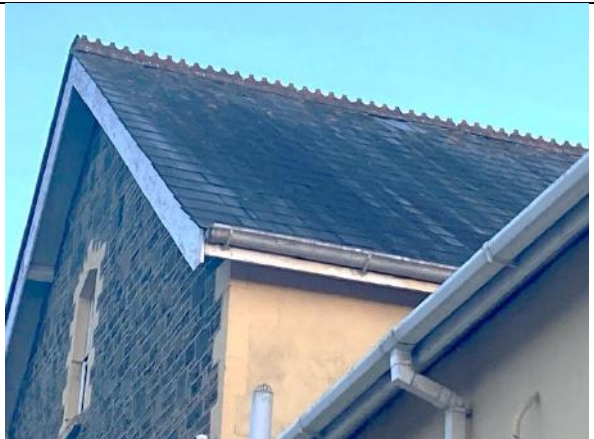
| <p>Photo 3: North facing gable end</p> | <p>Photo 4: Rear slate roof areas</p> |

Two bat access slates will be positioned in the rear slate roof areas of the main building from scaffolding during the works. A full re-roofing is not planned to be carried out, but patch roof repairs may be carried out.

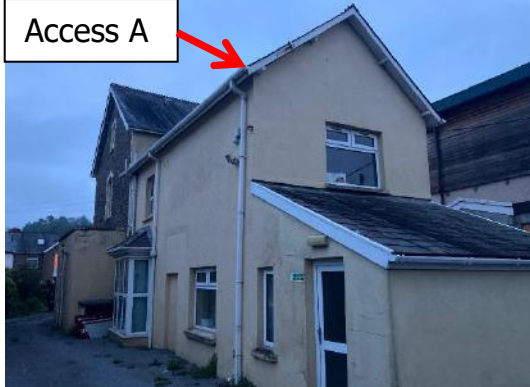
Access point A: The access point is likely to be a gap under a ridge tile in the slate roof areas of the rear two storey extension, with roosting areas in the cavity under the ridge.

A maximum count of one common pipistrelle bat was observed and recorded to be emerging from and entering the building during the dusk and dawn surveys, using the same access point (Access A). The access point is likely to be a gap under a ridge tile in the slate roof areas of the rear two storey extension, with roosting areas in the cavity under the ridge.

| <p>Photo 11: Access point by ridge of rear extension at dusk</p> | <p>Photo 12: Same access point by ridge of rear extension at dawn – bat entry at other side</p> |

The proposed works will cause permanent destruction of a bat roost identified (and may cause disturbance to nesting birds) as the pitched slate roof areas (and loft space) of the rear two storey extension will be permanently lost when these will be changed into a flat roof area. It will be necessary to apply for a European Protected Species (EPS) licence for bats with Natural Resources Wales (NRW) prior to the start of works.

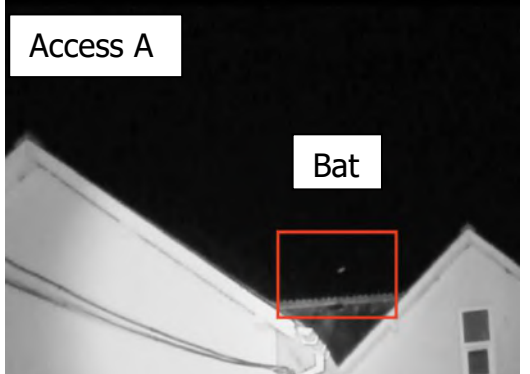
| <p>Photo 13: Same access point by ridge of rear extension at dawn – bat entry at other side</p> | <p>Photo 14: Same access point by ridge of rear extension at dawn – bat entry at other side</p> |

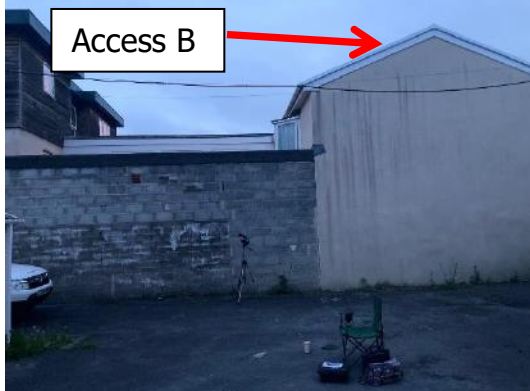
Access point B: The access point is an unknown gap of the roof areas of the adjacent rear neighbouring dwelling house to the south.

| <p>Photo 15: Access point at West neighbour to the rear</p> | <p>Photo 16: Access point at adjacent neighbour to the front</p> |

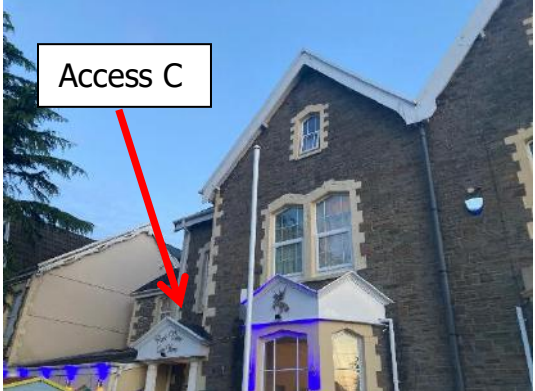
Access point C: Is an unknown gap in the front porch roof area of the adjacent semi-detached front neighbouring building to the south.

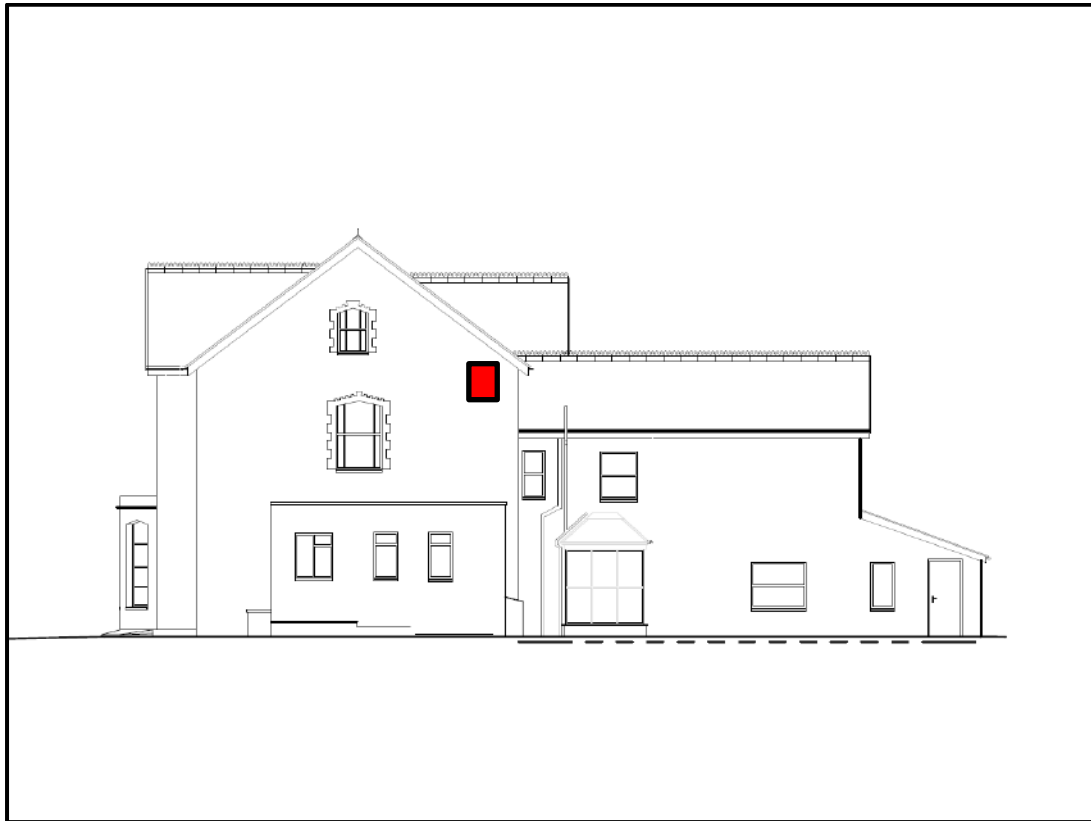
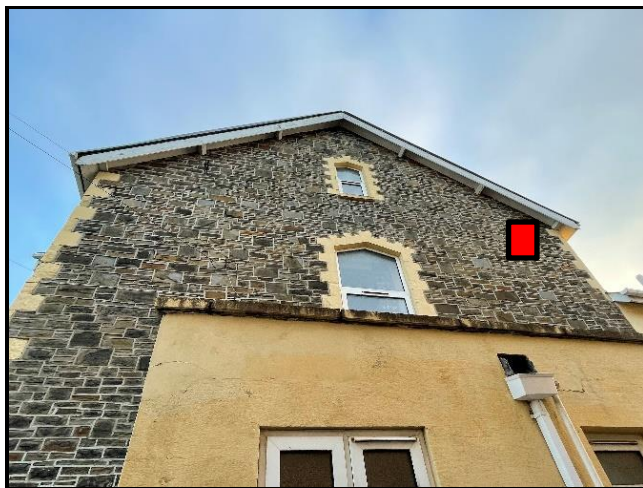
## Appendix 7: Position of Temporary Mitigation Bat Box – External Wall

= Position of temporary mitigation bat box on external wall

In advance of the works, one Beaumaris Woodstone Midi bat box will be positioned on the north facing external wall of the main building. No trees are available on this site to position the bat box.
