**Derelict House at  
Llandarcy Park  
Llandarcy  
Skewen  
Neath SA10 6FJ**

**An Ecological Survey  
Report By:**

| <b>Report Title</b> | An Ecological Survey Report |
| <b>File Reference</b> | JM3122 Report (Revision 1) |

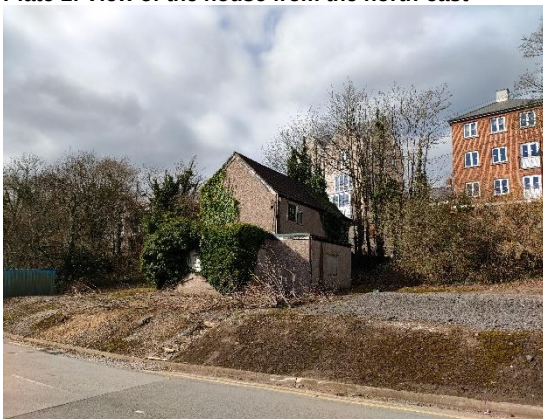
**Plate 1: View of the house from the north-east**

- 5.2 A two-storey former dwelling, the house is rectangular in shape, and closely aligned to an east-west axis. It is constructed with a mixture of materials including stone, cement blocks and brick. Exterior walls have been covered with a stone-chip or Canterbury spa render, and it features a pitched roof covered with cement tiles; supported by a timber purlins, rafters and trusses. A central ridge board is present and the roof is lined with a bitumen membrane. At the west end of the roof is a brick chimney. Attached to the east and north elevations are two single storey flat roofed sections, which are accessed internally. These two flat roofs are covered with felt and stone chippings. There is dense ivy (*Hedera helix*) growth partially covering all elevations of the structure.
