Llandarcy Campus  
**New MRI Scanner Unit**  
Bat and Bird Box Locations

**Document Title:** Bat and Bird Box Locations

**Document Reference:** 0330-RIO-XX-XX-RP-A-060003

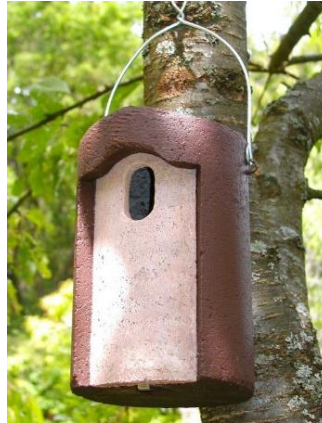
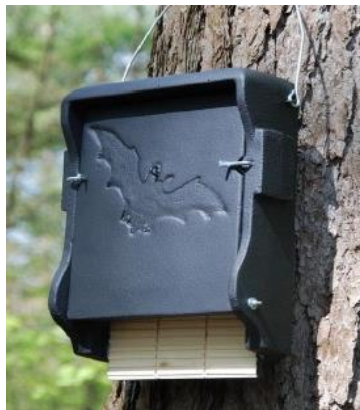
In line with the report we are proposing Schwegler 1FF Bat Boxes, as below.

In line with the report we are proposing Schwegler 1B Bird Boxes, as below.

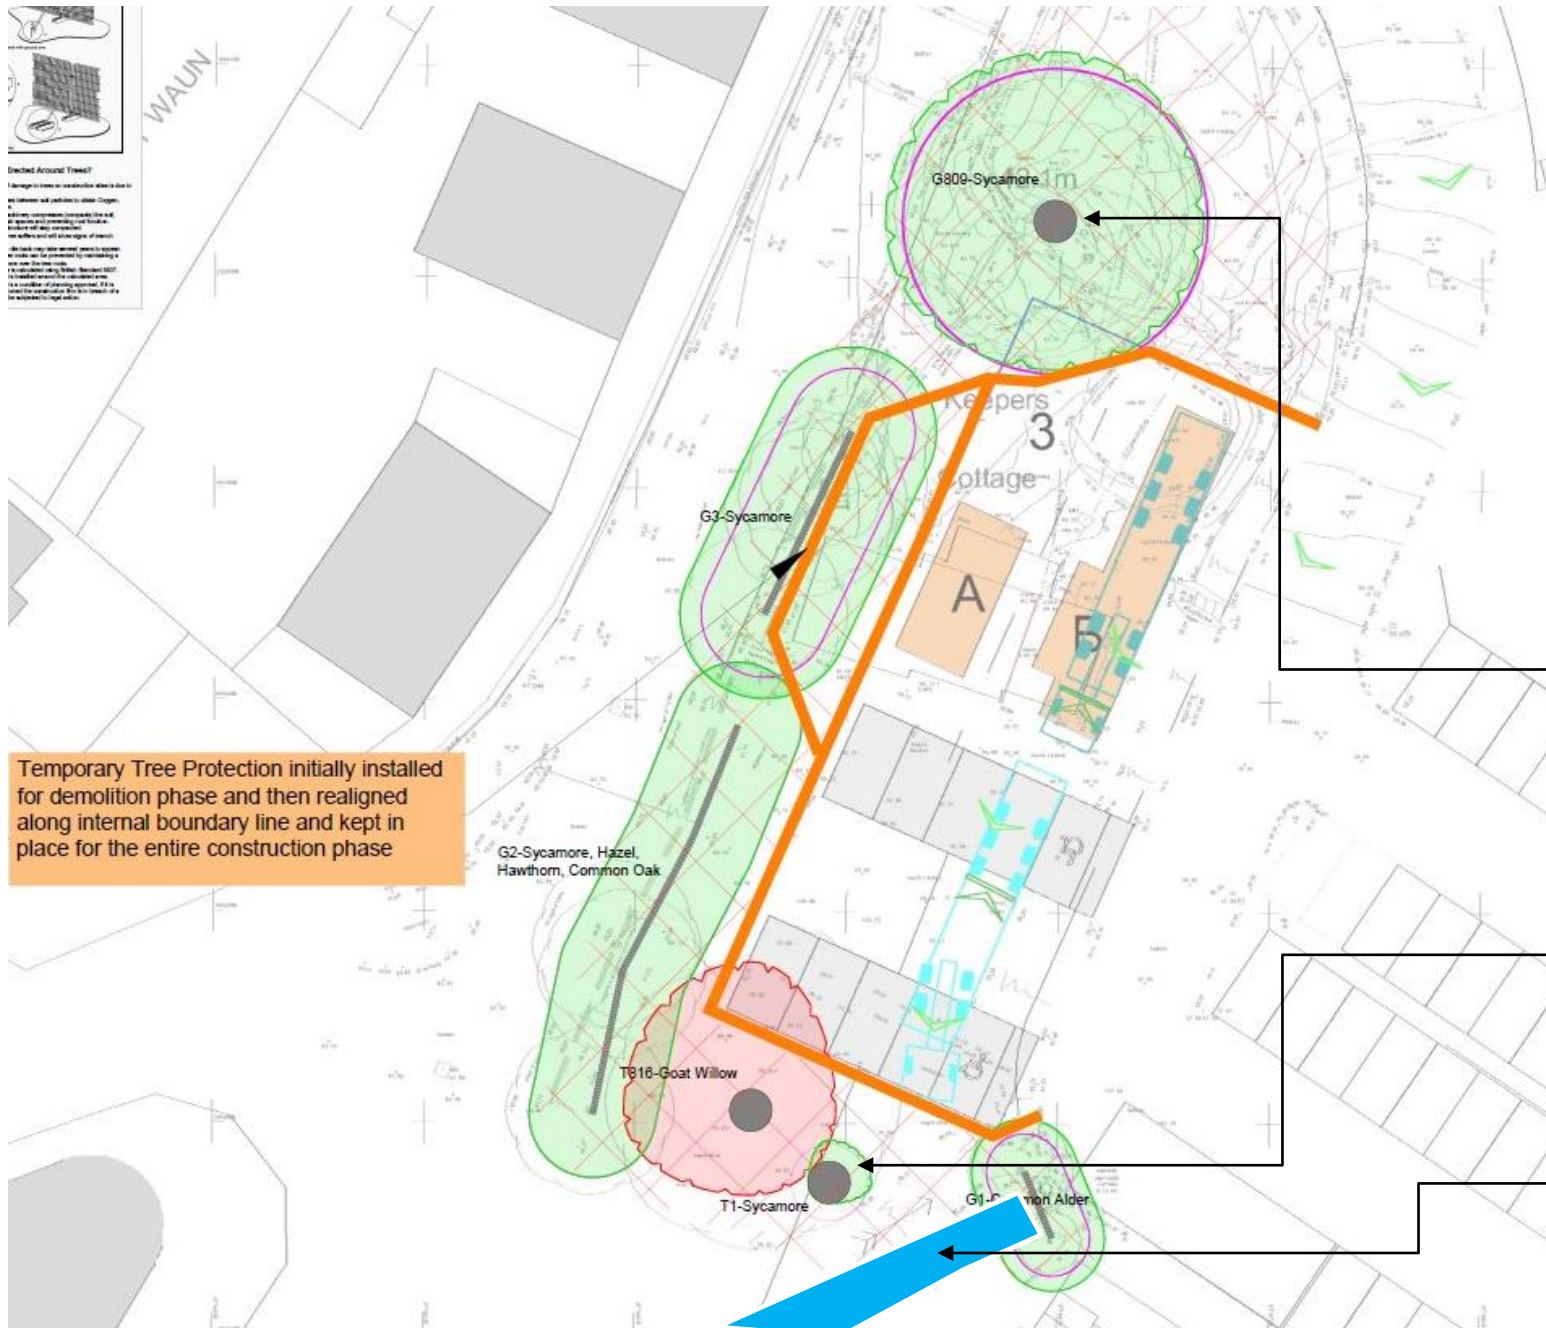
# Bat and Bird Box locations

We've positioned the bat boxes in a quiet location in a continuous habitat, with an open water course near by.

The boxes are to be positioned 4m high on the 7m high T1 Sycamore

Proposed location of 2no bird boxes (Schwegler 1B) one 26mm entry hole and one 32mm entry hole.

Proposed location of 2no bat boxes (Schwegler 1FF) one east facing and one west facing. On the T1 Sycamore

Existing open water course
