**Land adjacent to 100 Neath Road  
Resolven, Neath Port Talbot  
Proposed Residential Development  
Phase One Coal Mining Risk Assessment**

Report Reference: ESP.7168e.3163

## Land adjacent to 100 Neath Road Resolven, Neath Port Talbot Proposed Residential Development Phase One Coal Mining Risk Assessment

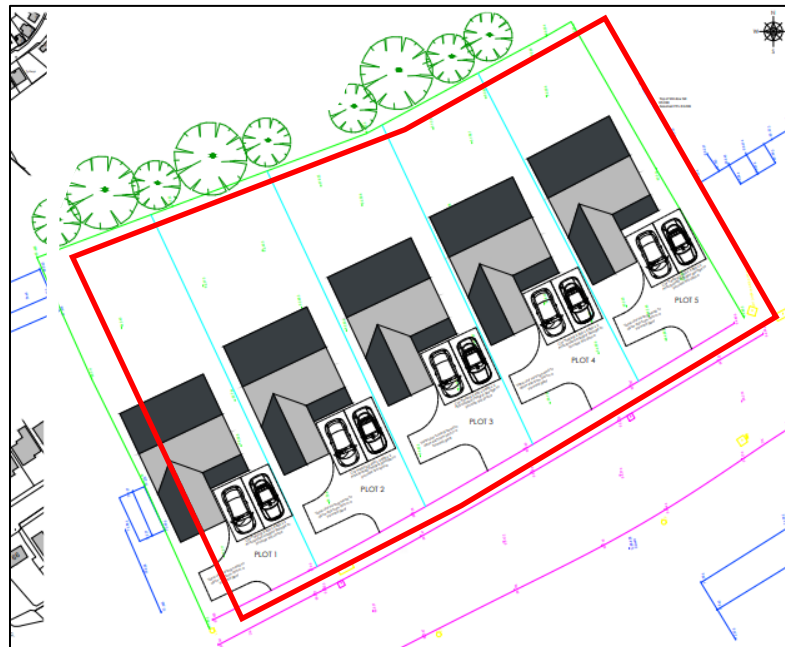
*Insert 2: Proposed Development Plan provided by the client. The red line is the site boundary. Not to Scale.*

A proposed development plan provided by the client indicates it will comprise 5no. detached residential dwellings with gardens, access roads and landscaping (see Insert 2). Such a development would be classified as being from Geotechnical Category 2 (BS5930:2015), i.e. conventional structures, with no exceptional risk.

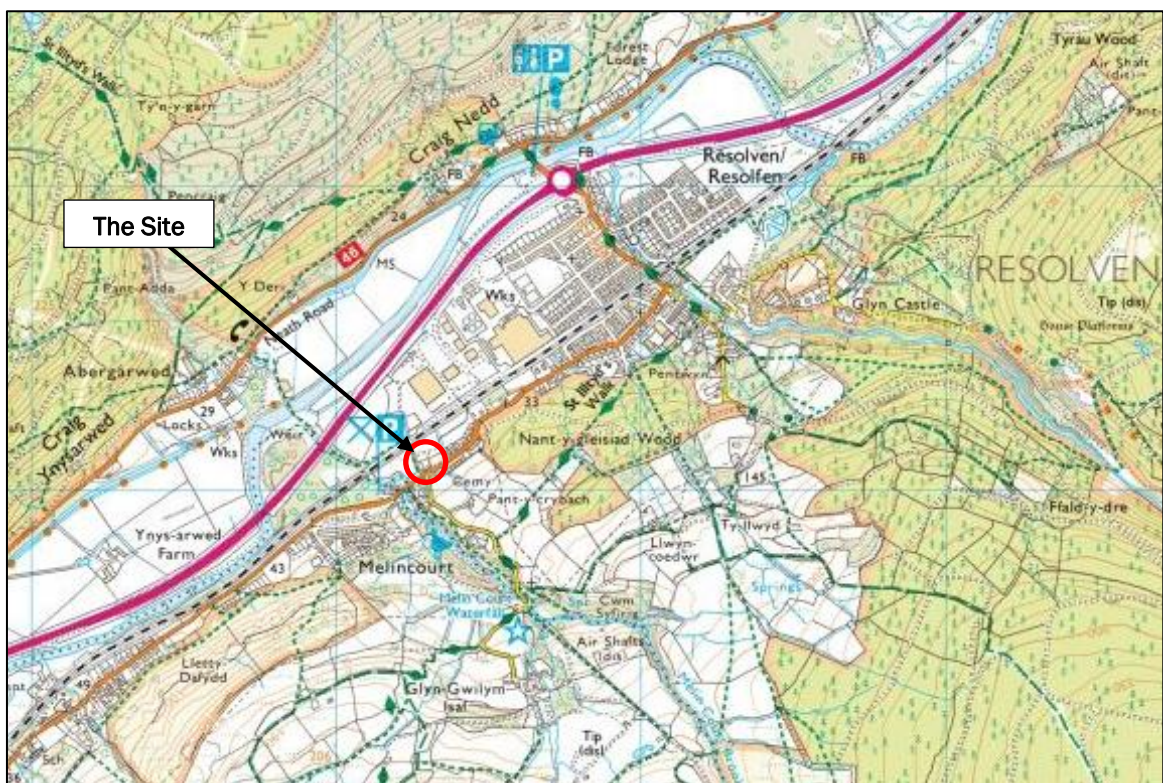
**Insert 2:** Site Location Plan. Extract from 1:25,000 scale Ordnance Survey map.  
(Reproduced with permission, OS License No.: AL100015788).

The site is located on the north side of Neath Road, New Road on the south west margins of the village of Resolven in Neath Port Talbot. The National Grid Reference of the centre of the site is (SN) 282328E, 202101N, and the postcode is SA11 4AN. A Site Location Plan is presented as Insert 1 below.
