**Neath Workingmen's & Social Club, 38–42 Wind  
Street, Neath, Neath Port Talbot, SA11 3HA  
Bat Survey Report for Castell Group**

| <b>Report type</b> | Bat Survey Report |
| <b>Report reference</b> | IG2022NeathWorkingmen'sClub |

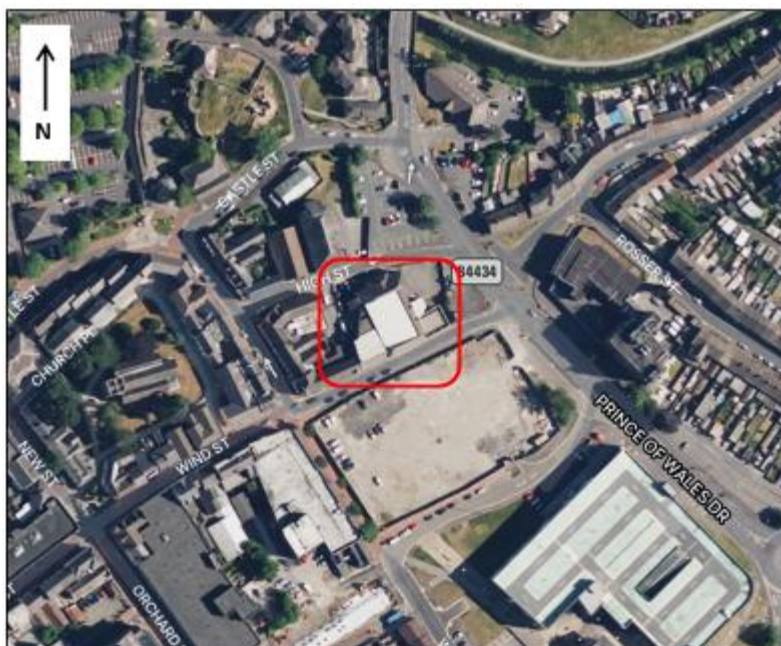
**Figure 1:** Aerial view of the property which is outlined in red (from Apple® Maps)

1.2.2 The property is subject to proposed plans for demolition to create space for a residential development. Figure 1 is an aerial view of the property, figure 2 on the following page is of the wider environment around the property, and figure 3 is a proposed site plan. Additional plans are included in Appendix 5.

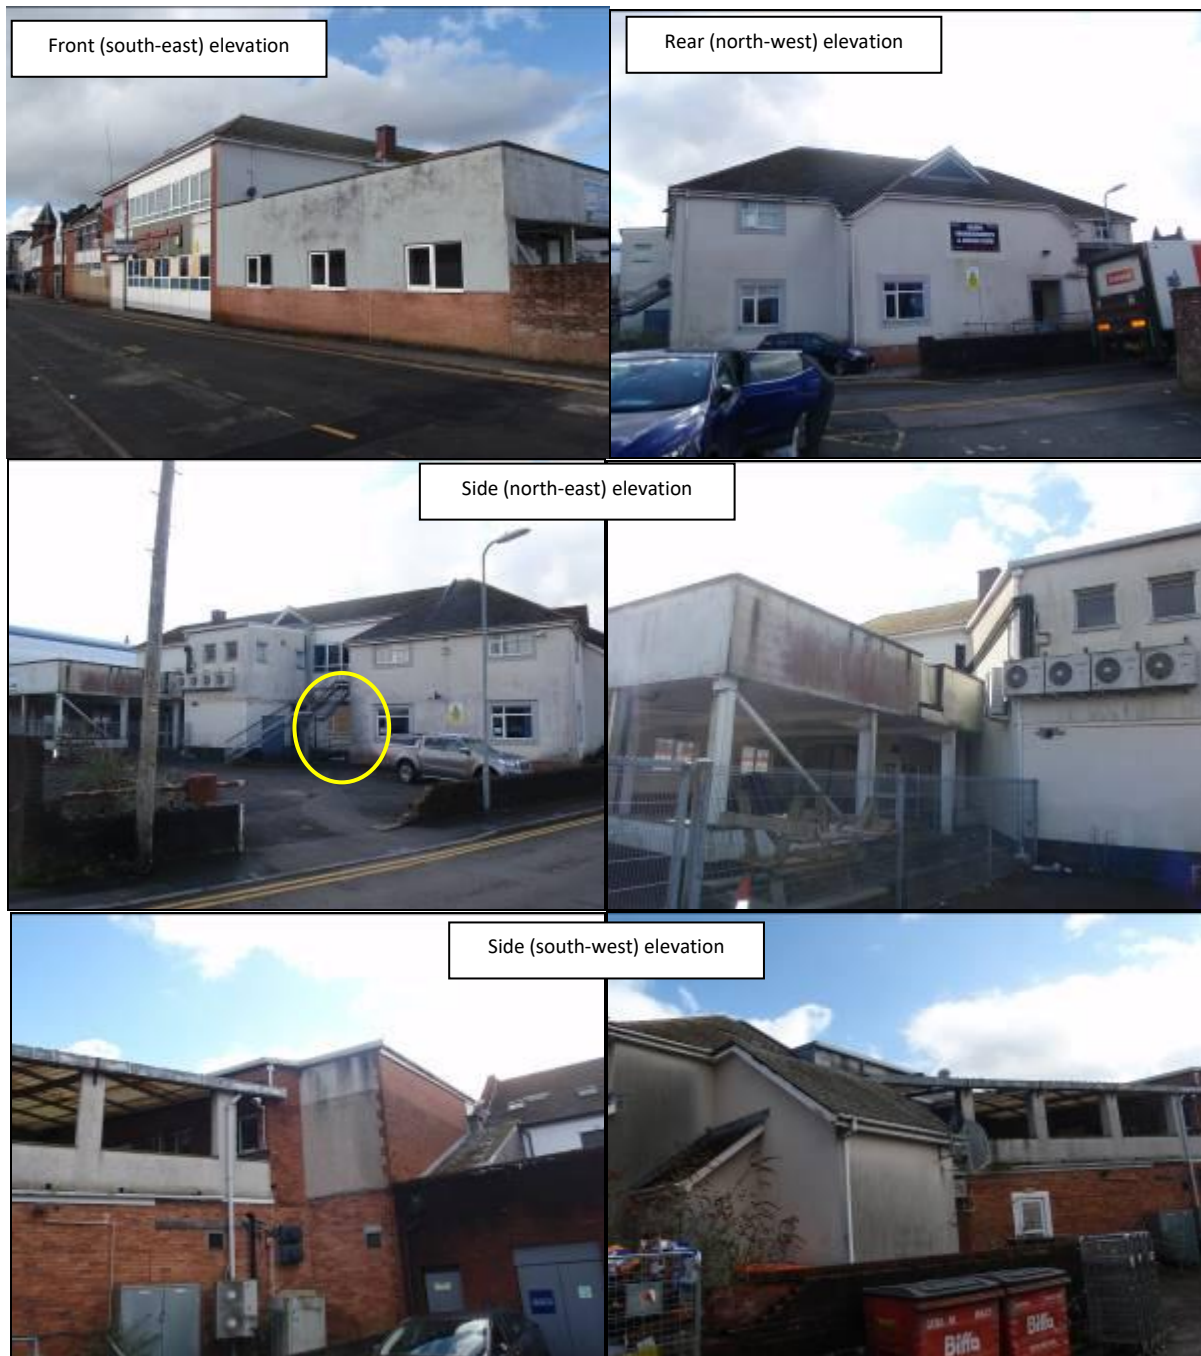
The property was formerly a workingmen's and social club which has been closed down and sold and is now subject to proposed plans for demolition to create space for a residential development. It is generally in good condition having been well maintained when in use and has only been subject to some vandalism – such as breaking windows – since it has closed. However, all damage has been repaired (see boarding in image three) It is constructed of block and brick walls (part rendered and part clad) with part bitumastic felt lined slate roofs, part fibreglass flat roofs, and part insulated box profile metal sheet roofs. The walls are in good condition with no cracks or crevices and there is mesh on the inside of the louvred vents. In addition, the uPVC soffits/fascias/barge boards are in very good condition with no gaps, and the predominantly uPVC framed windows and doors remain closed when not in use, and are repaired if damaged.

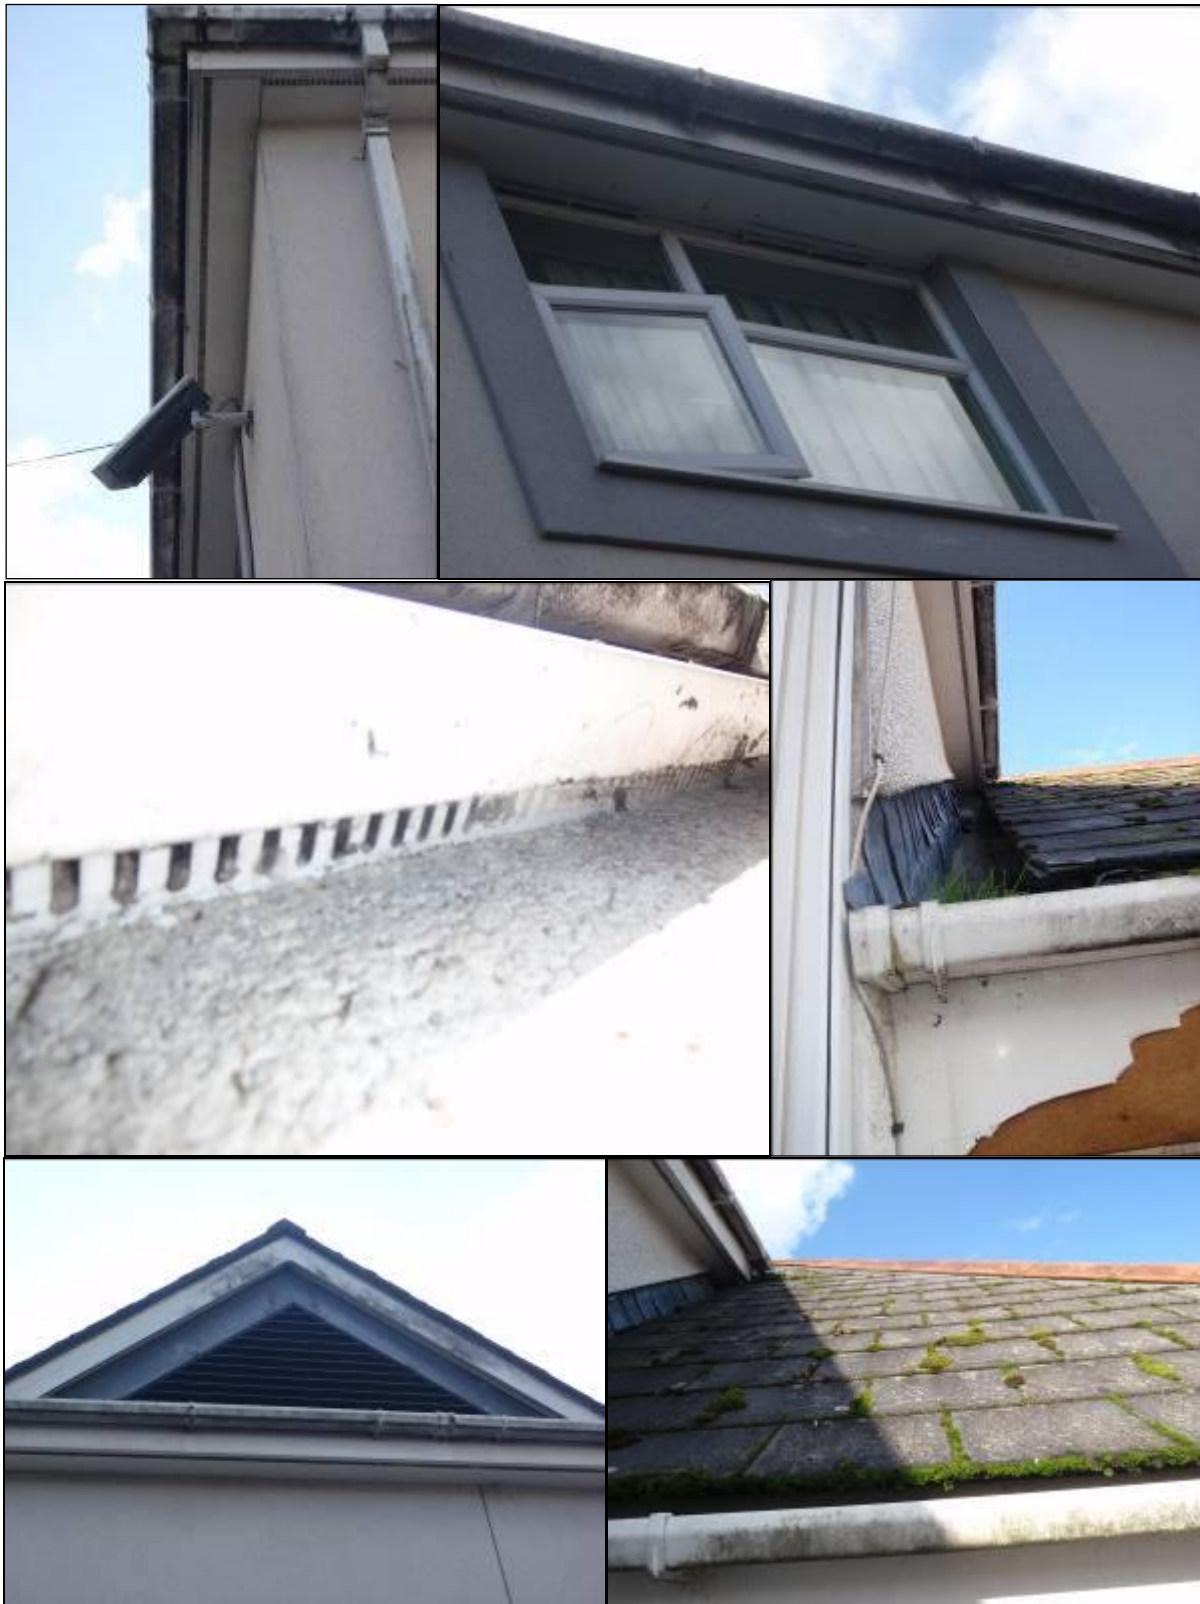
Additional exterior images. The roofs are also in very good condition with no missing/slipped/damaged slates or sheets, no damage to any flat roof, and no potentially exploitable gaps anywhere.

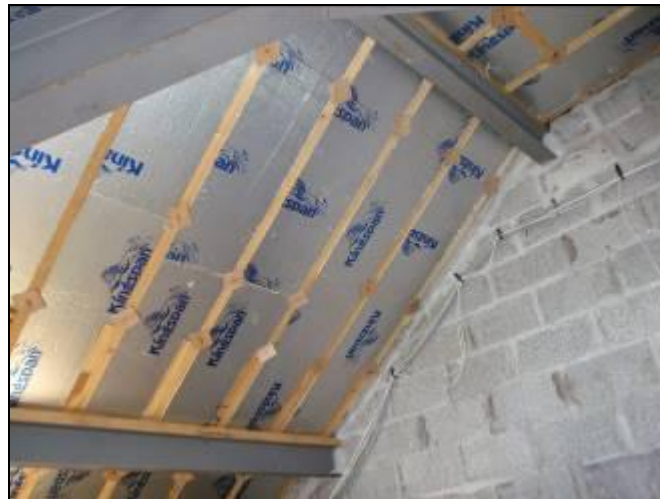
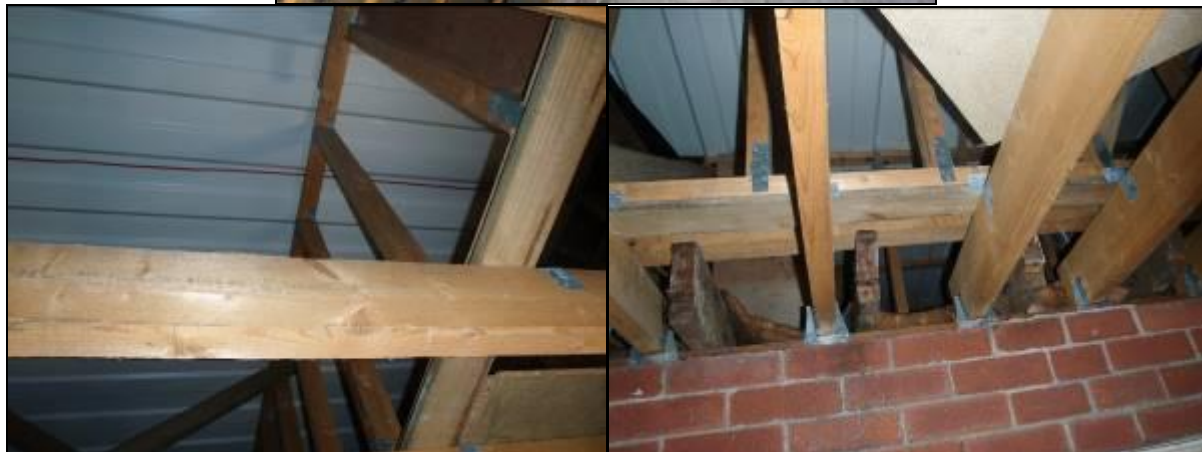
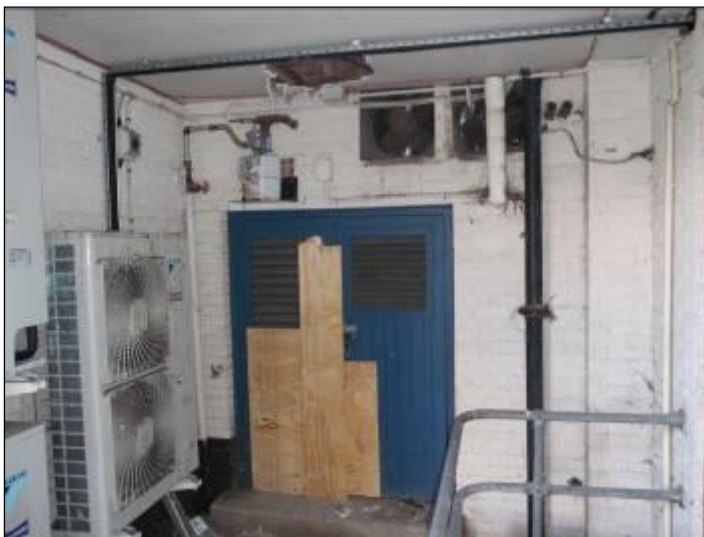
Internally, the roofs are all in good condition with no damage and while natural light enters the ground and first floor through the many windows, no natural light enters the attic spaces. In addition, the walls are in good structural condition with only a small number of in-wall and wall top gaps, but these were carefully examined with no bats or their signs found. There is damage to the ceilings in some areas but there are only

undisturbed cobwebs, dust, and debris on the timbers, walls, and surfaces and **none of the items or surfaces within had any signs indicating the presence of bats (e.g., live or dead bats, droppings, urine stains, smells).**
