**Former Primary School, Water Road,  
Gwaun-Cae-Gurwen, Neath Port Talbot, SA18 1HA**  
**Bat Survey Report for Messrs D. & D. Davies**

| <b>Report type</b> | Bat Survey Report |
| <b>Site</b> | Former Primary School, Water Street, Gwaun-Cae-Gurwen, Neath Port Talbot, SA18 1HA |

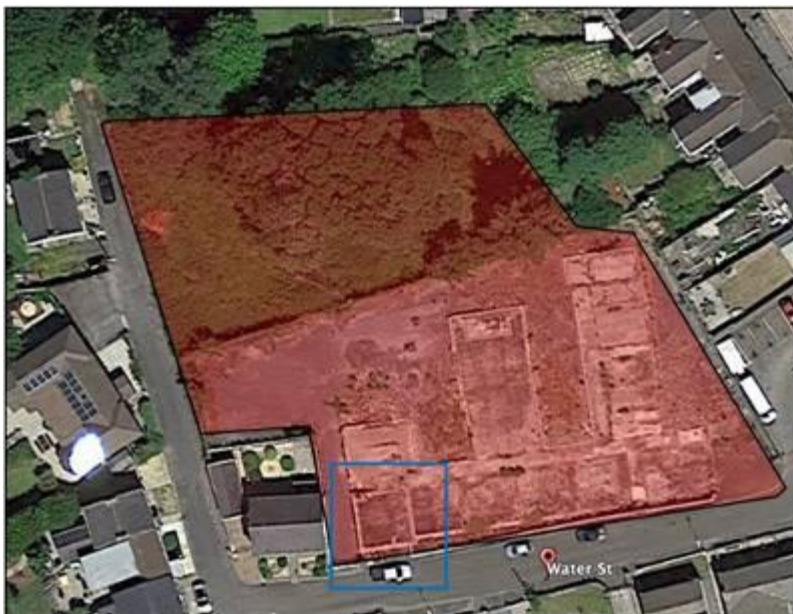
**Figure 1:** Aerial view of the property – the site is shaded in red (reproduced from the Ecological Appraisal Report) and the building is outlined in blue.

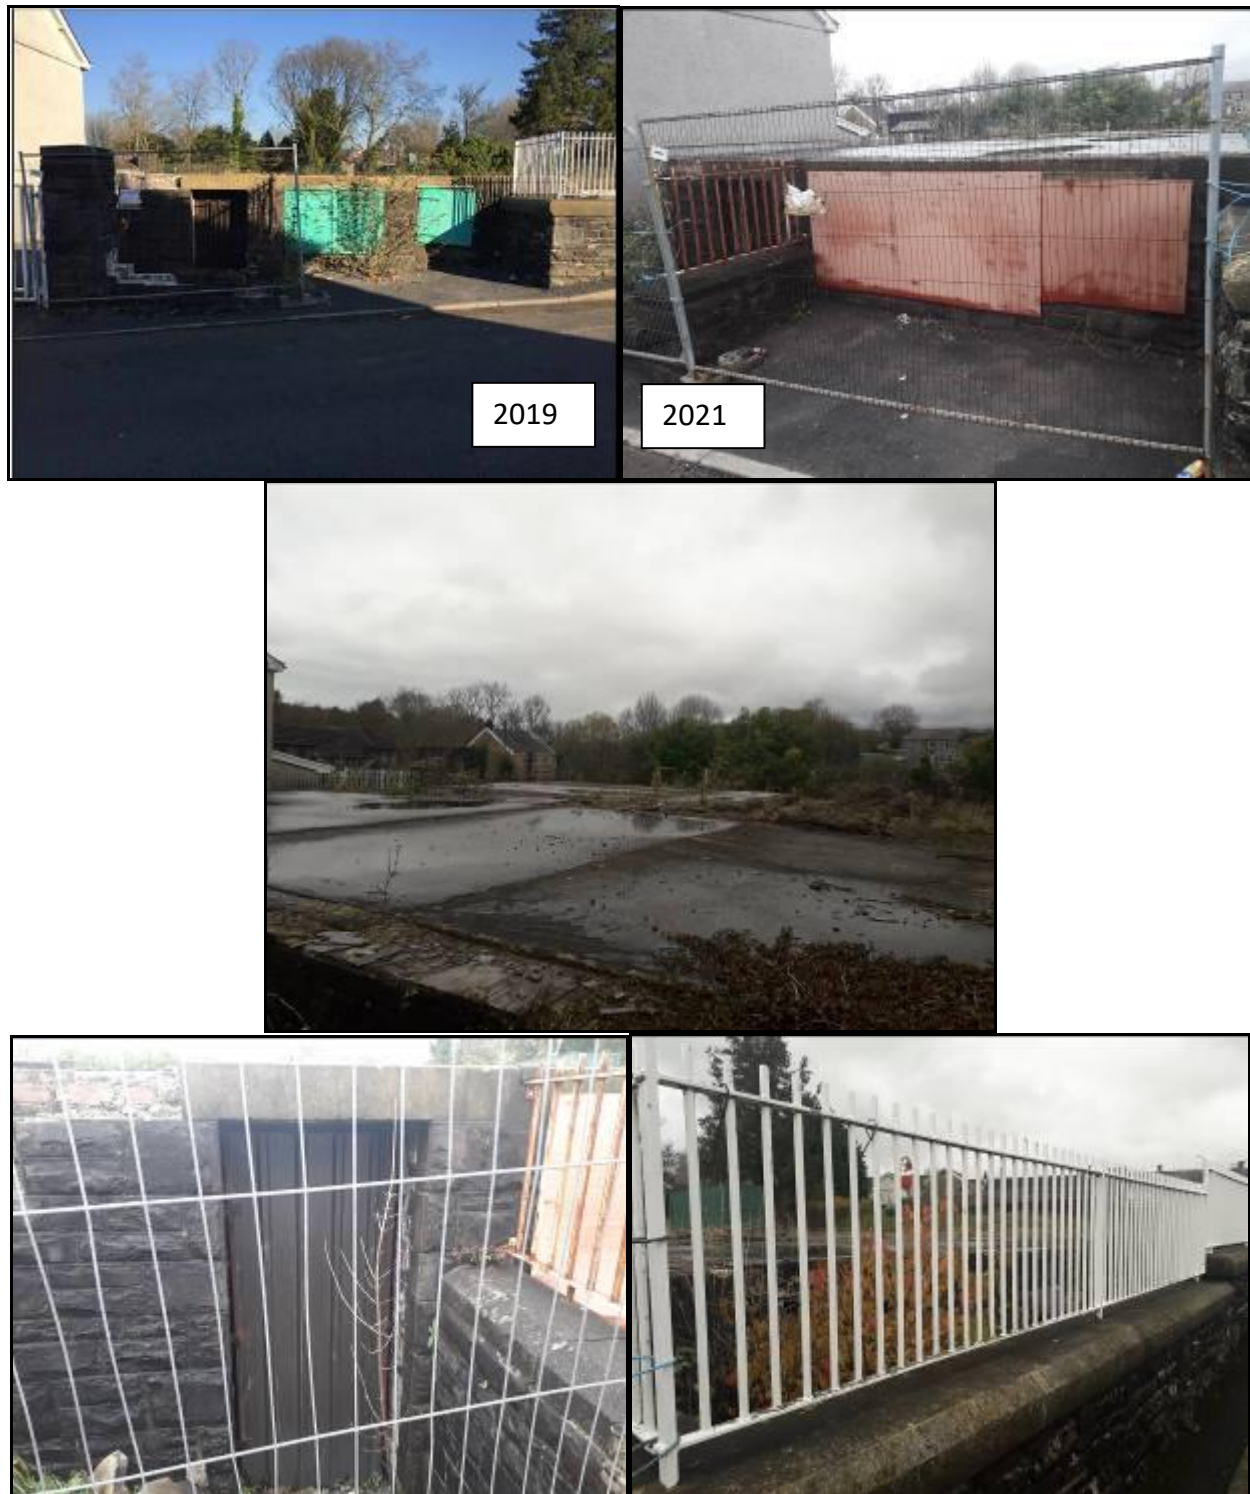
## Appendix 6: Site survey images

The 2021 PRA found that the only material change since the previous survey was the boarding up of windows/doors (including the door which had a slight crack). Internal access was possible through a door which has not been boarded up and the building remains damp and no light enters. **No live or dead bats or their signs (e.g., droppings, urine stains or smells) were found anywhere either externally or internally.**

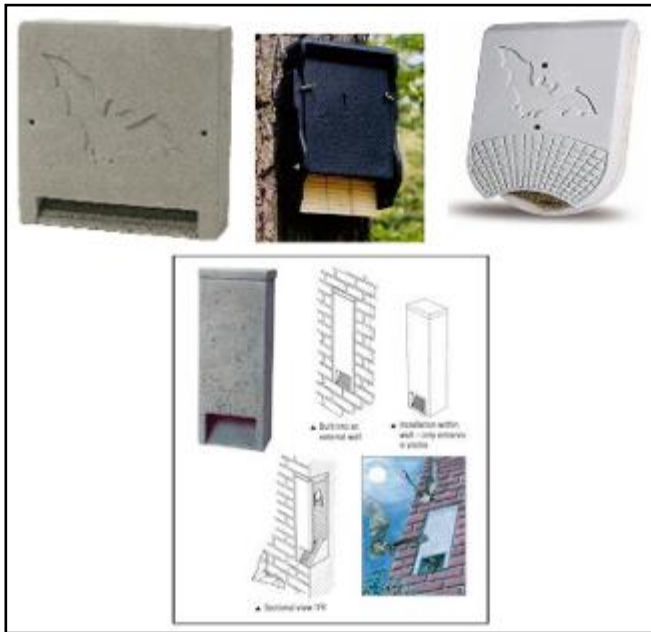
**Top:** From left to right, the in-wall Schwegler 1FE, the tree mounted 1FF and the multi season 1WQ. The bottom image shows the 1FR in situ.

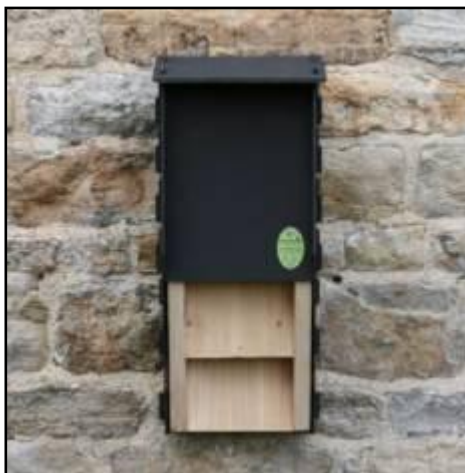
**Left:** The Eco Kent Bat Box is based on the popular and proven Kent Bat Box design. However, this box has an added weatherproof outer shell, making it more secure and long-lasting. The additional plastic layer also reduces draughts inside the box, thus providing a more attractive roosting environment for bats. It is suitable for crevice-dwelling species. The two crevices inside the box are approximately 18mm wide, ideal for common and soprano pipistrelles. The FSC-certified spruce wood is roughly sawn on the inside, providing good grip for bats once inside the box. This box is self-cleaning and does not require any maintenance, as the droppings fall straight down out of the bottom entrance.

These bat boxes can be mounted on either a tree or building using the three concealed keyhole fixings located at the top of the box. If possible, site the box at a height of between 4m and 6m in a sheltered sunny place, away from artificial light sources. The box should not be positioned in direct sunlight. Ideally, several boxes should be placed facing different directions, as this provides a choice for roosting bats. A clear path to the entrance of the box is essential.

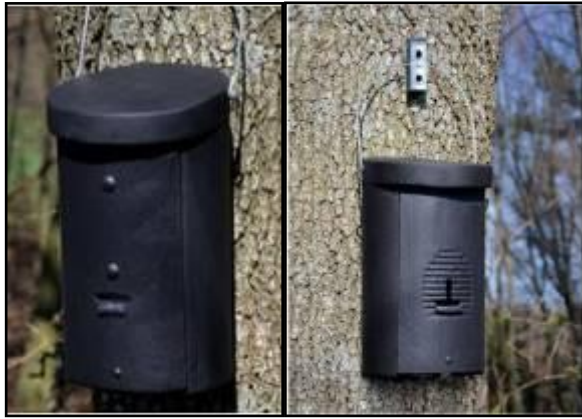
**Above:** The Schwegler 2FS (left) and 3FS (right)

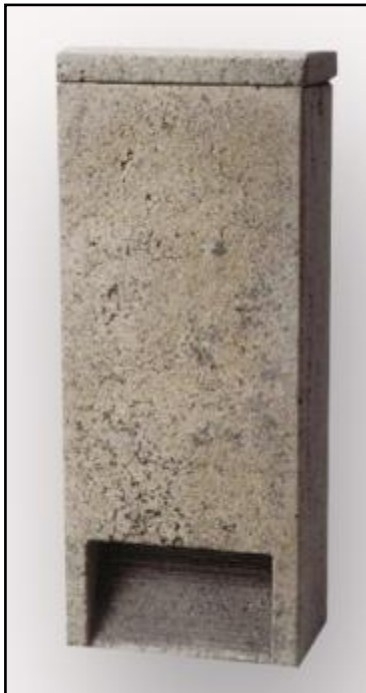
**Left:** The Schwegler 2FR is designed as a modular unit with interconnecting holes so that it can create larger spaces with transverse connections. If the bats are accessing the building interior (as in this case) then multiple 2FR units are recommended. The 2FR bat tube by Schwegler is for summer roosting bat species that prefer to inhabit buildings. It is designed to be built in i.e., either bricked in (in which case the front will remain visible) or rendered over into the building façade. The narrow depth, just 12.5cm, makes it very suitable for fitting into the thermal insulation. The 2FR is a modular unit with optional interconnecting holes in the side panels so that it can create larger spaces with transverse connections – a minimum of 3 units interconnected is recommended. Each tube has three different types of internal partition plus an optional hole in the rear panel that allows bats access to wall cavities (and their existing roosts). This provides an unobtrusive solution for older buildings and their conversion/renovation. All the above means bats can crawl out of one tube, into another, or into the wall behind the bat box. To make the holes, gently knock out the appropriate section. (See instructions for more details). Self-cleaning as any droppings just fall out of the entrance ramp. The bat box is made from Schwegler's Woodcrete, a tough, weather-resistant blend of wood and concrete that will last for years and won't rot, warp, crack or leak. Woodcrete is breathable/porous, so it can maintain an ideal, stable temperature inside and also provides a rough surface for the bats to cling to. Combine all this with a box design that prevents water from entering it and you have a unit that will protect bats for decades.

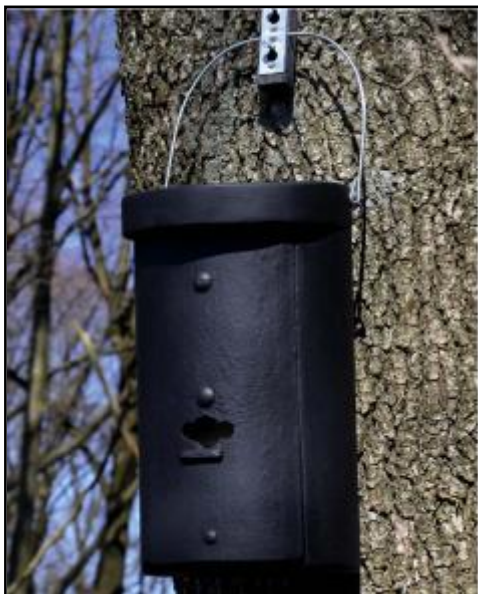
**Left:** The Schwegler 1FS Large Colony Box provides bats with a very large internal space. This allows high numbers of bats to congregate together and makes it very popular for accommodating large colonies in summer. It is particularly attractive to Noctule (*Nyctalus noctula*), Nathusius' Pipistrelle (*Pipistrellus nathusii*) and Common Long-eared Bat (*Plecotus auritus*) and nurseries containing 70-100 bats have been observed. The large internal space and variety of hanging places makes it ideal for bats to use as a nursing area. The 1FS is suitable for both summer and winter quarters. The front panel consists of three grooved wooden panels and the special roof panel with an insulated grill is ideal for bats to cling to. A special panel is fitted on the inside of the roof, with an insulated grille onto which the bats can easily grip or hang on to. The front panel can be easily removed for cleaning and inspection. If the box is being used by large numbers of bats it is advisable to check it regularly to remove the droppings.

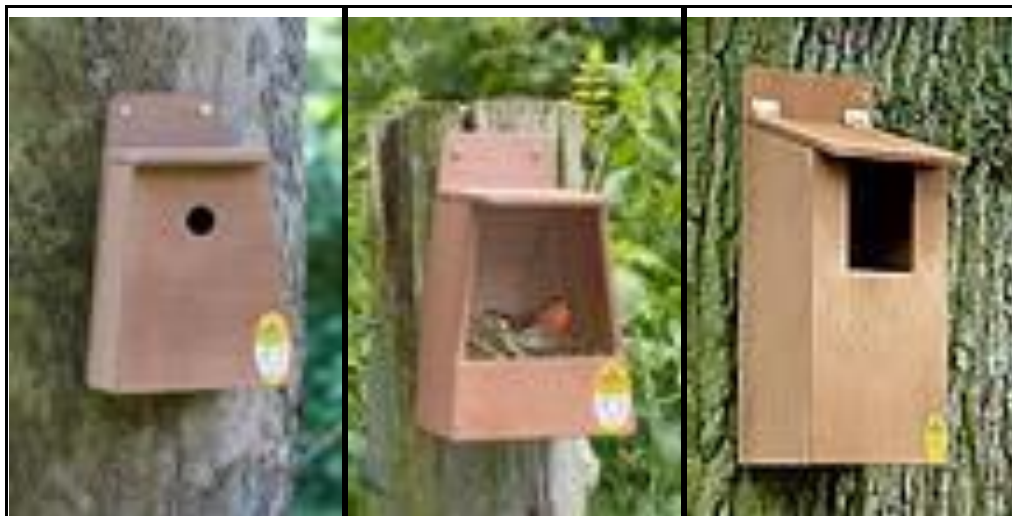
**Below left:** Small bird box. This comes in a variety of hole sizes: a 25mm hole for blue tits, coal tits and marsh tits; 28mm for tree sparrows and great tits; 32mm for nuthatch and pied flycatcher; and 38mm for redstarts. **Below middle:** Robin and spotted flycatcher box. **Below right:** Large bird nest box.

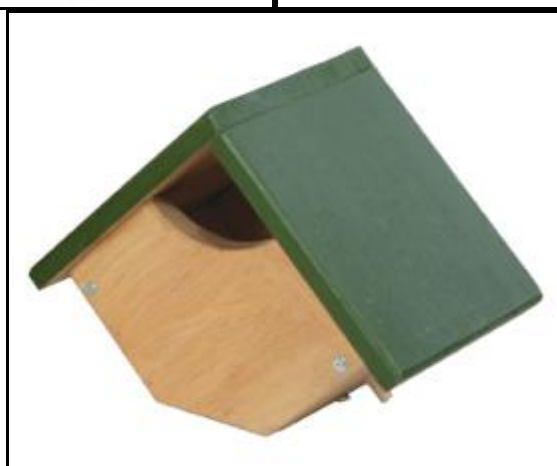
**Below:** Examples of small-holed and open-fronted nest boxes. Siting advice can be found at [Where To Put A Bird Box | Nestboxes - The RSPB](#)
