**18 Orchard Street, Neath,  
Neath Port Talbot, SA11 1DU**

**Bat Survey Report for Life Property Group Ltd**

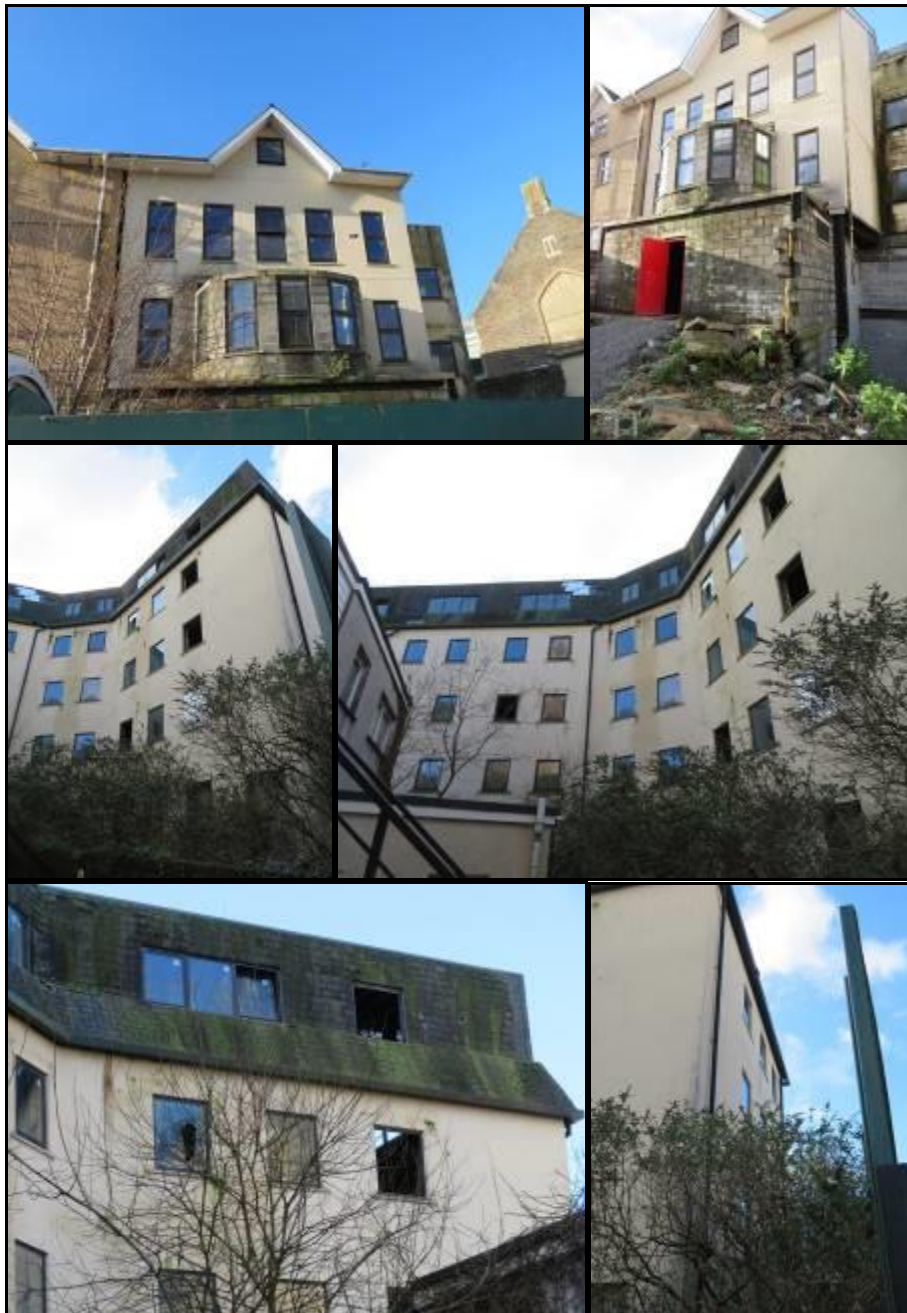
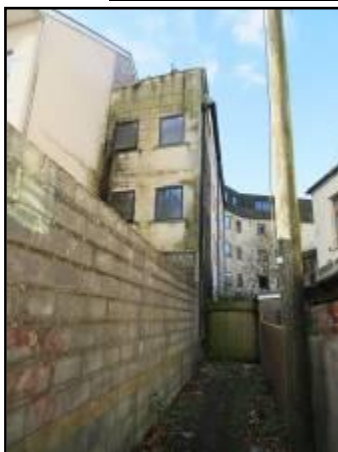
The property is a large east/west aligned office block which was constructed approximately 12 years ago. It is constructed of block cavity walls which have been rendered and painted and has a slate effect (felt shingle) roof and metal framed windows and doors (some of which have been boarded up).

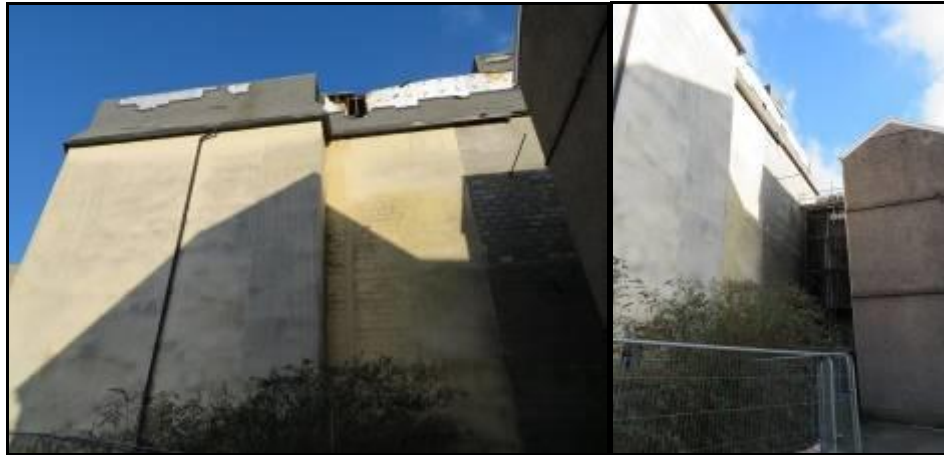
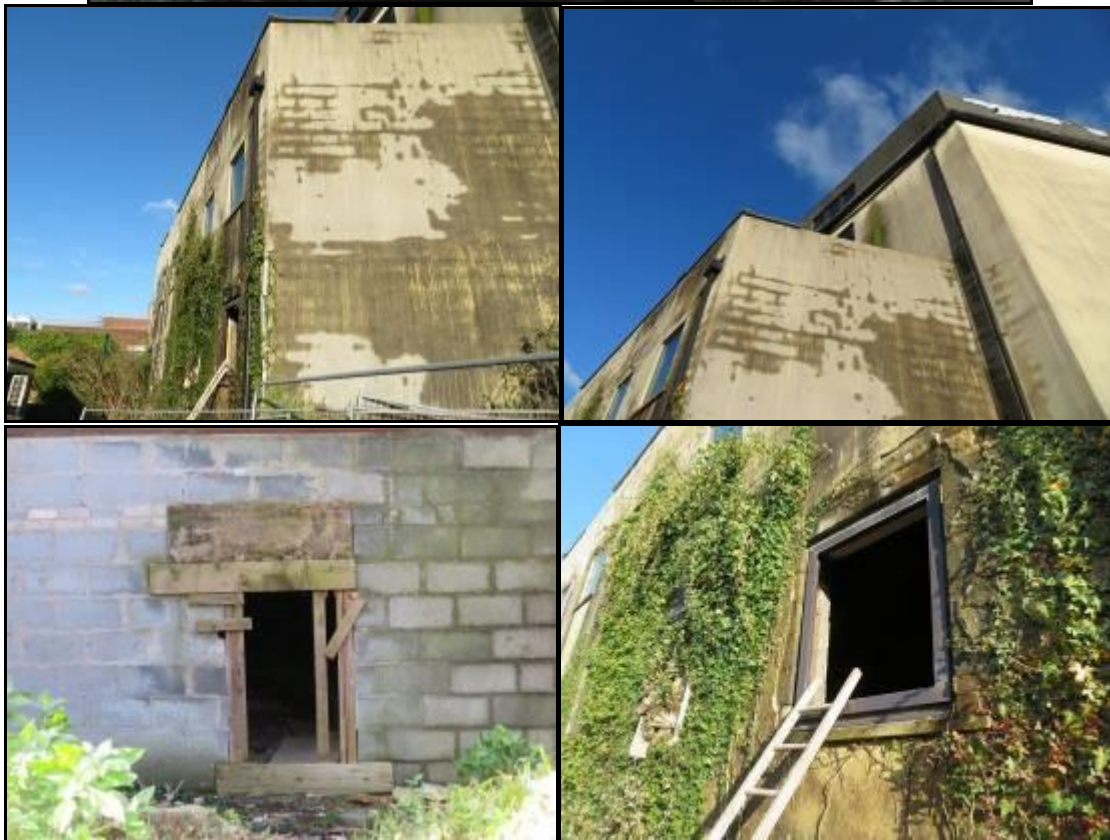
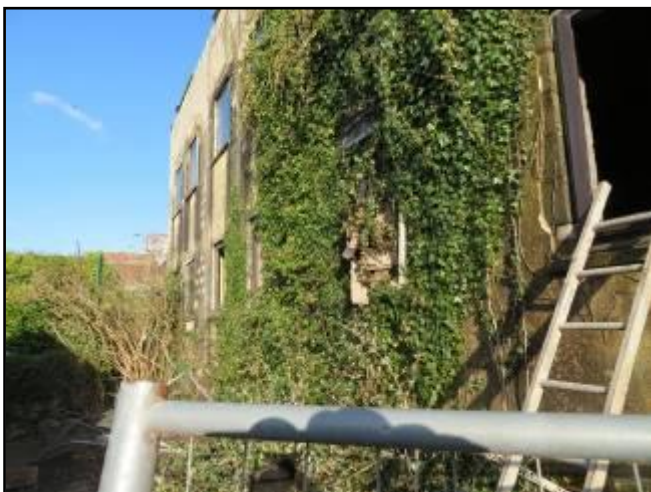
The walls are in good condition and the roof is largely intact (see drone images), but parts of the roof and some of the windows have been vandalised in places leading to a large population of pigeons establishing themselves on the top two floors. Seagulls were also seen on the roof top and these birds are known to predate on bats.

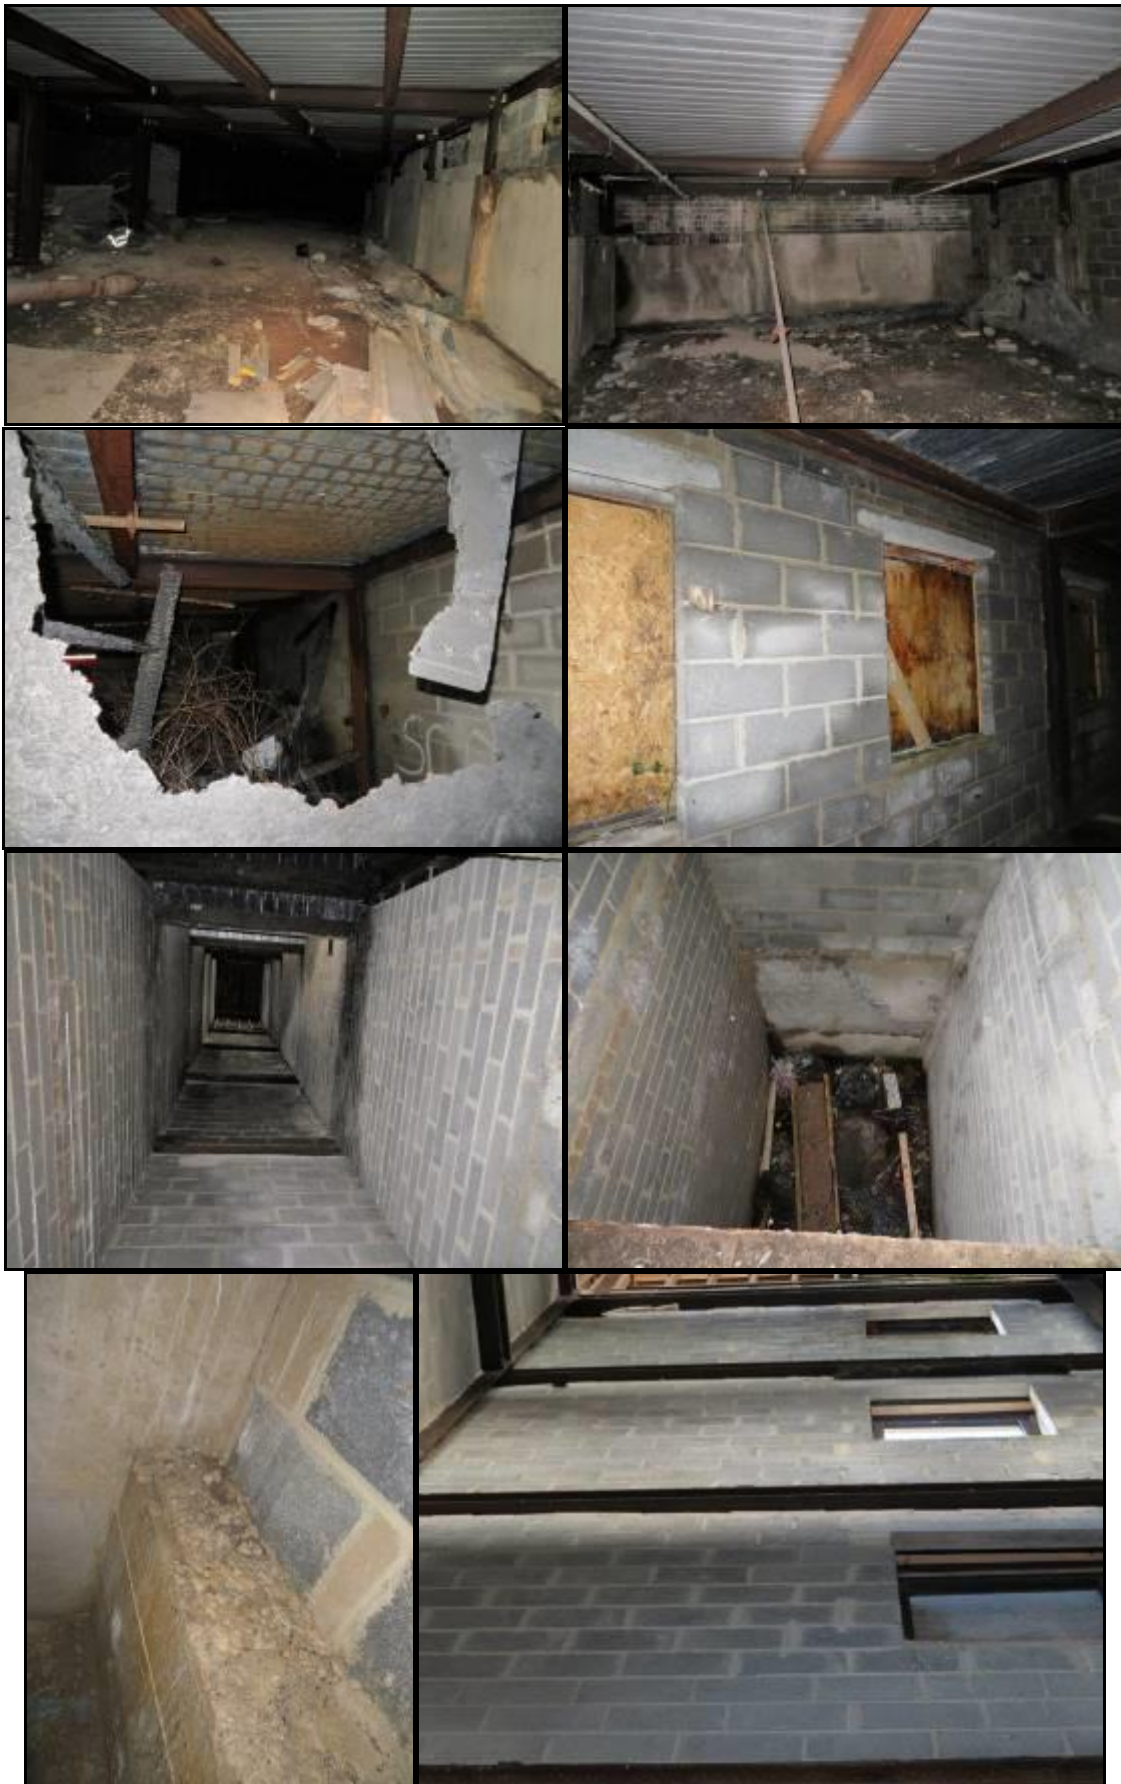
Internally, within the floors which were accessible, the walls and ceilings are in good condition with no bats or their signs, nor any signs of rodent use.

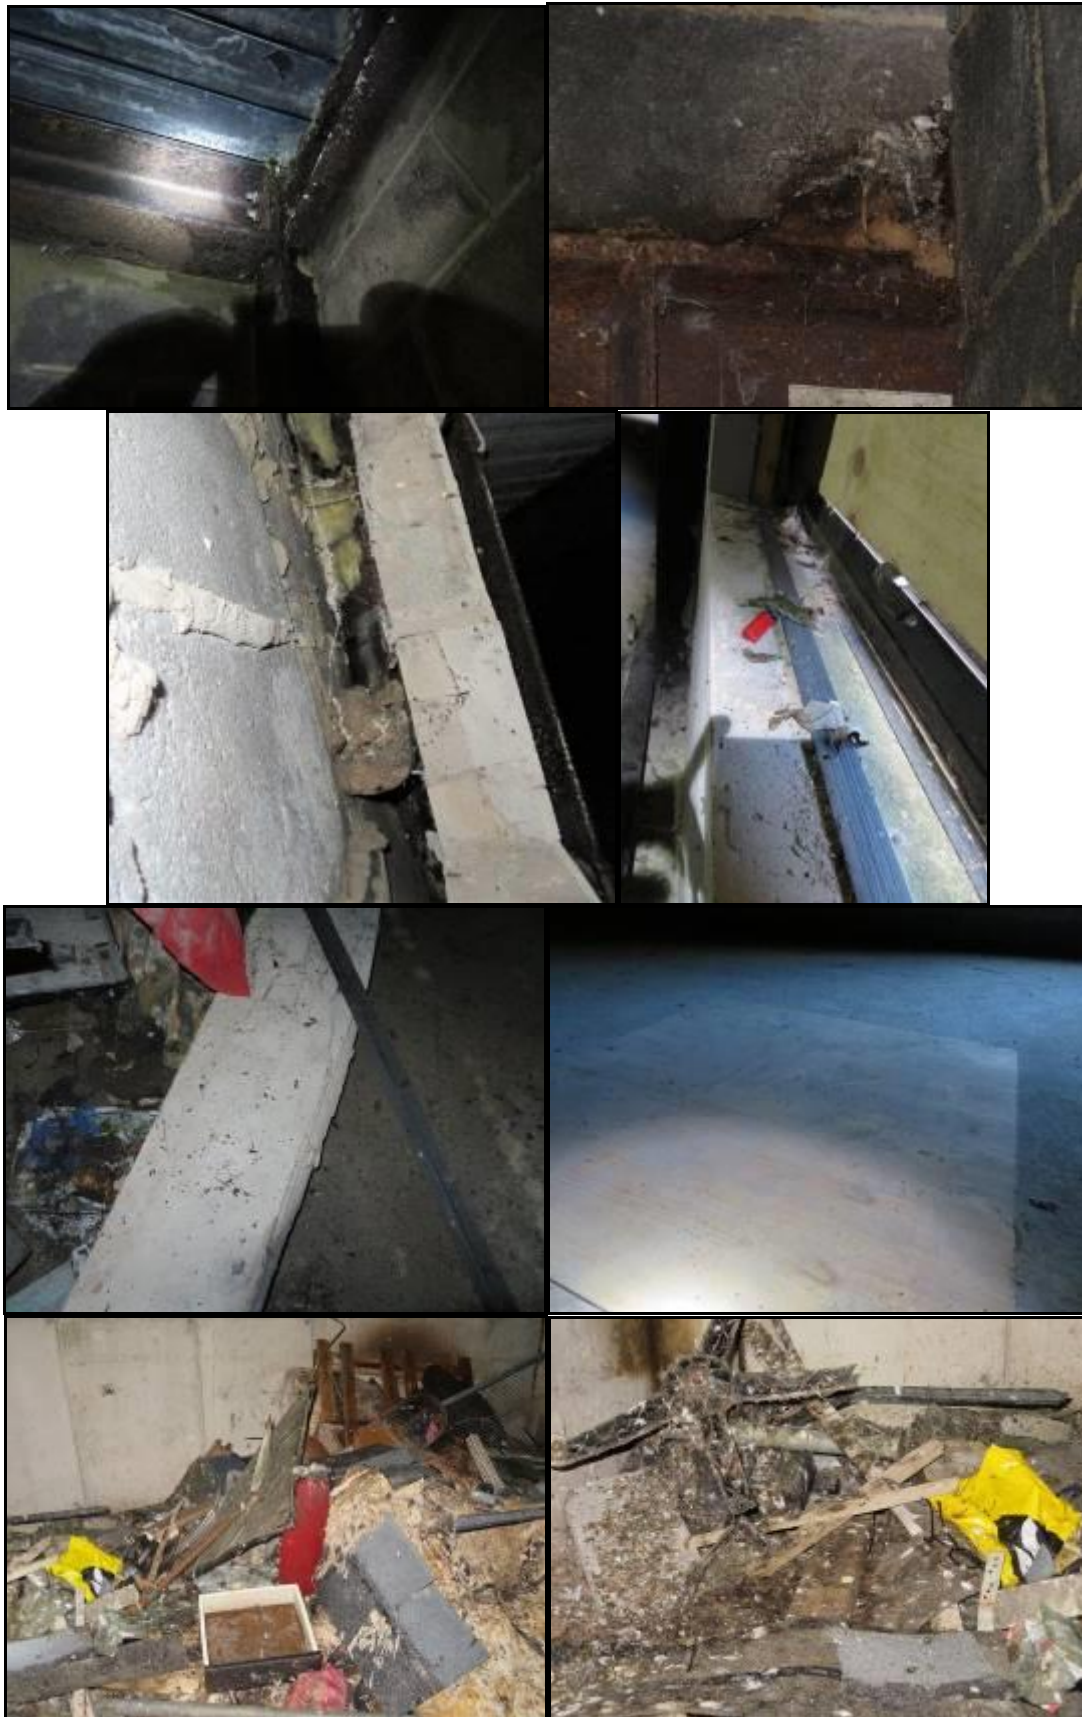
There were signs of fires, pigeon activity and intravenous drug use within the property.

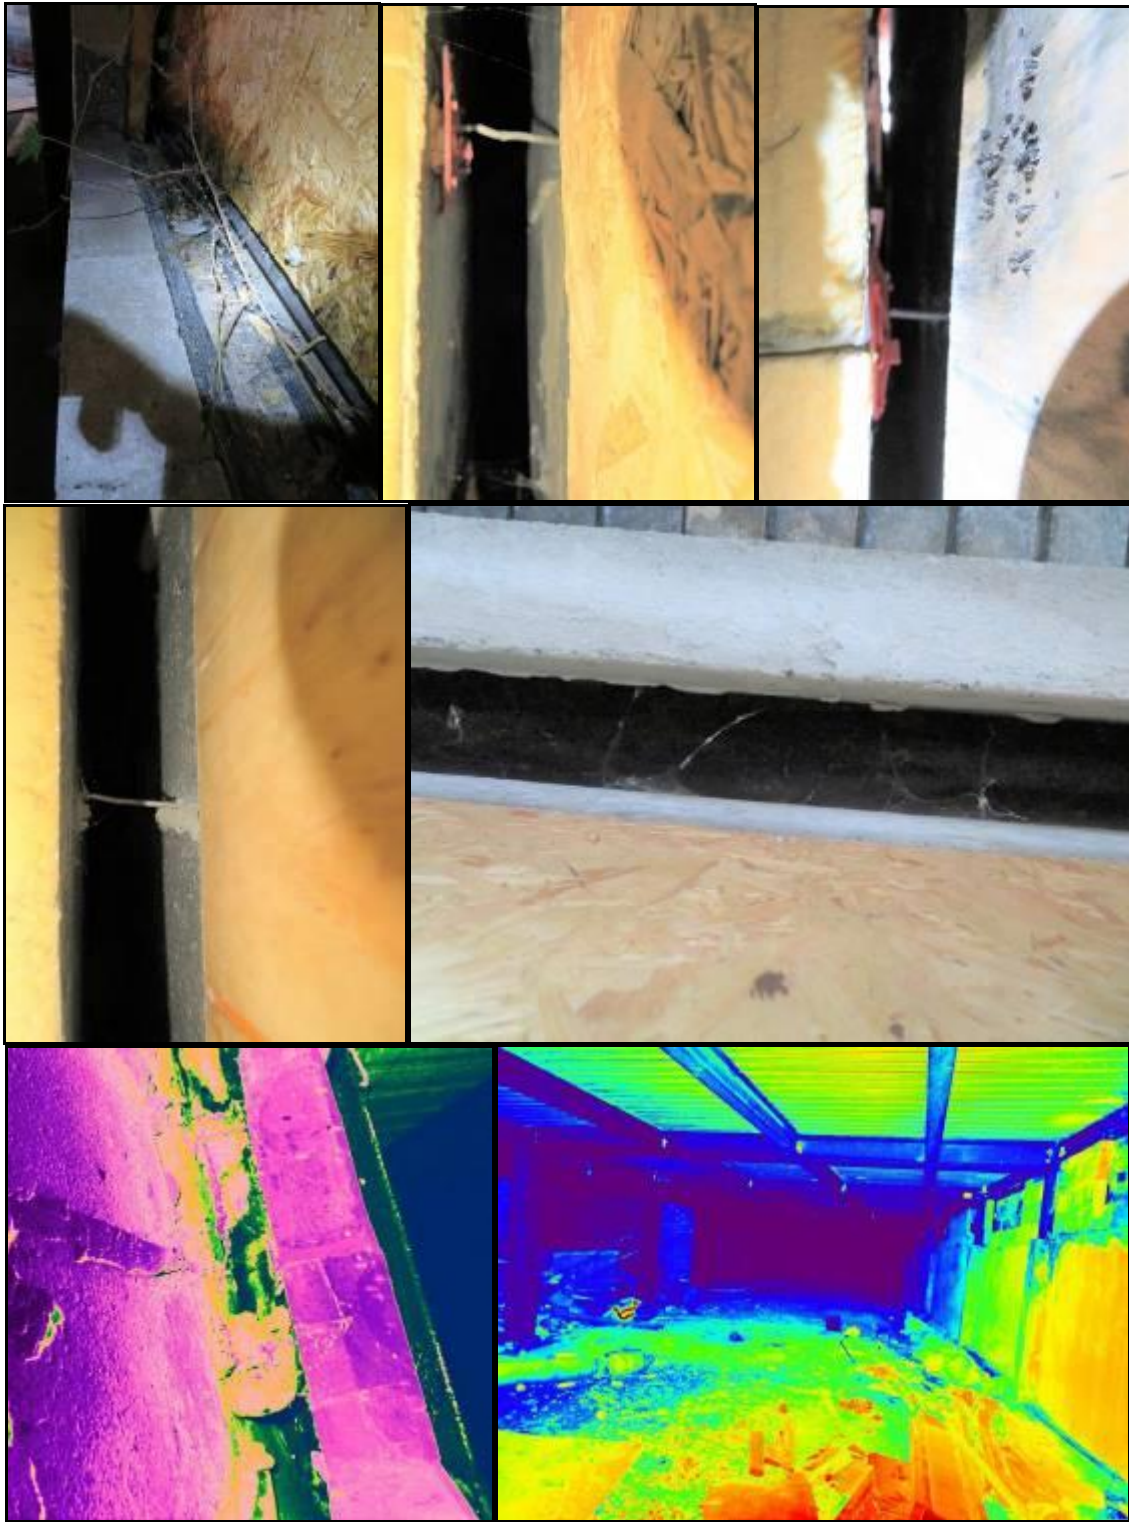
Additional interior images from the property showing inspection of the cavities. Thermal images were also taken with image seven being of one of the void spaces within the property (the green areas are the insulation). Image eight is a thermal image of the basement area showing no hotspots which could have indicated the presence of bats.

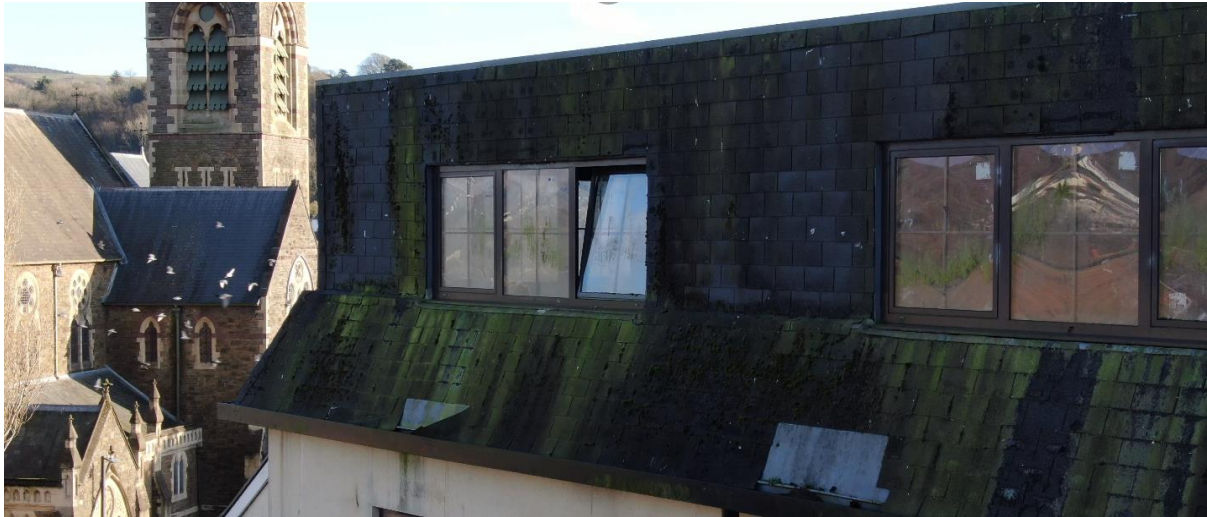
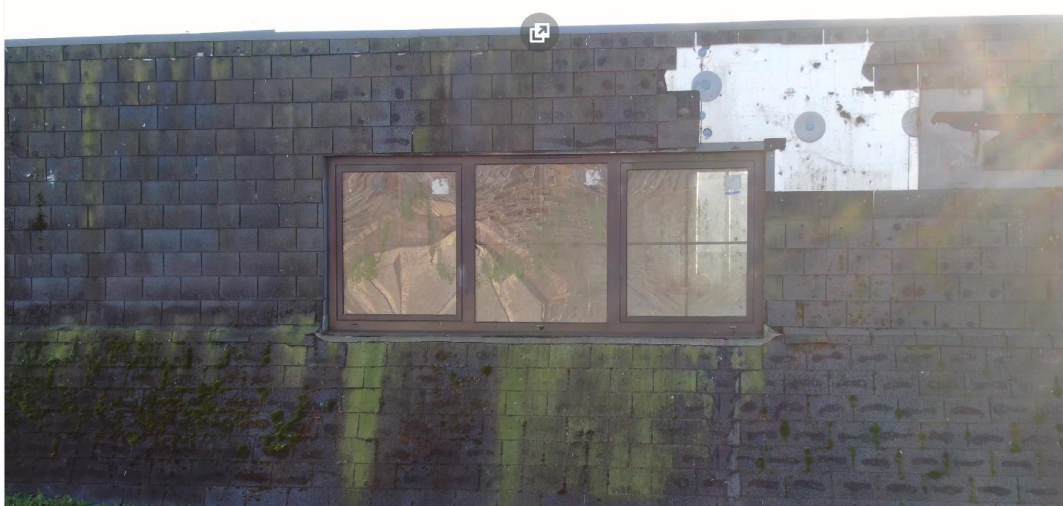
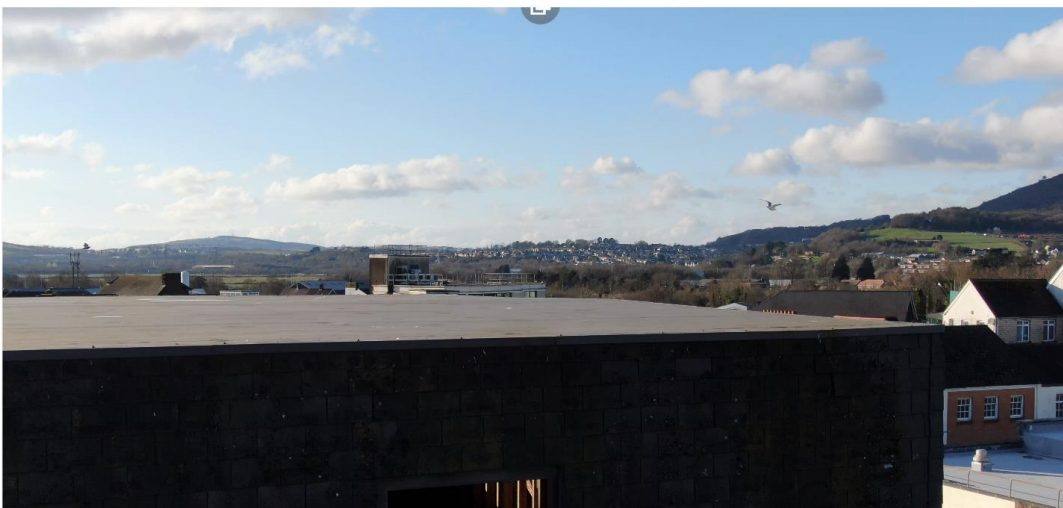
### Drone images

The roof is largely intact...but windows and one or two areas of the sides of the roof have been vandalised allowing pigeons in etc.

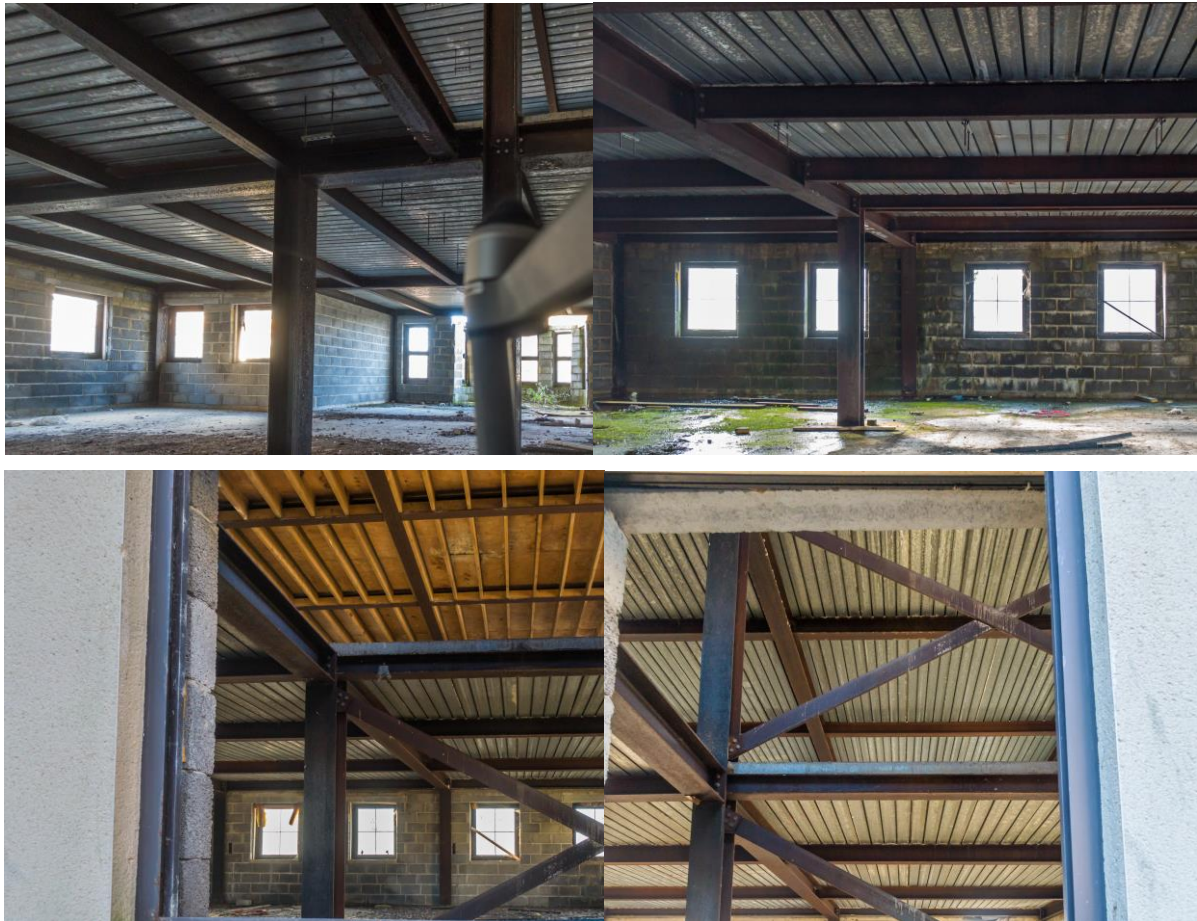
Images of the upper floors with post and beam ceilings. You can also see the timber floor of the roof space.

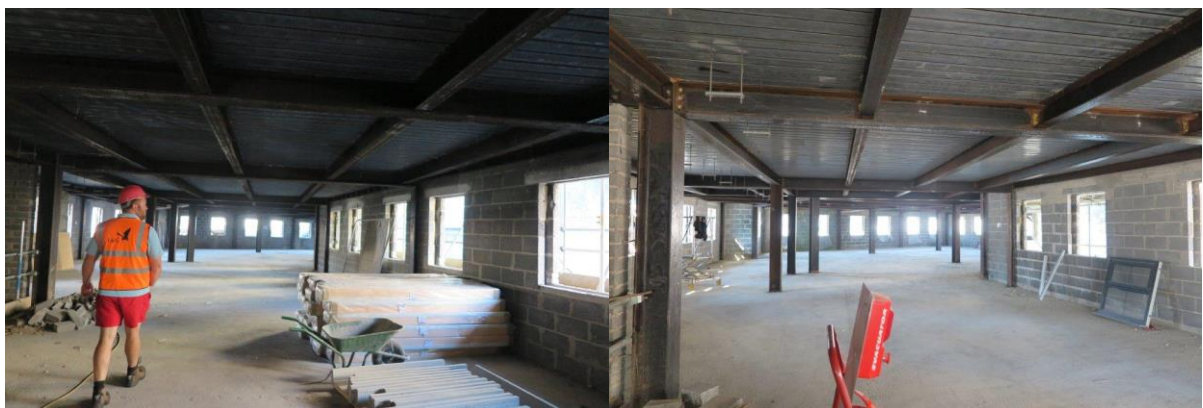
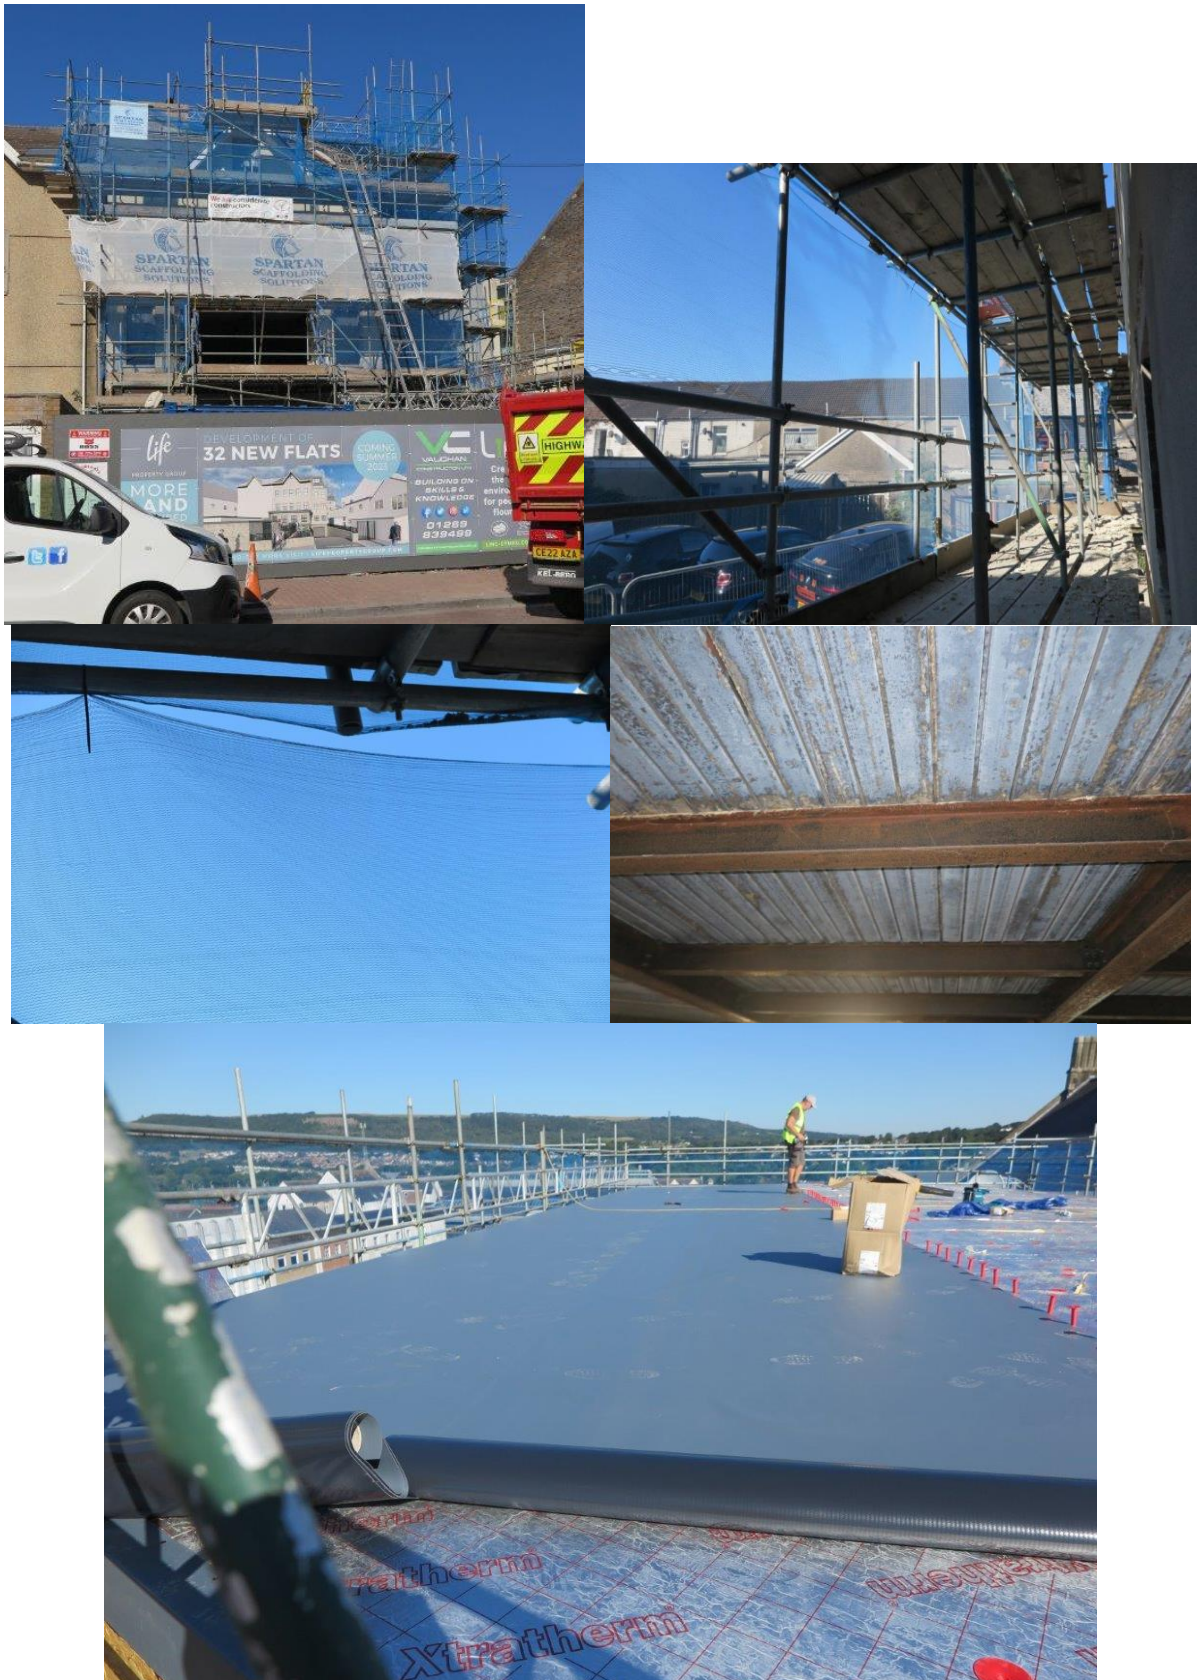
Updated images showing a busy worksite taken on 12<sup>th</sup> August 2022.

Zero bats/ birds or their signs were found. The site is now a tidy worksite , you can see the safety mesh on the scaffolding reducing access for bats and birds. The new robust and thermally efficient roof covering can also be seen. No crevices for the exploitation of bats were found.

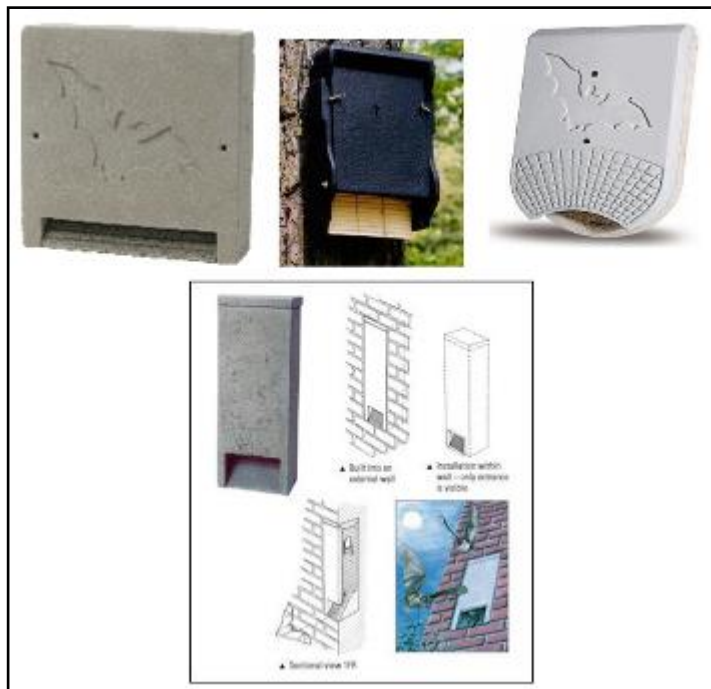
**Top:** From left to right, the in-wall Schwegler 1FR, the tree mounted 1FF and the multi season 1WQ. The bottom image shows the 1FR in situ.

- ✦ **Recommendation 1:** Based upon online searches for bats and having undertaken bat surveys in the near vicinity 2x Schwegler 1WQ (or similar) boxes are to be erected to the rear elevation of the building once works are complete.
- ✦ **Recommendation 2:** One sparrow terrace box is to be erected to the rear elevation also.

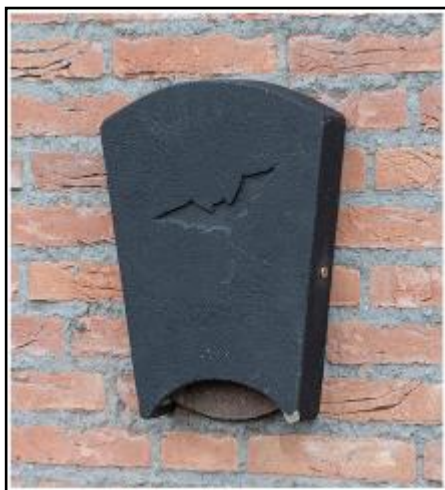
**Middle:** The Beaumaris bat box is made entirely from Woodstone, a robust material comprising concrete and wood fibres. This means that, not only does the box have excellent insulating properties maintaining a more consistent temperature throughout the year, it also provides excellent protection from predators. The Beaumaris box has a single narrow cavity which makes it suitable for crevice roosting bats. The interior of the box has a rough surface for bats to cling to and the front of the box features a subtle but attractive imprint of a bat in flight. It is suitable for attaching to external walls and available in two sizes: Midi and Maxi.

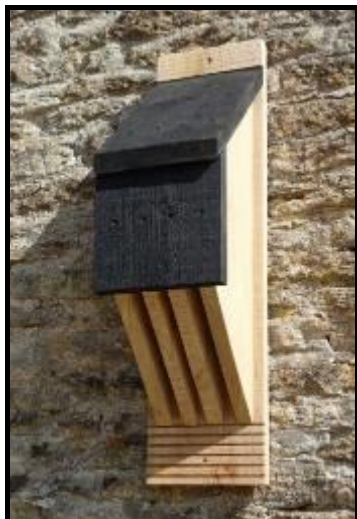
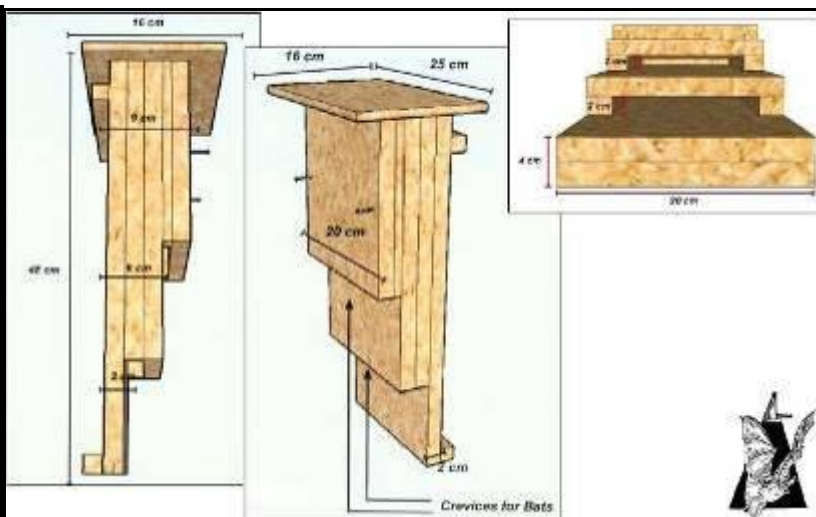
**Bottom:** The Vincent Pro bat box (left) and the Kent Bat Box (right)
