## **Bat Survey**

Cymmer Bowls Club,  
Cymmer,  
Port Talbot,  
SA13 3EP

**DKEcology**  
20 Glanymor Road,  
Loughor,  
Swansea,  
SA4 6SA

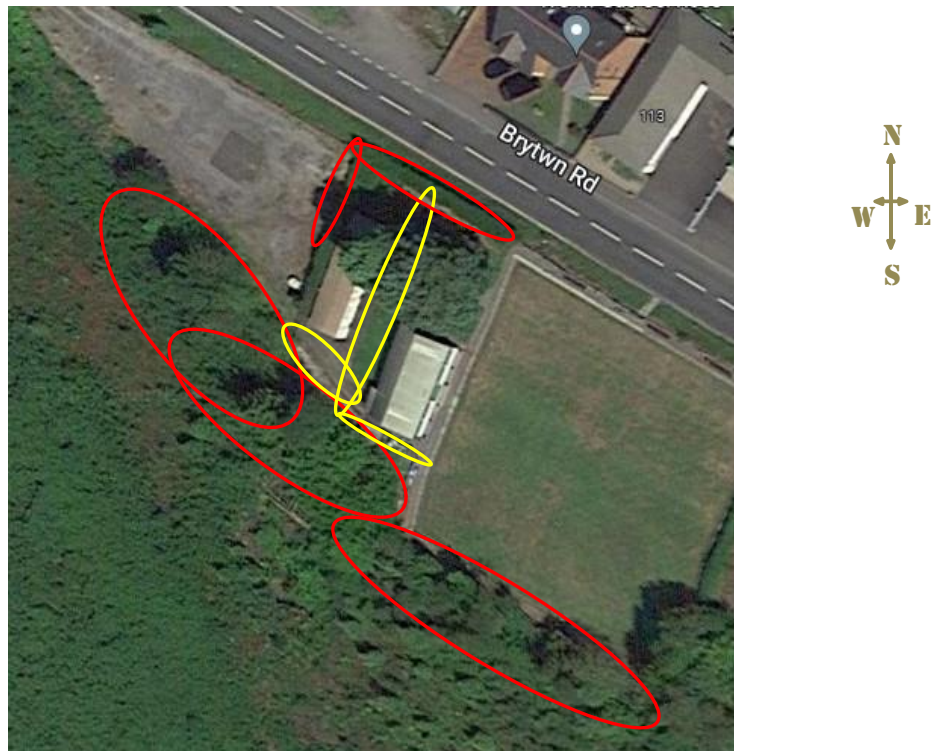
**Fig 7.2** Areas where external lighting should be avoided (red) and where external lighting should be modified and kept to a minimum (yellow)

- 7.8 Lighting must not illuminate any planned bat access points and should not illuminate the main areas of activity i.e. the vegetated slope to the south of both buildings, avoid illuminating the boundary hedges to the north and west and should be kept to a minimum along the east side of the changing rooms and south elevation of both buildings see Fig 7.2.

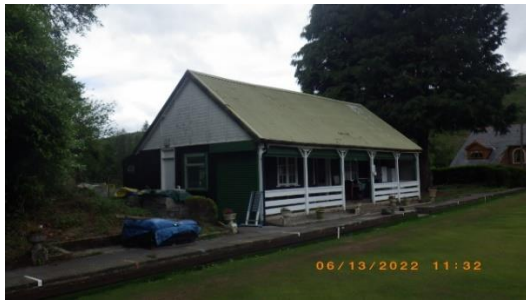
- 4.2.1 The property consists of 2 single storey detached buildings, the pavilion (club house) and the changing rooms. The pavilion is a wooden framed building built in the 1920's. The exterior of the building is sealed with wooden cladding, and it has an A framed roof covered in metal roof sheets. A veranda runs along the east side of the building. Internally the building is well lit and open to the roof line which is well sealed with no potential access points noted. The building has no loft spaces.

South and east elevation of the Pavilion

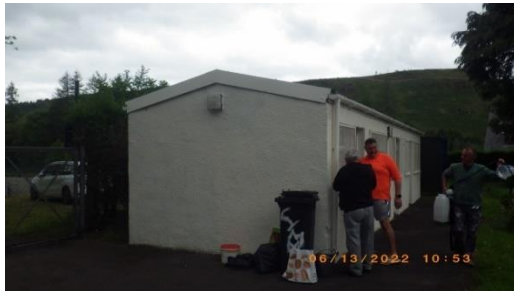
South and east elevation of the changing room

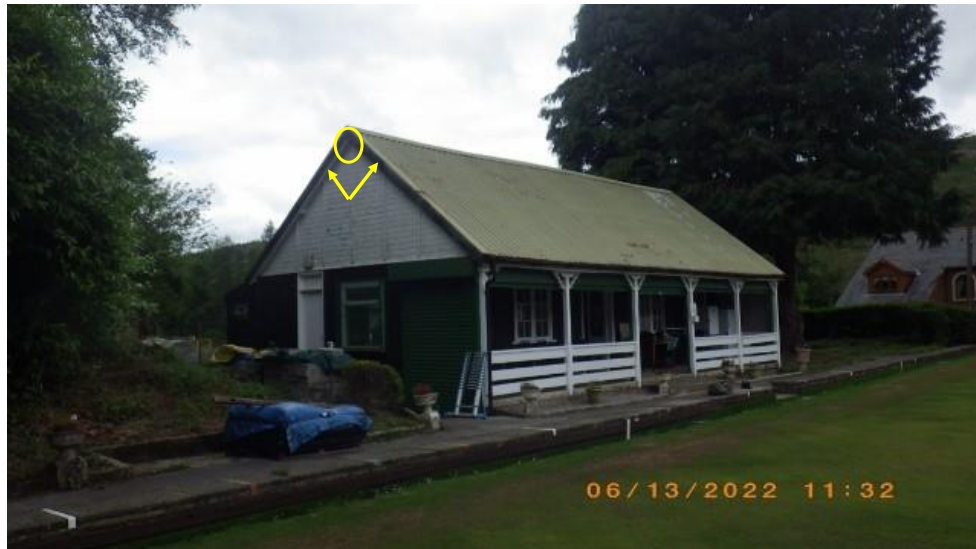
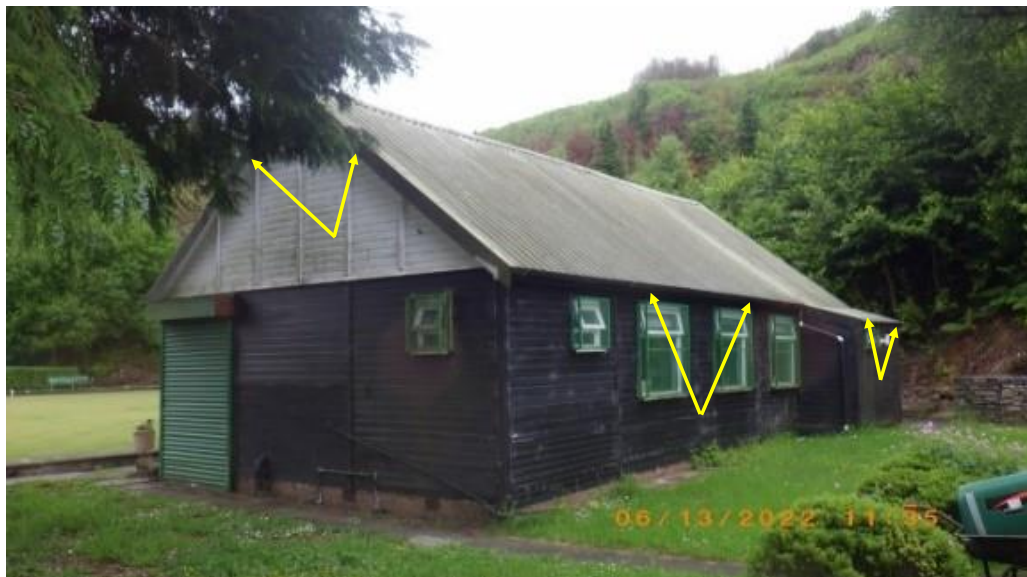
- 4.2.2 All of the external walls of the pavilion are well sealed and the roof sheets intact. Metal dry verges are fitted on both gables. A small number of crevice gaps that could be used by bats were noted along the eaves to the west and on the north and south gables of the pavilion. No free flight access points in to the property were noted.

Pavilion potential access/roost points

- 7.1 While no evidence of bats was found to be using either of the buildings, it is recommended that works to remove any roof materials, fascias/gutters or exterior wooden cladding be carried out using the precautionary principle set out in 7.2. When carrying out the works it is advised to be mindful that bats by their very nature are mobile and will often move between different roosts sites staying for short periods throughout the active season.

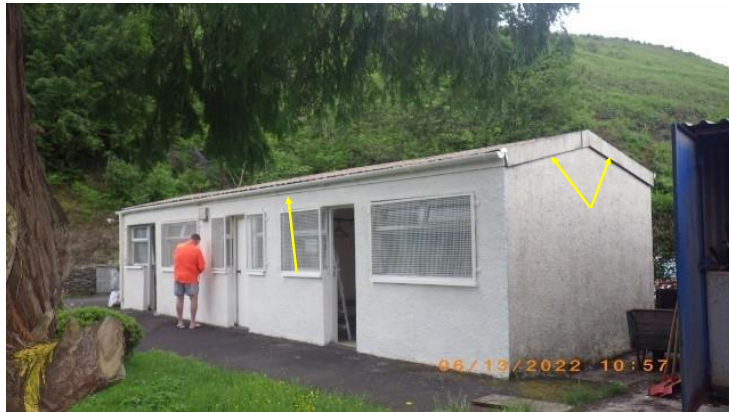
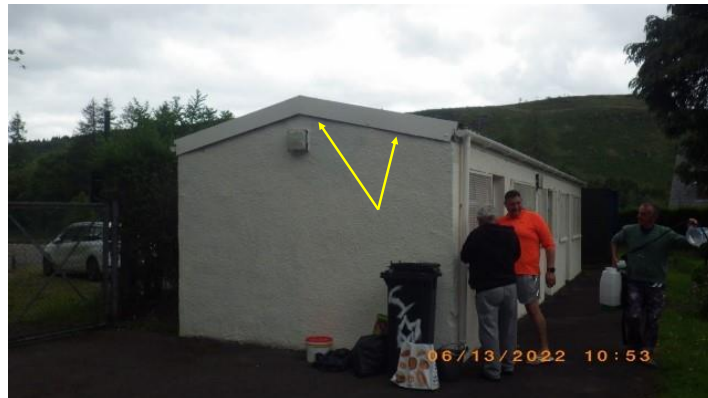
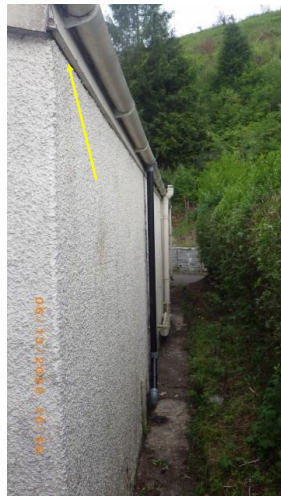
4.2.4 All of the external walls of the changing rooms are well sealed and the roof sheets intact. A small number of shallow crevice gaps that could be used by bats were noted along the west and east eaves. Raised sections of the dry verge were also noted along the north and south gables and behind the of the building. No free flight access points in to the property were noted.

Changing rooms potential access/roost points

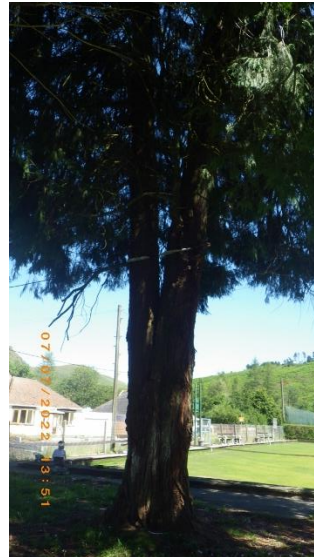
Tree 1

4.2.7 Tree 1: A 2 stemmed lawson cypress tree approx. 90 plus years of age located closest to the north gable of the pavilion. Signs of historical branch pruning. No potential access points or roost sites were noted.

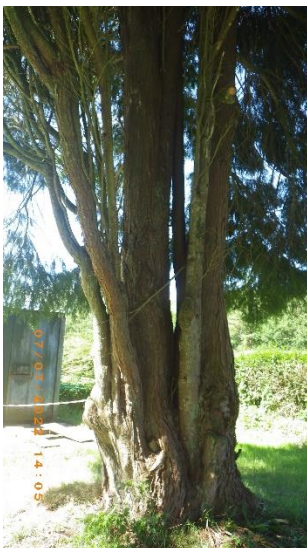
4.2.8 Tree 2: A 4 stemmed lawson cypress tree approx. 90 plus years of age located immediately north west of the pavilion. Signs of historical branch pruning. A small number of features were observed that had the potential to support individual bats opportunistically.

- 5.8 Although the survey found no evidence of bats currently or historically using tree 2. Bats are active within the area albeit it at a low level. Therefore as a precaution it would be recommended that tree 2 be soft felled. If bats are found during the felling, work should cease, and Natural Resources Wales (NRW) should be contacted for advice (see recommendations in section 7).

- 7.9 While no evidence of bats using the Lawson Cypress trees (Tree 1 and 2) was found as Tree 2 does have some potential to support bats albeit it low, it is recommended that Tree 2 be soft felled following the principles outlined in section 7.10. When carrying out all felling works it is advised to be mindful that bats by their very nature are mobile and will often move between different roosts sites staying for short periods throughout the active season.
- 7.10 As a precaution, and where possible, it is recommend any felling works are ideally conducted in September/October, to avoid maternity and hibernation seasons when bats are most vulnerable to disturbance. Tree 2 must be soft felled, where tree limbs are cut, and lowered with ropes and left grounded over night to allow any bats to make their way out.

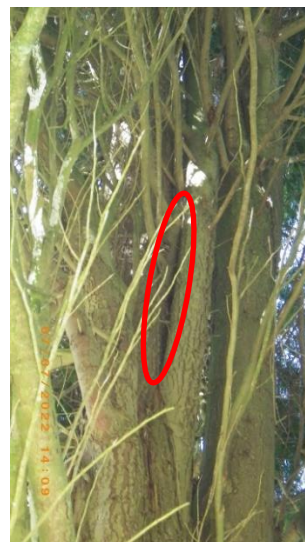
Potential roost crevice in stem 3 of Tree 2
