# **Afan Valley**

## **Initial Peat Survey**

Afan Valley Ltd

December 2017

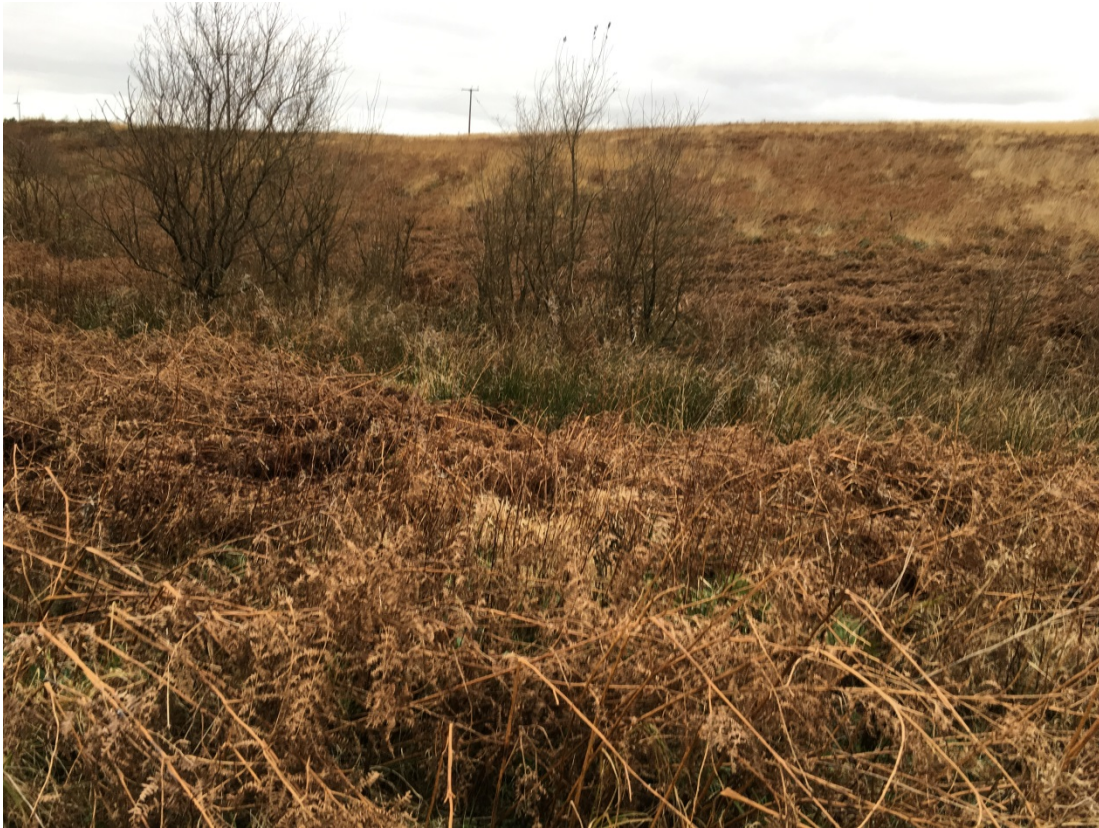
L1 facing north west

| Location Number | Observations and Comments |
|---|---|
| <b>L1</b> | Area of standing water characterised by vegetation such as ferns, tall reeds. Shallow scraping using a geological hammer revealed semi decomposed plant material |

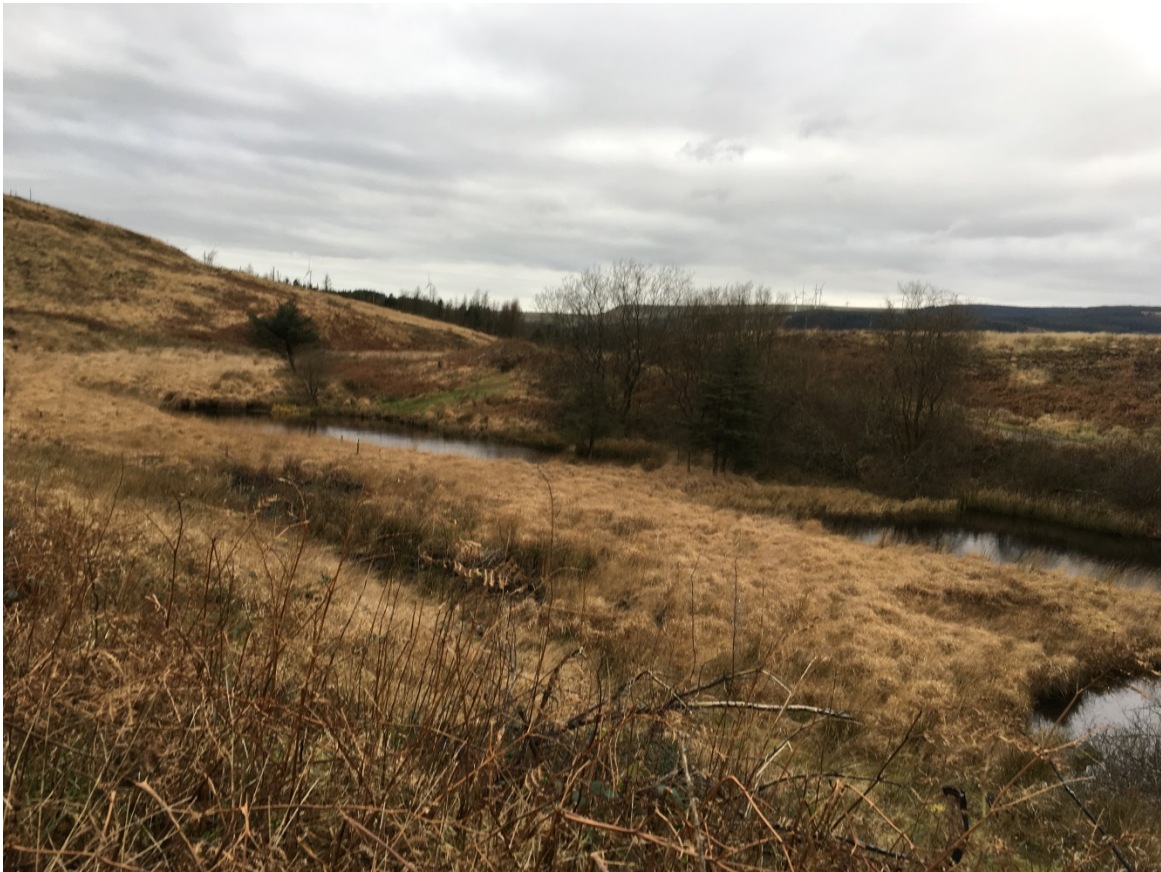
L2 facing north- west towards L3

| Location Number | Observations and Comments |
|---|---|
| <b>L2</b> | Two ponds both approximately 40m in length, with a width varying from 10m to 15m. The ponds are surrounded by tall grasses and reeds. The land between the ponds is spongy/springy when pressure is applied. When scraped with a geological hammer black soft to firm clay with organic semi decomposed material was encountered. The ponds are in a low lying area with steep slopes (approximately 1v:2h to 1v:1h) at the edges. L1 and L2 are separated by a raised track constructed on an embankment with slopes of approximately 30 degrees. |
| <b>L3</b> | Appears to be a natural low lying area, which is continuous with the ponds but separated by a track that is at the same elevation. There is standing water on the track and in this low lying area black organic clay with decomposed plants and roots is present. |

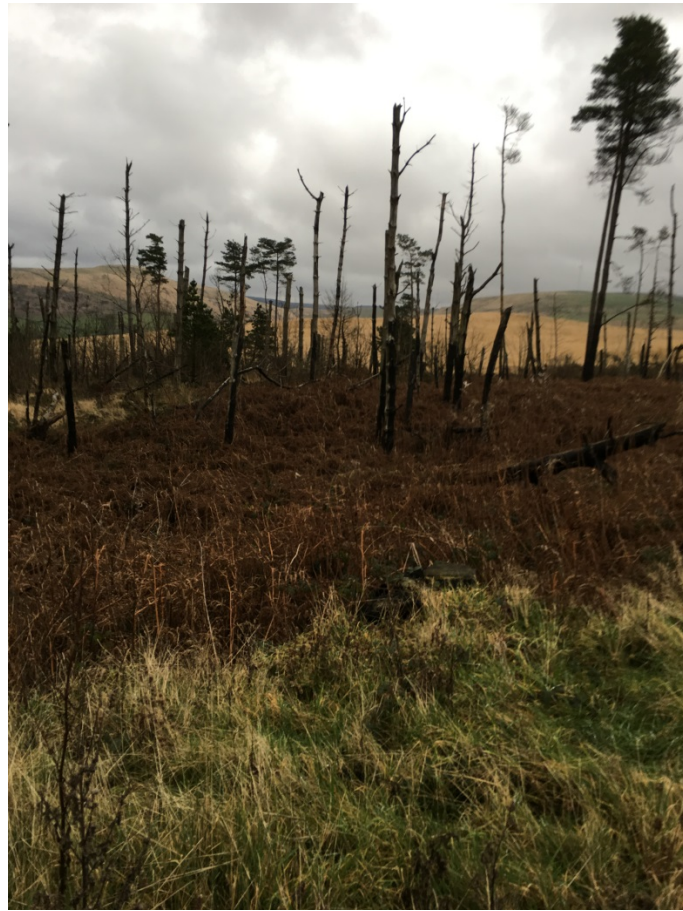
L4 facing north-east

| Location Number | Observations and Comments |
|---|---|
| <b>L4</b> | Area is low lying in relation to the surrounding area, with burnt trees and steep embankment slopes on either side. The ground is undulating and composed of firm clay and decomposed plant material. There is a thick undergrowth of moss forming a continuous carpet over the soil. |

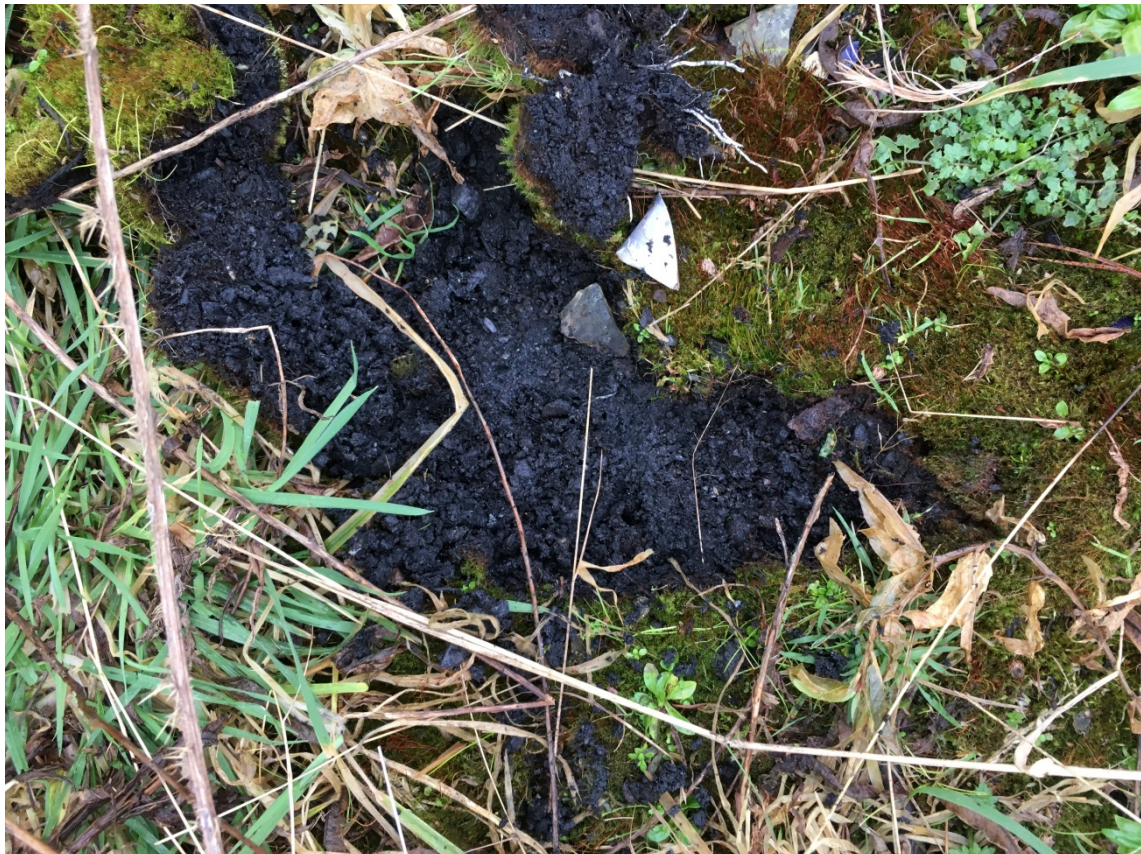
L4 – material under the moss
