Afan Valley Adventure Resort

Ground Investigation

Factual Report

G22033

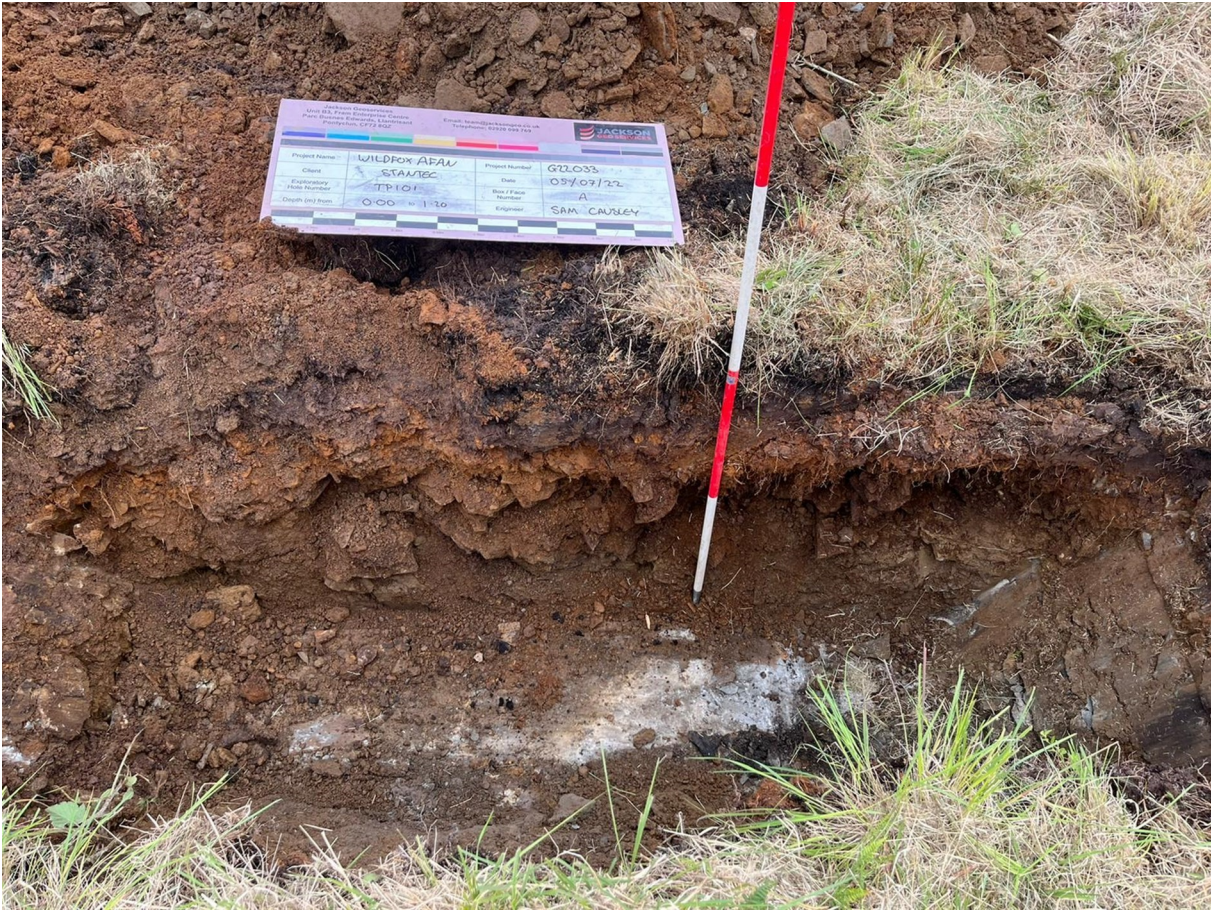
TP101 Face A

| 1 D | 0.20 - 0.40 | | | 0.00 | 291.31 | | Dark brown soft organic slightly sandy SILT with abundant rootlets. Sand is fine to medium. (TOPSOIL) | | | 0.50 | | | |
| 2 B | 0.80 - 1.20 | | | (0.20) | 291.11 | | Soft to firm orangish brown sandy gravelly CLAY. Sand is fine to medium. Gravel is angular to subangular fine to coarse of sandstone. (Weathered RHONDDA MEMBER) | | | 1.00 | | | |
| | | | | | 290.31 | | Greyish brown clayey gravelly medium to coarse SAND with low cobble content. Gravel is angular to subangular fine to coarse of sandstone. Cobbles are angular to subangular of sandstone. (Weathered RHONDDA MEMBER) | | | 4.00 | | | |

| | | <b>EXPLORATORY HOLE PHOTOGRAPHS</b> | | | <b>Remarks</b><br>Machine excavated trial pit from GL to 1.20m. No groundwater encountered. 3 soakaway testing cycles in accordance with BRE365 was completed. Backfilled with arisings. | <b>Exploratory Hole</b><br><br><b>TP101</b> |

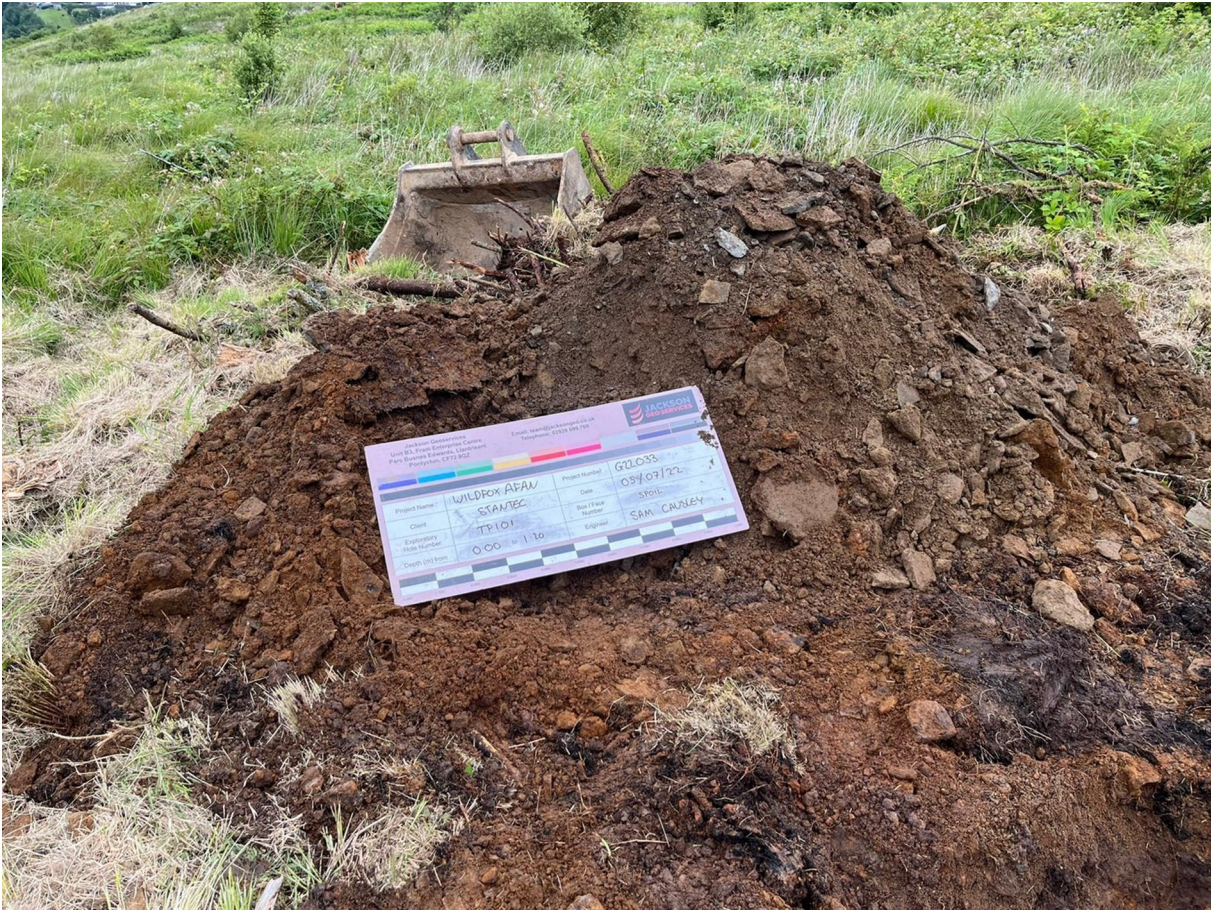
TP101 Spoil

| | | <b>EXPLORATORY HOLE PHOTOGRAPHS</b> | | <b>Remarks</b><br>Machine excavated trial pit from GL to 1.20m. No groundwater encountered. 3 soakaway testing cycles in accordance with BRE365 was completed. Backfilled with arisings. | | <b>Exploratory Hole</b> |
