RHONDDA  
GEOTECHNICAL  
SERVICES

PHASE 2  
CONTAMINATED LAND RISK ASSESSMENT  
NEATH PORT TALBOT  
PLANNING APP. P/2021/0019  
DETACHED DWELLING  
37 PARISH ROAD  
CWMGWRACH  
NEATH  
CF63 2HJ  
14/07/2021

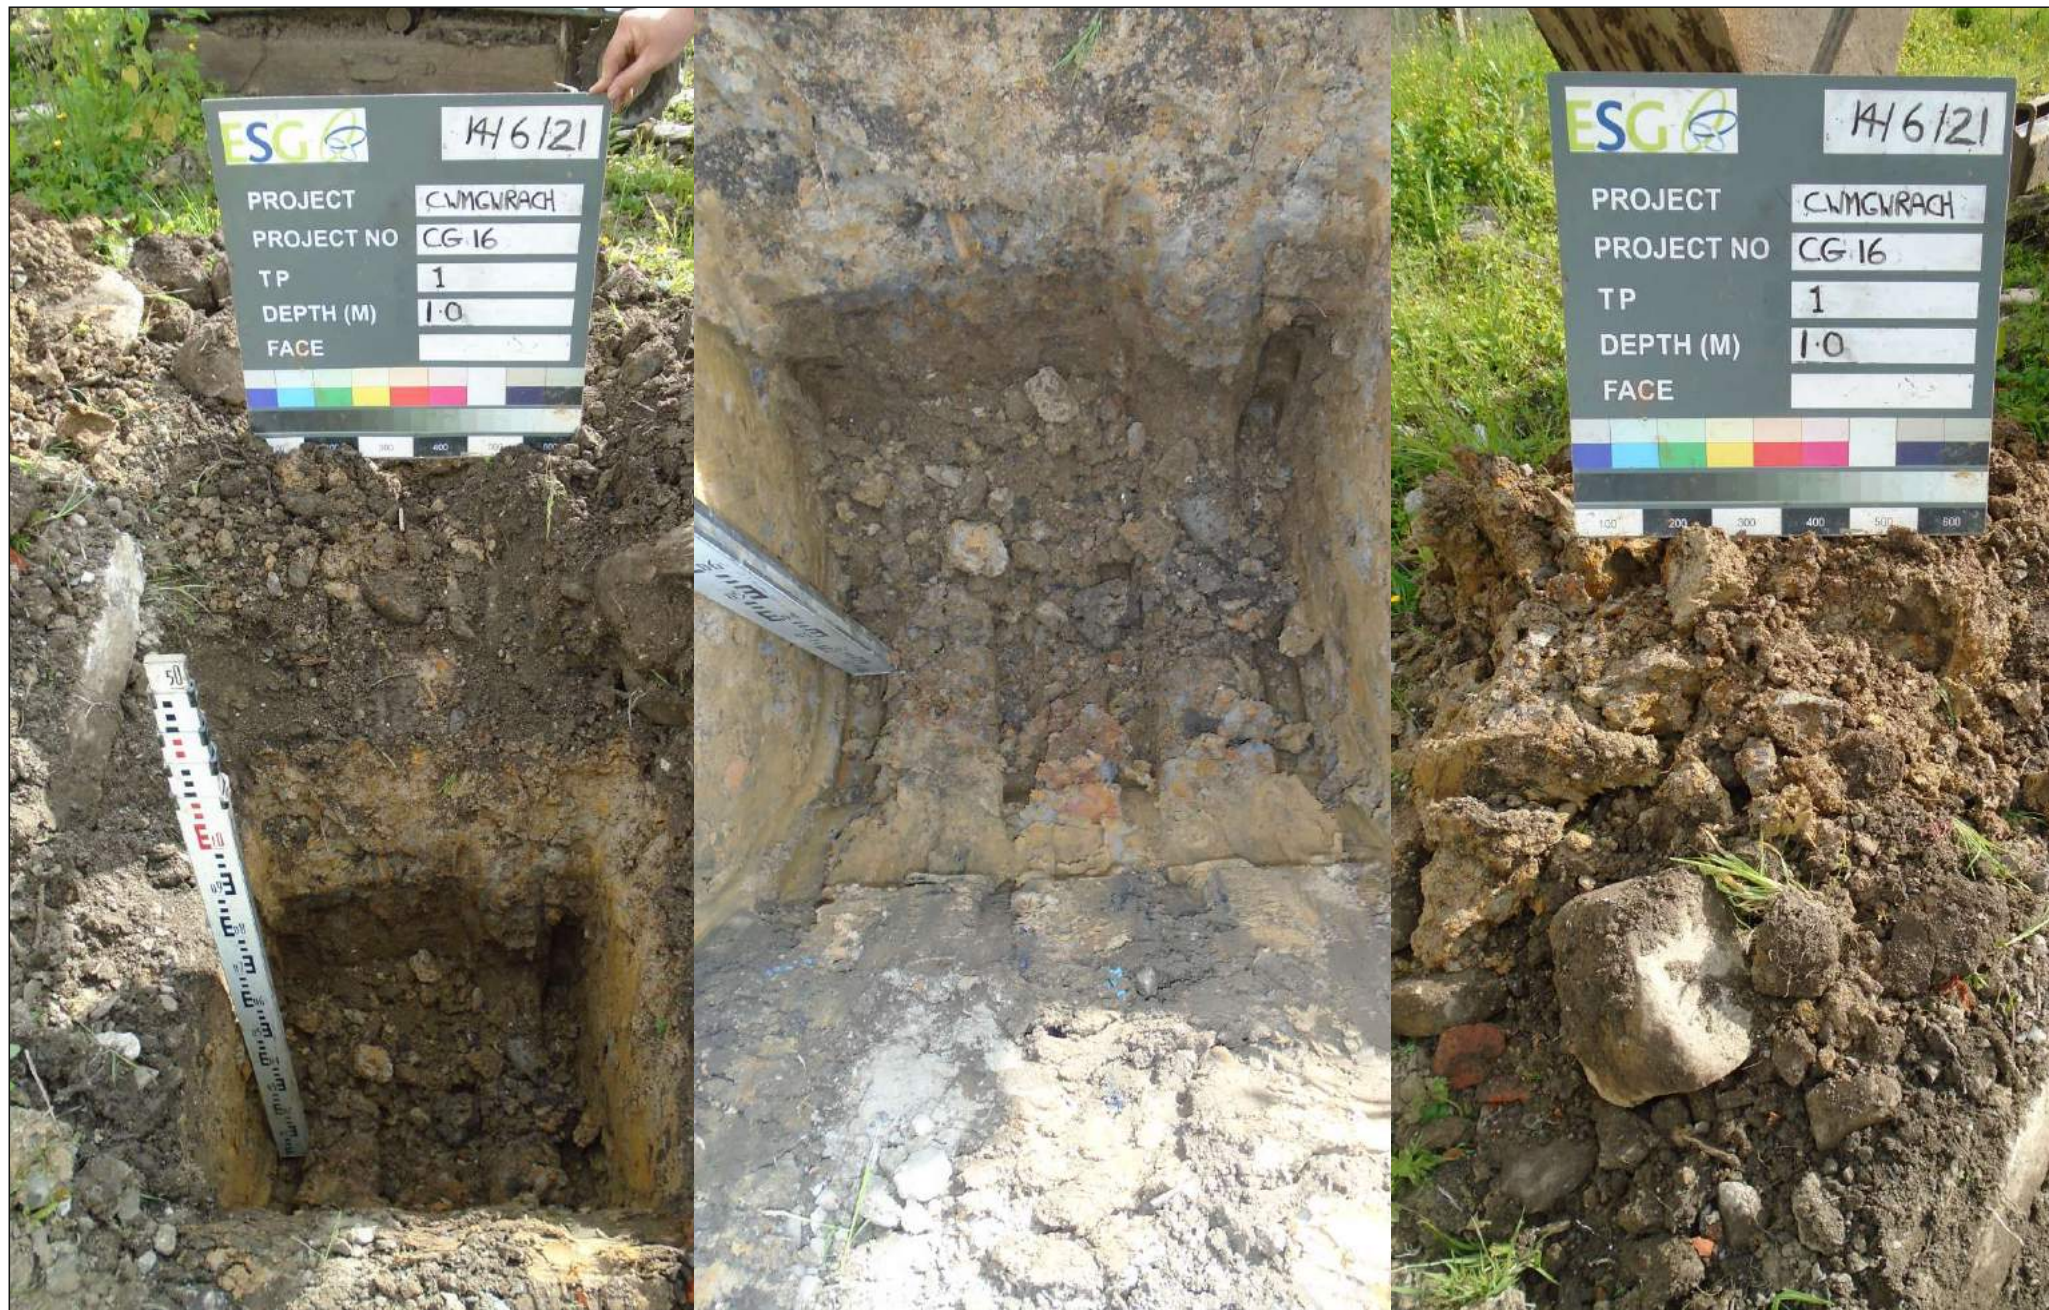
FIGURE 2

| Samples and Tests | | Strata | |
|---|---|---|---|
| | | G.L. | MADE GROUND. Loose greyish black sandy, clayey GRAVEL. Gravel is angular, fine to coarse of concrete, brick and tiles. |

TP 1

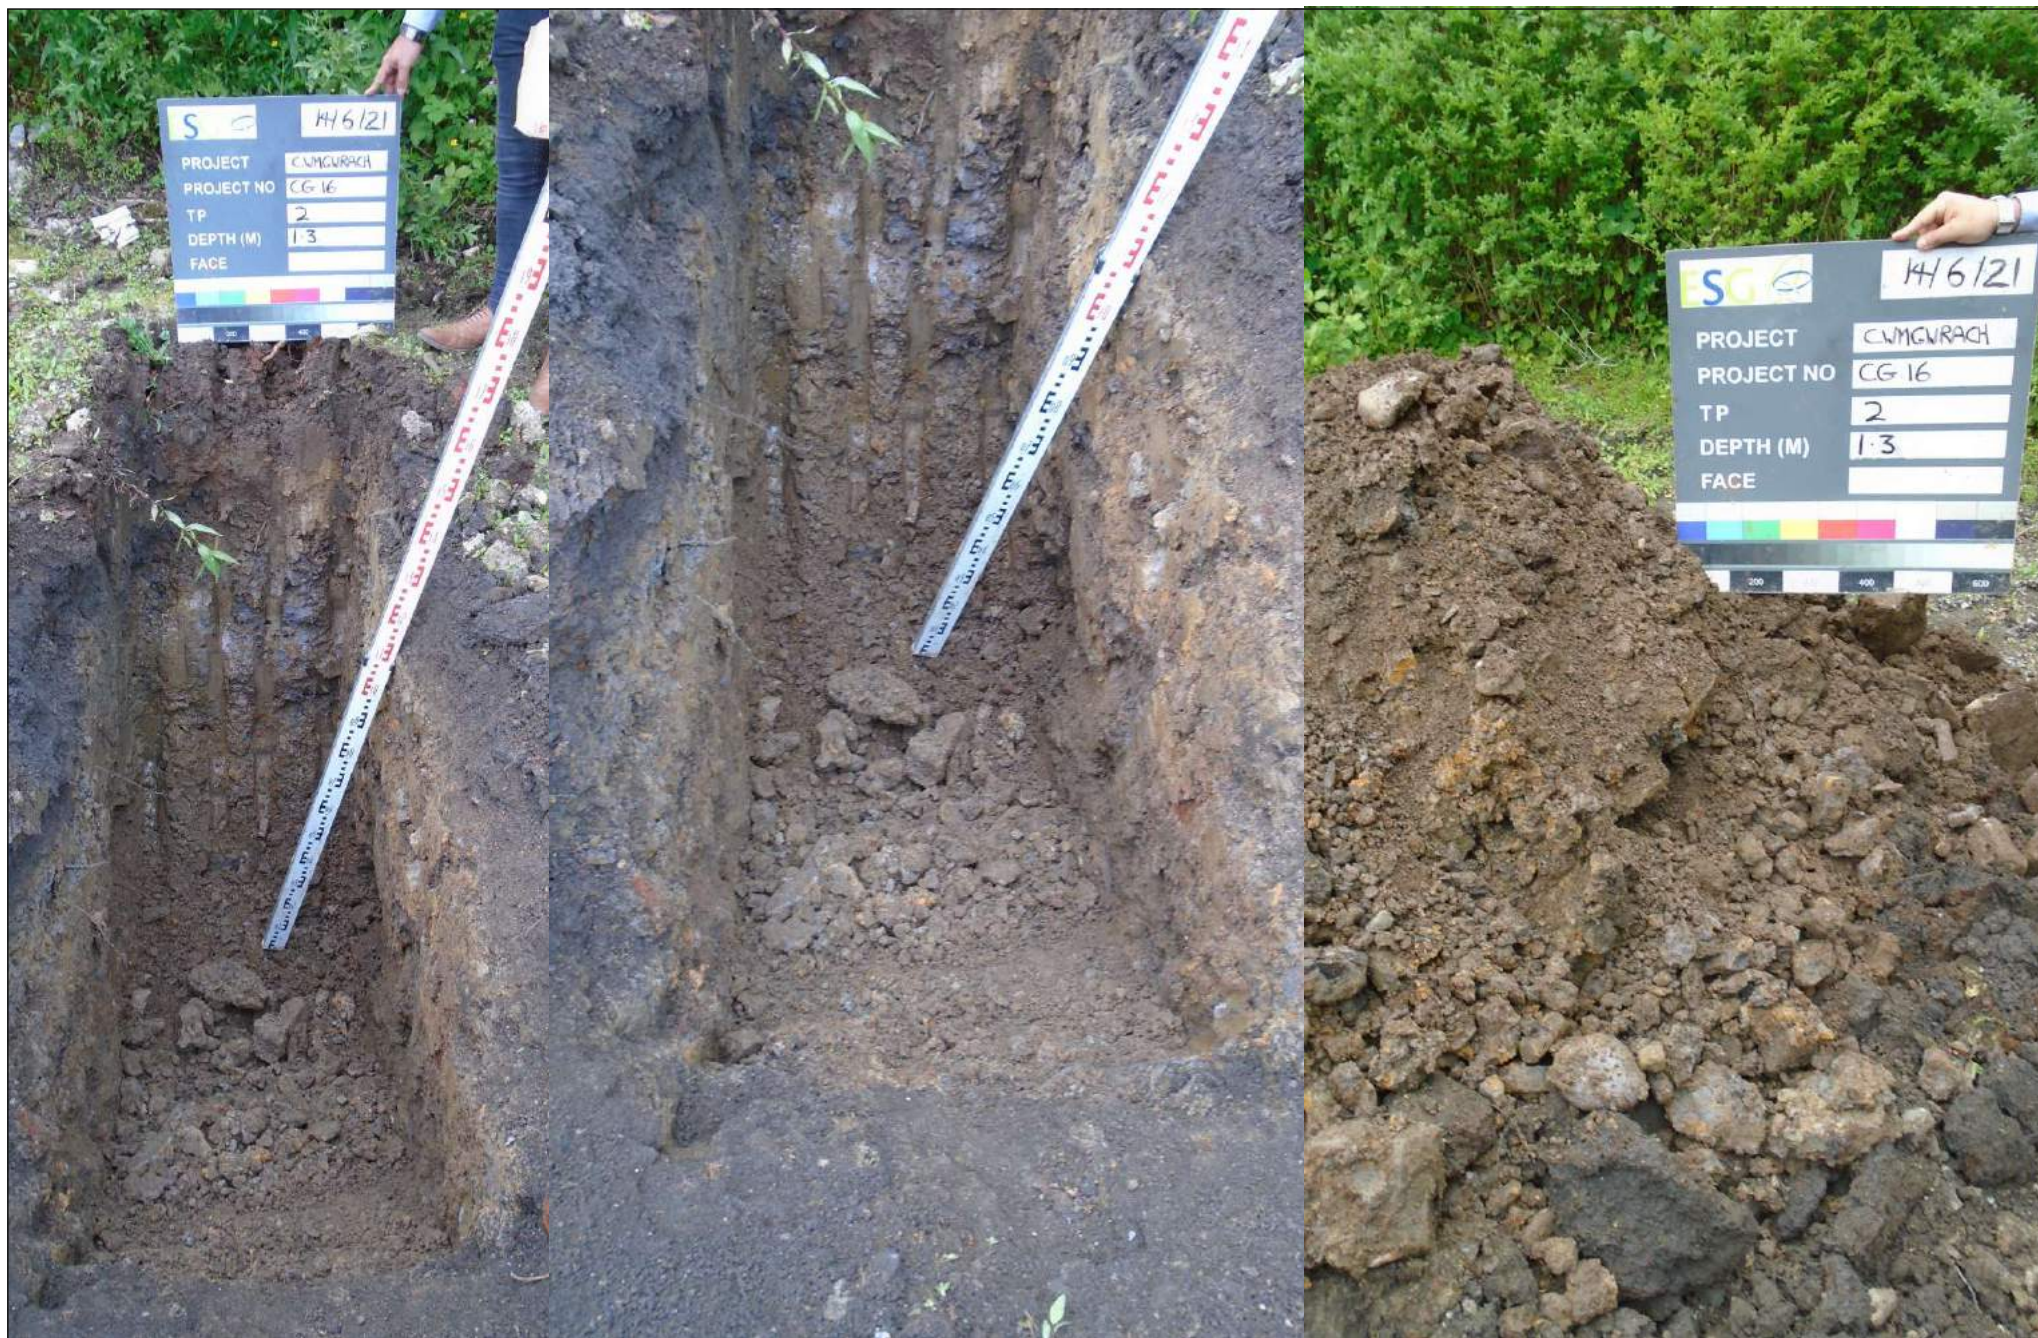
FIGURE 3 TP 2

| Samples and Tests | | Strata | |
|---|---|---|---|
| | | G.L. | MADE GROUND. Loose greyish black sandy, clayey GRAVEL. Gravel is angular, fine to coarse of concrete, brick and tiles. |

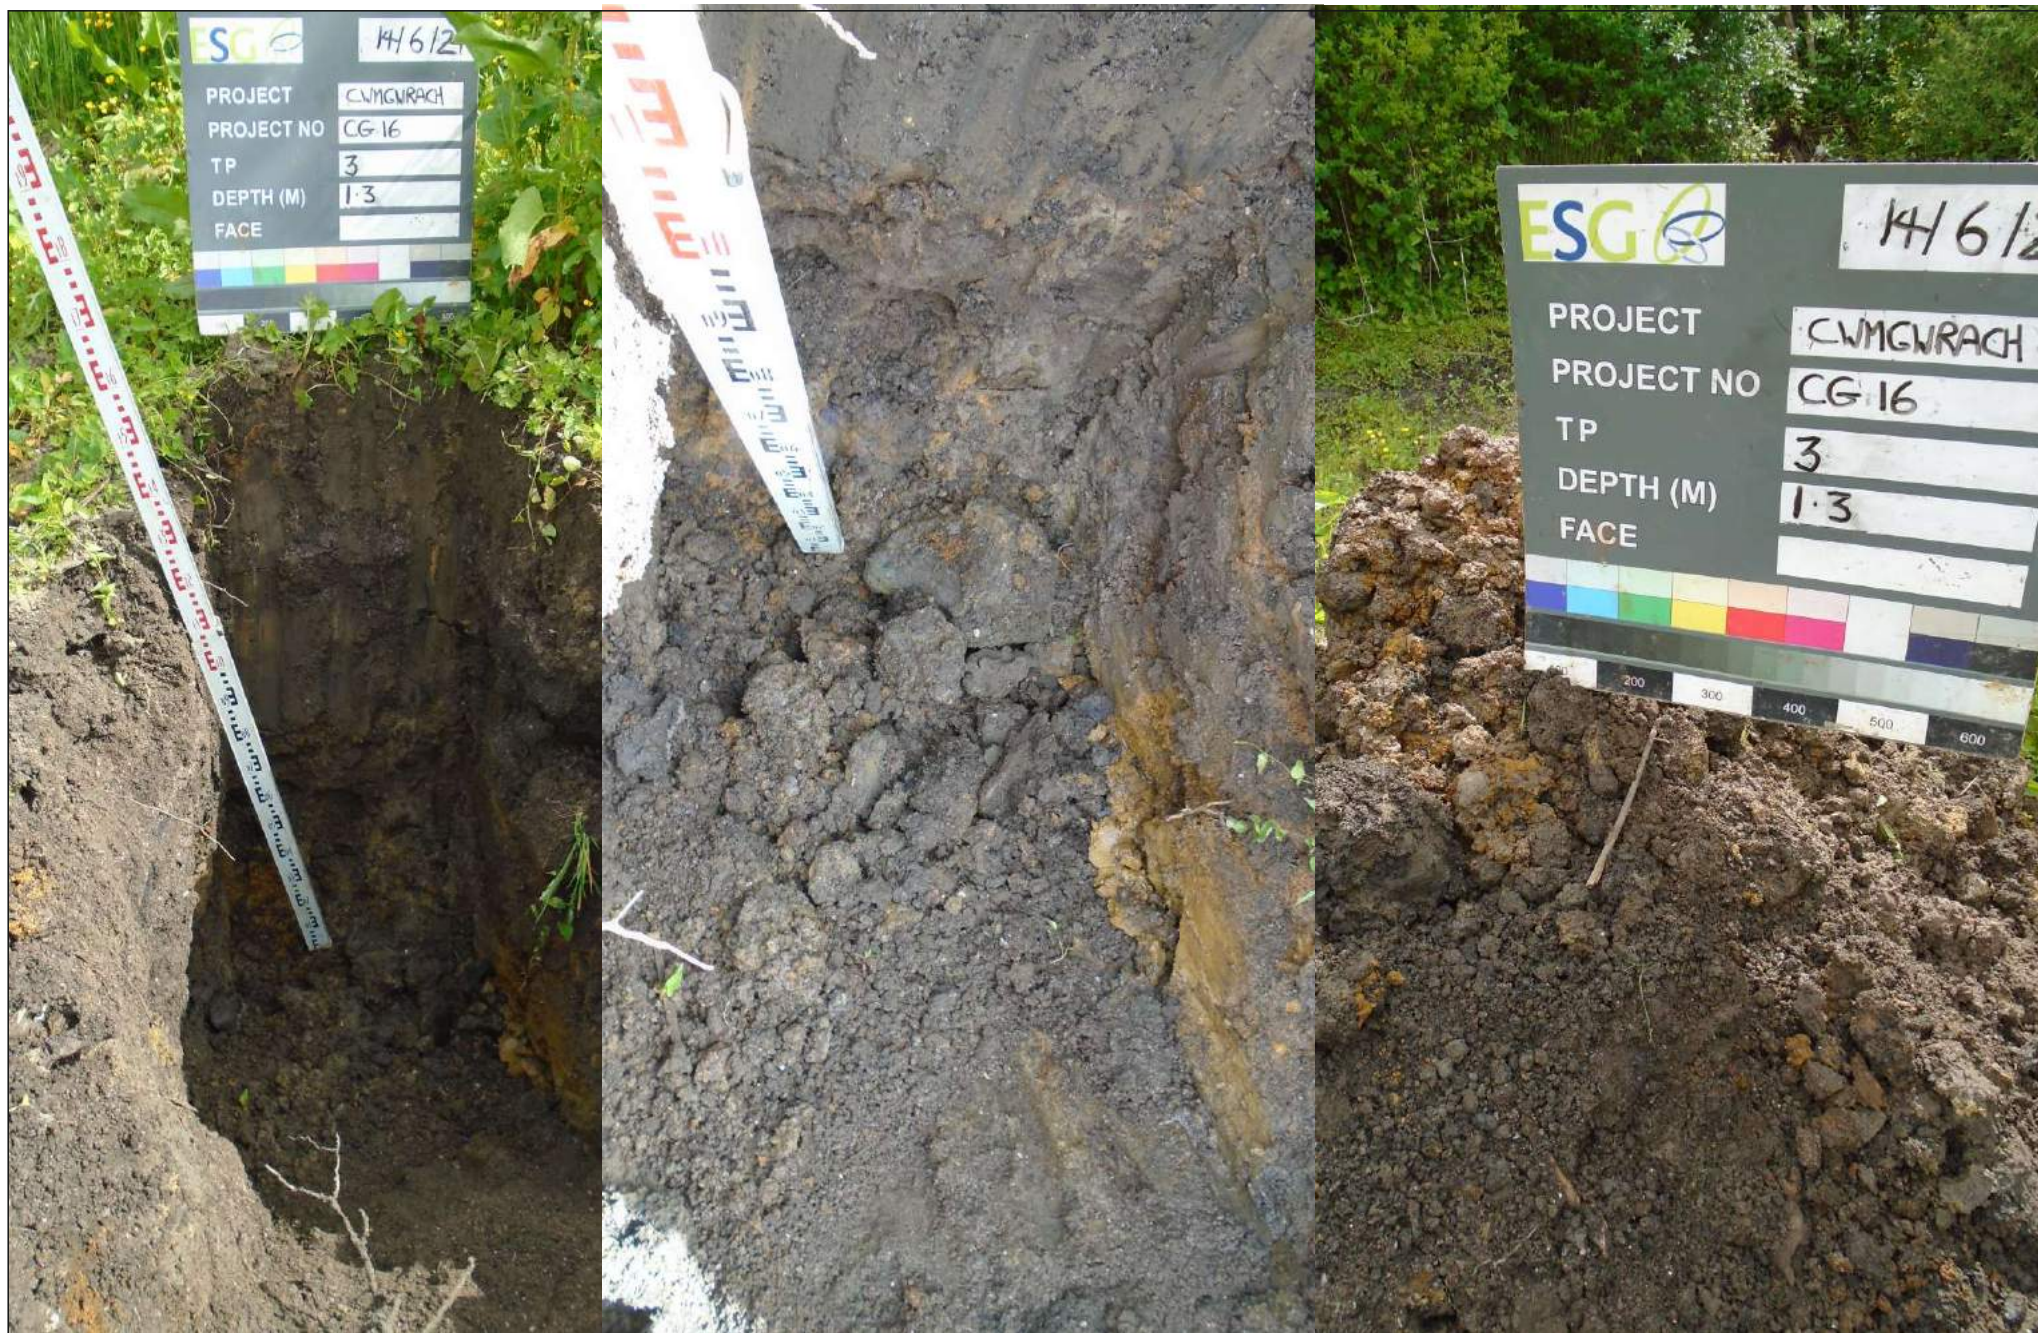
FIGURE 4 TP3

| Samples and Tests | | Strata | |
|---|---|---|---|
| | | G.L. | MADE GROUND. Loose to medium dense blackish grey clayey sandy GRAVEL. Gravel is angular, fine to coarse of brick, concrete and masonry. |

With the inorganic substances in Table 6, there was a single exceedance of one of the S4UL levels for the metals tested for. The Arsenic level in the sample from TP3 at 0.75m (highlighted in red) was above the relevant S4UL (44.8 mg/kg, S4UL= 37 mg/kg).

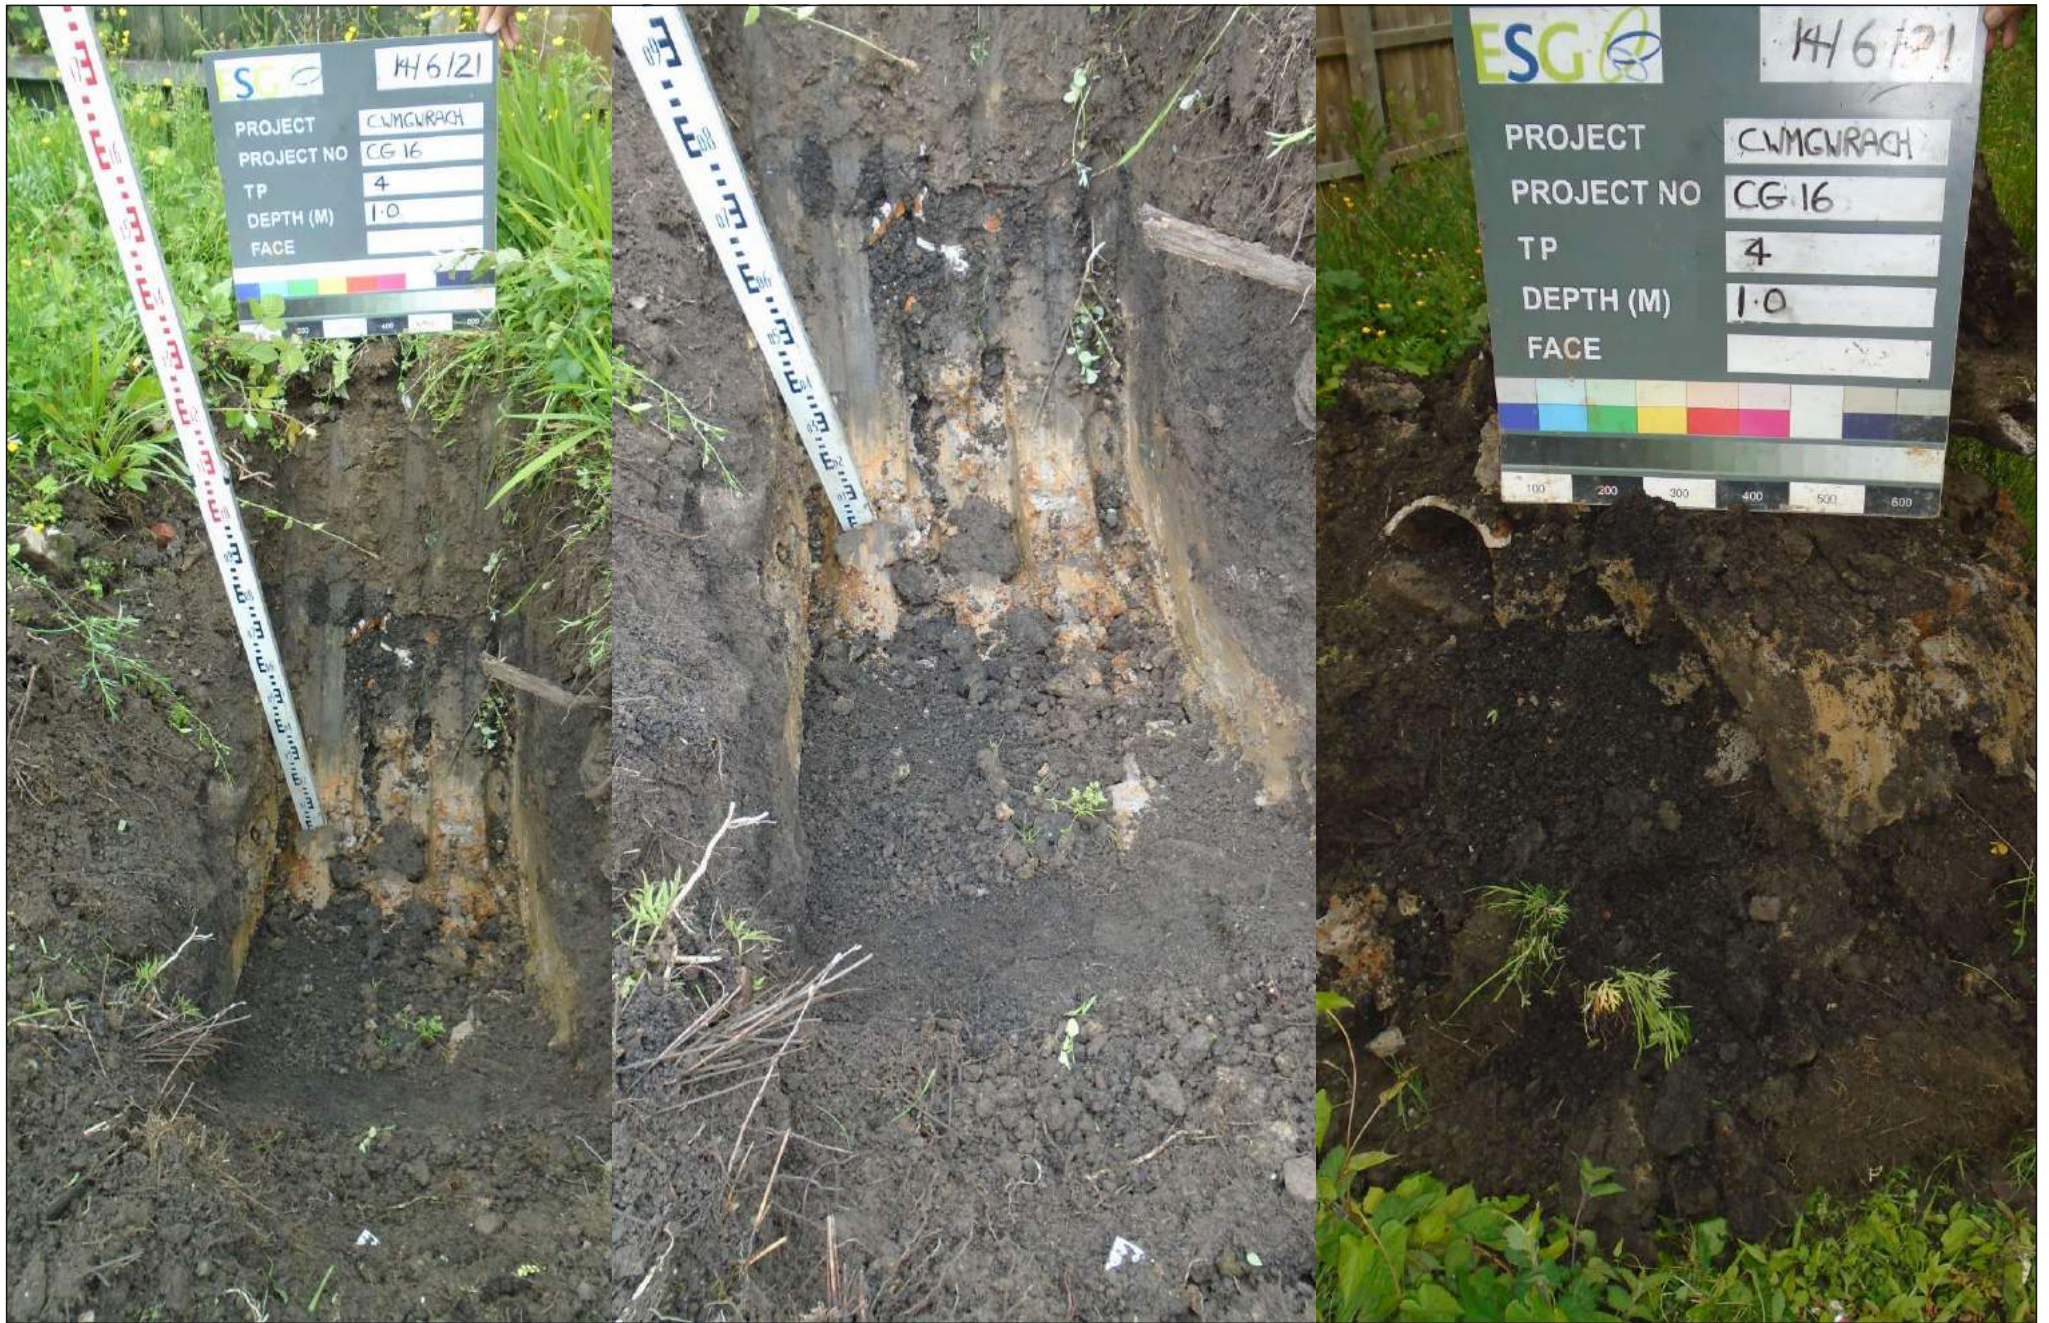
FIGURE 5 TP 4

| Samples and Tests | | Strata | |
|---|---|---|---|
| | | G.L. | MADE GROUND. Loose to medium dense blackish grey clayey sandy GRAVEL. Gravel is angular, fine to coarse of brick, concrete and masonry. |

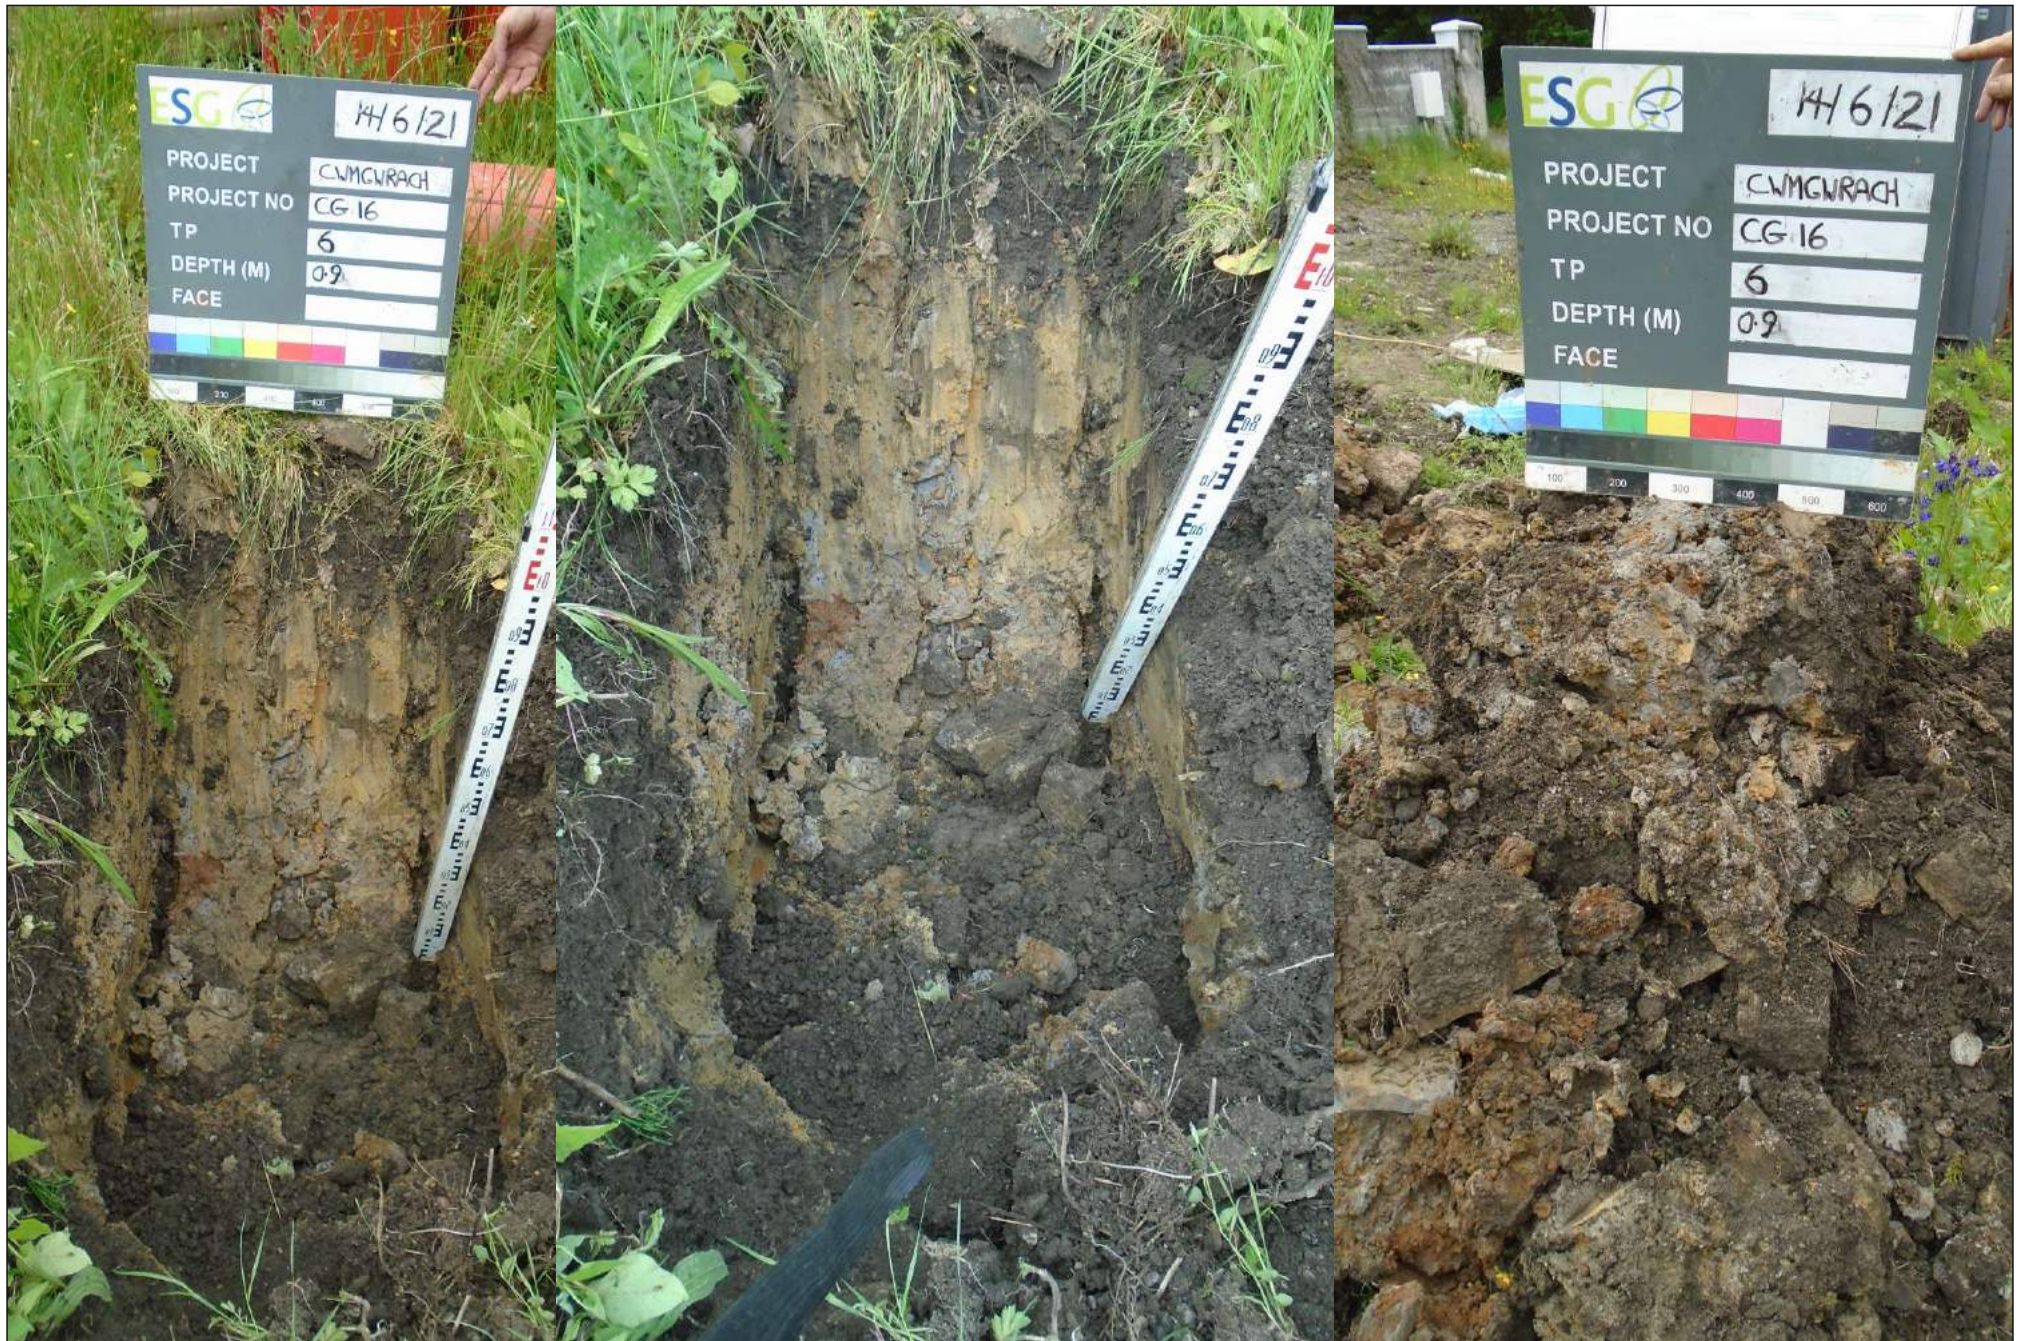
FIGURE 7

| Samples and Tests | | Strata | |
|---|---|---|---|
| | | G.L. | MADE GROUND. Loose to medium dense blackish grey clayey sandy GRAVEL. Gravel is angular, fine to coarse of brick, concrete and masonry. |

TP6
